Strength and Serviceability of Damaged Prestressed Girders

Habib Tabatabai
Azam Nabizadeh

University of Wisconsin-Milwaukee
Milwaukee, Wisconsin

WisDOT ID no. 0092-17-02
May 2019

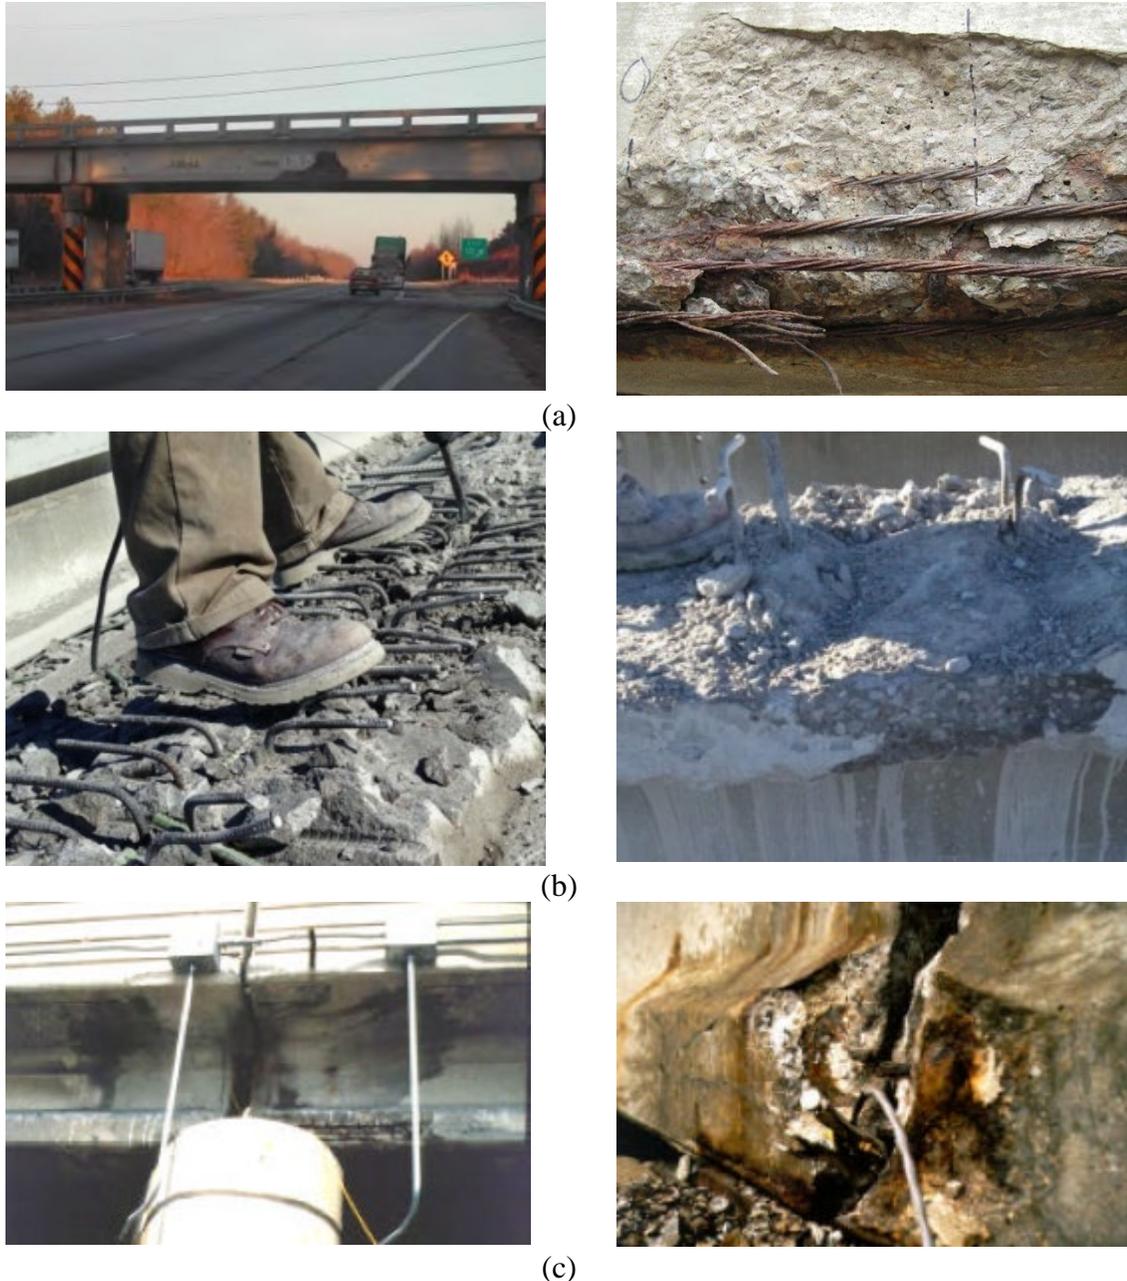
Figure 1.1. Modes of damage to prestressed girders: a) Accidental over-height vehicle impact (Harries 2006); b) Unintended damage during deck slab removal (Assad, 2014); and c) Corrosion damage to prestressed beam ends (Tabatabai et al., 2005)

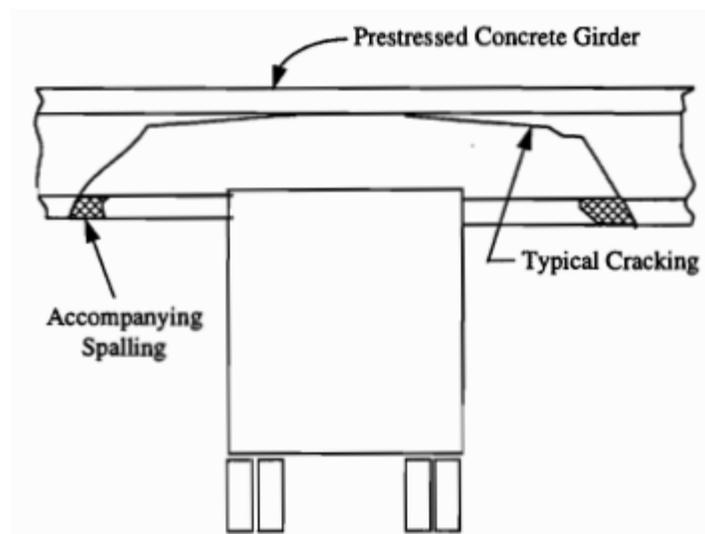
Figure 2.1. Typical crack pattern due to side truck impact (from Feldman et al., 1996)

The authors describe typical cracking pattern (Figure 2.1) associated by side impact by a truck (Feldman et al., 1996).

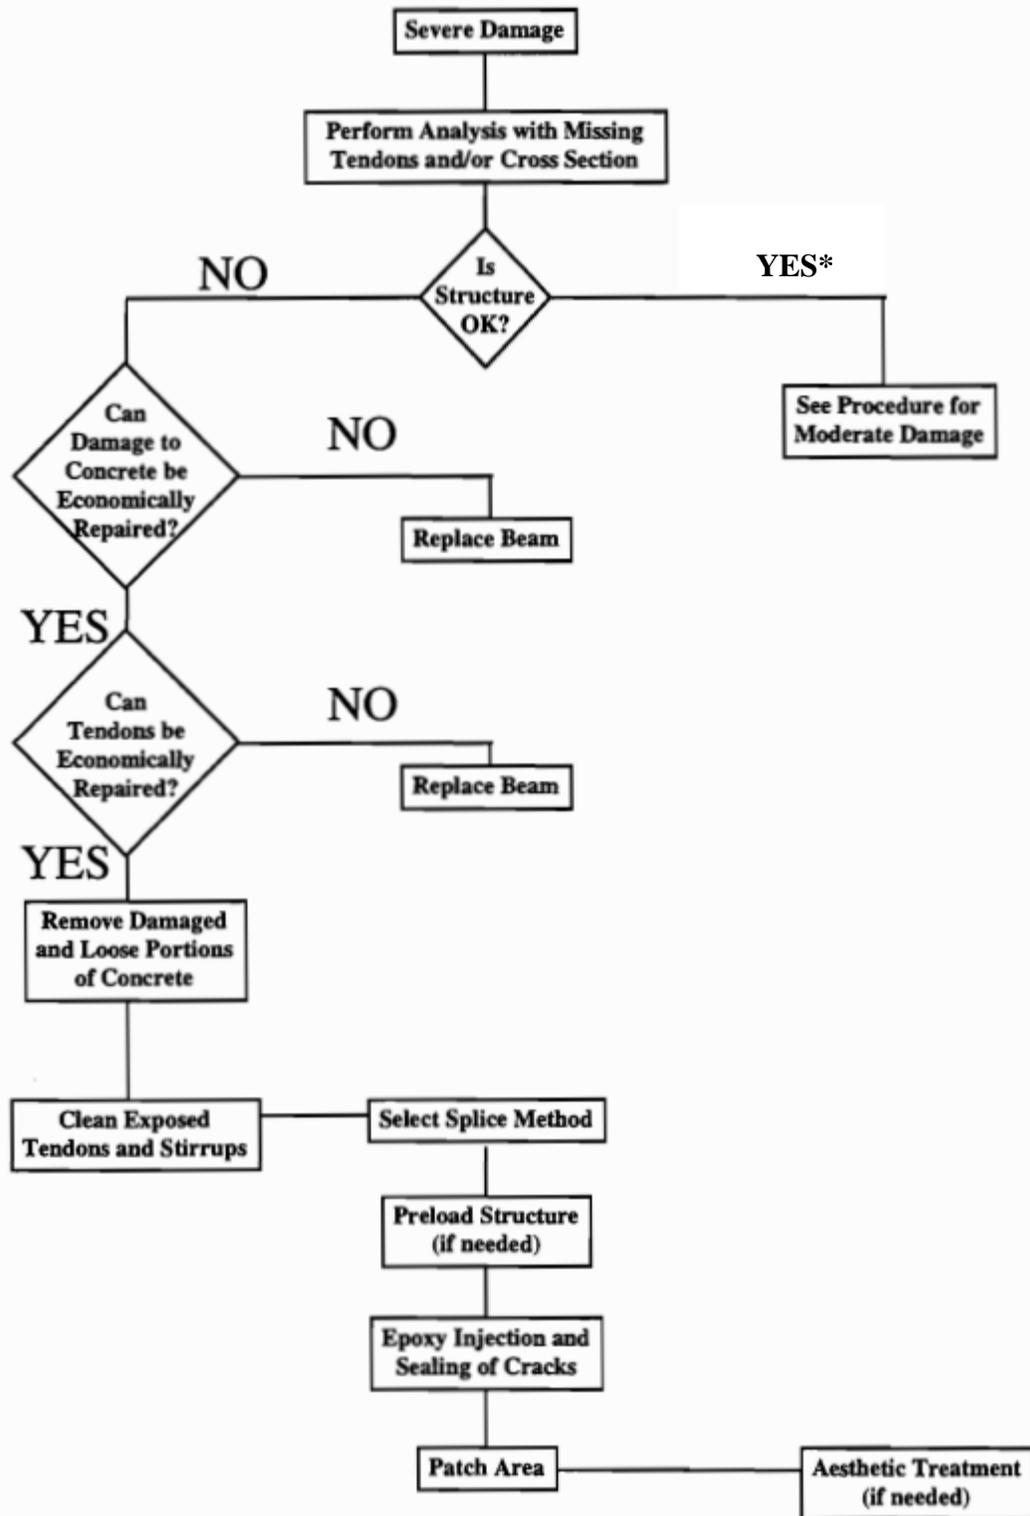
Figure 2.3. Flowchart for repair of severely damaged girders (from Feldman et al., 1996) (*apparent typographical error has been corrected).

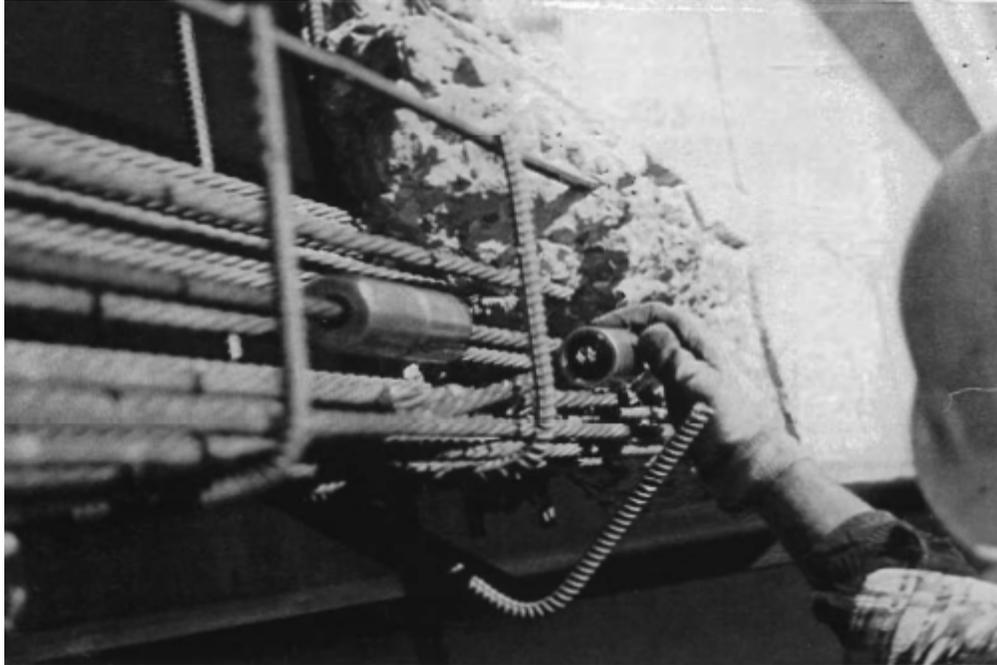
Figure 2.4. Installation of internal splice device (from Feldman et al., 1996)

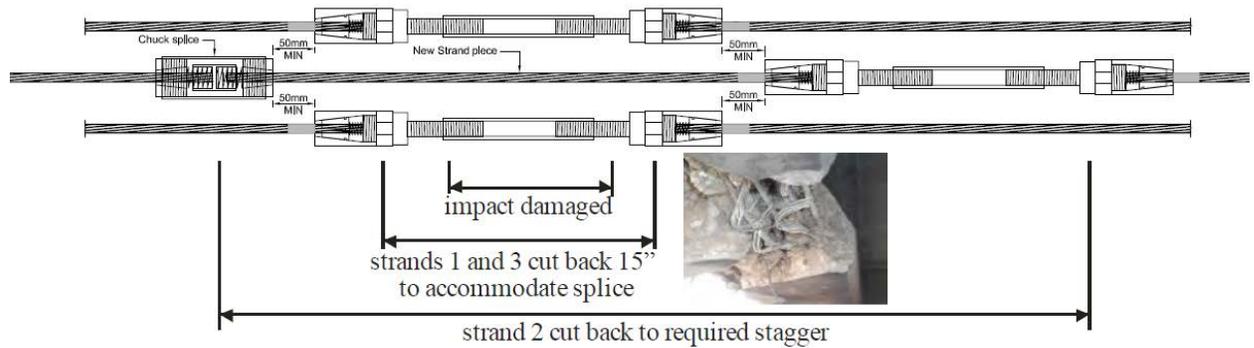
Figure 2.6. Internal strand splices and chucks (Harries et al. 2012 and Prestress Supply 2018)

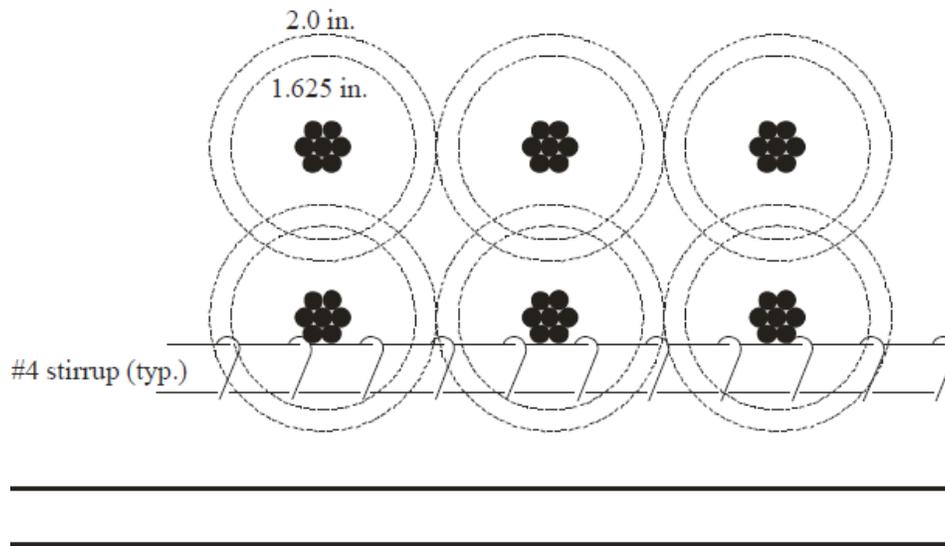
Figure 2.7. Physical interference of internal strand splices (Harries et al. 2012)

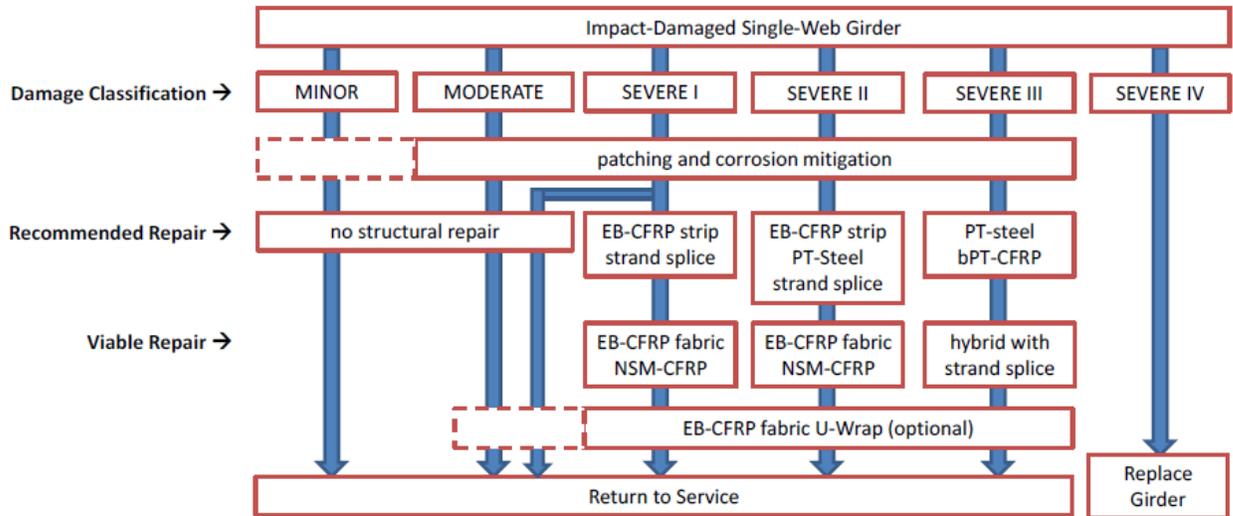
Figure 2.8. Selection of repairs for damaged prestressed I girders (Harries et al. 2012)

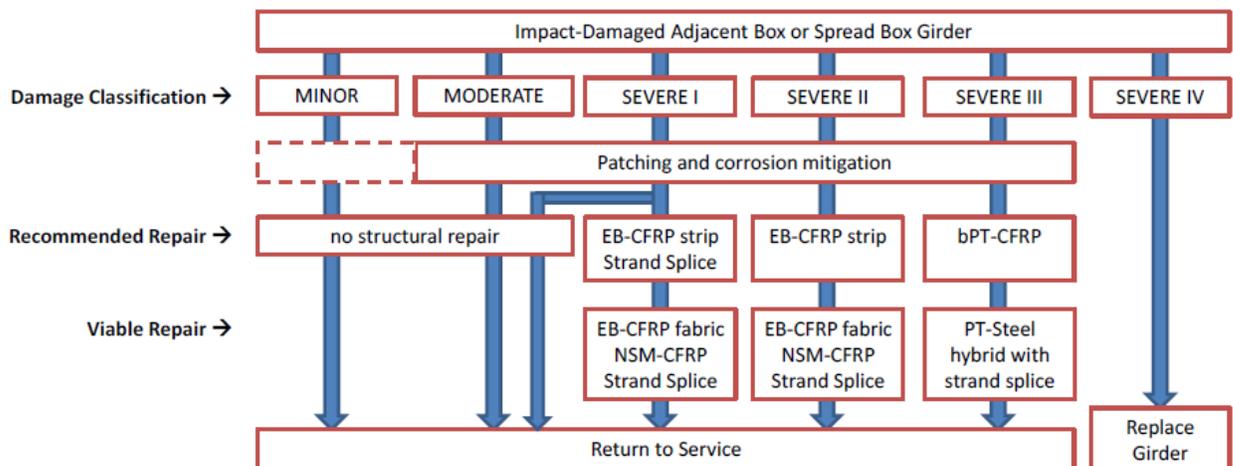
Figure 2.9. Selection of repairs for damaged prestressed box girders (Harries et al. 2012)

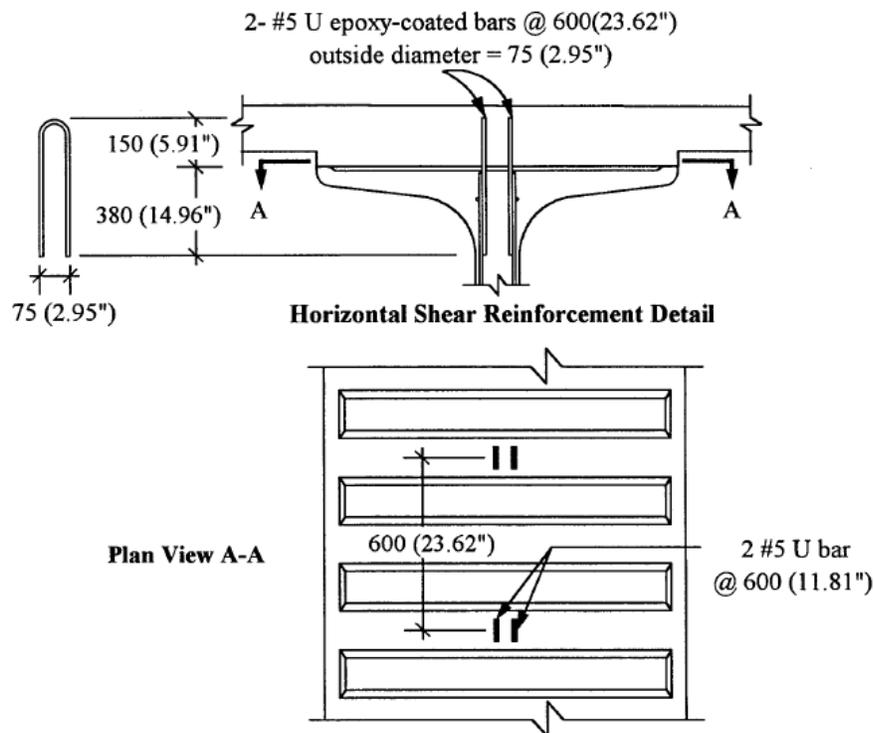
Figure 2.10. Debonded shear key system (Badie and Tadros, 2000)

The authors concluded that the debonded shear key system was a “competitive replacement” for the traditional roughened surface and would minimize damage to top flange of NU girders during deck replacement operations.

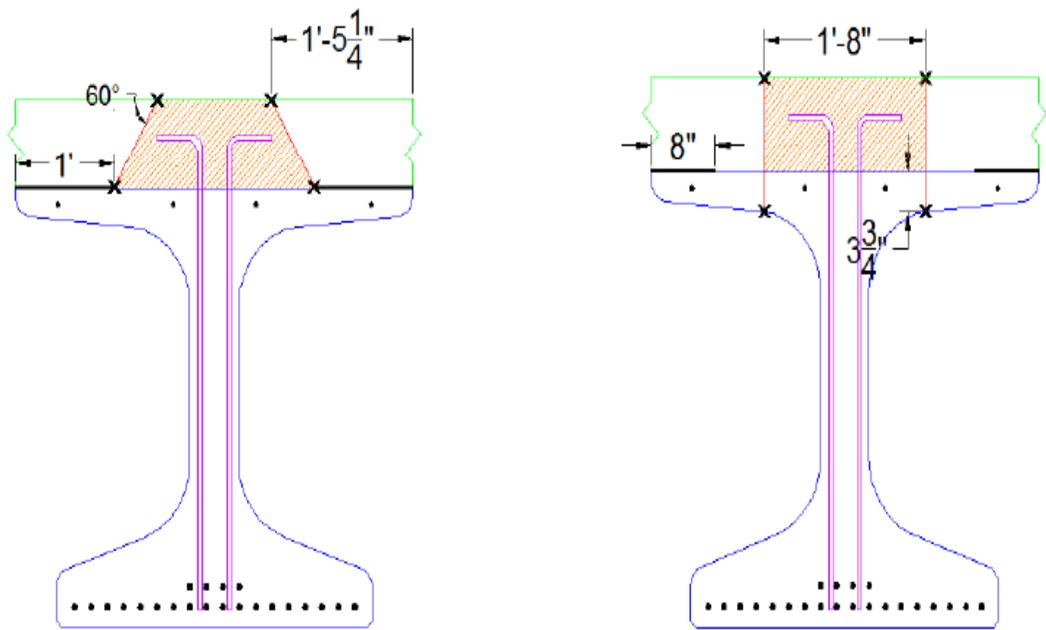
Recommend Method A: 1-ft-wide debonding width and sloped cuts

Finally, the author recommended a method for new construction involving increased debonding length and 60-degree sloped cuts (Method A in Figure 2.12), and a method for existing bridges with low span-to-depth ratios involving vertical cuts through the deck and flange, and removal of the remaining concrete using 60-lb jack hammers above the shear connectors, and 30-lb hammers below the shear connectors (Method B in Figure 2.12).

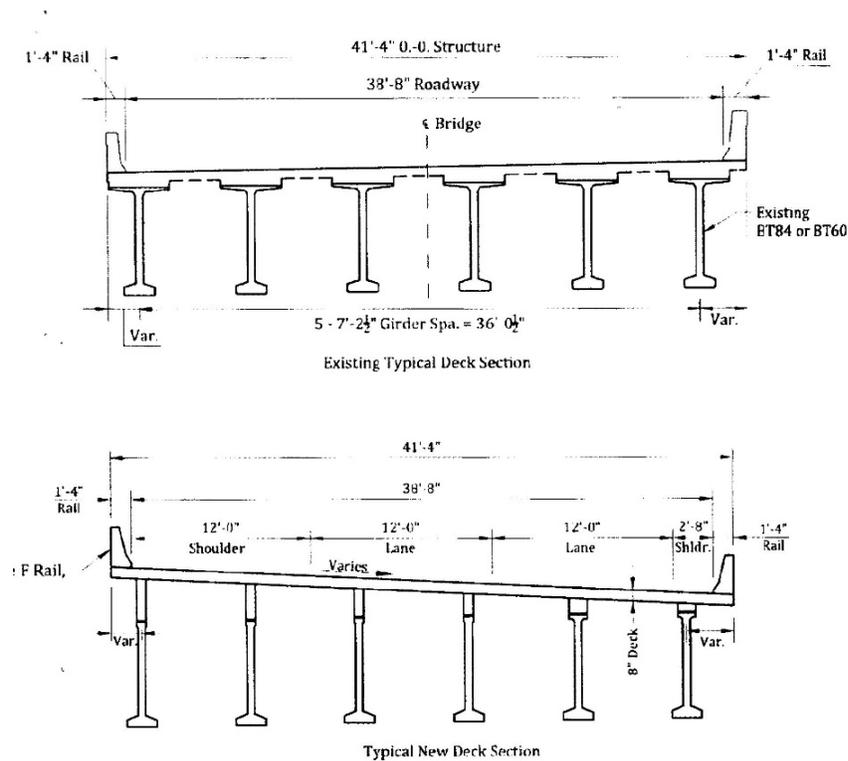
Figure 2.13. Deck removal and raising the height of prestressed girder (Potisuk et al., 2016)

the web was extended to achieve the new super-elevation (Figure 2.13.) A sweep of up to 1 in. was noted on the exterior girder after the deck was cut, which “was stabilized by the existing intermediate diaphragm in each span.” Cracks were also noted at the bottom of the girders near support, but these cracks closed after placement of the new deck slab. Cracks that developed on the webs of the extended girders near supports were epoxy injected. The authors considered the crack issues to be minor and suggested that restraining elements be provided to avoid girder sweeping when the deck and top flange are removed.

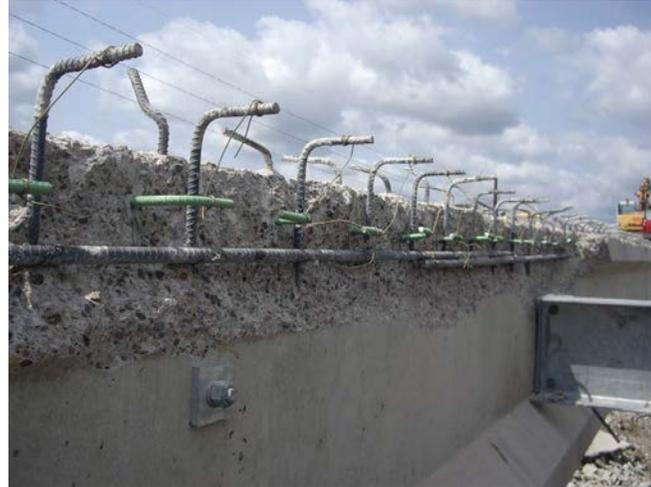
Figure 3.1. Damage to the top flange of prestressed concrete girder on B-64-122 resulting from deck removal.

Structures B-64-122 and B-64-123 are a pair of parallel bridges in Walworth County that sustained a significant amount of damage to the top flanges of several girders during a bridge deck replacement project. Figure 3.1 shows the damage incurred during deck removal to a section of the top flange of a girder on structure B-64-122 that was repaired using patching material. There are two girders that have approximately 15-20-foot-long repair patches to the top flange (Figure 3.1) and another girder that incurred damage to the top flange on both faces of the flange. Figures 3.2 and 3.3 show the repair done to the damaged girders of bridge B-64-122 and B-64-123, respectively. The available repair information for bridge B-64-123 is shown in Figure 3.4.

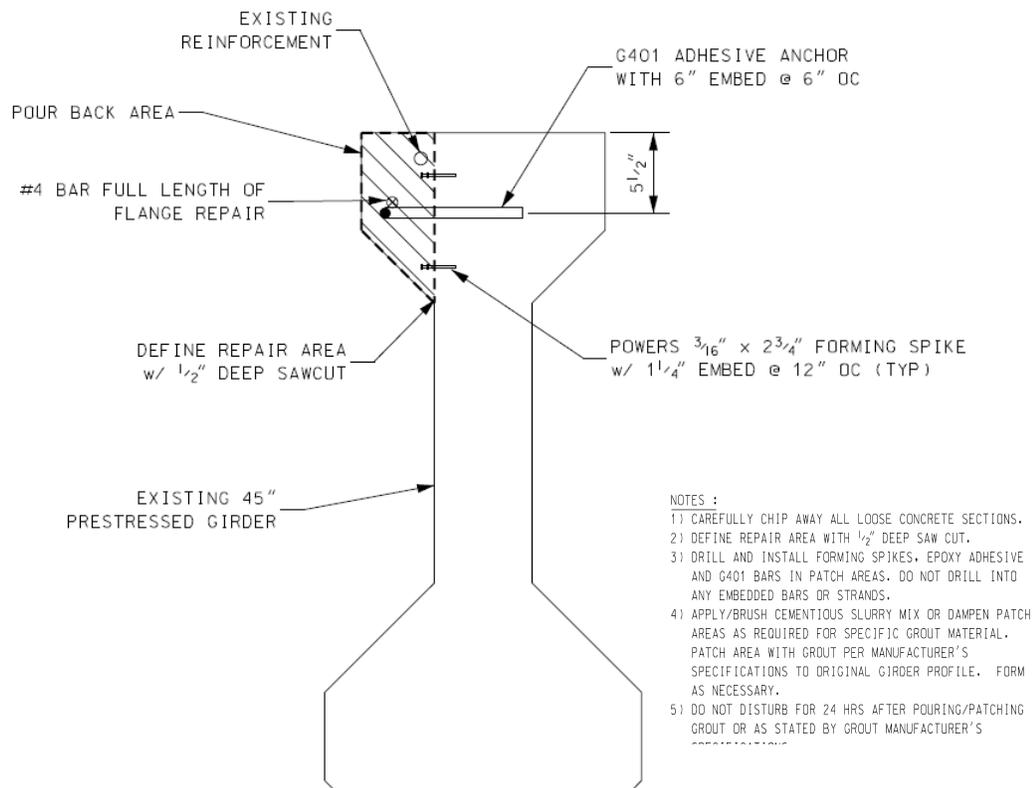
Figure 3.4. Girder repair section, (WISDOT, HSI report)

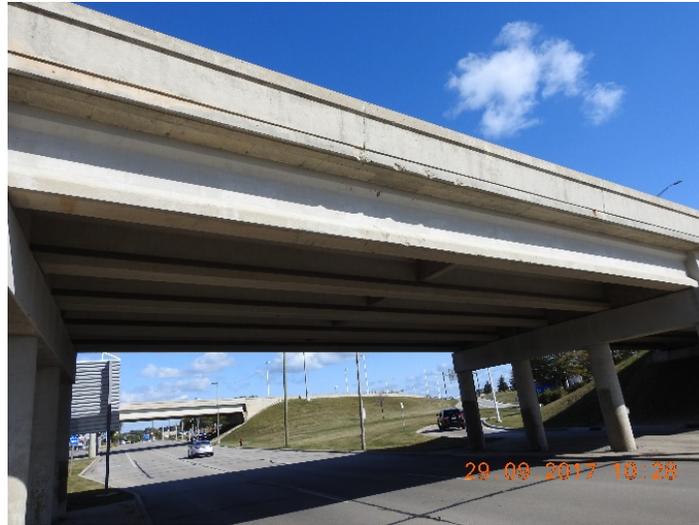
Figure 3.5. Bridge B-40-485 with minor damage on the prestressed girder

This structure had numerous instances of minor damage to the bottom flanges of girders (Figure 3.5) as well as spalling on the bridge deck soffit. Deck spalling appears to be unrelated to the accidental flange damage. While the girders on this bridge do not appear to have any major damage, there are numerous nicks and gouges to the exterior girders. Figure 3.6(a) shows small nicks and gouges to an exterior girder and bottom of the barrier facing oncoming traffic. These are considered minor as they are small and do not expose any steel. Figure 3.6(b) shows a repair patch approximately 18-24 inches long that has subsequently experienced more minor damage.

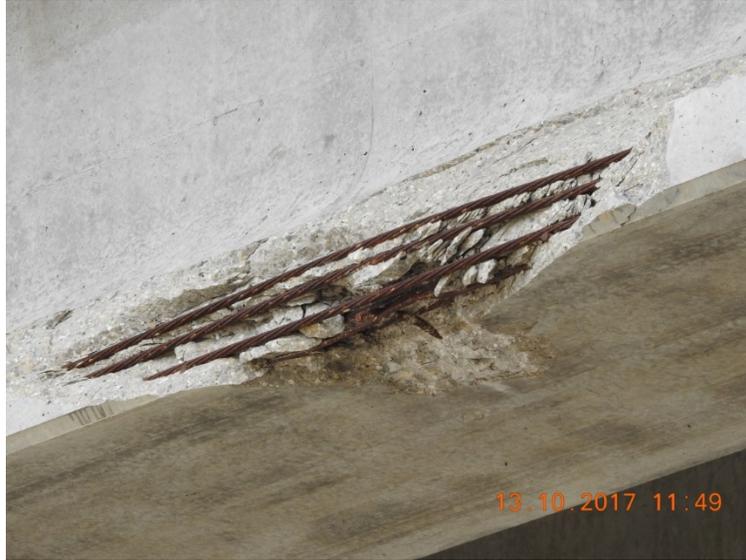
Figure 3.7. Impact damage to bottom flange of Girder 4 in B-20-157 (initial strike)

The damage shown in Figure 3.7 and Figure 3.8 show the impact damage. Concrete damage was relatively narrow (approximately 1 to 1.5ft) at the bottom of the flange where impact occurred. The damage and spalling were wider (a length of 3-4 feet) at the top of the bottom flange. Both instances of damage exhibit a similar pattern.

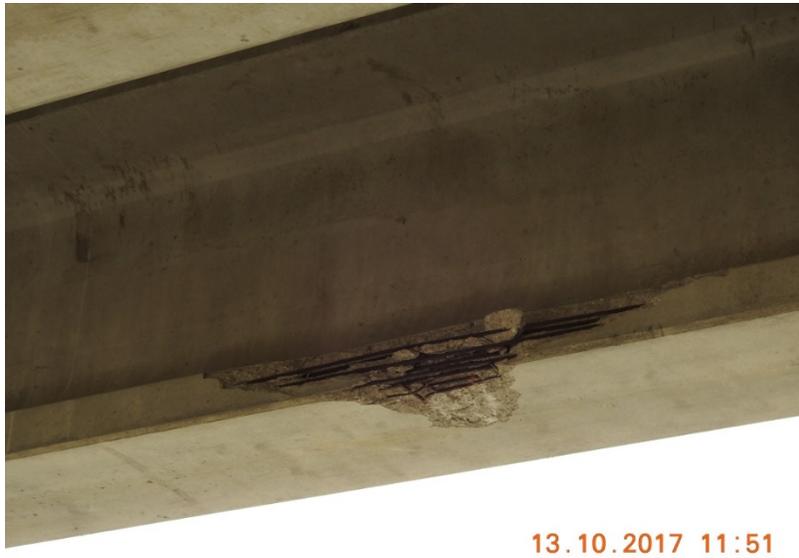
Figure 3.8. Damage to the bottom flange of Girder 1 in B-20-157 (rebound impact)

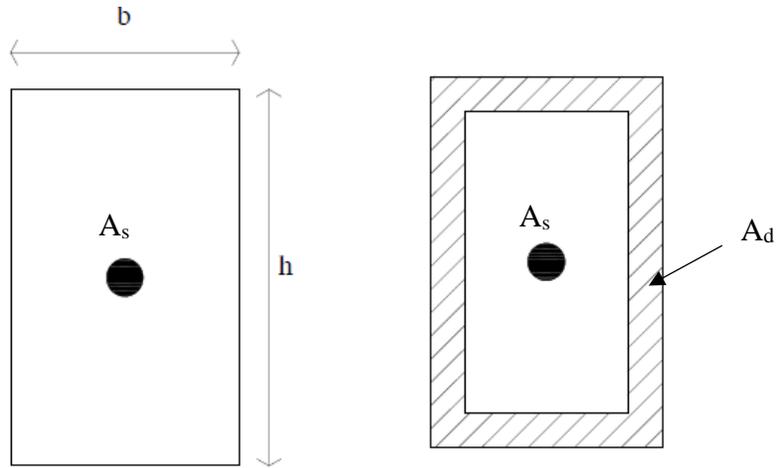
a) Undamaged section b) Damaged section (loss of A_d)

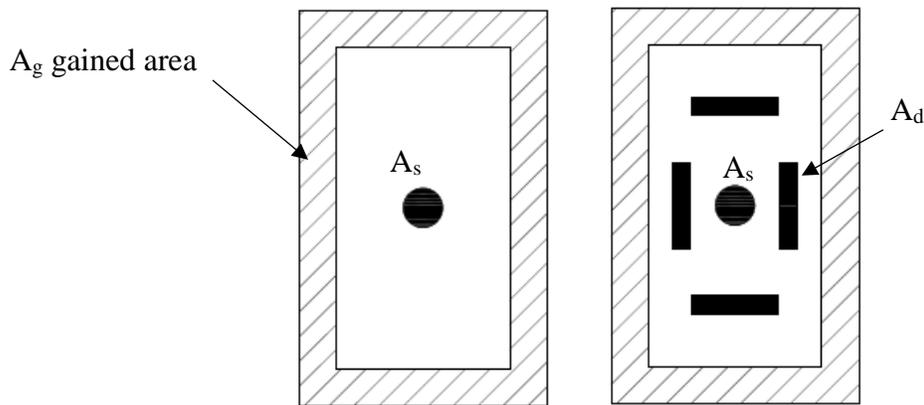
Figure 4.4. Addition of area (A_g) with a subsequent loss in section due to damage (A_d)

this example, assuming that the prestress force was applied on the original (non-augmented) section, the subsequent addition of an area (area gain or A_g) to the section would not redirect stresses to the new areas. This is analogous to adding a deck area on the girder, which would remain stress free without the action of creep, shrinkage, and composite dead loads. In a composite prestressed girder/slab system, the addition of slab augments the beam area without a redistribution of the stresses that already exist in the girder alone. If a subsequent loss of section occurs (A_d), it would not be immediately clear how existing forces would be redistributed in the composite section ($A_c + nA_s + A_g$). It is assumed here that both the gain and loss areas occur symmetrically with respect to the original section.

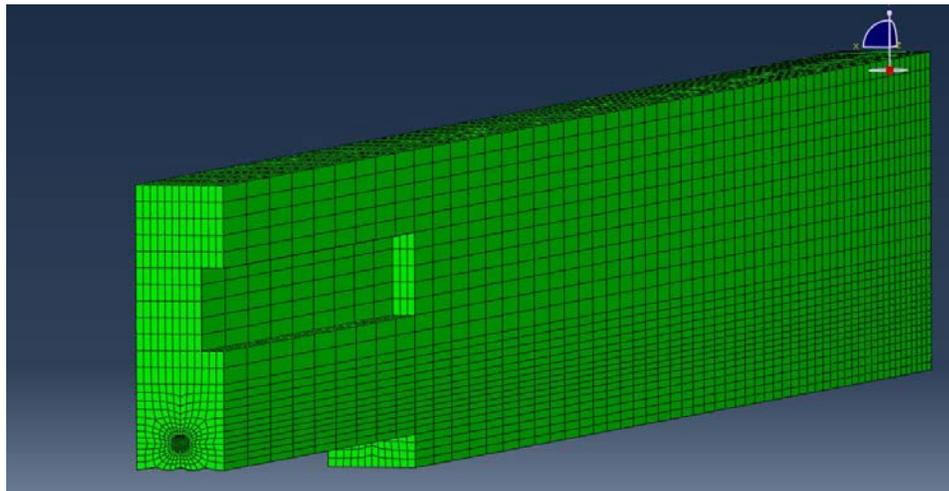
Figure 4.9. Damage simulation near the midspan of the beam (the cross section seen on the left is at midspan)

Prestressing forces was specified as a predefined field stress in the longitudinal direction of the strands, considering the effective stresses in each strand, and accounting for the calculated effects of long-term relaxation, shrinkage and creep. Elastic shortening was modelled through the finite element model itself. The model change technique was used to simulate a damage scenario in the beam. The damage was introduced at (and near) midspan as shown in Figure 4.9.

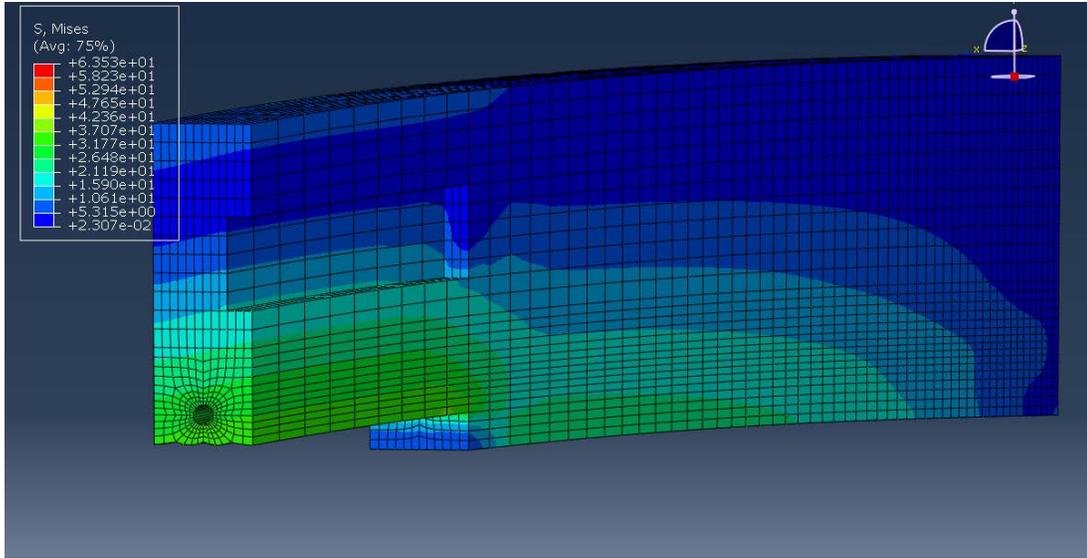
Figure 4.10. Stress contour after introduction of damage

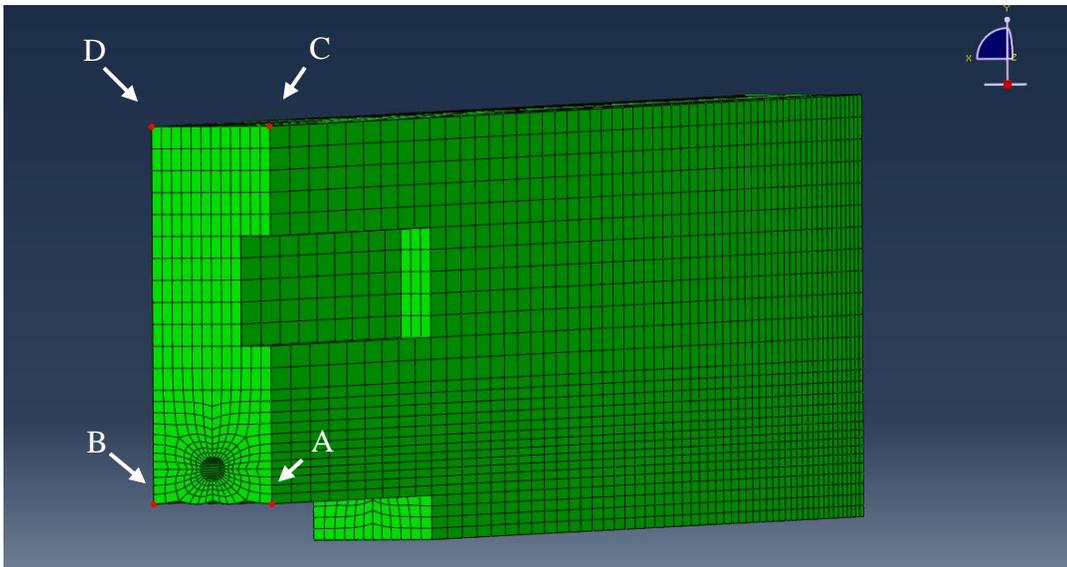
Figure 4.11. Measurement points (A, B, C, D) for calculations of change in stress due to damage

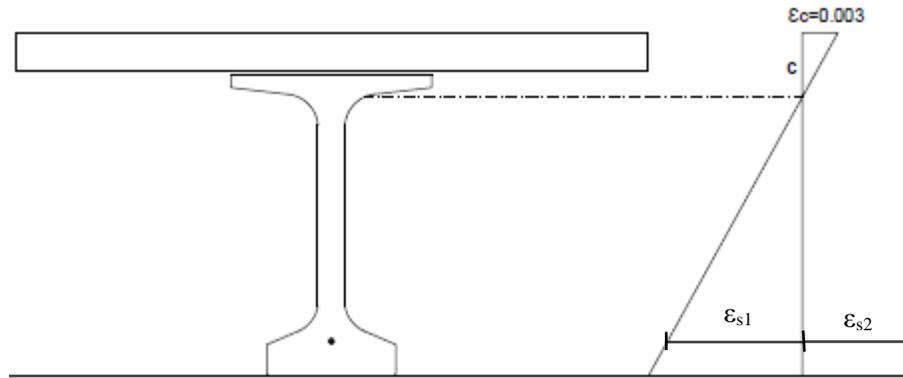
Figure 5.1. Strain diagram at strength limit state associated with crushing of concrete

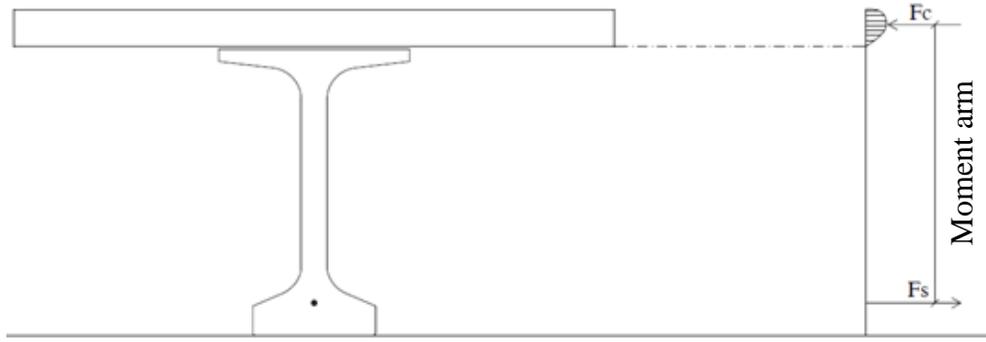
Figure 5.2. Strain and stress diagrams at the strength limit state

As c increases, the difference between tension and compression forces decrease until it approaches zero. At a point that the difference changes the sign from negative to positive, dF passes the zero value and the iteration in the loops stops at that point reporting the last two c values, tension and compression forces for further strength analysis. The PreBARS program interpolates the last two c values corresponding to the last two steps in the loop. The moment strength of the section can be calculated using the net value of tension or compression forces and the distance between the centroids of the two forces (Figure. 5.2).

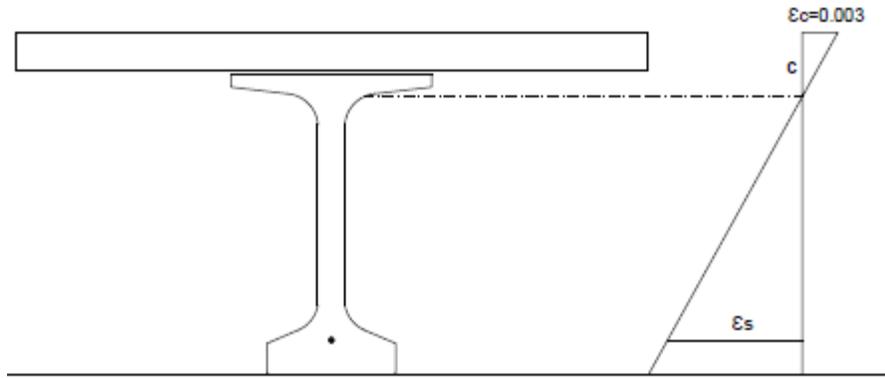
Figure 5.3. A typical strain compatibility diagram for undamaged composite section (before applying bottom damage)

Typical strain diagrams in undamaged, damaged, and repaired sections for top and bottom damage cases are shown in Figure. 5.3 through Figure. 5.9.

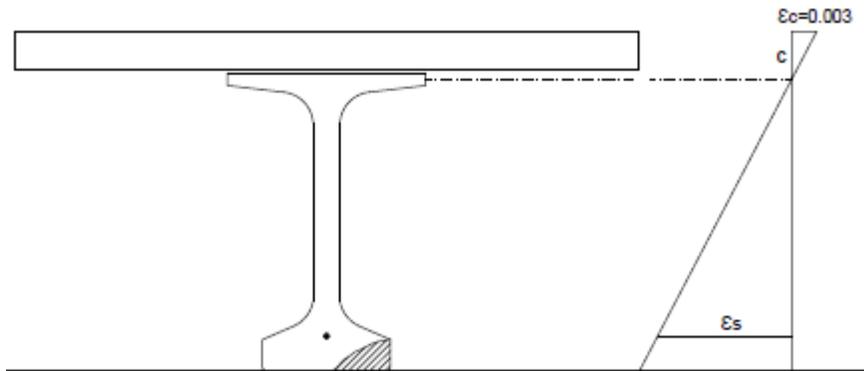
Figure 5.4. A typical strain compatibility diagram for bottom damage composite section

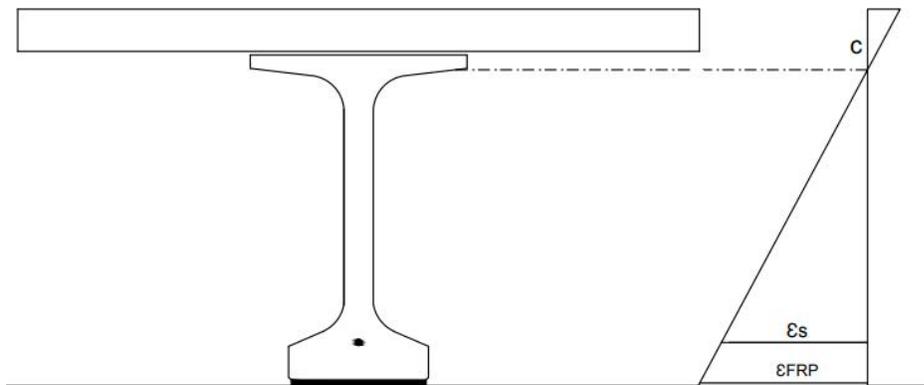
Figure 5.5. Typical strain compatibility diagram for composite section that is repaired after bottom damage (CFRP on soffit)

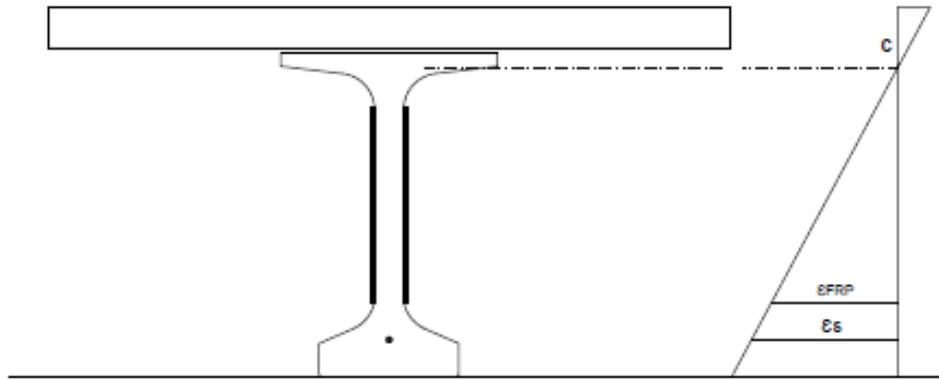
Figure 5.6. Typical strain compatibility diagram for repaired composite section after bottom damage (CFRP on web)

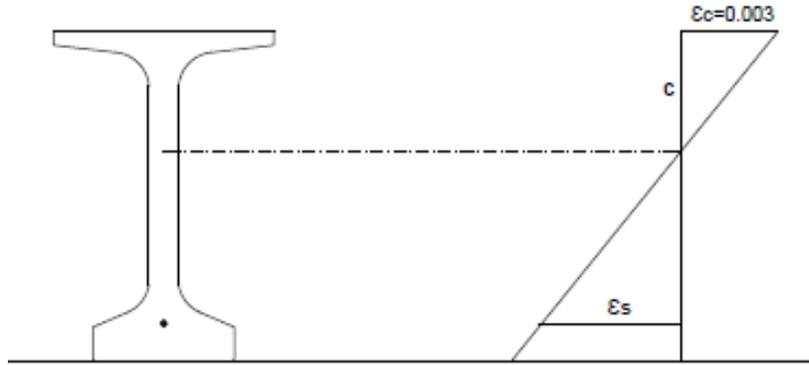
Figure 5.7. Typical strain compatibility diagram for undamaged non-composite section before top damage

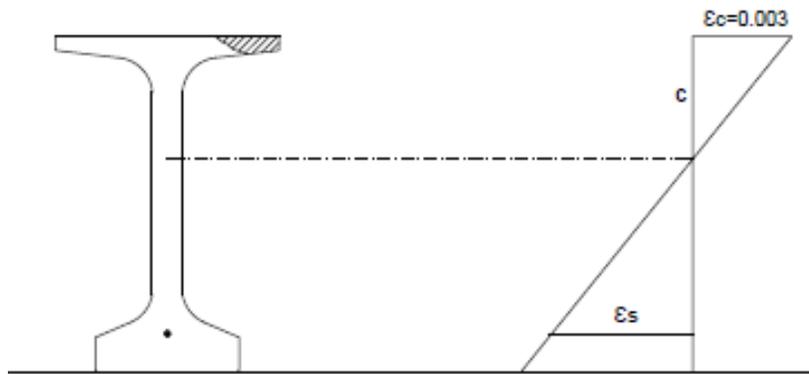
Figure 5.8. Typical strain compatibility diagram for top damage non-composite section

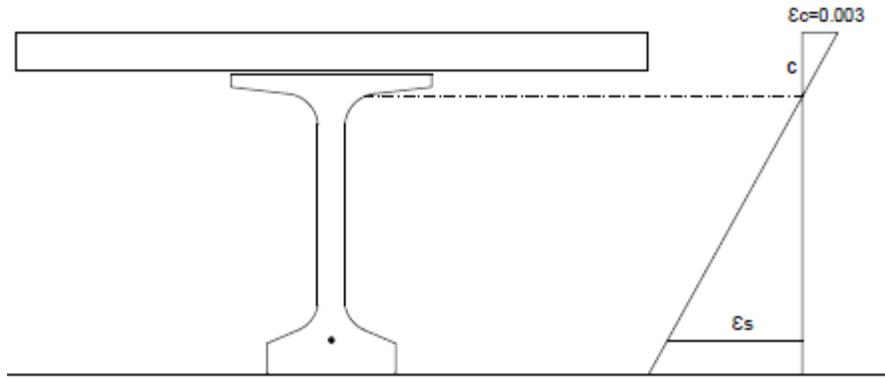
Figure 5.9. Typical strain compatibility diagram for repaired composite section after top damage

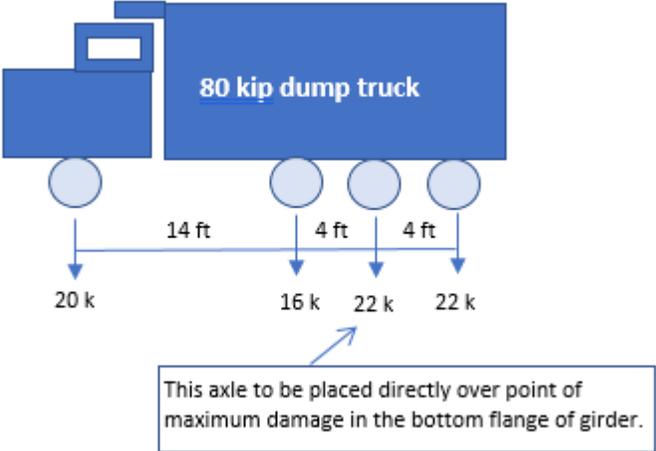
Figure 6.7. Preload 4-axle truck assumed in PreBARS

in the patch material, which could then exceed the allowable tension under Service III loading. An application of preload can reduce or eliminate this tension. This typically involves strategic placement of a loaded truck (or load(s) applied through hydraulic jacks) over the damaged area and maintaining the load while the patch hardens. Subsequent removal of preload would introduce compressive stresses in the patch based on the modulus of elasticity of the patch material. In PreBARS, the user can specify whether preload would be applied prior to patching. To simplify the preload application, it is assumed that a 4-axle dump truck (typically loaded with sand) would be used to apply the preload. In the current version of PreBARS, the total weight of the truck is assumed to be 80,000 lbs with the axle loads and spacings as shown in Figure 6.7. PreBARS would provide guidance as to the direction that the truck should face to maximize the moment introduced into the damaged girder. The axle loads and spacings can be changed (as an internal change to the program) if desired by the user.

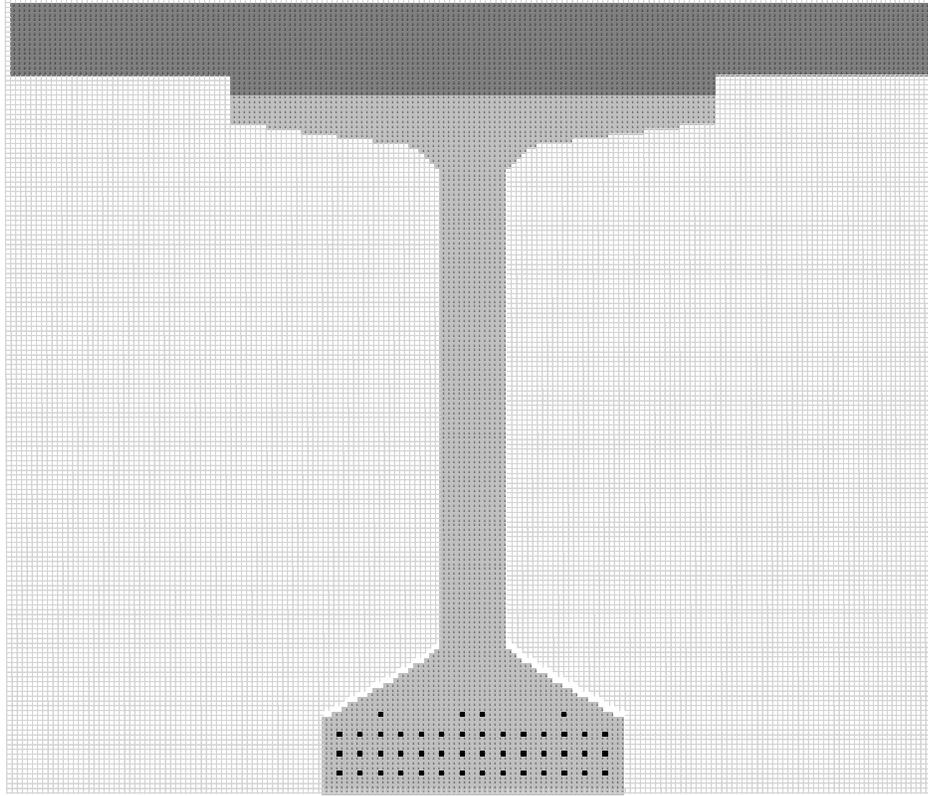
Figure 6.8. Undamaged Wisconsin 72W girder/slab cross-section with forty-six 0.6-in-diameter strands

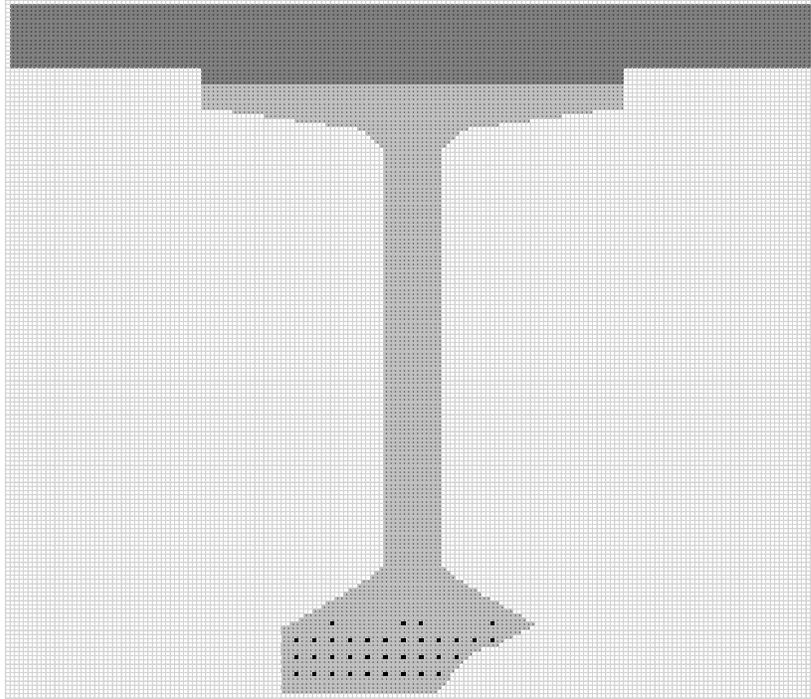
Figure 6.10. An example of modeling bottom damage with spalled concrete and severed strands

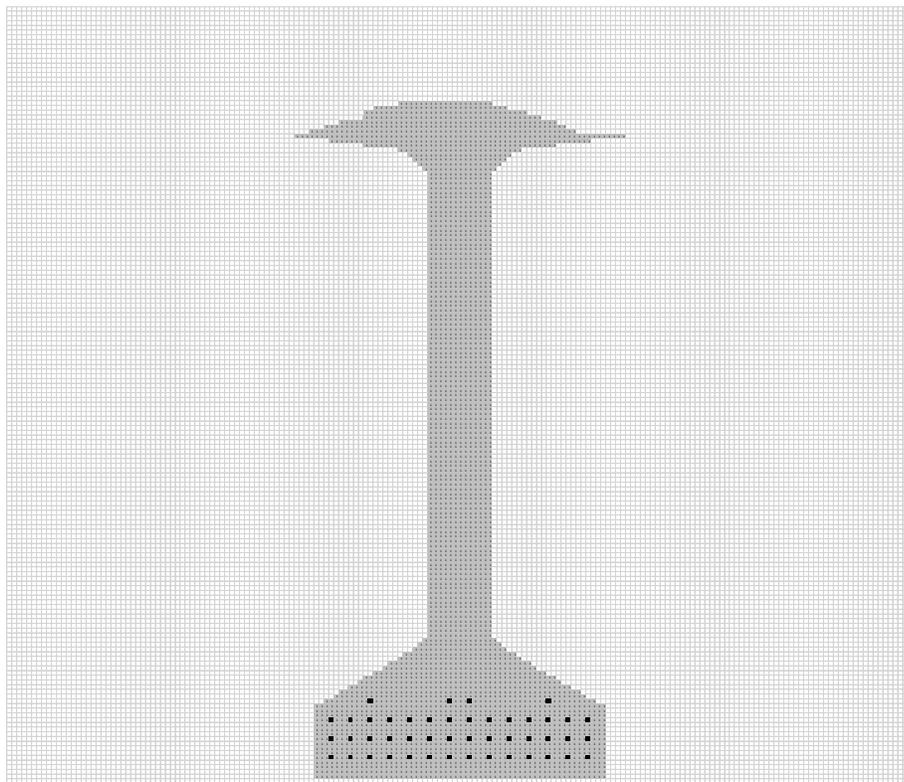
Figure 6.11. An example of modeling top damage

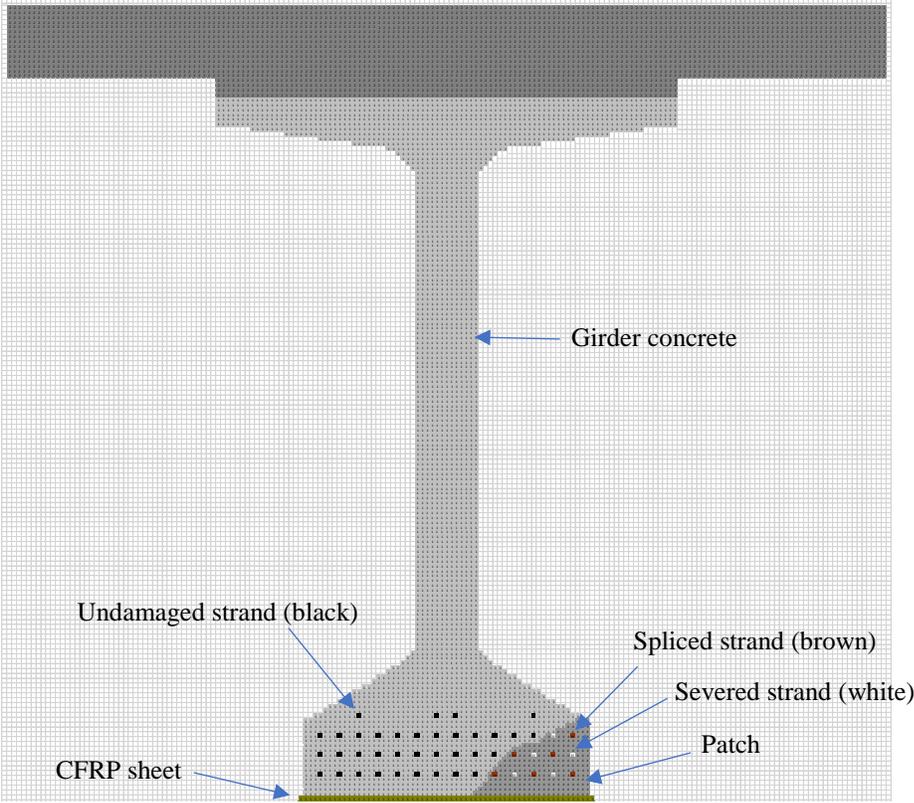
Figure 6.12. Repaired section for a bottom-damaged girder

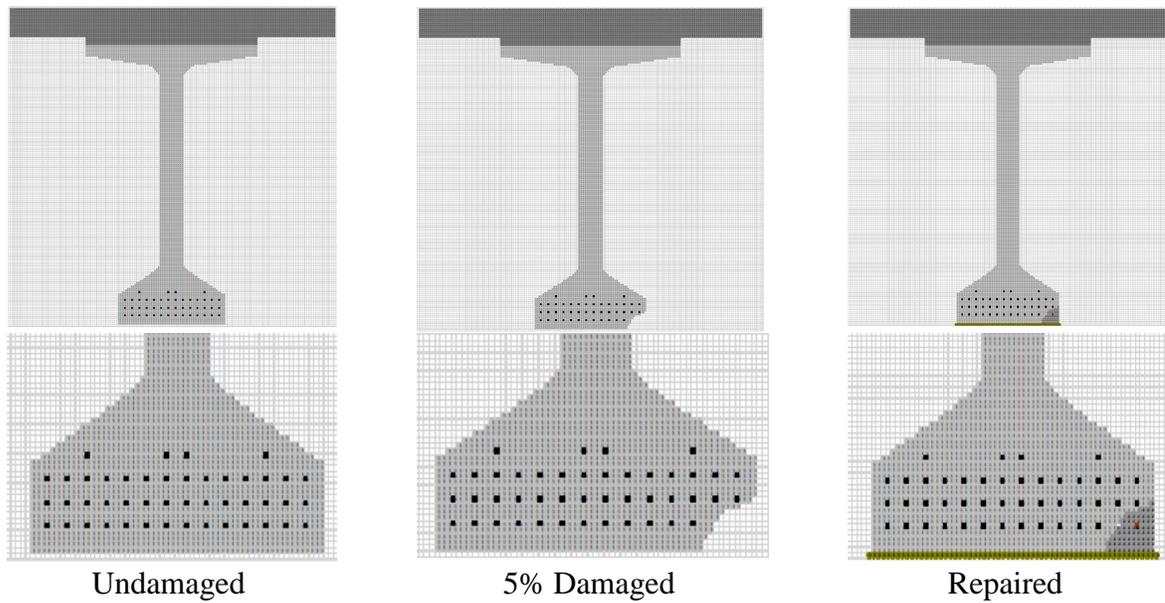
Figure 7.1. Structure 1 under the 5% bottom damage case

Figures 7.1 through 7.6 shows examples of damage and repair conditions in various damage cases for both structures.
