Strength and Serviceability of Damaged Prestressed Girders

Habib Tabatabai
Azam Nabizadeh

University of Wisconsin-Milwaukee
Milwaukee, Wisconsin

WisDOT ID no. 0092-17-02
May 2019

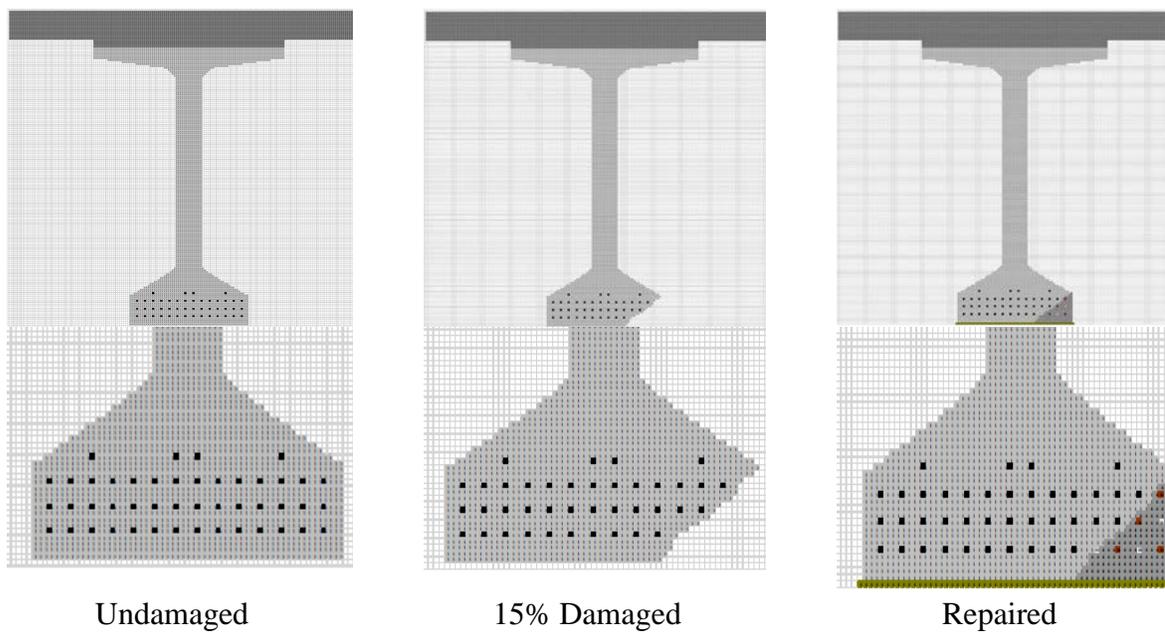
Figure 7.2. Structure 1 under the 15% bottom damage case

Figures 7.1 through 7.6 shows examples of damage and repair conditions in various damage cases for both structures.

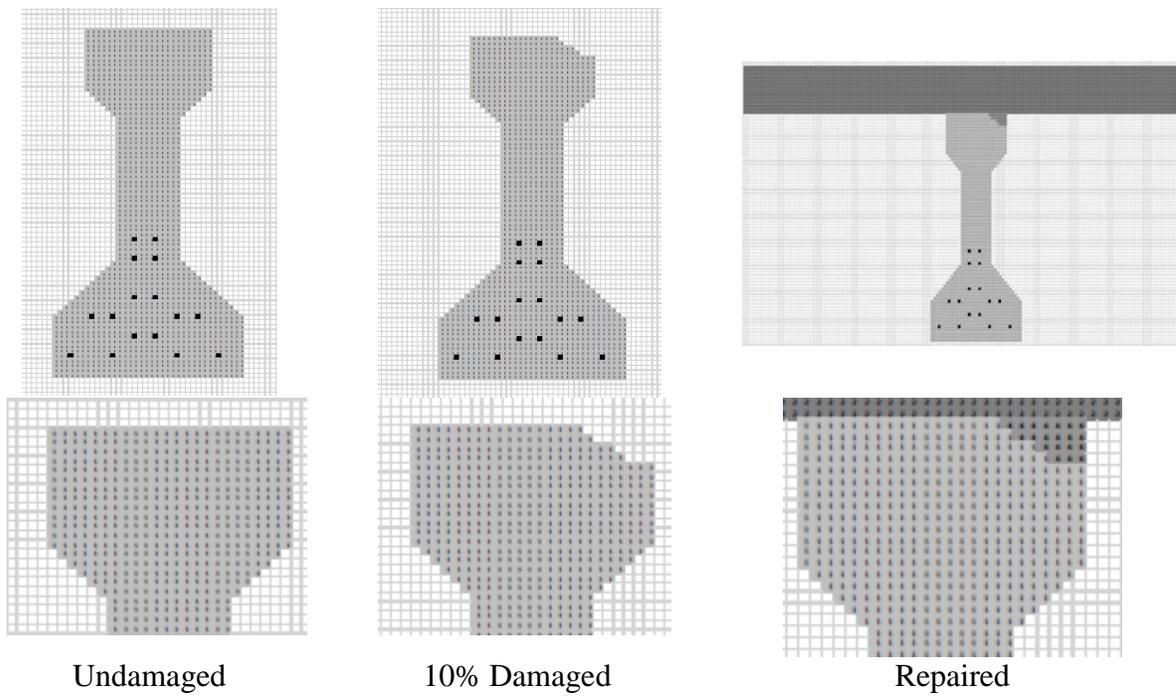
Figure 7.4. Structure 2 under the 10% top damage case

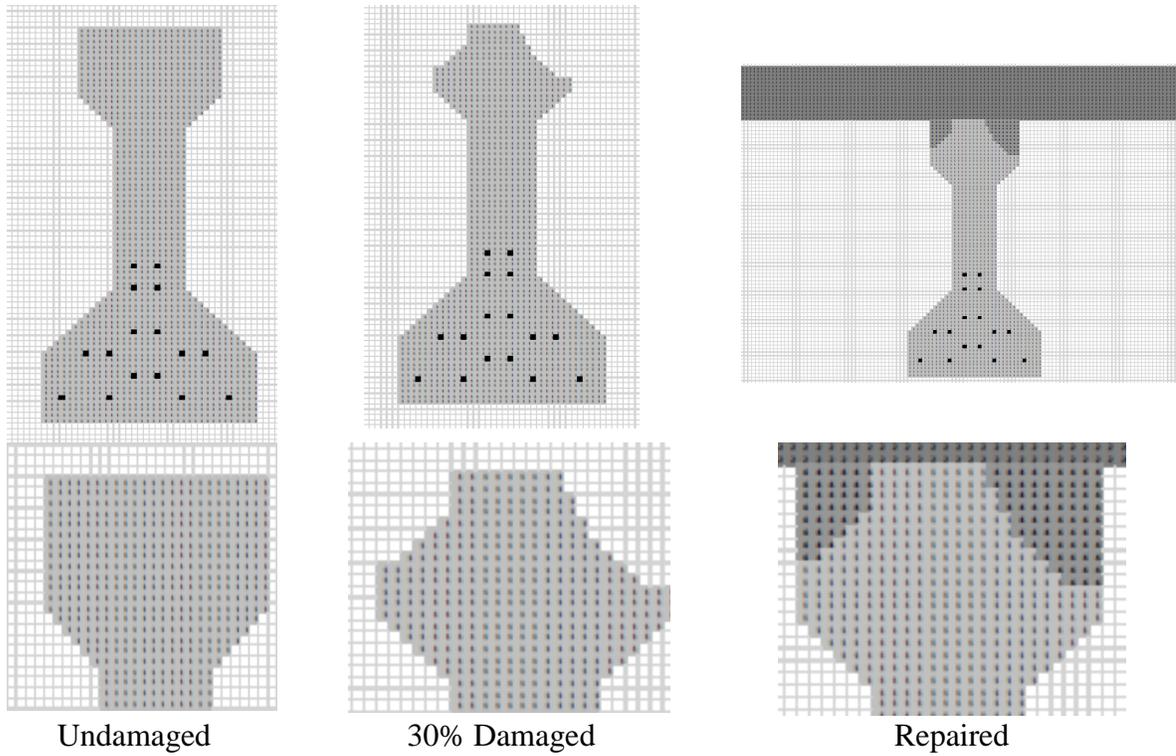
Figure 7.5. Structure 2 under the 30% top damage case

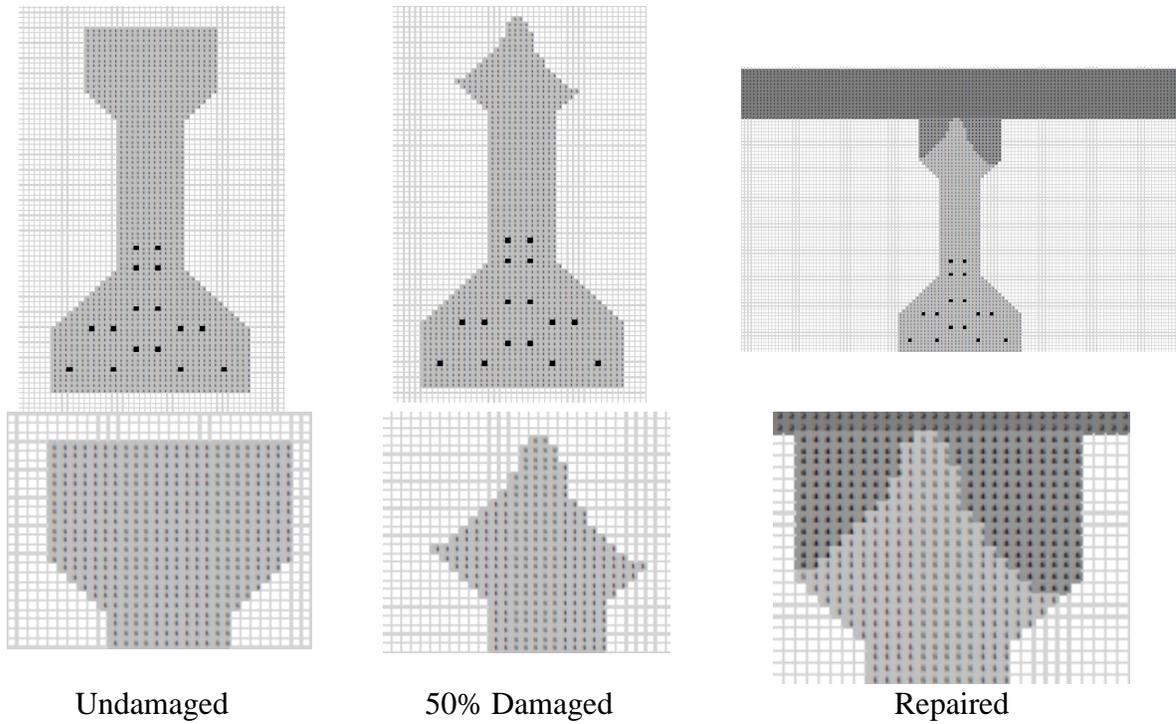
Figure 7.6. Structure 2 under the 50% top damage case

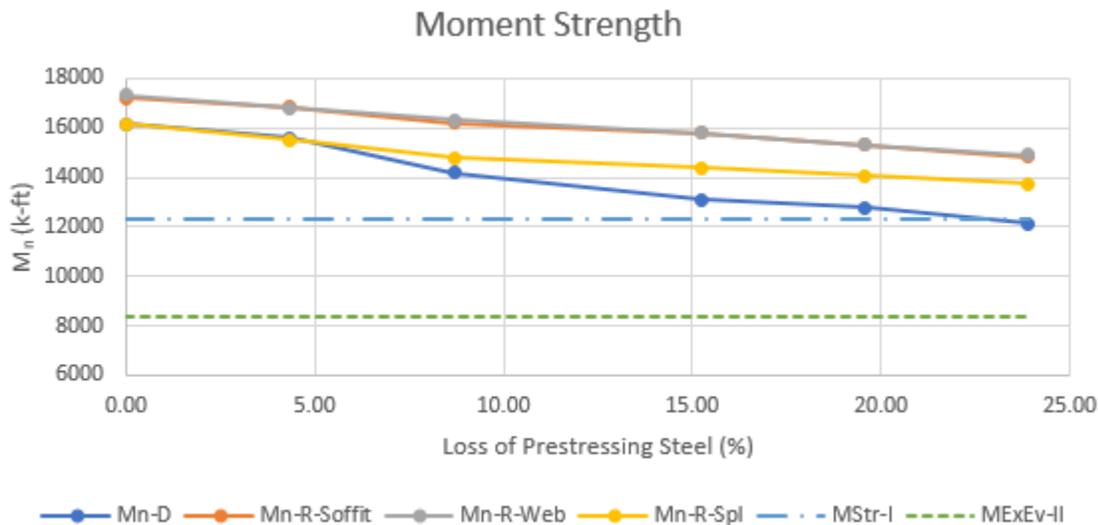
Figure 7.7. Structure 1 – variation of moment strength with loss in prestressing steel

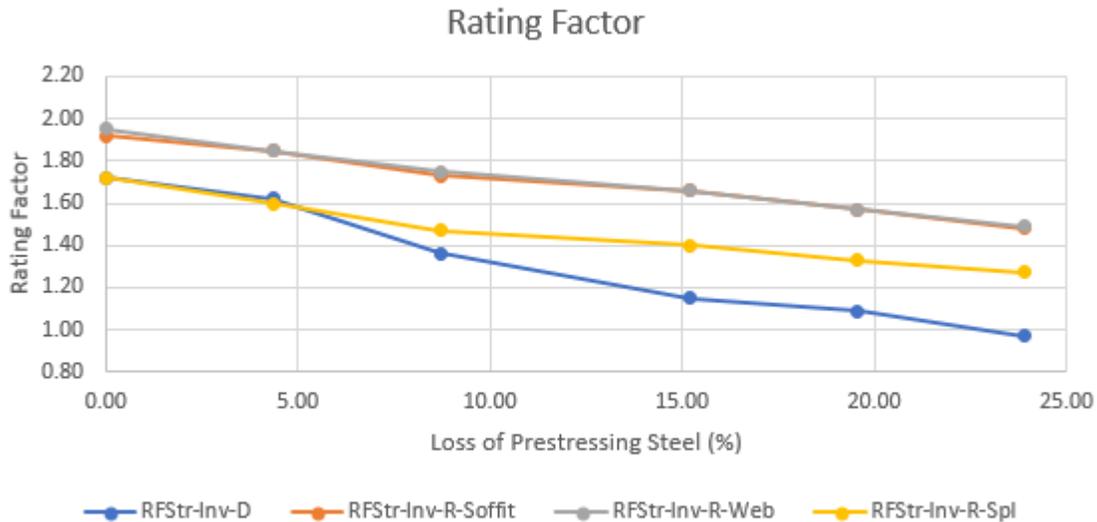
Figure 7.8. Structure 1 – variation of inventory rating factor with loss in prestressing steel

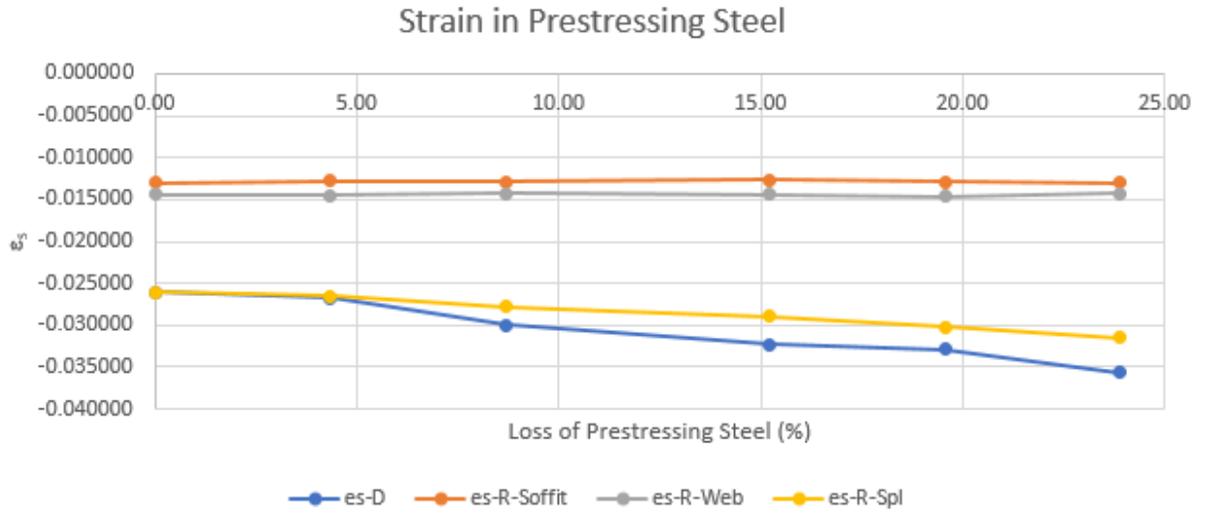
Figure 7.9. Structure 1 – variation of prestressing strain (at flexural failure) with loss in prestressing steel

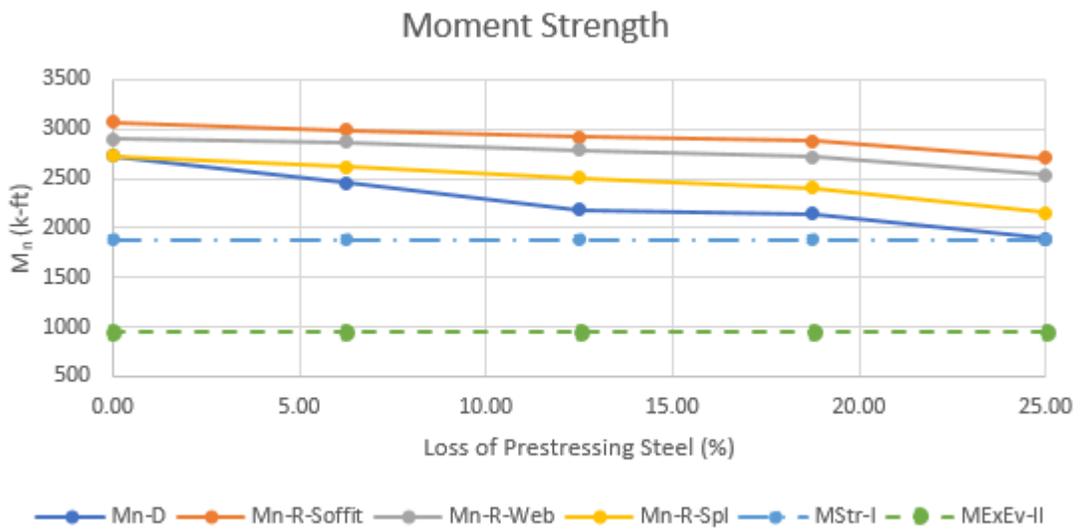
Figure 7.10. Structure 2 – variation of moment strength with loss in prestressing steel

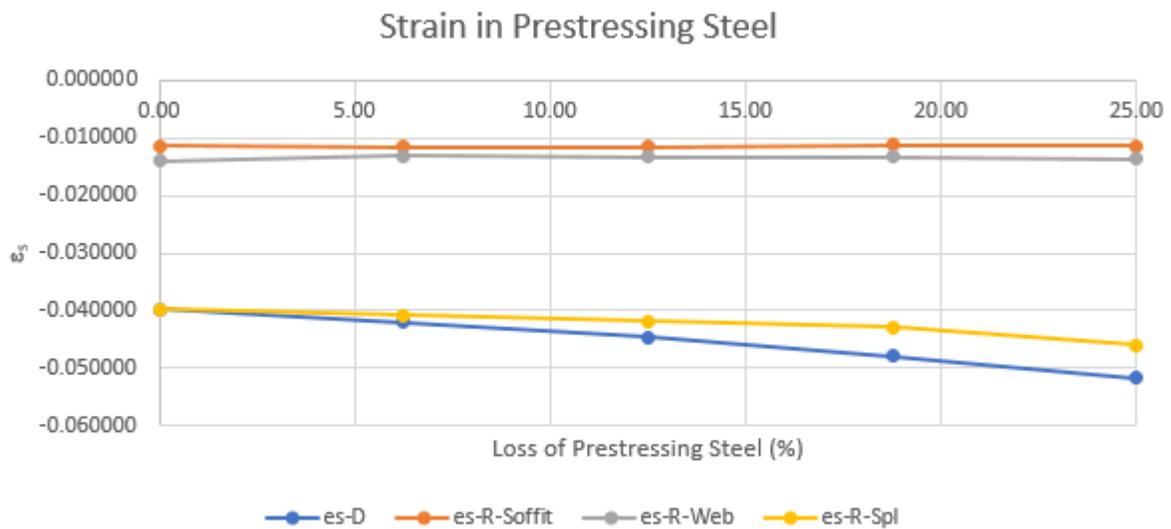
Figure 7.12. Structure 2 – variation of prestressing strain (at flexural failure) with loss in prestressing steel

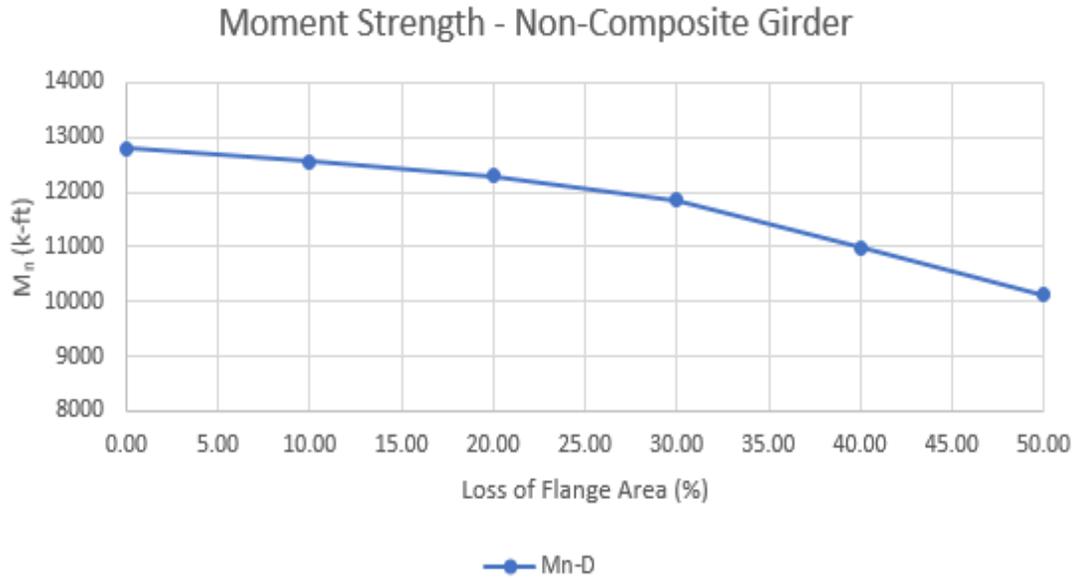
Figure 7.13. Structure 1 – variation of moment strength of non-composite girder as a function of extent of damage to top flange

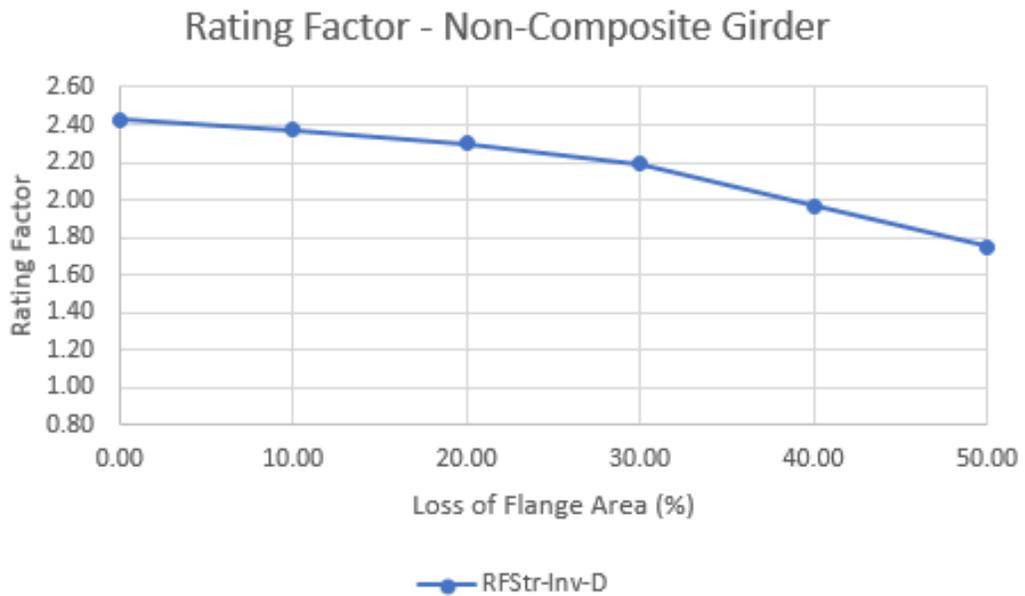
Figure 7.14. Structure 1 – variation of inventory rating factor for the non-composite girder as a function of extent of damage to top flange

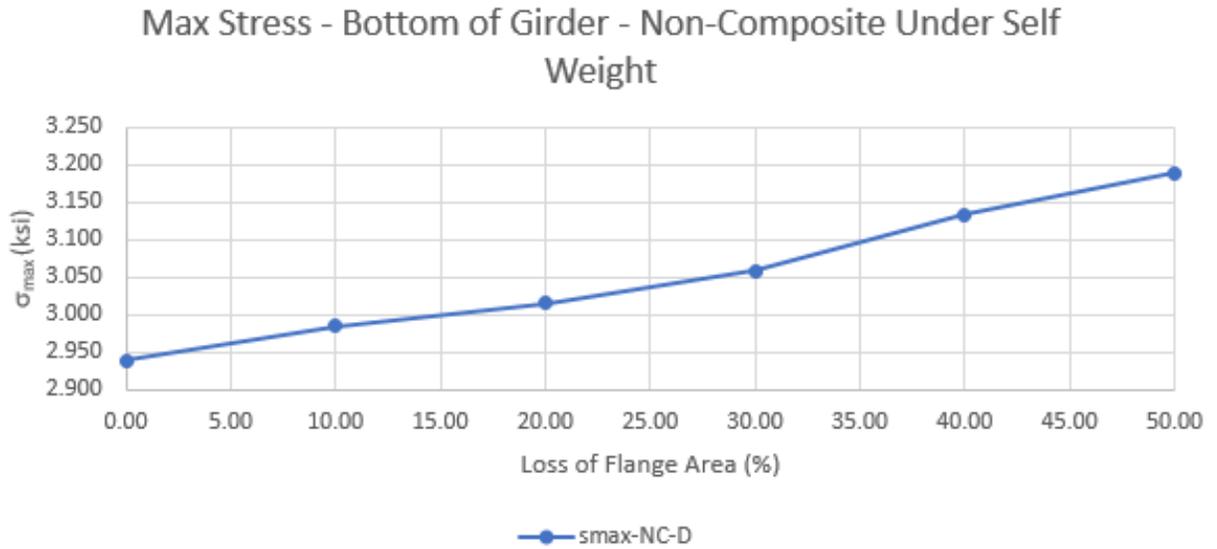
Figure 7.15. Structure 1 – variation of maximum compressive stress at the bottom flange for the non-composite girder as a function of extent of damage to top flange

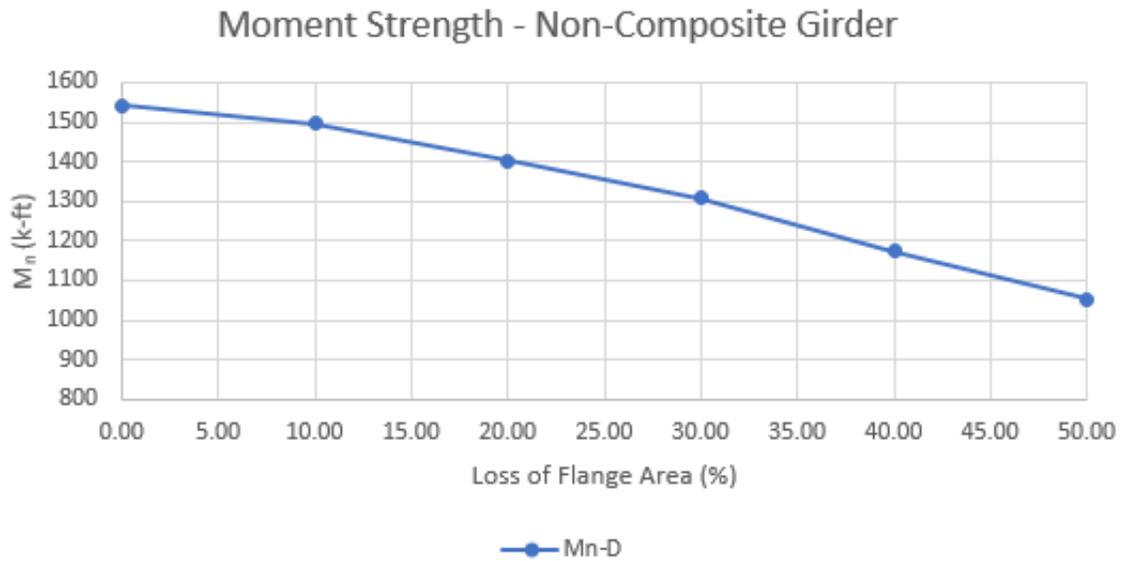
Figure 7.16. Structure 2 – variation of moment strength of non-composite girder as a function of extent of damage to top flange

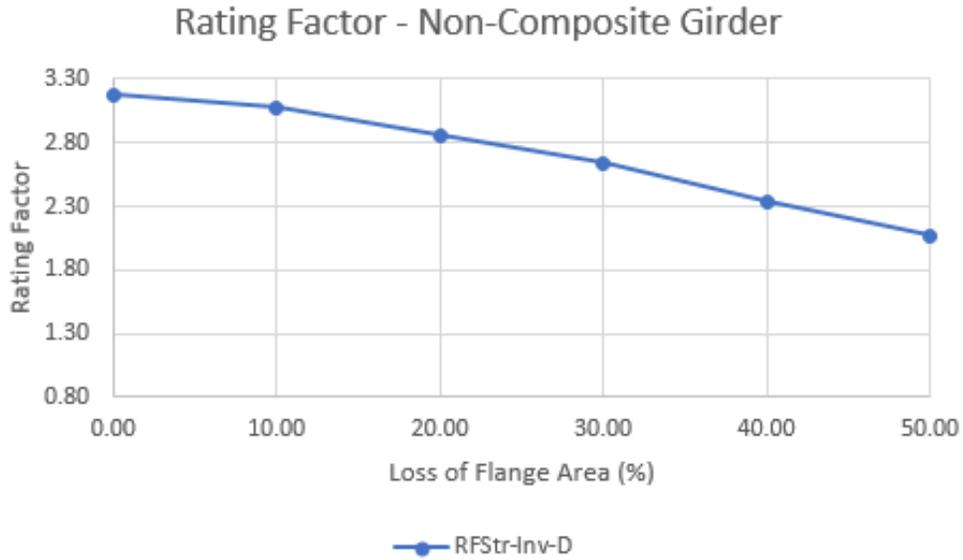
Figure 7.17. Structure 2 – variation of inventory rating factor for the non-composite girder as a function of extent of damage to top flange

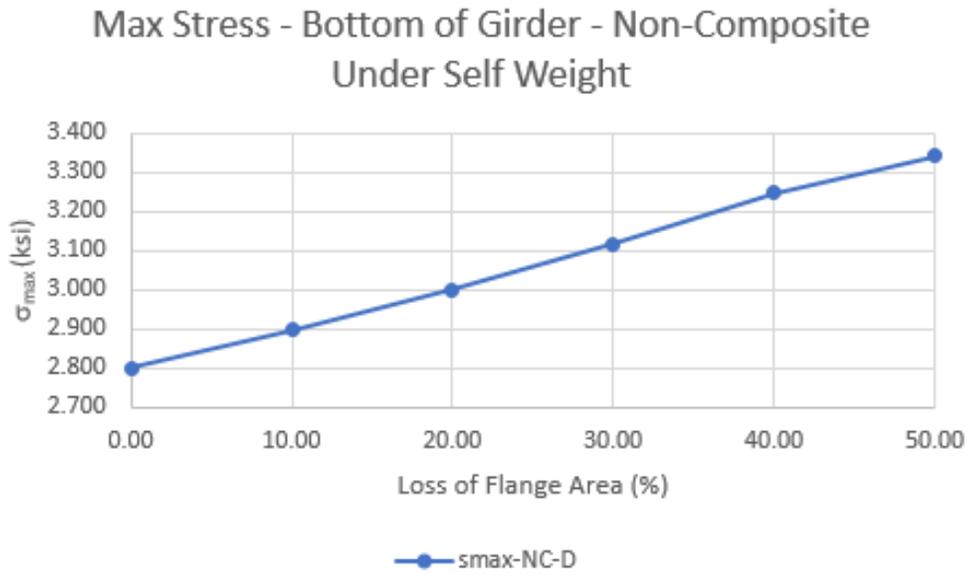
Figure 7.18. Structure 2 – variation of maximum compressive stress at the bottom flange for the non-composite girder as a function of extent of damage to top flange
