Evaluation of Penetrating Sealers Applied to Saw Cut Faces in Concrete Pavement Joints

Danny X. Xiao, Ph.D., P.E., ENV SP
Samuel Owusu-Ababio, Ph.D., P.E.
Robert Schmitt, Ph.D., P.E.
Department of Civil and Environmental Engineering
University of Wisconsin-Platteville

WisDOT ID no. 0092-18-01

March 2020

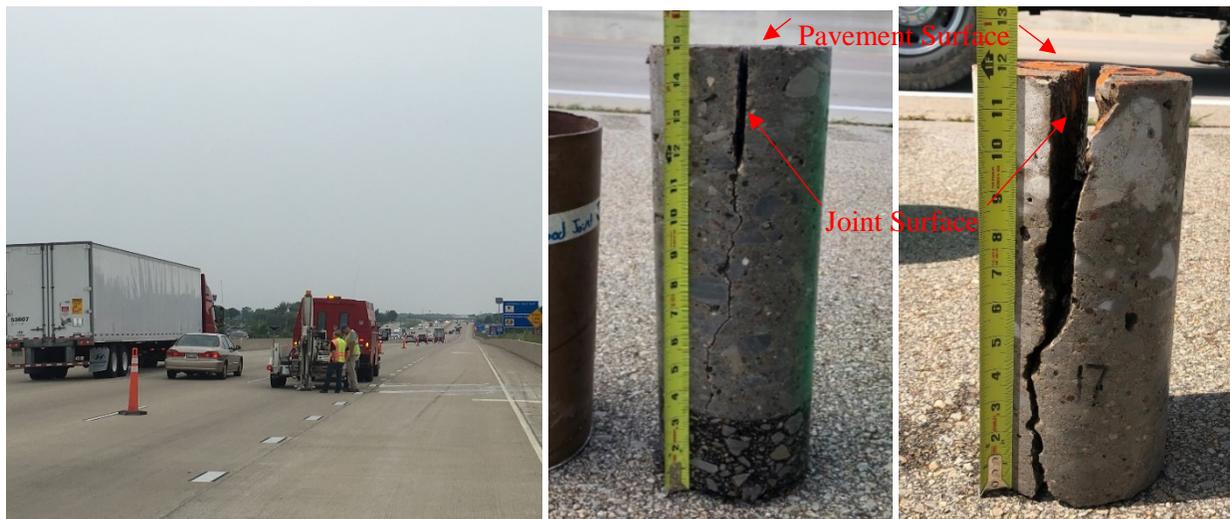
Figure 3.2 (a) Taking field cores (b) A core sample of good joint (c) A core sample of spalled joint

Core samples were then taken at three locations from each project: 2 cores from good performing joints, 2 cores from spalled joints, and 1 core from mid-slab as the control since penetrating sealer was only applied to joints. Figure 3.2 shows the field operation and example of core samples. All cores were taken from the main traffic lane where most trucks use except core #4,5,6 from the ramp of Exit 156 on I-39. A total of 17 cores were collected (Table 3.2).

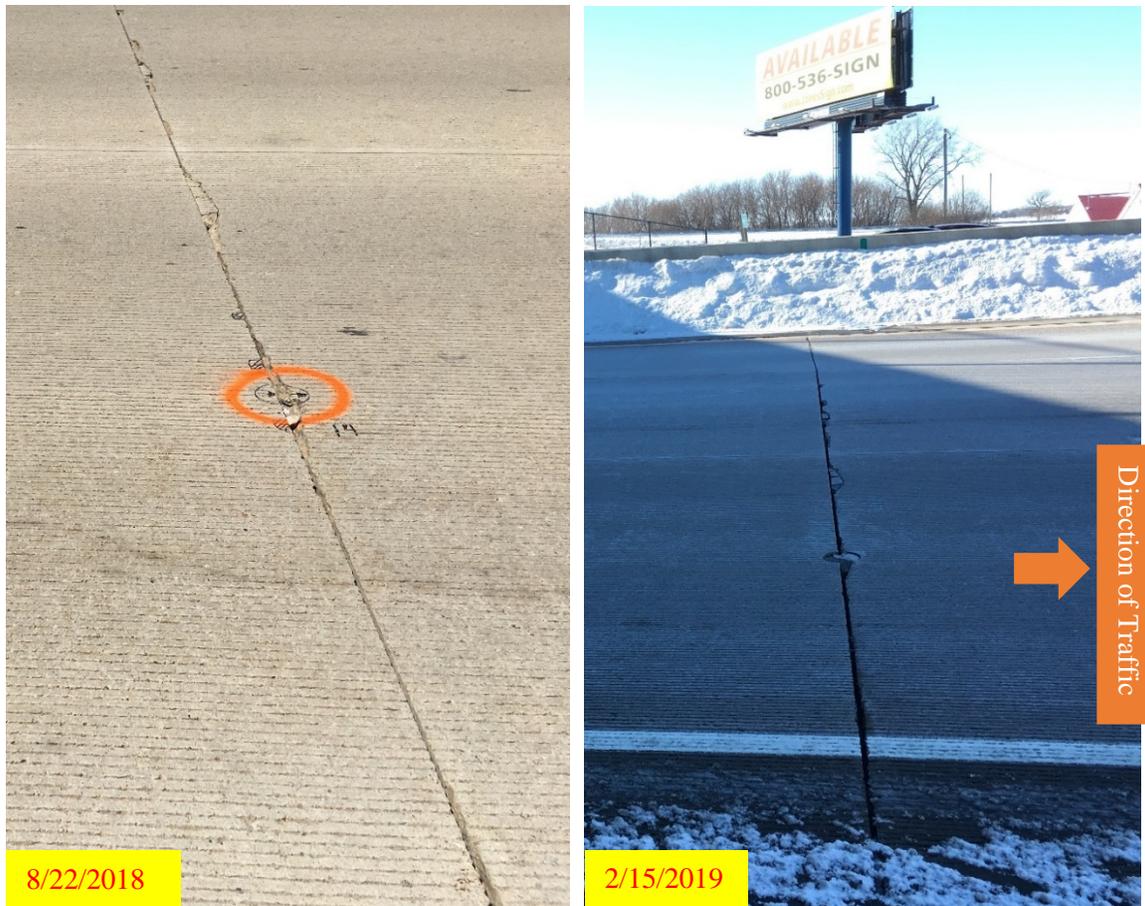
Figure 3.10 Picture Taken from Shoulder of Core #14 Joint on I-41

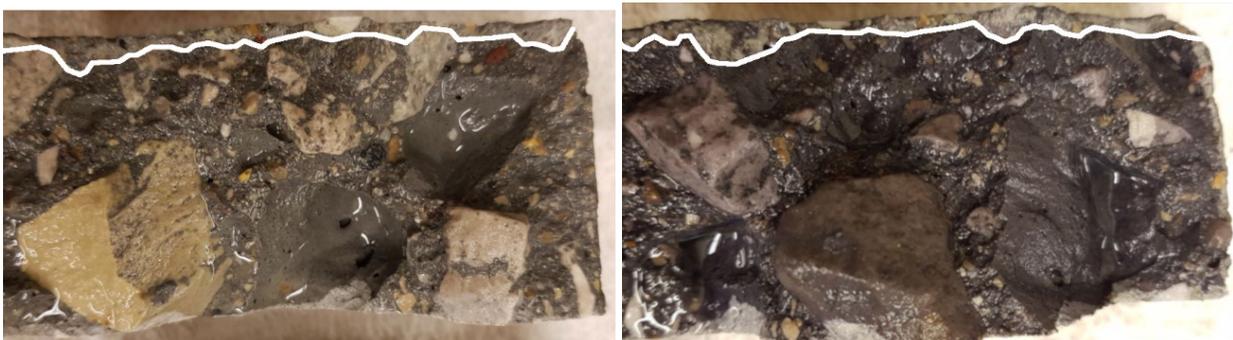
Figure 4.4 Example Depth of Penetration for SME-PS Specimen (Left: water, Right: blue fabric dye)

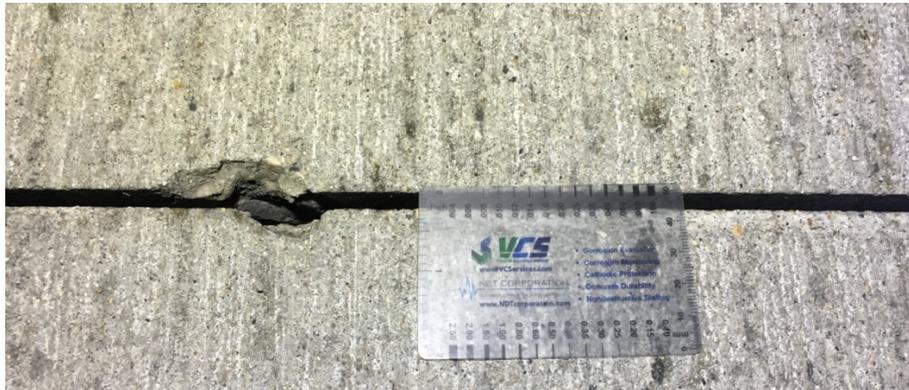
Figure 5.5 Close-up of small spalling at Joint #104

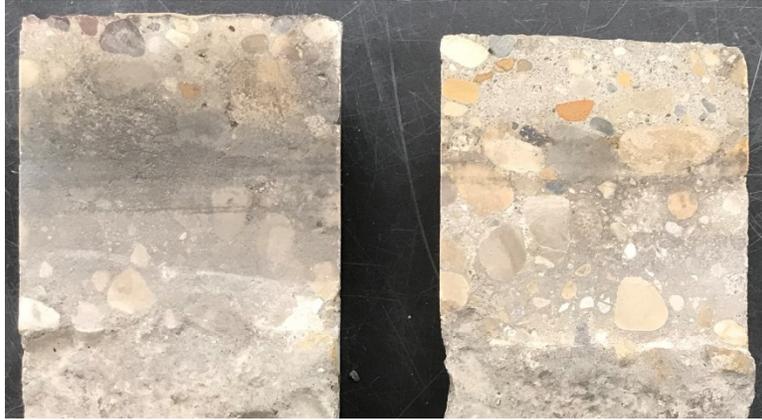
Figure 5.6 Untreated core samples (left) as received and (right) after cleaning

After one year in service, fifteen 4-inch-diameter core samples were removed from non-adjacent slabs and transported to the laboratory for testing. It was observed that all core samples were quite dirty with salt and tire residue. Figure 5.6 shows an untreated core in the as-received condition on the left and after cleaning in an ultrasonic bath on the right. All cores were visually similar in the as-received condition. After cleaning the core samples treated with silane (Figure 5.7) and SME-PS had less black residue than the siloxane mixture or lithium silicate mixture.

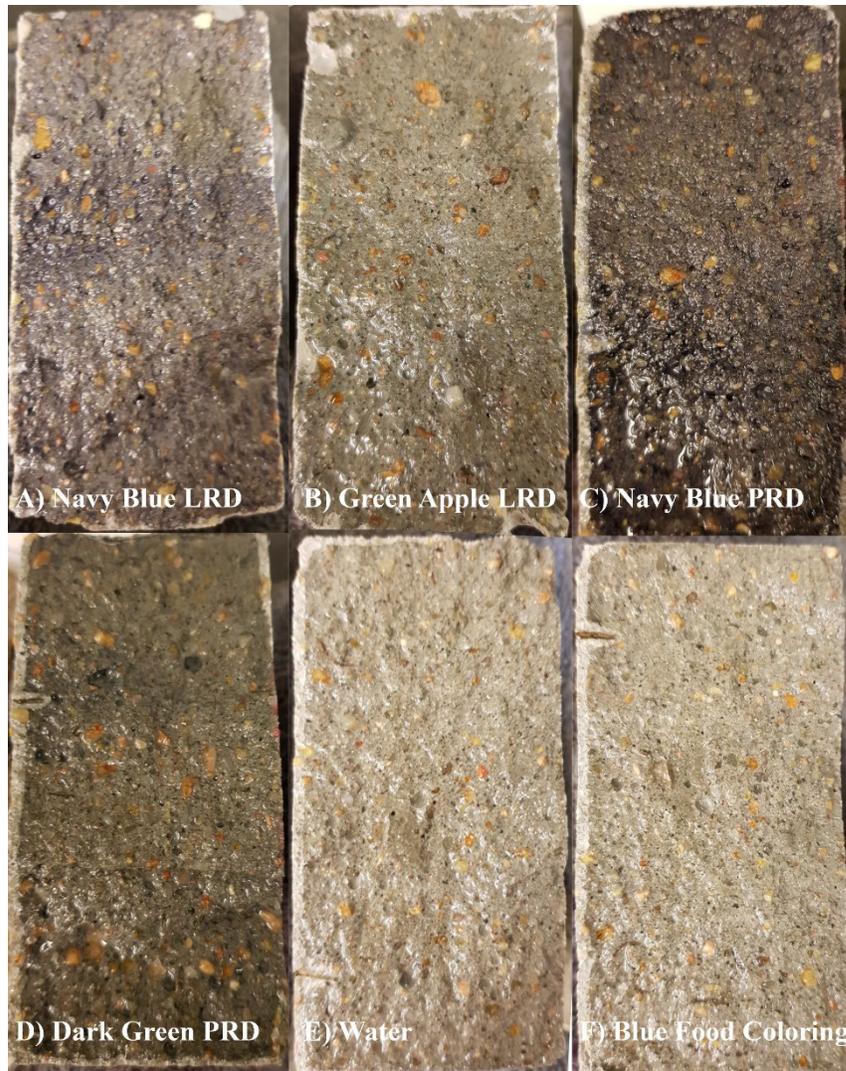
Figure C.3 Secondary Dye Testing for Depth of Penetration

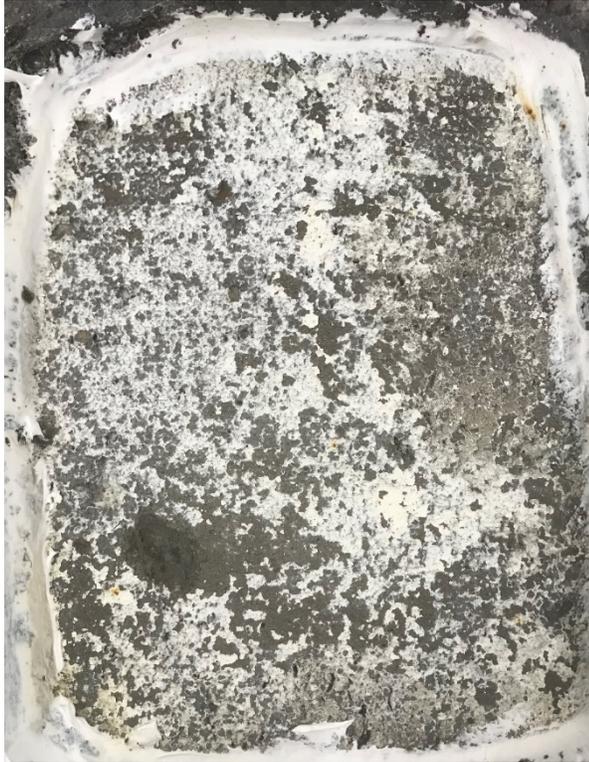
Figure C.4 FA Control after 50 Cycles

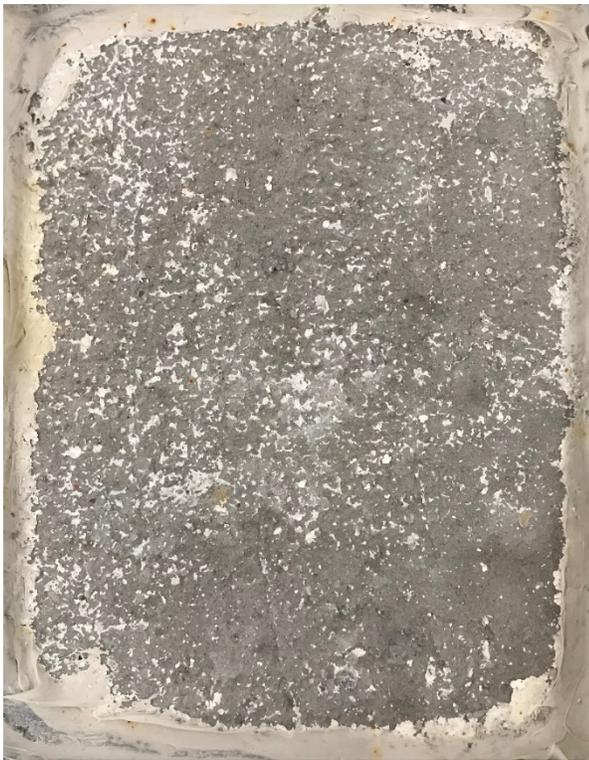
Figure C.5 FA Silane applied dry after 50 Cycles

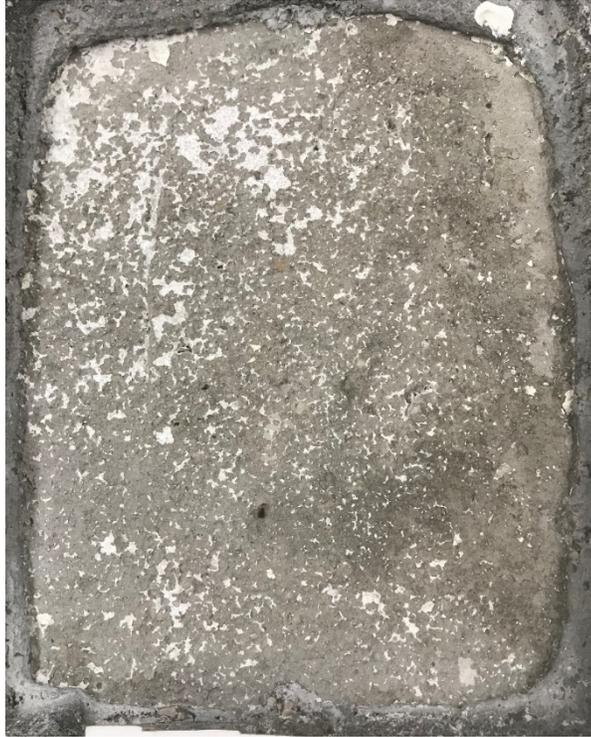
Figure C.6 FA Silane applied moist after 30 minutes after 50 Cycles

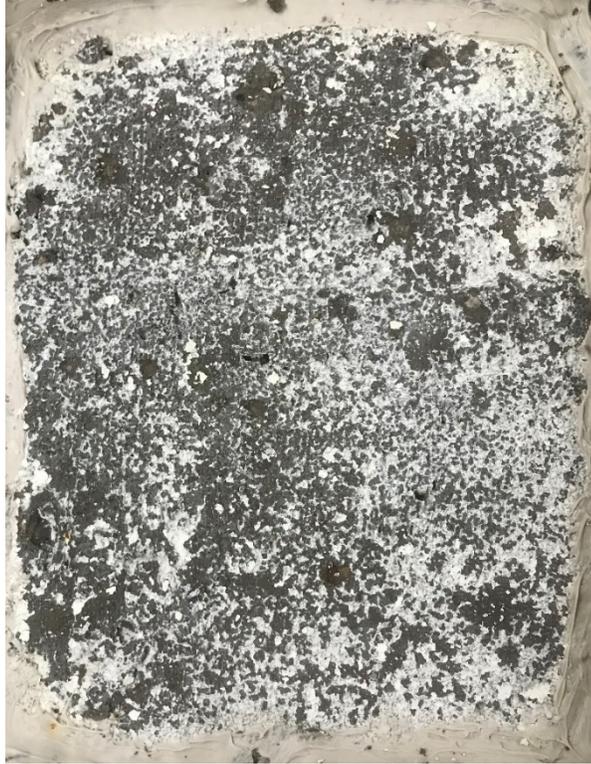
Figure C.8 FA Lithium Silicate mixture applied moist after 30 minutes after 50 Cycles
