Concrete Pavement Repairs with Non-Cementitious Materials

This brief summarizes Project 0092-18-02,
“Non-Cementitious Repair Materials Study”
Wisconsin Highway Research Program

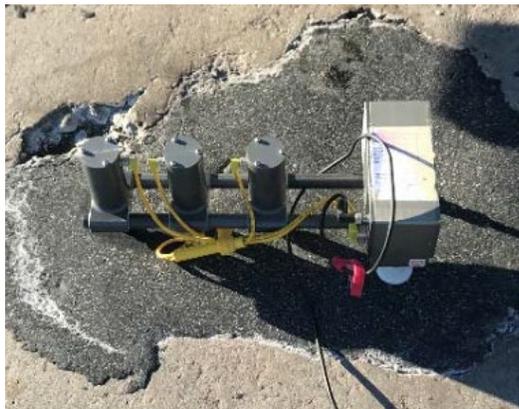
Portable seismic pavement analyzer testing of a repaired pavement section on WIS 66 in Stevens Point

Five non-cementitious repair materials were evaluated for their in-service performance on 23 sites across the state. The research team conducted visual investigations, coring and non-destructive tests with a portable seismic pavement analyzer (PSPA).
