# Mechanically Stabilized Earth (MSE) Wall Backfill Water Infiltration

WisDOT ID no. 0092-18-07

June 2021

WISCONSIN HIGHWAY RESEARCH PROGRAM

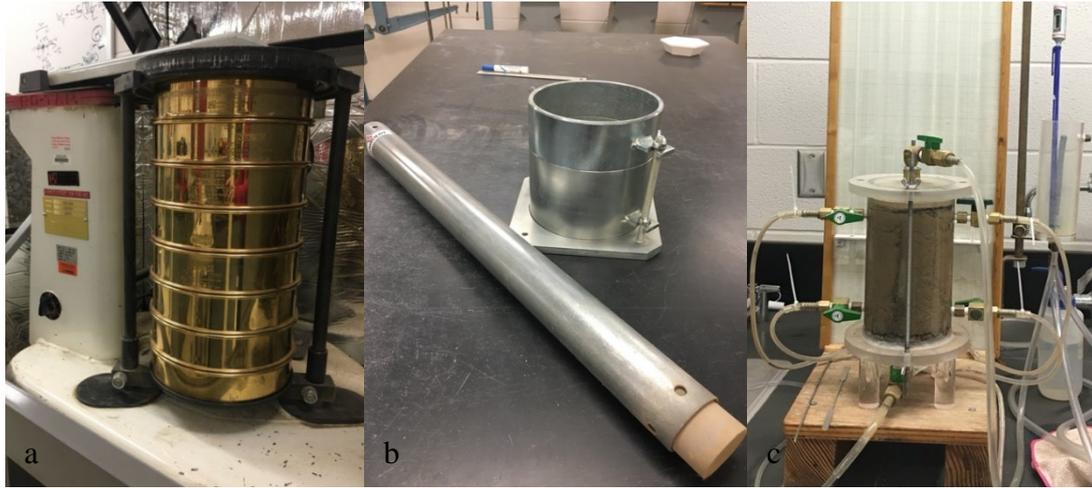
Figure 3-2. Laboratory tests (a) Grain size analysis; (b) Standard Proctor test; (c) Permeability test.

To classify the backfill soil grain size analysis (Figure 3-2-a) was performed. From the grain size results, it was possible to classify the material following the USCS (Unified Soil Classification System) classification. The Standard Proctor Test was used to find the maximum dry density and optimum moisture content (Figure 3-2-b). A series of direct shear tests were also conducted on the material in accordance with ASTM D3080. From regression of peak shear strength values were determined for both walls. The permeability tests were conducted to determine the coefficient of permeability by a constant-head method (Figure 3-2-c).

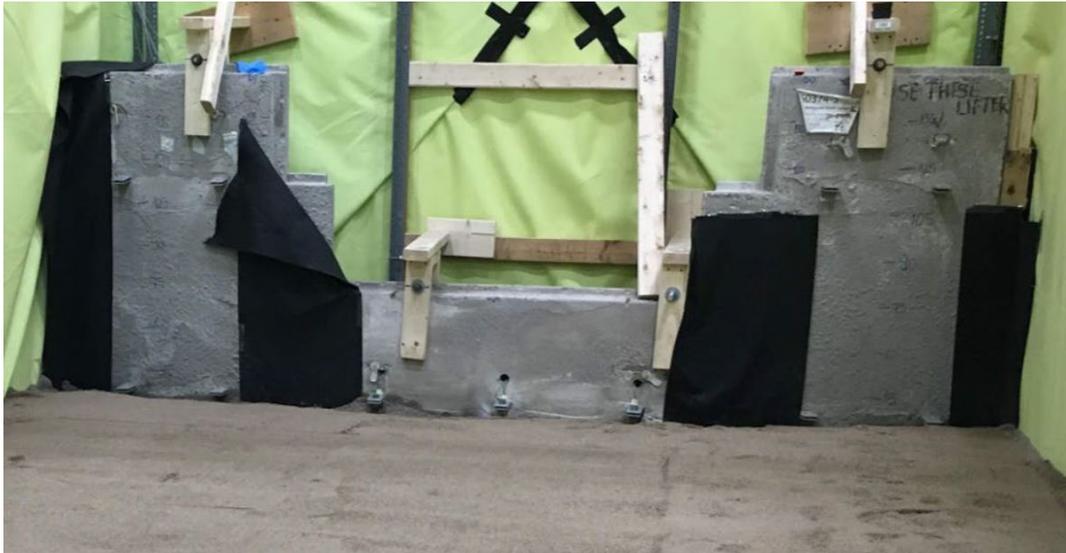
Figure 3-5. View from inside of facility displaying geotextile used to cover gaps between adjacent panels.

The joints between the panels are spaced using pad rubbers that do not allow one panel to touch the other (avoiding concrete breakage). These joints are covered by geotextiles on the back face to provide adequate drainage of the structure while preventing backfill loss (Figure 3-5). Details of the connections between the face panels and steel strips are shown in Figure 3-6.

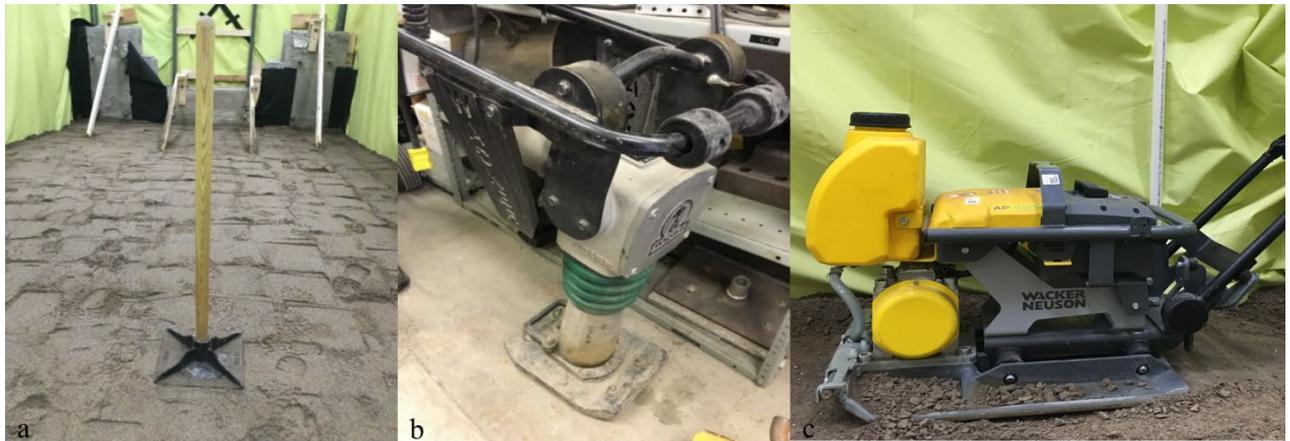
Figure 3-7. Compaction devices (a) hand tamping plate and (b) lightweight jumping jack tamper (c) vibratory plate.

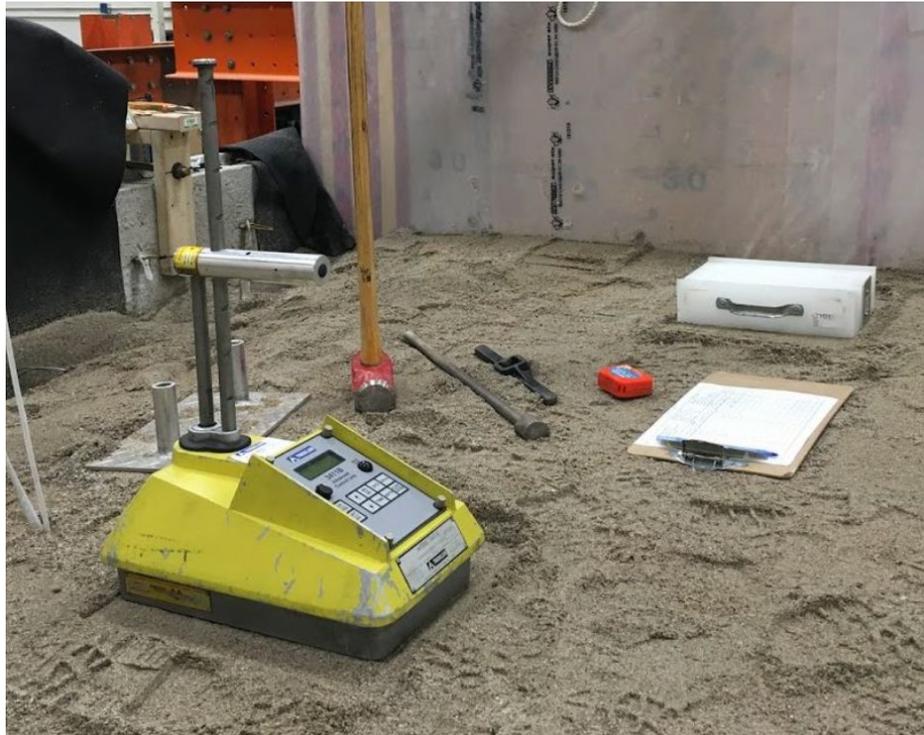
Figure 3-8. Nuclear densometer – Troxler 3411\_B.

Density and moisture content readings were obtained using a Troxler 3411-B nuclear densimeter surface moisture density gauge (Figure 3-8). For each layer, nine readings were taken at specified locations. The average measured values of moisture content and bulk unit weight were verified to be within 95% of dry density for each layer.
