Improving Bridge Concrete Overlay Performance

University of Wisconsin – Milwaukee
 North Dakota State University

WisDOT ID no. 0092-22-01 October 2023

WISCONSIN HIGHWAY RESEARCH PROGRAM

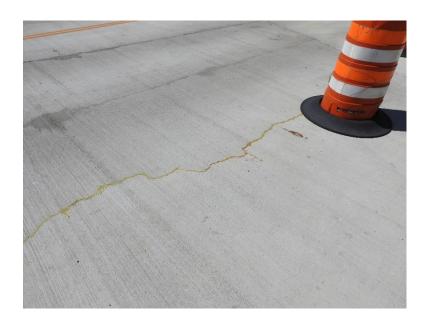
Figure 14. Large crack in B67-099 (epoxy sealed).

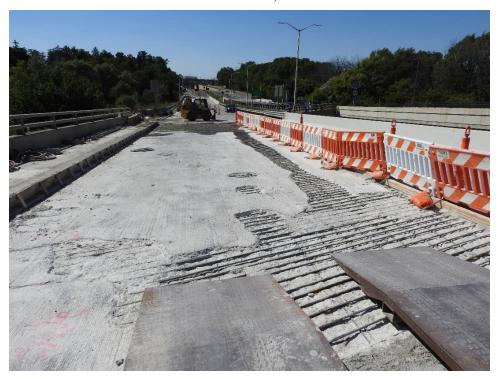
Figure 16. Bridge B40-336 before placement of new overlay.

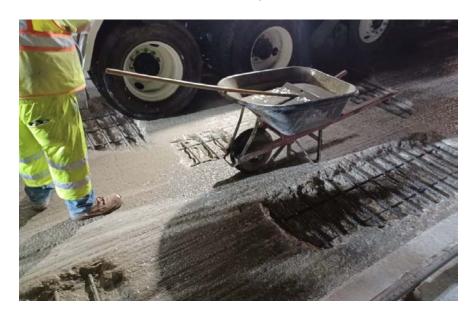
Figure 18. Application of cement-water slurry before overlay placement.

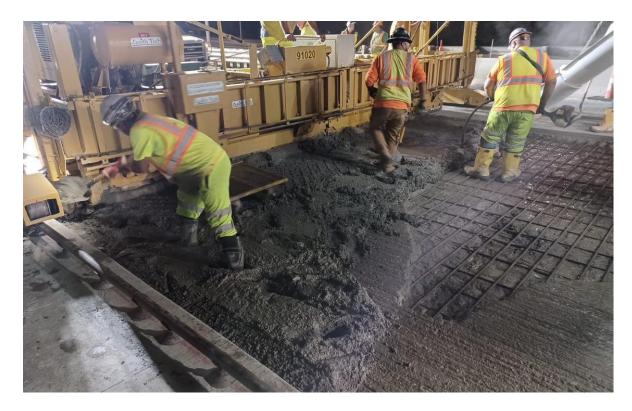
Figure 19. Placement of overlay using double vibrating screed.

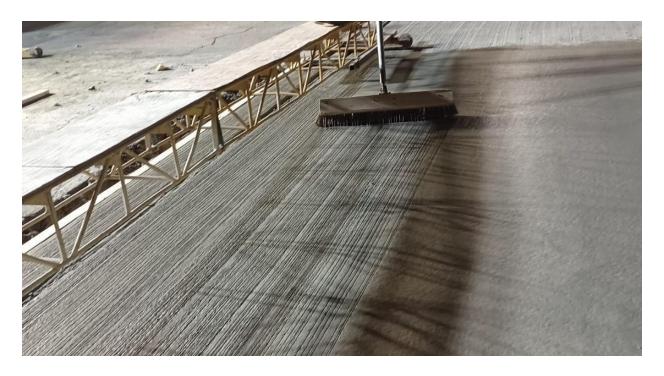
Figure 21. Broom finish.

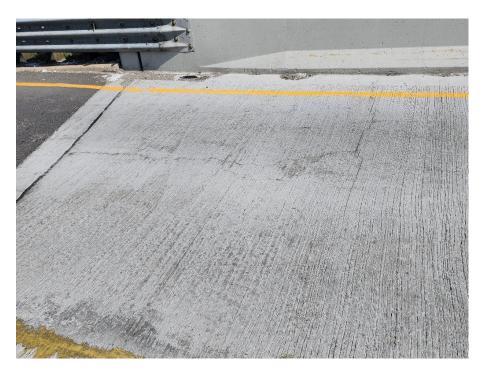
Figure 23 Overlay cracking observed on Bridge B40-336 eight months after placement.

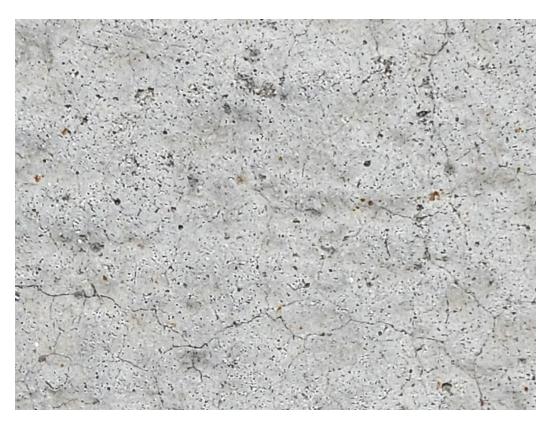
Figure 24 Localized overlay map cracking observed on Bridge B40-336 eight months after placement.

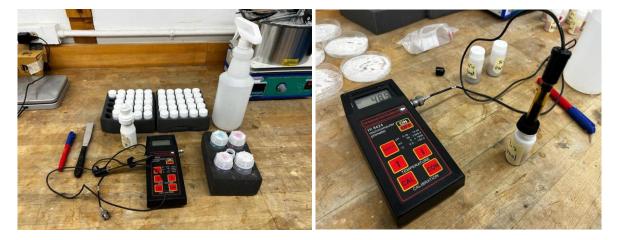
electrometer, electrode with a wetting agent, calibration liquids, plastic ampoules for measuring test samples, and RCT-1023 vials with extraction liquids for chloride extraction (Figure 30).

Figure 30. Rapid Chloride test setup and measurement

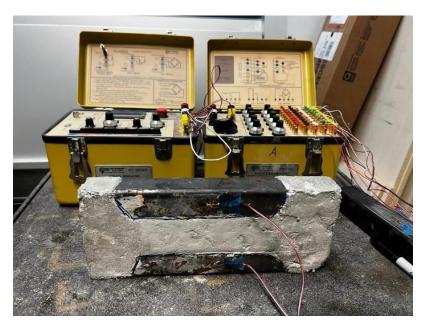
An additional set of tests was performed on a similar dog bone specimen considering a 15% reduction in cement, with a new w/c ratio of 0.381 instead of the original w/c ratio of 0.324. Two restrained specimens were prepared and subjected to the 7-day wet burlap (PB) curing. These specimens are designated as NPB7.

Figure 32. Restrained dog bone specimens.
