# Field Investigation of Dowel and Tie Bar Placement

Shreenath Rao, Ph.D., P.E., Laxmikanth Premkumar, P.E., and Abu Talha, Ph.D.

Applied Research Associates, Inc.

WisDOT ID no. R22-02

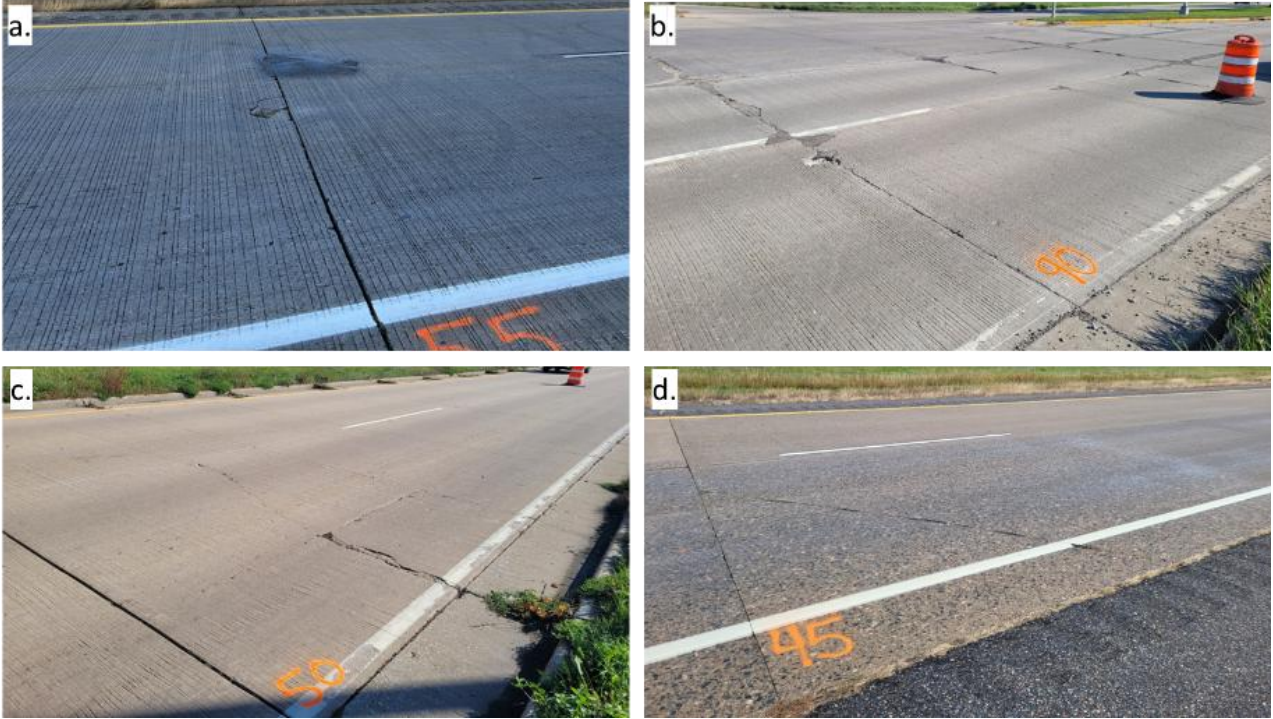
**Figure 6. (a) Joint spalling in Eau Claire County on STH 53, (b) joint spalling in Jefferson County on US 12 EB, (c) cracking in Jefferson County on US 12 EB, and (d) cracking in Wood County on US 10 EB.**

In addition to MIT-DOWEL-SCAN and MIT-SCAN-T2 testing, a condition survey was conducted to document the presence of spalling and cracking. The condition of the pavement, particularly the joints, was documented by capturing the photograph of the respective joint during the MIT-DOWEL-SCAN testing. The distress information such as spalling and cracking and the respective severity of the distresses were documented from the captured images and used in the post-process analysis to investigate any correlation between dowel bar misalignment and distresses at the joints. The images were tagged with field notes to ensure consistency between the image and the MIT-DOWEL-SCAN data. Figure 6 shows images of some tested joints associated with different types of distress with different severity levels.

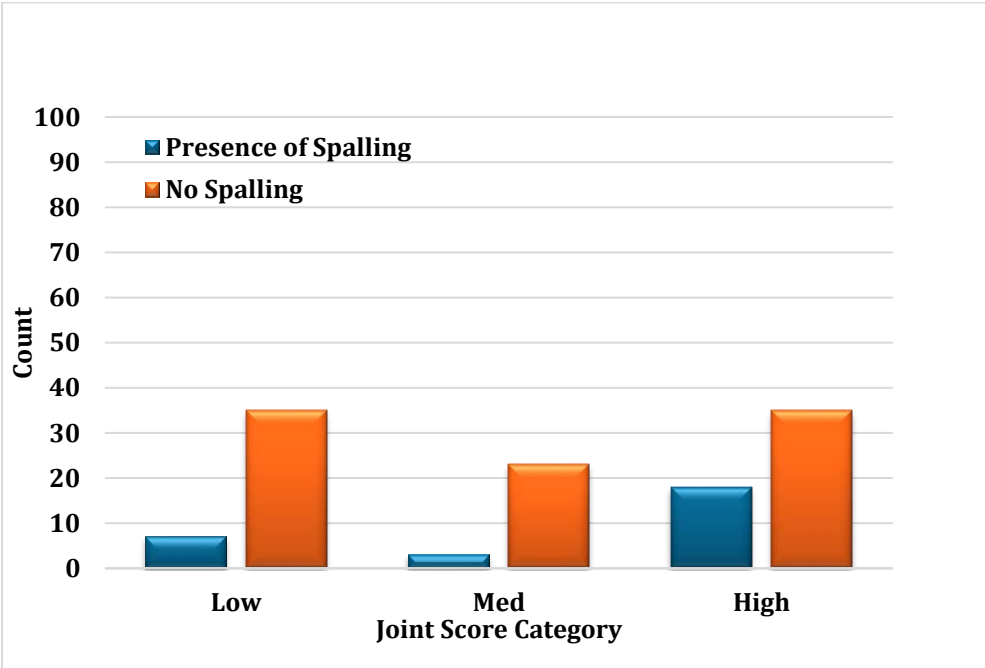
Figure 723. Joint score and presence of spalling for Chippewa NB.

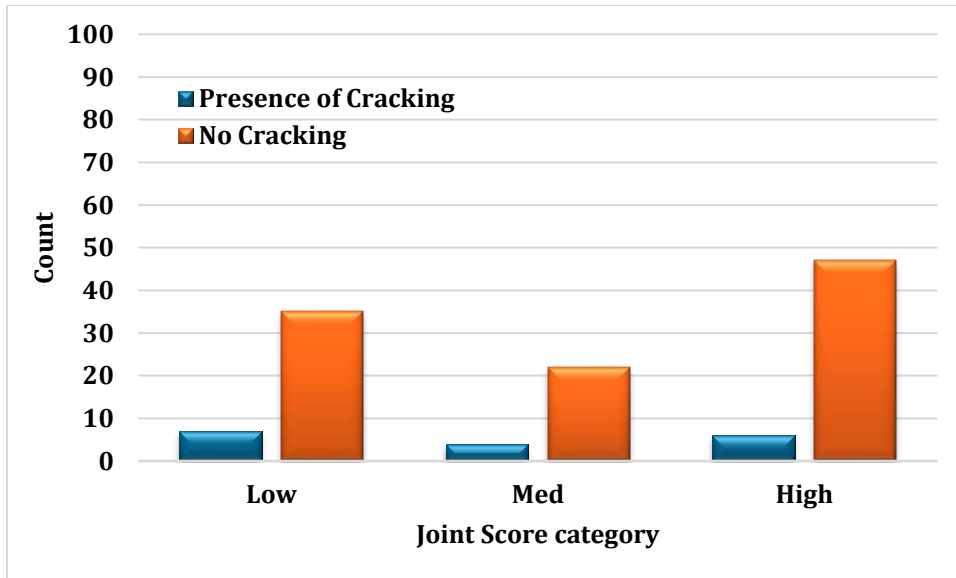
Figure 824. Joint score and presence of cracking for Chippewa NB.

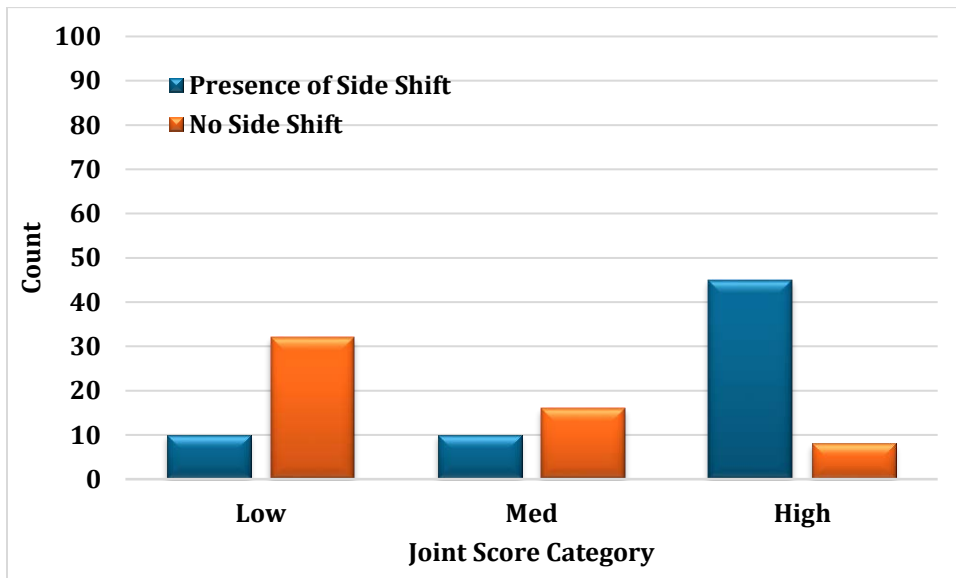
Figure 925. Joint score and presence of side shift for Chippewa NB.

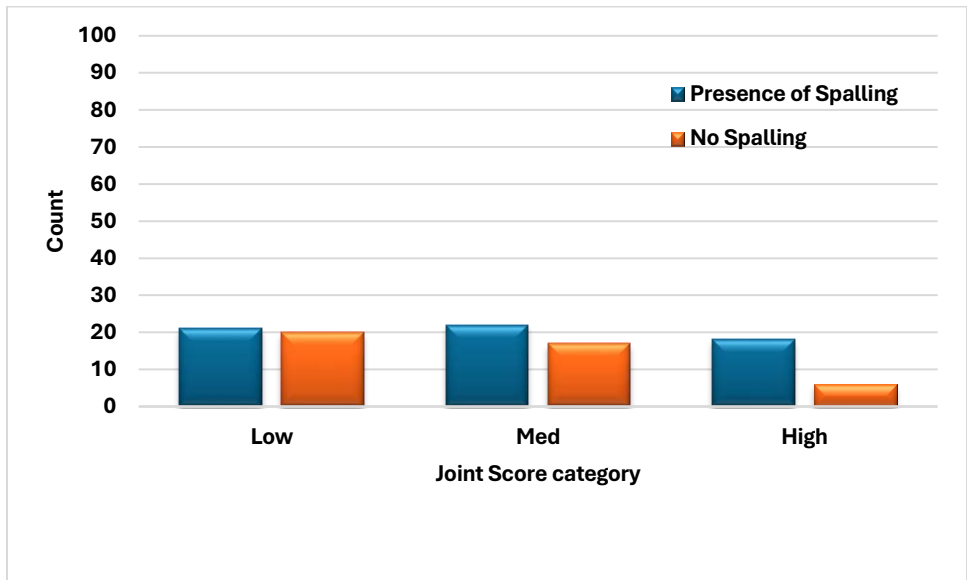
Figure 1626. Joint score and presence of spalling for Chippewa SB.
