Field Investigation of Dowel and Tie Bar Placement

This brief summarizes Project 0092-22-02
Field Investigation of Dowel and Tie Bar Placement

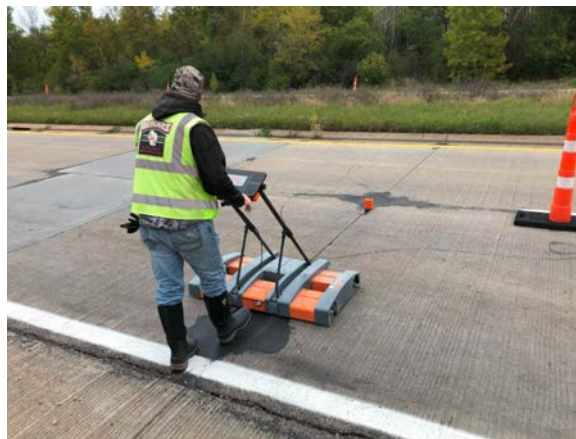
*MIT-DOWEL-SCAN
testing in Chippewa
County*

The data was analyzed using the latest version of the MagnoProof® software to calculate the various dowel alignment parameters including horizontal skew, vertical tilt, longitudinal translation, and vertical translation. These measured parameters were used to compute joint score (JS) and equivalent dowel diameter (EDD). Chi-squared tests were performed to determine any relationship between JS and spalling, slab cracking, and longitudinal translation. AASHTOWare® Pavement ME Design (PMED) was used to evaluate the impact of dowel misalignment on pavement performance.
