BRIEF

Strategies to Prevent Early Concrete Joint Distress

This brief summarizes Project 0092-05-05, “Analysis of Concrete Pavement Joints to Predict the Onset of Distress,” produced through the Wisconsin Highway Research Program for the Wisconsin Department of Transportation Research Program, 4802 Sheboygan Ave., Madison, WI 53707.

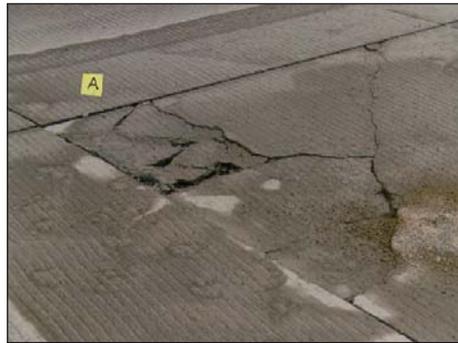
This project identified the causes of premature corner cracking and pumping of pulverized concrete, left, on a section of I-90/94. A significant number of dowels from this section showed corrosion and loss of epoxy coating, right, reducing their effectiveness at transferring loads (Fig. 12 of the final report).

Expected life spans for concrete pavement are measured in decades, so serious damage after only five or six years is unusual. The types of distress that developed in this section were also unusual, particularly corner cracking, which is atypical for layers this thick. Examination of slabs removed during rehabilitation showed corroded dowels with epoxy coating worn away and delamination in the slabs at the dowel line, separating portions of the concrete into two layers.

Based on forensic investigation and modeling, researchers identified several factors that likely contributed to the distress. Analysis suggested that acute joint angles, curling and unstable base support led to weakness at slab corners, higher than normal deflections in the slabs, and high stress concentrations at the dowels and slab corners. Primary factors contributing to this distress included:
