Guidance, Parameters, and Recommendations for Rubblized Pavements

WHRP 06-13

**Final Report
Report No. WHRP 06-13
(ARA Project No. 16730)**

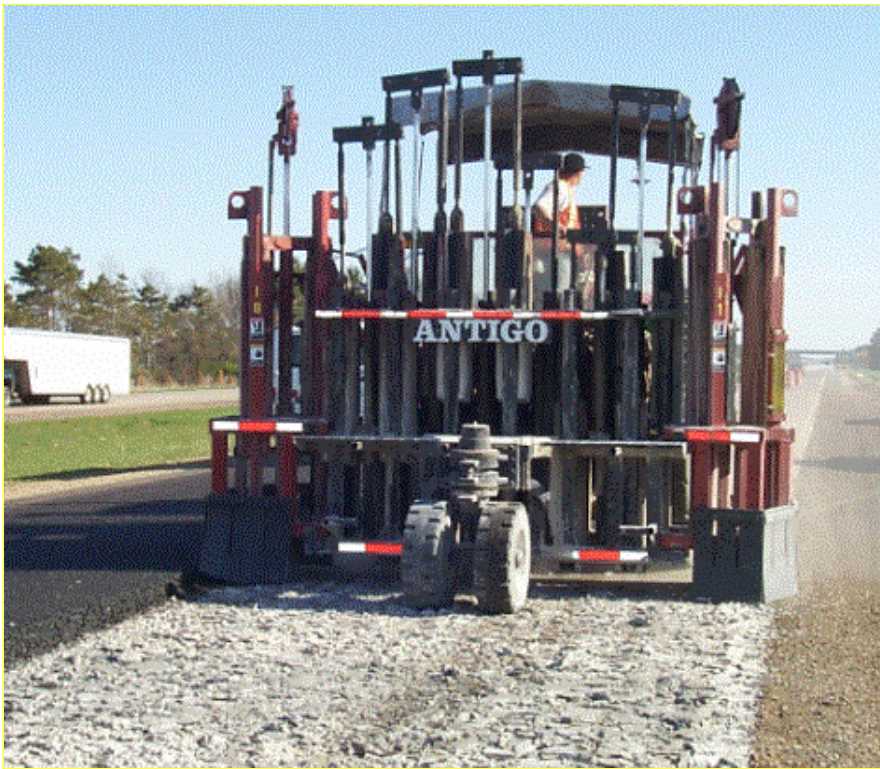
Figure 8 Photo of the multiple drop hammer for rubblizing PCC slabs.

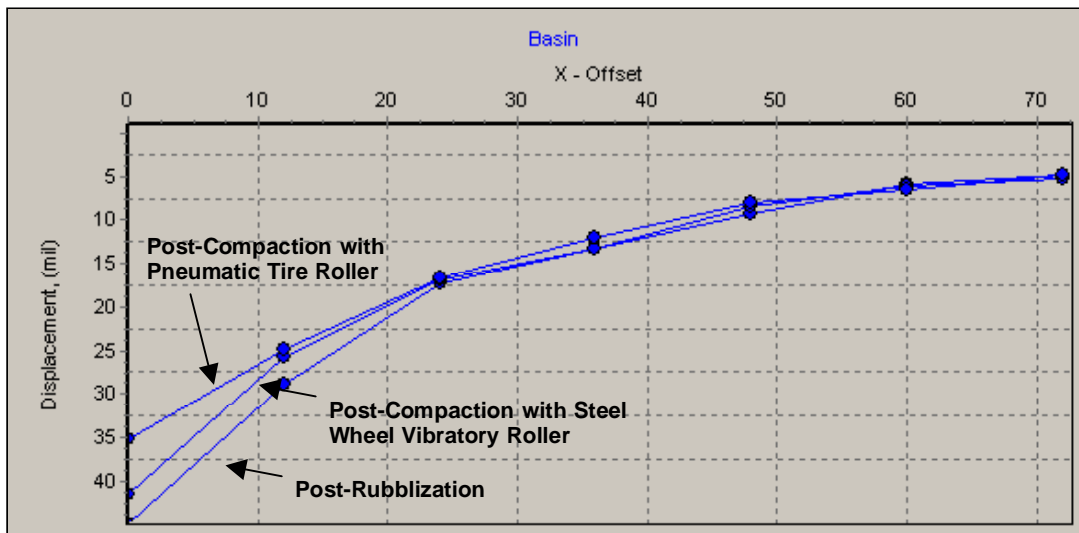
Figure 10 Effect of compaction on deflection basin; Grand Forks AFB.

For the resonant breaker seating process, the rubblized pavement should be rolled with a minimum of two passes over the entire width of the pavement with a vibratory smooth steel drum roller. The engineer may require more roller passes to achieve proper compaction. When using the multi-head breaker rolling process, the entire width of the pavement has to be rolled with vibratory and pneumatic-tire rollers. After the rubblization process, two passes with the “Z-Grid” roller have to follow the multi-head breaker to reduce the bigger concrete pieces at the surface. Immediately following, one pass of the pneumatic-tire roller should be completed. The benefit of the seating and compaction operations is graphically presented in Figure 10. As shown, the deflection measured under the load decreases with different roller passes.

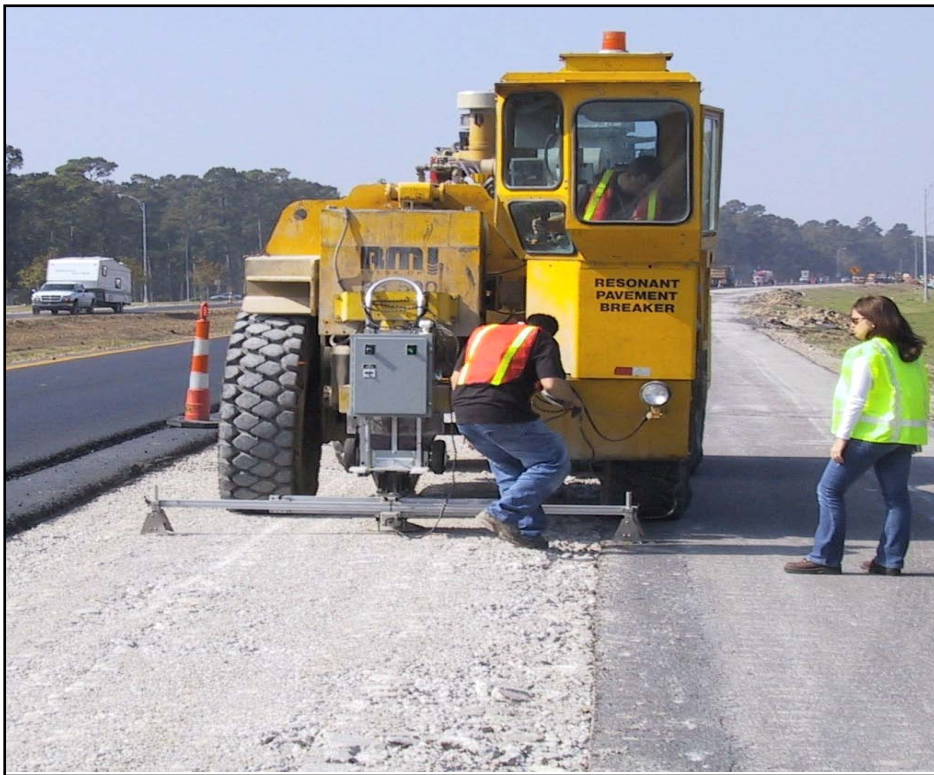
Figure 12 RMI bulk modulus test on rubblized PCC highway pavement.

A possible candidate that is being looked at for quality control testing is the bulk modulus device being developed by RMI. Figure 12 shows the bulk modulus device being used on a highway project. This device measures the deflection of the rubblized layer when a load is applied, and the in-place bulk modulus is directly related to the type and condition of base and subgrade underneath the rubblization layer. The static load ranges from 62 to 155 MPa (9 to 22.5 kips). The average in-place bulk modulus value for a 230-mm (9-in) rubblized pavement, and a 2-MPa (9-kip) load was about 1,075 MPa (156 ksi) on one project. Data collected by ERDC showed a correlation between bulk modulus measured in this manner and calculated elastic modulus values from other deflection basin tests.

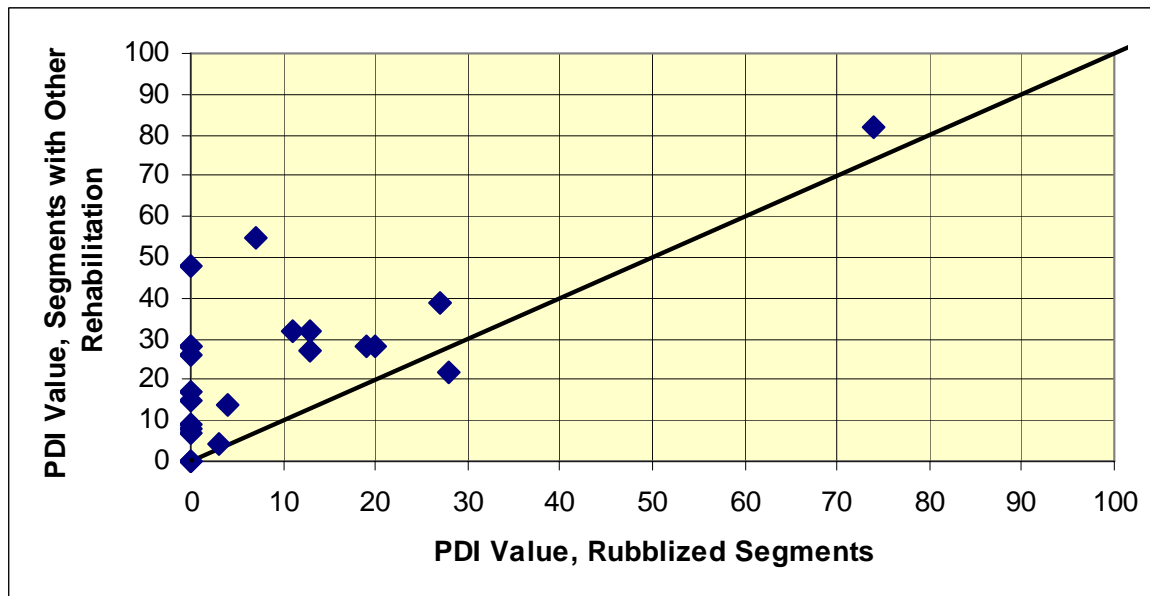
Figure 30 Comparison between PDI values measured on rubblized segments and on companion segments with other rehabilitation strategies.

Figures 30 to 32 compare the PDI, rut depth, and IRI values measured on the rubblized segments to those values measured on companion segments with other rehabilitation strategies. These companion segments were taken from sections of a similar age (construction date) and along the same route, but for other rehabilitation strategies. Other rehabilitation strategies include crack and seat and HMA overlays with and without repairs to the PCC pavement. The data for the companion sections were taken from the studies completed by Smith, et al and Titus-Glover, et al., 2006.
