## Reducing Corrosion on Fiberglass Wrapped Concrete Bridge Columns

*This brief summarizes Project 0092-07-07, “Evaluation of Fiberglass Wrapped Concrete Bridge Columns,” produced through the Wisconsin Highway Research Program for the Wisconsin Department of Transportation Research Program, 4802 Sheboygan Ave., Madison, WI 53707.*

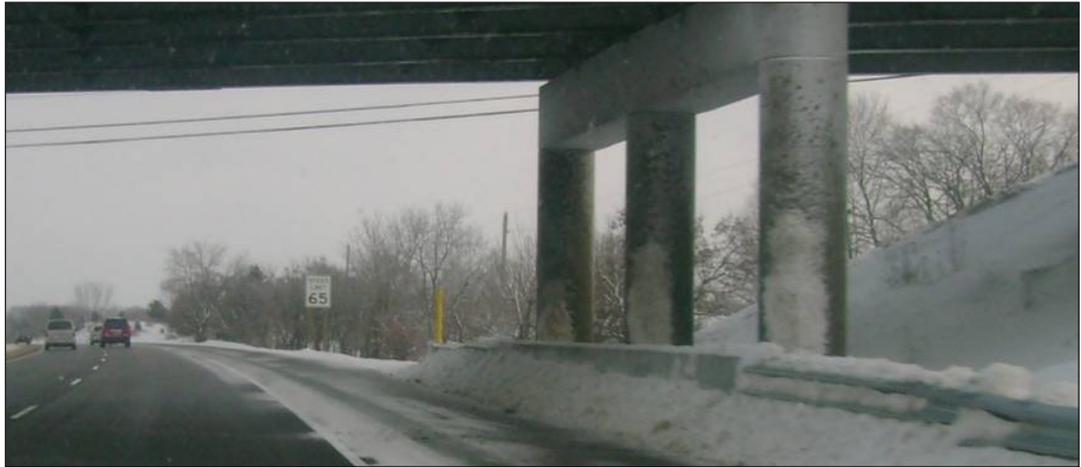
Snow and deicing salts that are splashed on concrete bridge columns cause premature deterioration unless countermeasures like fiberglass wrapping are undertaken.
