## What's Causing Cracking in New Bridge Decks?

*This brief summarizes Project 0092-09-06, "Concrete Cracking in New Bridge Decks and Overlays," produced through the Wisconsin Highway Research Program for the Wisconsin Department of Transportation Research Program, PO Box 7915, Madison, WI 53707.*

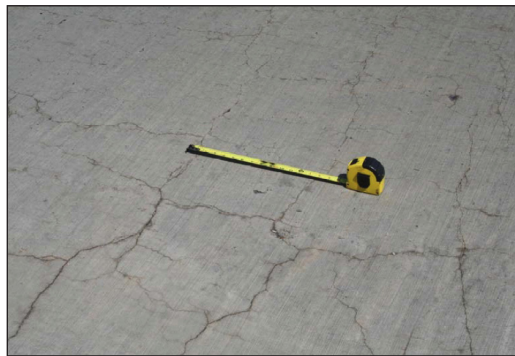
Researchers examined the causes of cracks that plague concrete bridge decks and overlays soon after construction. Pictured here is a typical map-crack, in which the crack extends along the bridge's length and width.
