Evaluation of a Hot Mix Asphalt Perpetual Pavement

FINAL REPORT

Research Study # FEP-02-02

Report # FEP-01-10

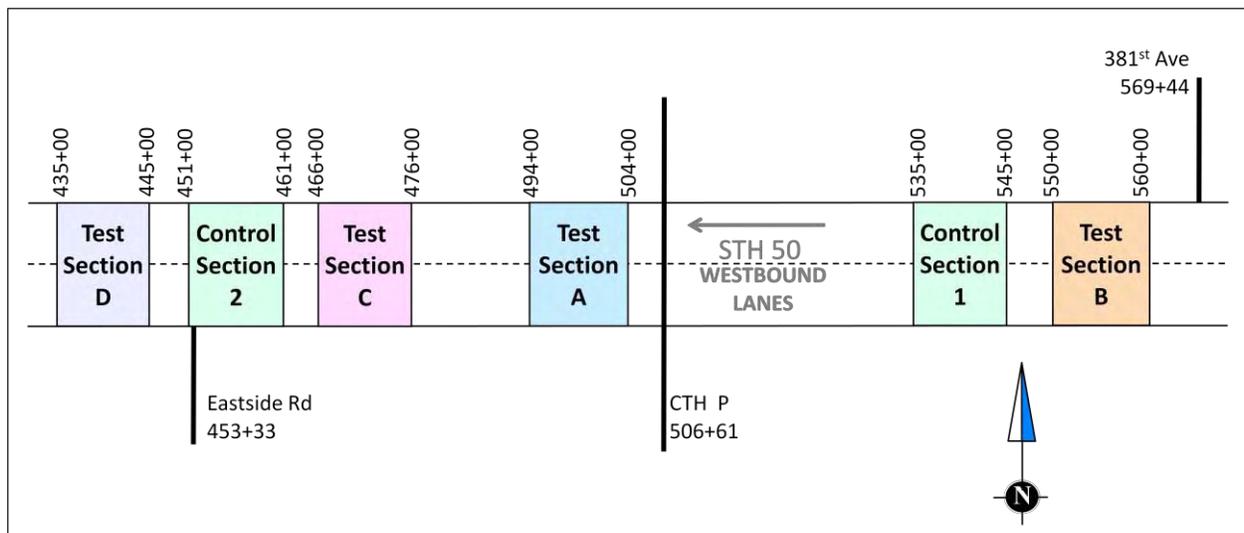
Figure 1. STH 50 perpetual pavement test section layout.

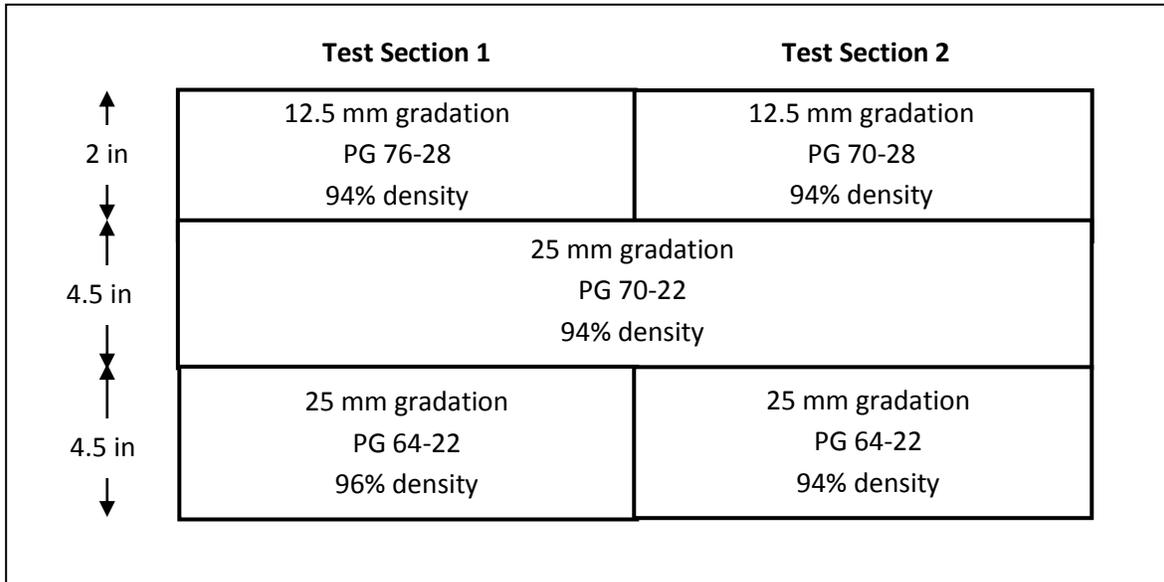
Figure 3. Test section cross sections. (Not to scale)

Test Section	Layer	Thickness (in)	Gradation	HMA Mix Type	Binder	In-place Air Voids
1	Surface	2	12.5 mm (0.5 in)	E-30x	PG 76-28	6%
	Middle	4.5	25 mm (1.0 in)		PG 70-22	6%
	Bottom	4.5	25 mm (1.0 in)		PG 64-22	4%
2	Surface	2	12.5 mm (0.5 in)	E-30x	PG 70-28	6%
	Middle	4.5	25 mm (1.0 in)		PG 70-22	6%
	Bottom	4.5	25 mm (1.0 in)		PG 64-22	6%

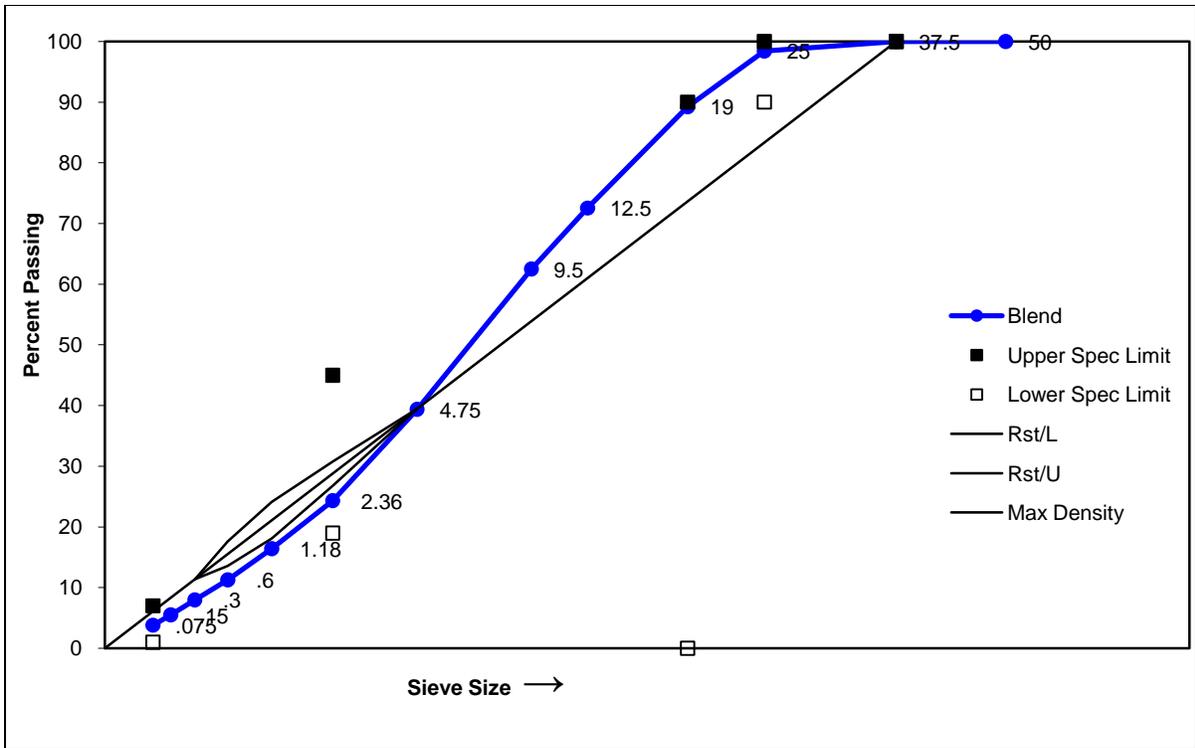
Figure 4. Aggregate gradation chart, 25.0 mm mix.

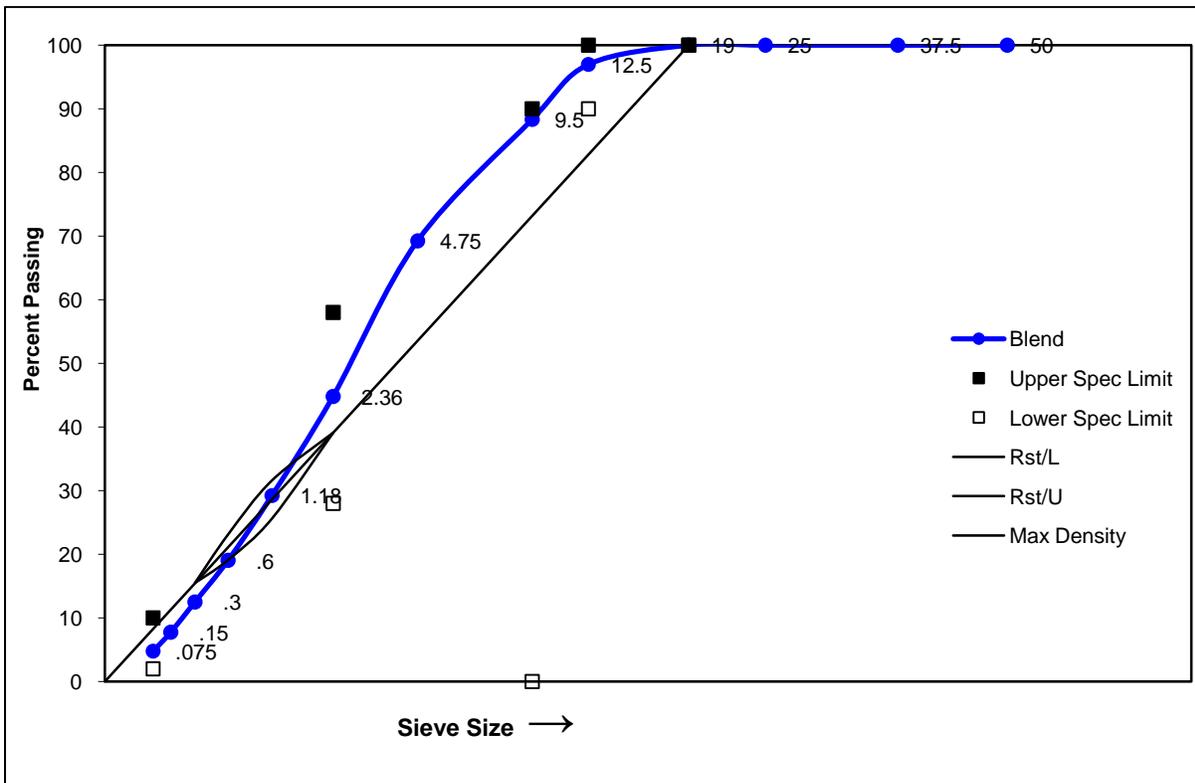
Figure 5. Aggregate gradation chart, 12.5 mm mix.

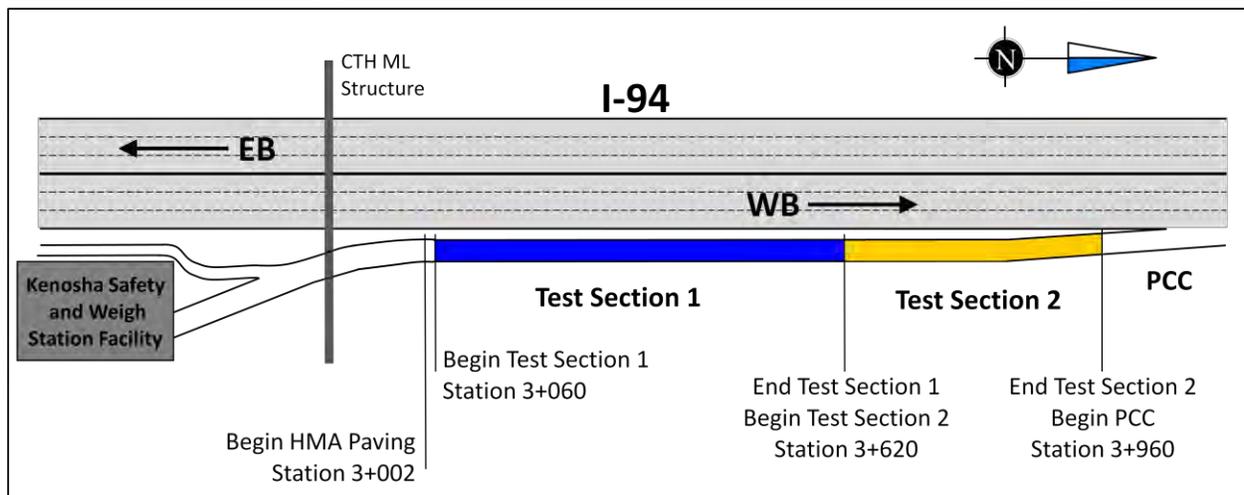
Figure 6. Test section layout. Note: metric stationing

The two perpetual pavement test sections were constructed end-to-end on the weigh station entrance ramp. There was no control section. Test section 1 was constructed 1,840 ft (560 m) long, and test section 2 was 1,110 ft (340 m) long. The remainder of the entrance ramp and other weigh station service roads were built with 11 inches of Portland cement concrete (PCC) pavement. Figure 6 depicts the layout of the weigh station facility and test sections.

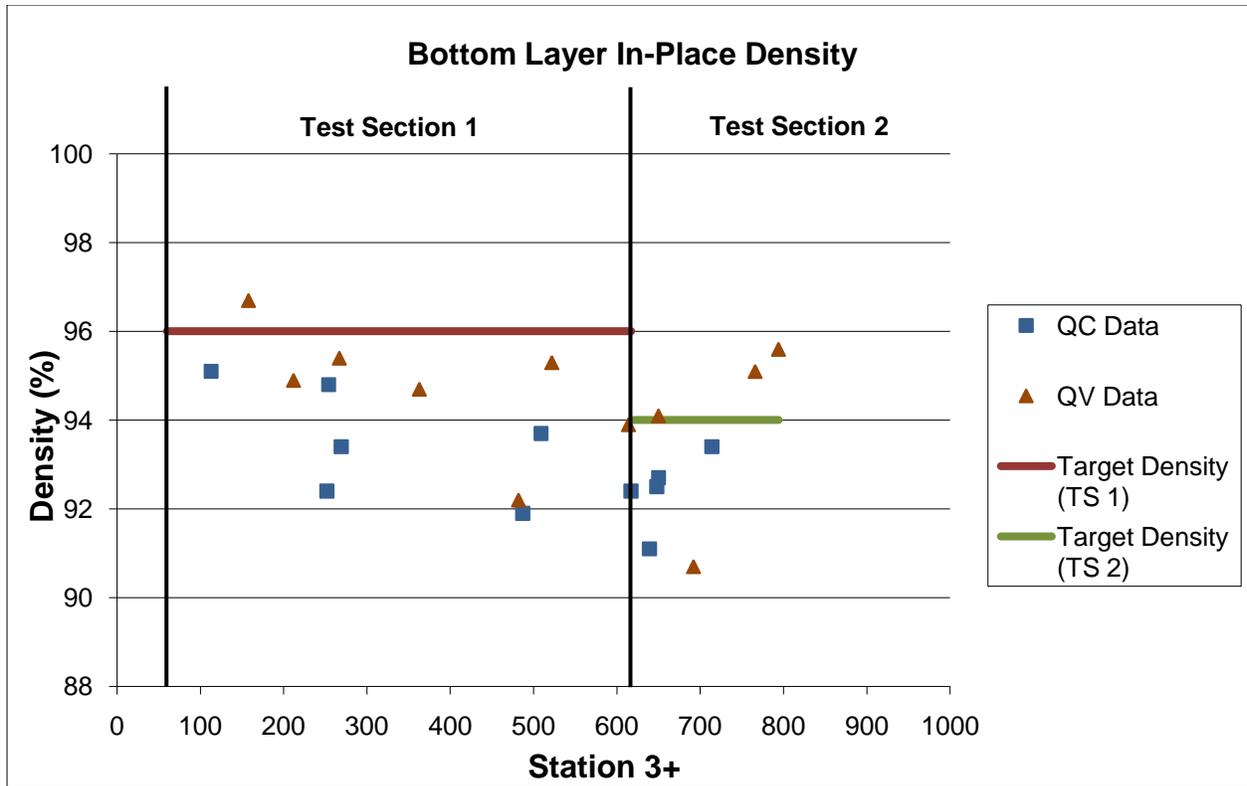
Figure 7. In-place density measurements, bottom HMA layer. Note: metric stationing.

Low in-place density might have been due to low temperatures in the mat during compaction (temperature was not monitored), or due to stiffness of the base course layer, which affects the compactive effort of layers paved above. The low in-place density would allow for additional compactive action by truck traffic, but was not exactly as designed for the perpetual pavement test sections.

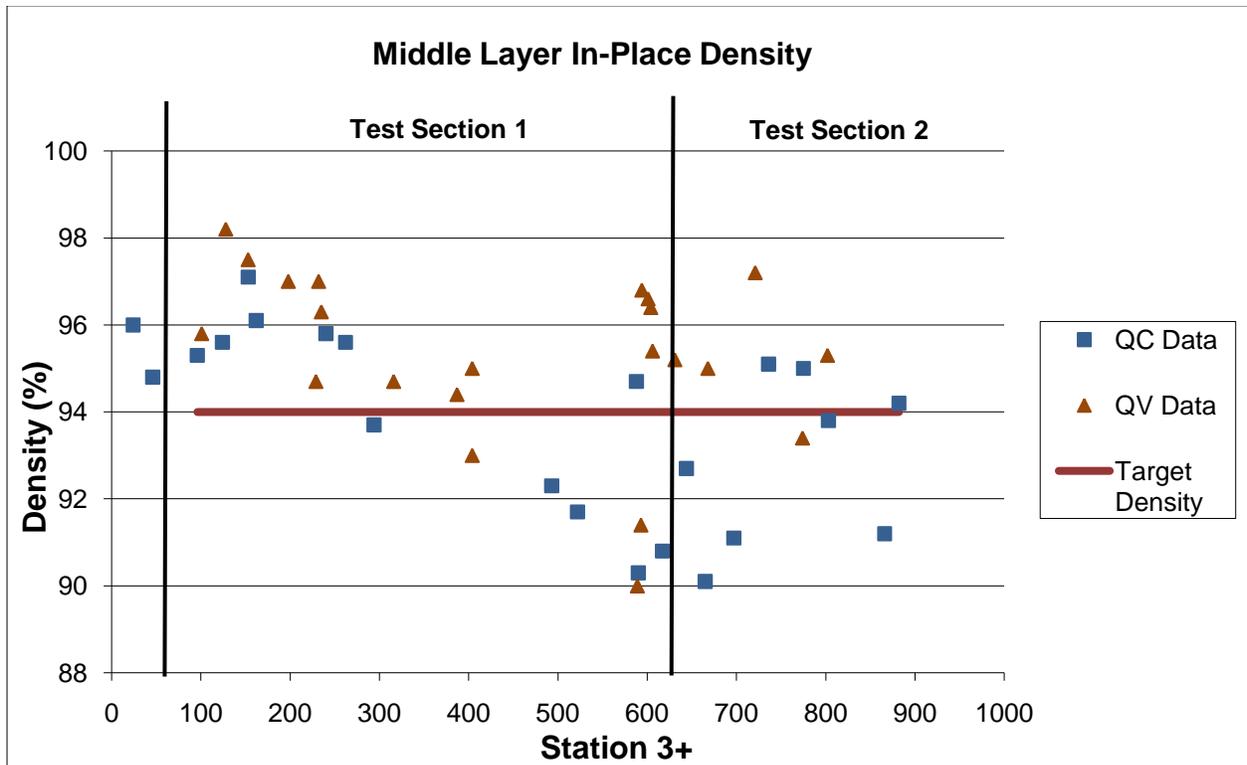
Figure 8. In-place density measurements, middle HMA layer. Note: metric stationing.

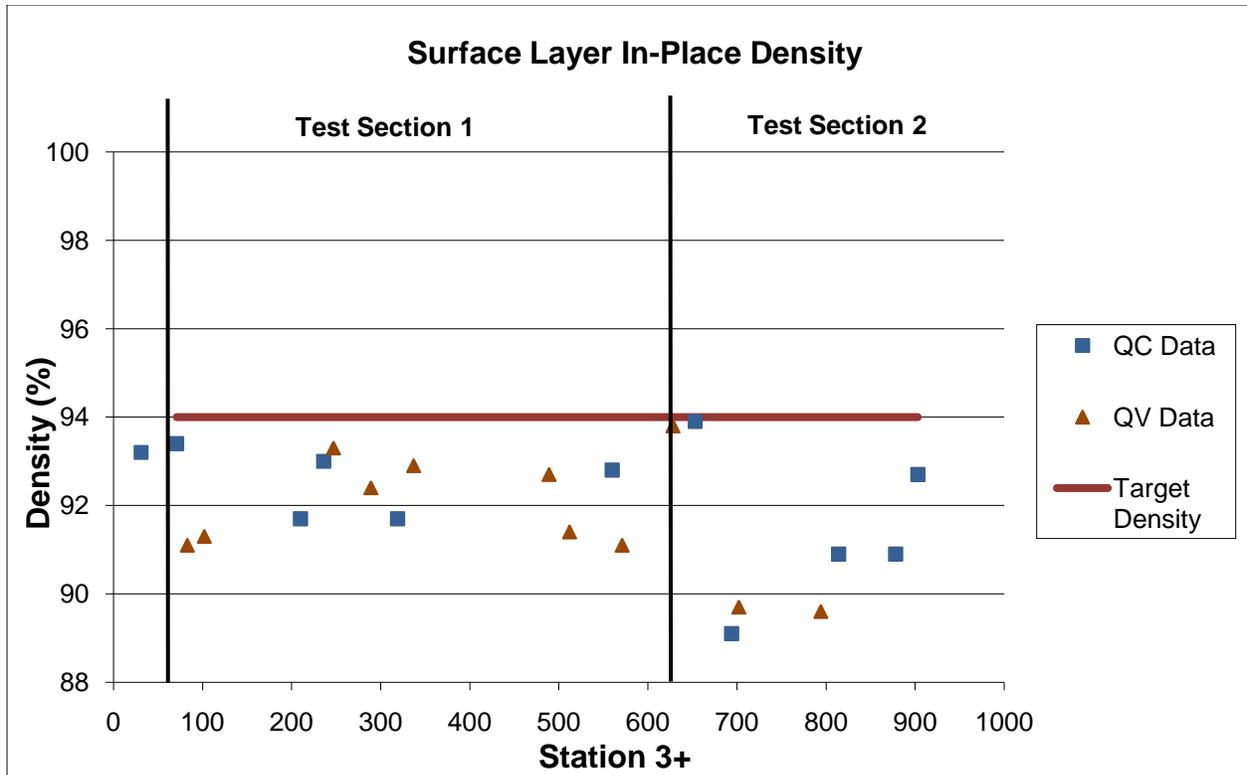
Figure 9. In-place density measurements, surface HMA layer. Note: metric stationing.

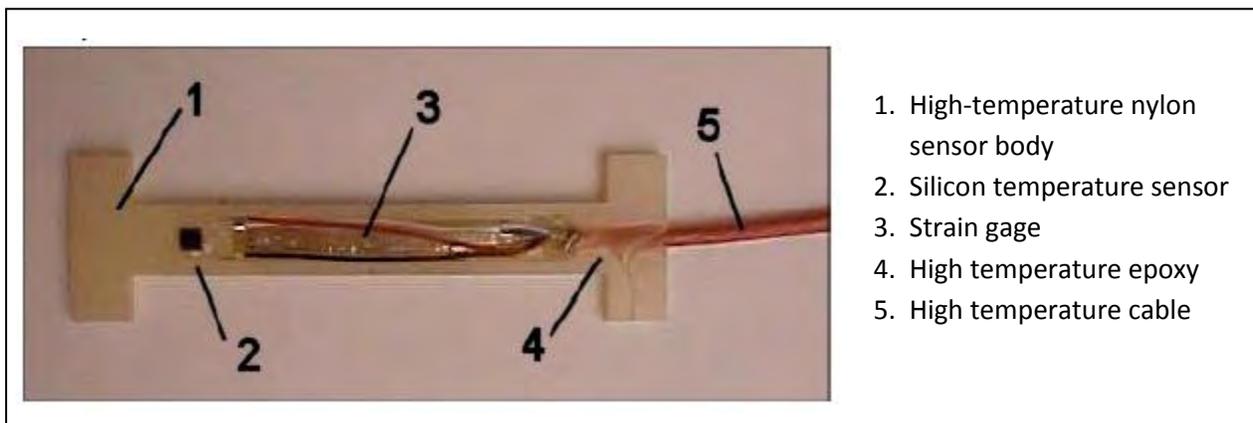
Figure 10. Strain gage fixture.

Romus, Inc. designed and provided the sensors for this study. Each sensor consisted of a strain gage and a temperature sensor mounted on an adhesive-coated nylon substrate. This allowed the sensor to become adhered to the bottom of an individual layer of HMA. The temperature range of the gages was -100 to 200°F for continuous measurement. A labeled picture of the strain gage fixture is shown in Figure 10, and a schematic and wiring details are provided in Figure 11. Strain gage specifications are provided in Appendix C.

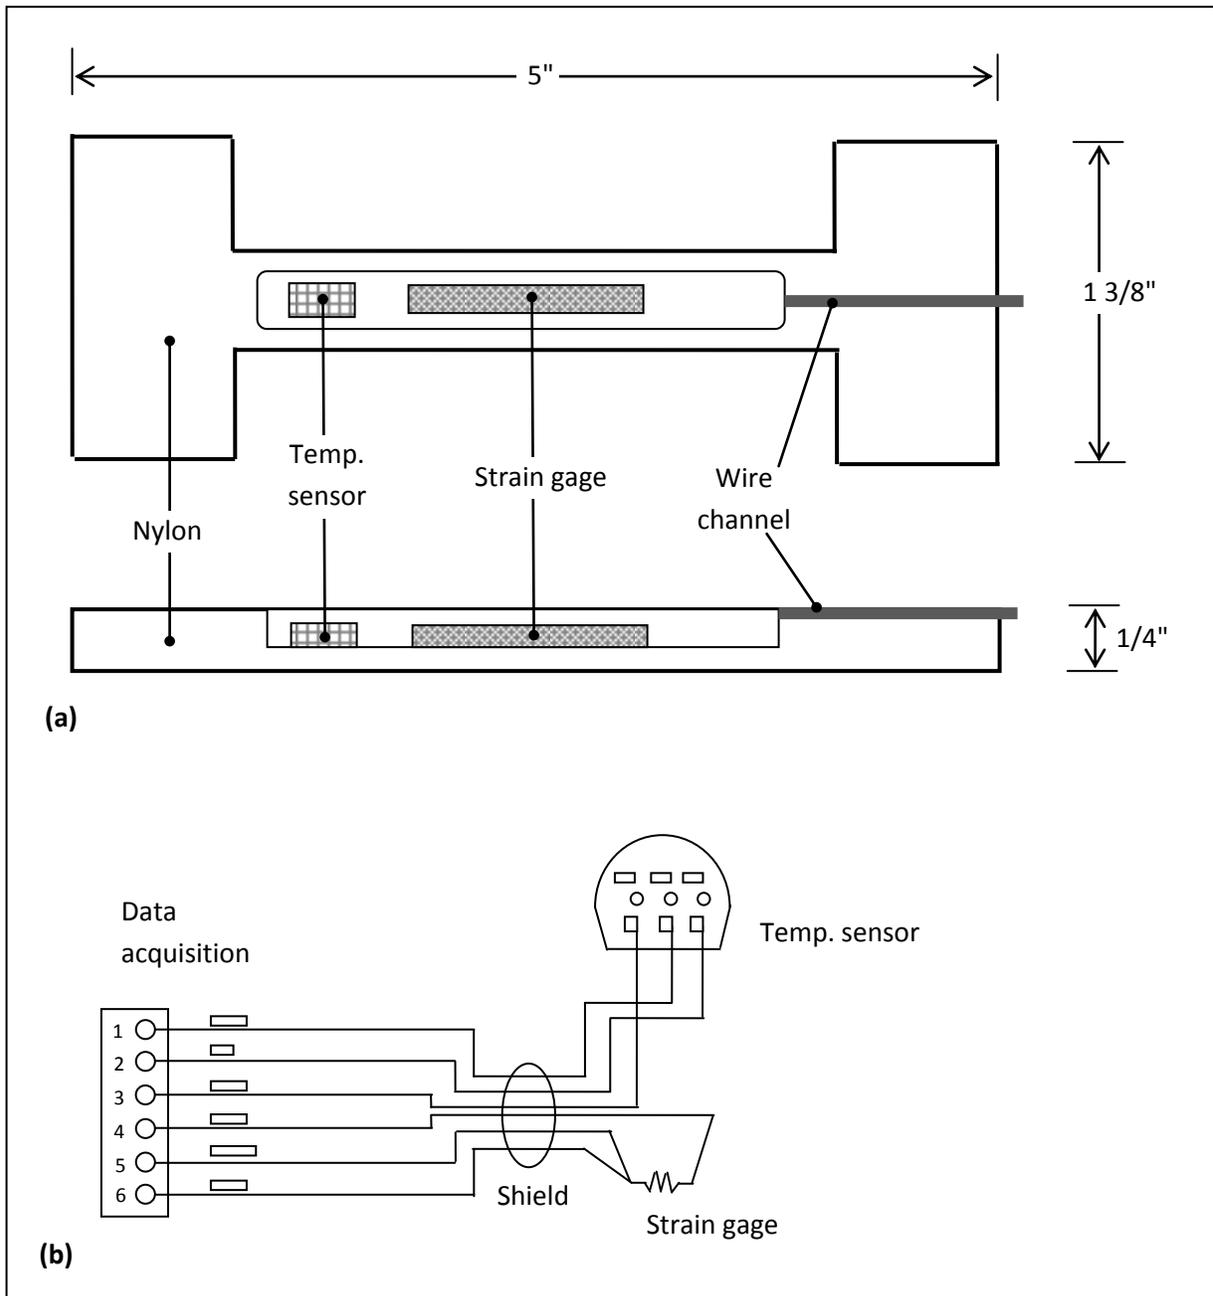
Figure 11. Strain gage (a) schematic diagram, and (b) wiring details.

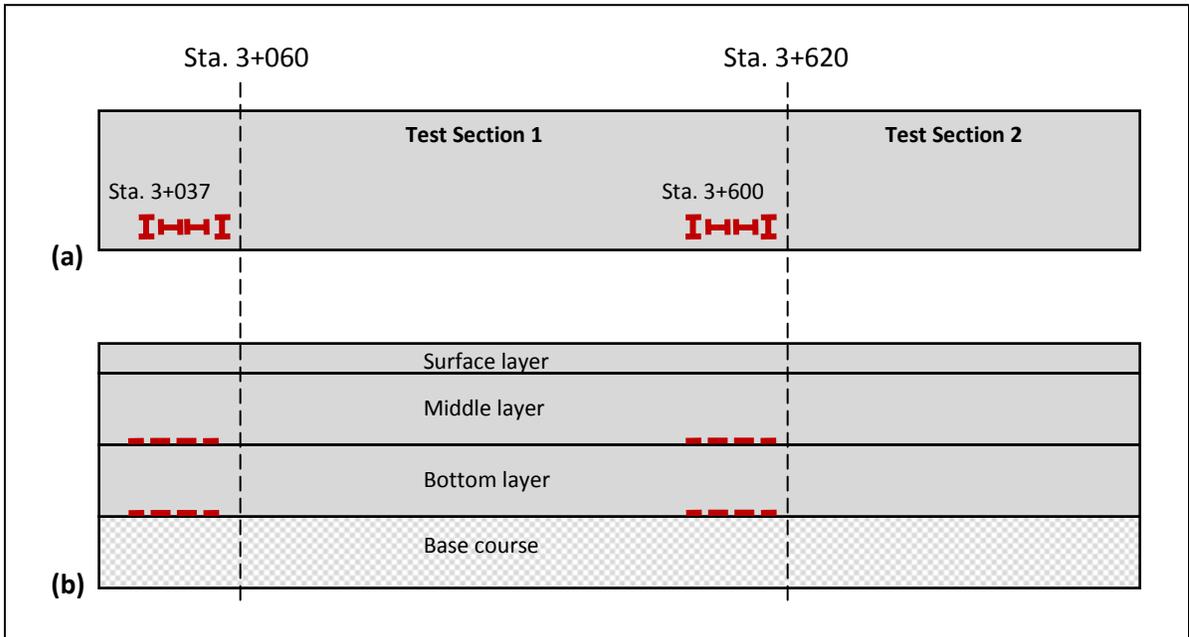
Figure 12. Strain sensor location: (a) plan view, and (b) pavement profile view.

A total of 16 strain sensors were installed in the perpetual pavement. Eight sensors were installed at the interface between the base course and the bottom layer of HMA, and the remaining eight sensors were placed at the interface between the bottom and middle layers of HMA. Sensors were positioned in groups of four, with two sensors oriented longitudinally (in the direction of traffic flow), and two sensors oriented transversely (perpendicular to traffic flow). This created a redundant set of sensors at each installation location. All sensors were located in the plane of the right wheel path. Sensor orientations are depicted in Figure 12.

Initial plans called for both test sections to be instrumented with a set of strain sensors. However, because the test section limits were altered slightly during construction due to the construction issues described in Section 4, this was not possible. One set of sensors was installed prior to the start of test section 1, and the second set was installed prior to the start of test section 2 (Figure 12).

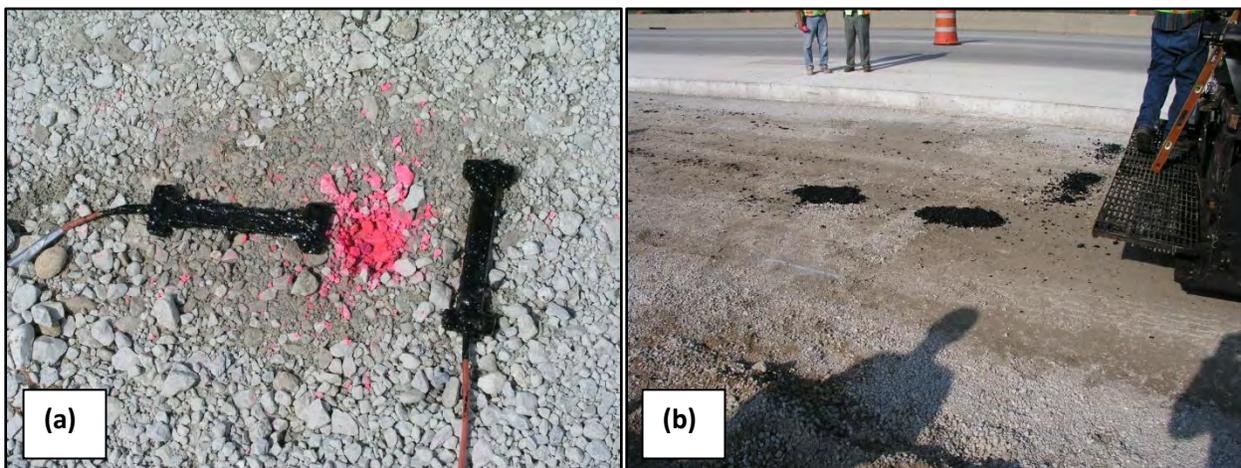
Figure 13. Strain gage installation (a) on top of base course, and (b) just prior to paving of the lower HMA layer.

Installation of the strain sensors took place during paving operations on August 5th and 7th, 2003. Marquette University staff coordinated the installation. Data cables were run from the sensors to the edge of the pavement, where the cables ran under a concrete barrier to a vault secured to the outside wall of the barrier. To prevent dislocation during paving, the sensors and data cables were secured with staples to the top of the aggregate base course and the top of the bottom layer of HMA. The cables were encased in protective plastic pipes from the edge of pavement to the vaults. The sensors were stabilized with one shovel of HMA just prior to paving over them. Figure 13 shows the strain sensors as they were installed during paving.

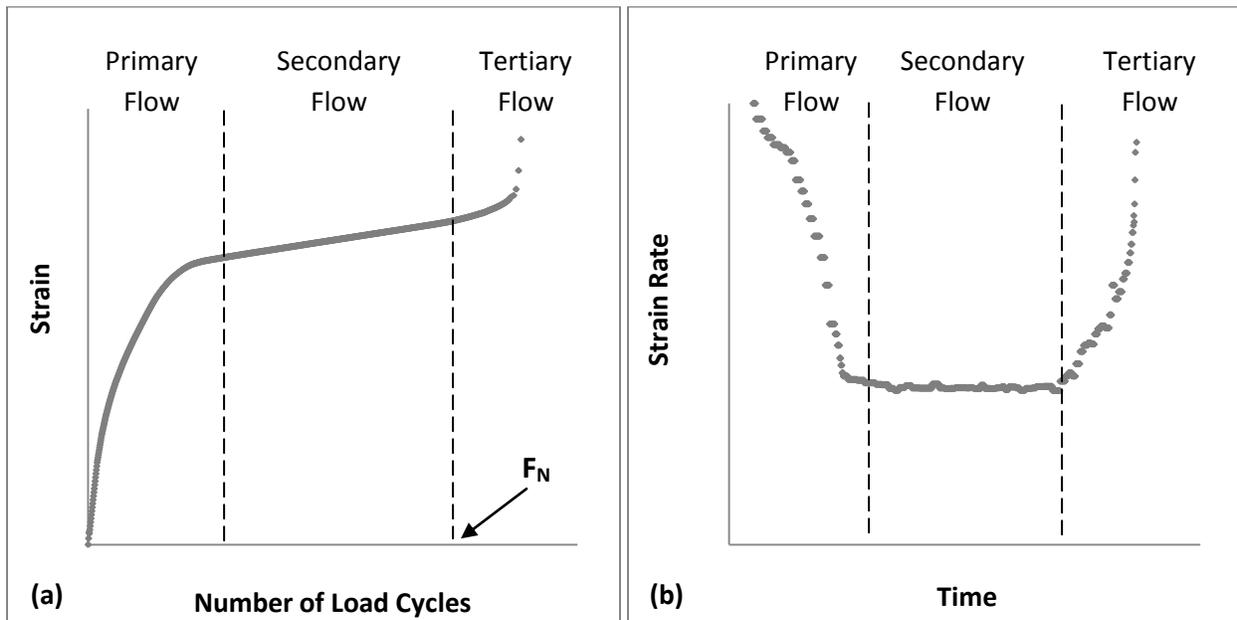
Figure 14. Demonstration of primary, secondary, and tertiary flow for (a) strain measurements and (b) strain rate measurements.

In the test for flow number (F_N), a cyclic axial load is applied to an HMA specimen. The load cycle consists of application of the load for 0.1 s, followed by a rest period of 0.9 s. The permanent strain of the specimen is measured at the end of each rest period. [17] A viscoelastic solid, such as HMA, follows a particular strain pattern under repeated loading. The strain pattern can be divided into three phases, as shown in Figure 14. In the primary flow phase, the rate of strain ($d\epsilon/dt$) decreases. During secondary flow, the rate of strain is relatively constant. Tertiary flow commences when the strain rate begins to increase again, and generally continues to increase until specimen failure. The specimen's F_N is defined as the number of load cycles at which tertiary flow begins (Figure 14). Higher F_N indicates greater in-service rutting resistance.

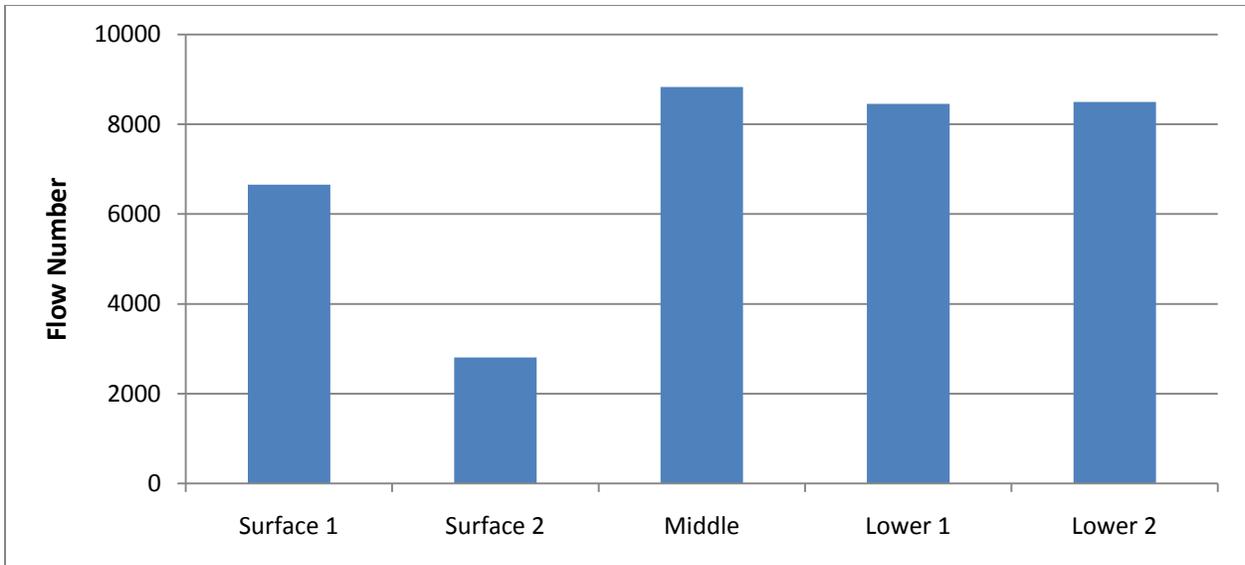
Figure 15. Flow number test results for the five perpetual pavement mixture types.

Results from F_N testing are shown in Figure 15. The middle and lower layer mixtures had the highest F_N (8500 to 8800), while the surface layer mixtures displayed lower F_N values (approximately 6650 and 2800 for test sections 1 and 2, respectively). The higher F_N values for the middle and lower layer mixtures indicate a greater resistance to rutting than the surface layer mixtures. This result is characteristic of a perpetual pavement system, where the surface layers are intended to reach their service life after 12-15 years and be replaced, while the lower layers must remain in service much longer. The mixture F_N for the surface layer was higher for test section 1 than test section 2, indicating that test section 2 would not have as great rutting resistance as test section 1. This is likely due to the fact that a stiffer asphalt binder was used in test section 1: PG 76-28 versus PG 70-28 in test section 2.

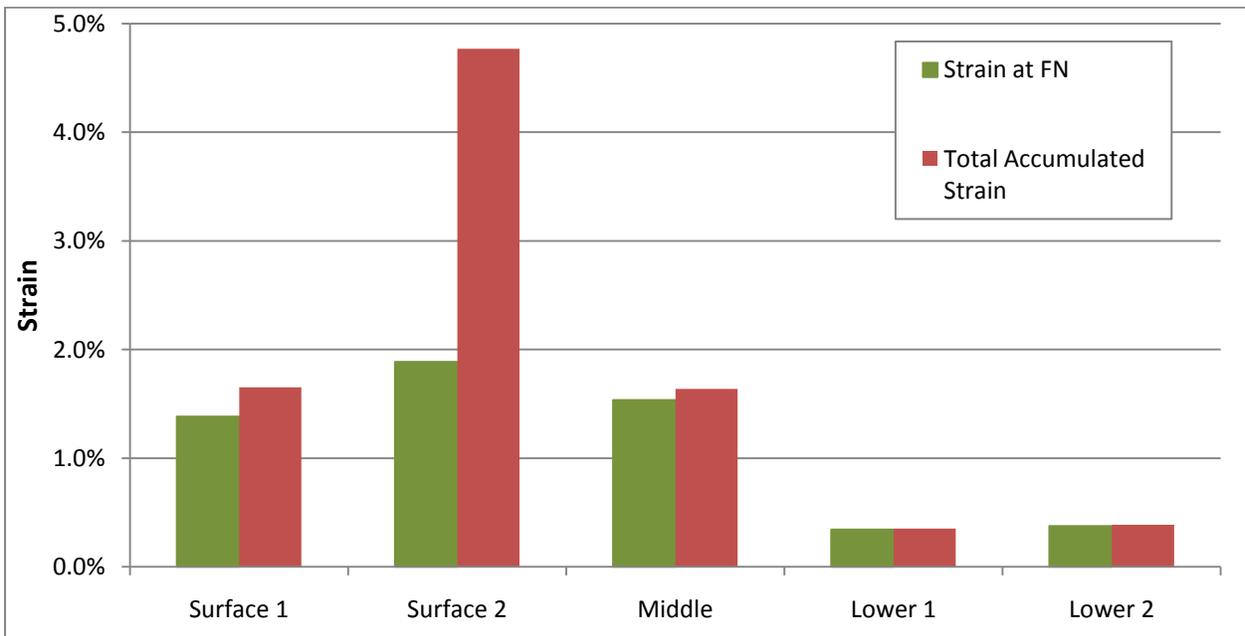
Figure 16. Accumulated strain test results for the five perpetual pavement mixture types.

Permanent strain measurements were also recorded during F_N testing; these results are shown in Figure 16. Higher strain levels when tertiary flow is reached (F_N point) and at the end of the test generally indicate that a mixture has less resistance to rutting. However, it has also been proposed that accumulated permanent strain is a parameter that is more useful for comparing specimen quality within one mixture subset than for comparison among mixture types. [18] Therefore, more emphasis was placed on the F_N results (Figure 15).

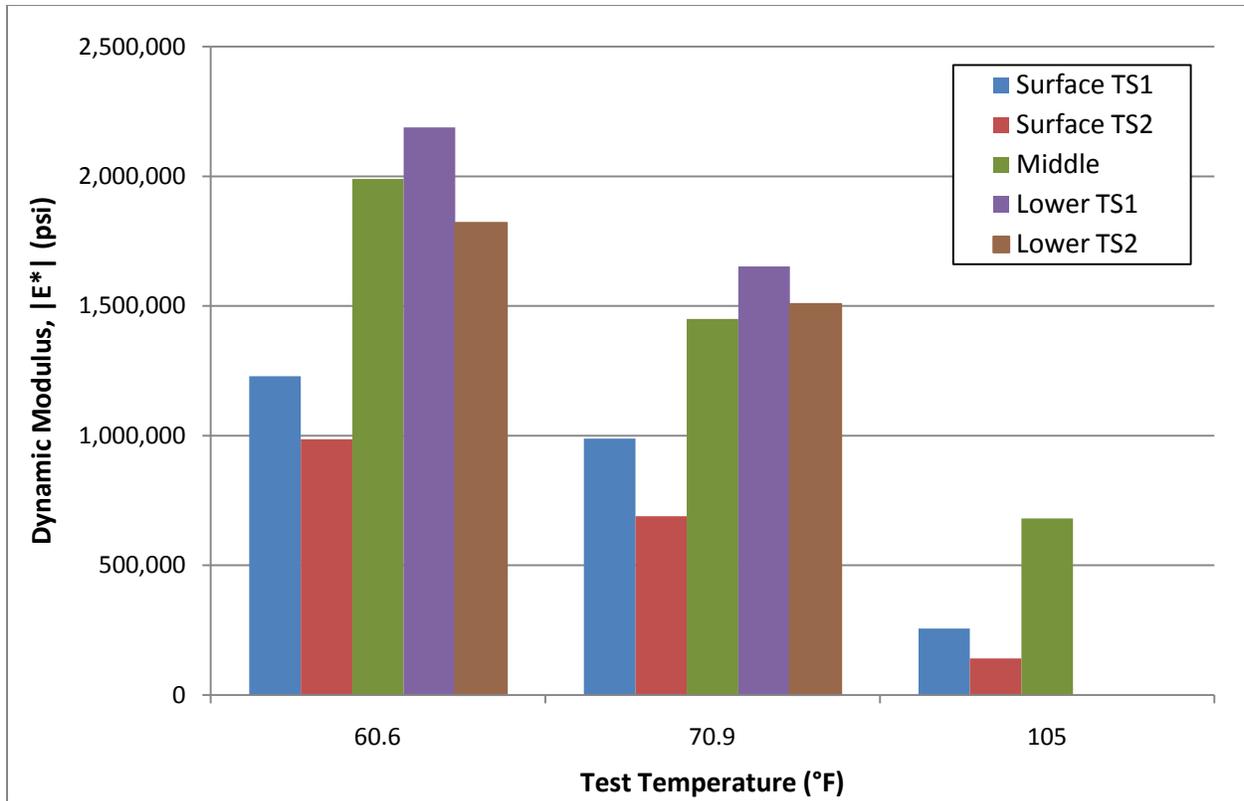
Figure 17. Average dynamic modulus test results, 25 Hz.

The $|E^*|$ values for the lower and middle HMA layers were higher than for the two surface layers at all test temperatures. This indicates that the lower and middle layers had more potential to resist permanent deformation (rutting) than the surface layers. The higher $|E^*|$ results might be due to the larger aggregate size used in the lower and middle layers. Long-lasting lower layers is important in a perpetual pavement system, as these layers are not meant to be replaced during rehabilitation efforts. The base layer in test section 1 slightly out-performed that for test section 2, but no statistical difference was found between test results for these layers.

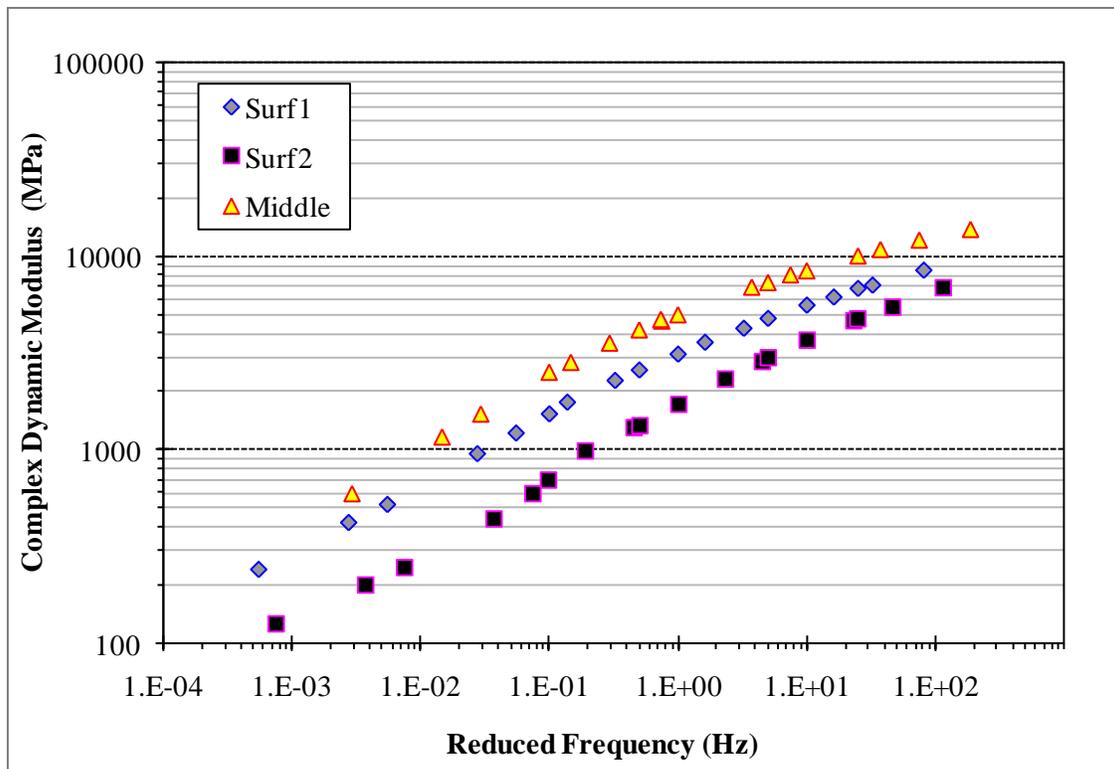
Figure 18. Dynamic modulus master curves for surface and middle layers. From NC Superpave Report (see Appendix E). Note: 1 MPa = 145 psi

When results are available for $|E^*|$ testing at a minimum of three temperatures, results can be reduced to form a master curve showing $|E^*|$ versus test frequency. This curve is useful because a material's performance at various test frequencies is related to its behavior under different traffic speeds, with higher frequencies representing faster traffic speeds. Data was available to create master curves for the surface and middle HMA layers. These curves are shown in Figure 18. The middle layer was stiffest at all test frequencies. Comparing surface layers, the material from test section 1 was stiffer than that for test section 2.

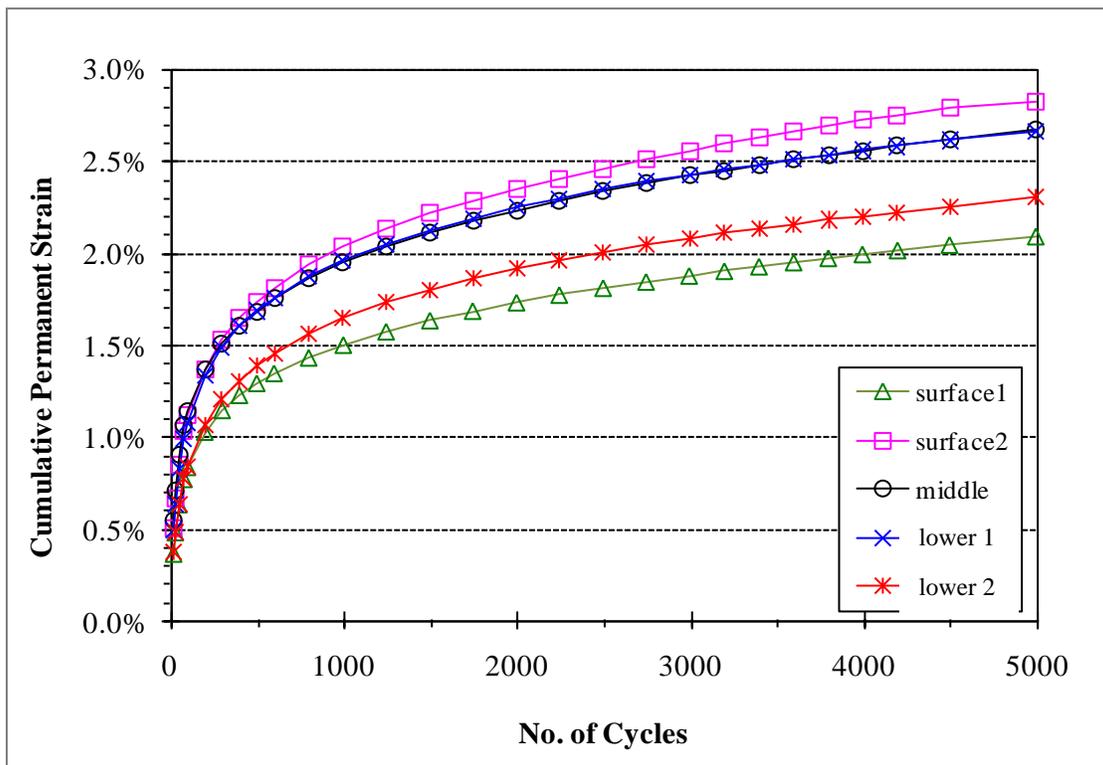
Figure 19. Cumulative permanent shear strain profiles. From NC Superpave Report (see Appendix E).

The average permanent shear strain profiles recorded during the tests are shown in Figure 19 for all mixtures tested. The cumulative permanent shear strain noted after 5000 cycles can be used to evaluate a mixture's rutting potential, with lower cumulative strain indicating better rutting performance. The test section 1 surface layer performed best, and the test section 2 surface layer performed worst, with the middle and base layers falling in between (the middle and lower 1 strain profiles fall on nearly identical curves).

All mixtures had between 2 and 3 percent permanent shear strain at 5000 cycles, which is a range considered to indicate adequate rutting resistance. According to Asphalt Institute (AI) guidelines, these mixtures would show fair rutting performance. The AI guidelines, however, were for mixtures with 3 to 4 percent air voids, which is a lower range than the mixtures tested in this study. A study at the NCAT Test Track did not find a good correlation between RSCH results and field rutting measurements. [20] However, the RSCH values provide a measure of comparison among the mixtures tested in this study's pavement system.

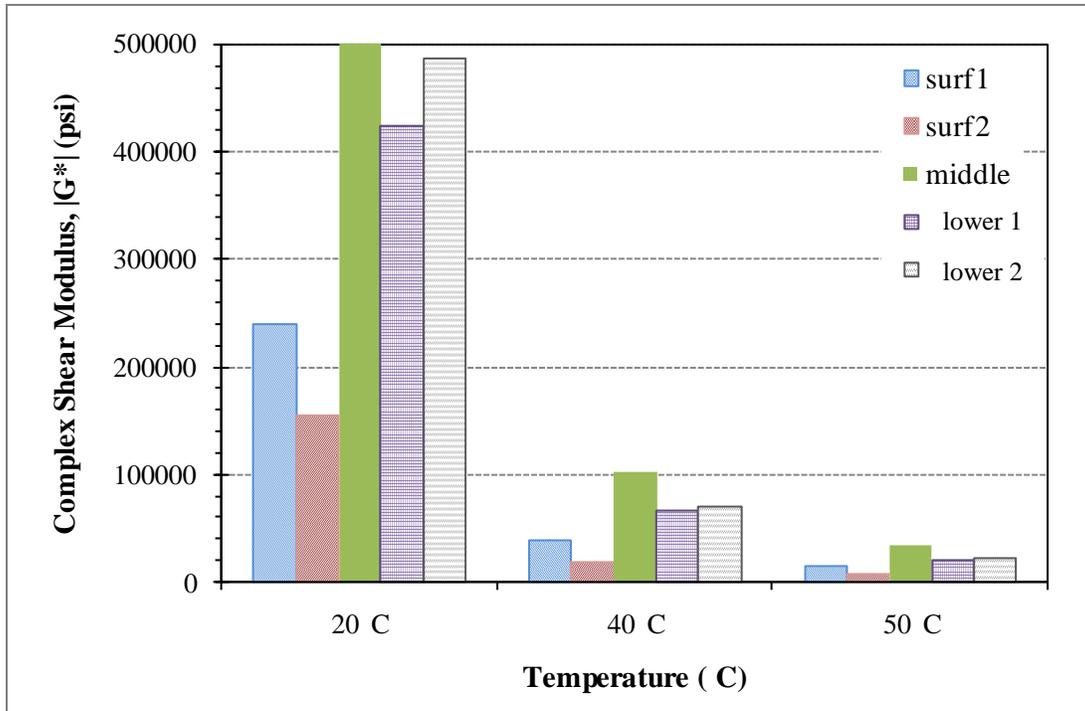
Figure 20. Average complex shear moduli ($|G^*|$) at 10 Hz test frequency. From NC Superpave Report (see Appendix E).

The complex shear modulus is an indicator of rutting resistance. Based on the FSCH test results, the middle and lower HMA layers would be expected to have greater rutting resistance than the two surface layers, and surface layer 1 would show better rutting performance than surface layer 2. Shear loading performance categories developed by the AI indicate that surface layer 2 would show poor performance, surface layer 1 would show fair performance, and the middle and lower layers would show excellent performance. These guidelines are based on samples with an air void content of 7 percent.

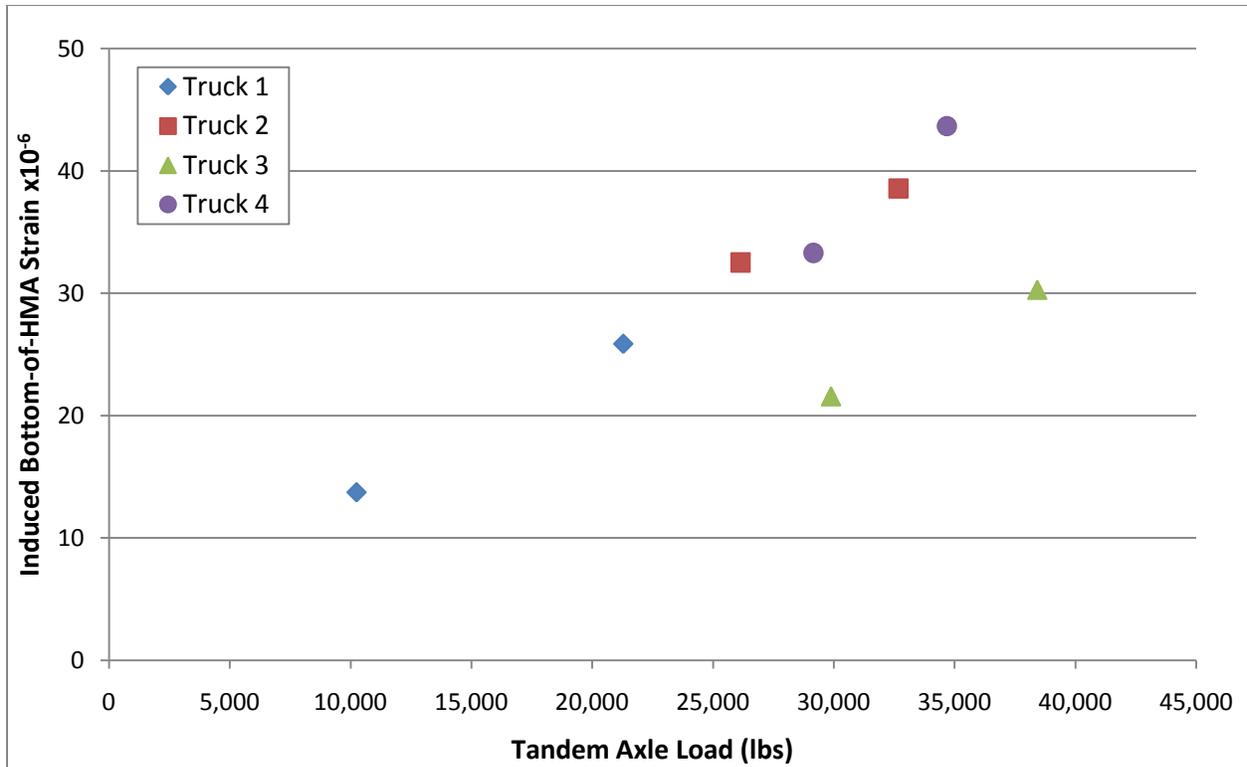
Figure 21. Induced strain at the bottom of HMA pavement. Adapted from [15]

Maximum tensile bottom-of-HMA strain readings induced by the trucks' tandem axles are shown in Figure 21. All strains were less than 50x10⁻⁶. A relatively linear response was noted between load and induced strain. [15] The Truck 3 strain readings were proportionately lower than other trucks' readings. This could be due to the fact that Truck 3 traveled over the sensors at a slightly higher speed; loads applied more quickly tend to induce lower strain in a material.

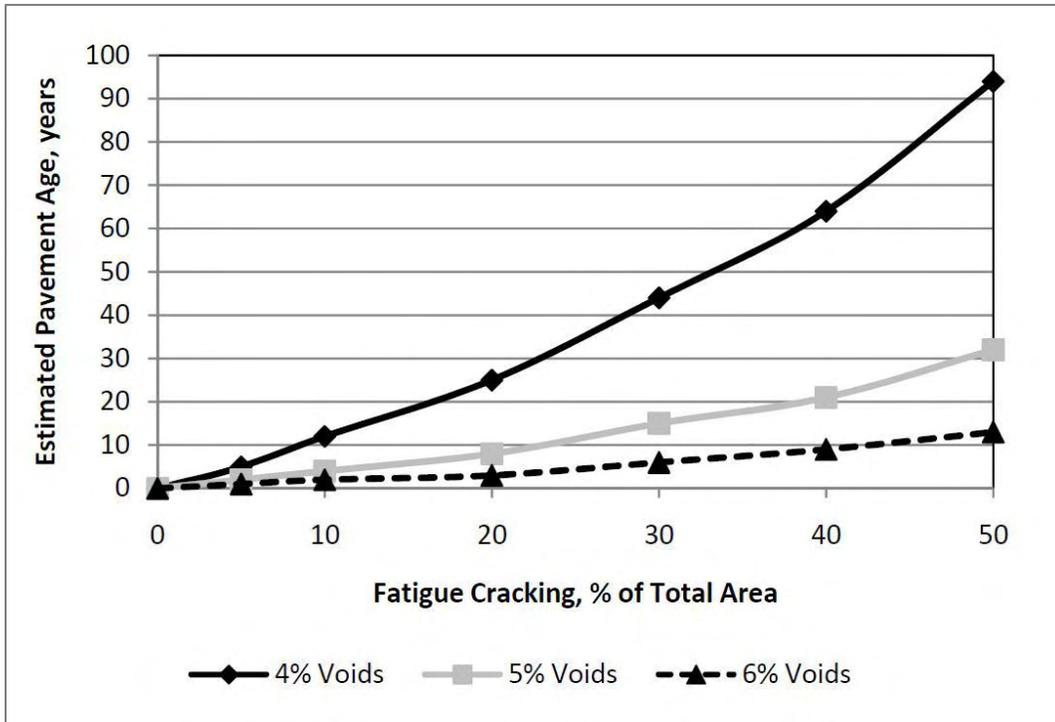
Figure 22. Service life prediction for 4, 5 and 6 percent air voids in the middle and lower HMA pavement layers. From [15]

The final portion of the analysis by Crovetti included a service life prediction based on a mechanistic appraisal. In this investigation, pavement failure was indicated by bottom-up fatigue cracking covering 50% of the HMA pavement surface. Cumulative fatigue damage was calculated based on average monthly pavement temperatures and assumed traffic levels of 520,000 ESALs per month (6,240,000 ESALs per year). To evaluate the effect of air void variability, the pavement system was analyzed with 4, 5 and 6 percent voids in the fatigue-resistant middle and lower (25 mm) HMA layers. [15]

The results from this analysis are shown in Figure 22. In the mechanistic evaluation, increased air voids in the 25 mm layers resulted in a shorter service life. The predicted service life was 94 years for 4 percent voids and only 13 years for 6 percent voids. [15] The average measured air voids for the middle layer were 5.4 and 5.8 percent for test sections 1 and 2, respectively; for the lower layer, the average measured air voids were 6.0 and 6.9 percent for test sections 1 and 2, respectively (Section 4.3). Based on these averages, neither test section would be expected to perform well in the bottom-up fatigue cracking category. Although only top-down cracking was noted in the forensic coring analysis (Section 7.4), the alligator cracking observed in the wheel paths during the time since coring could be bottom-up fatigue cracking.

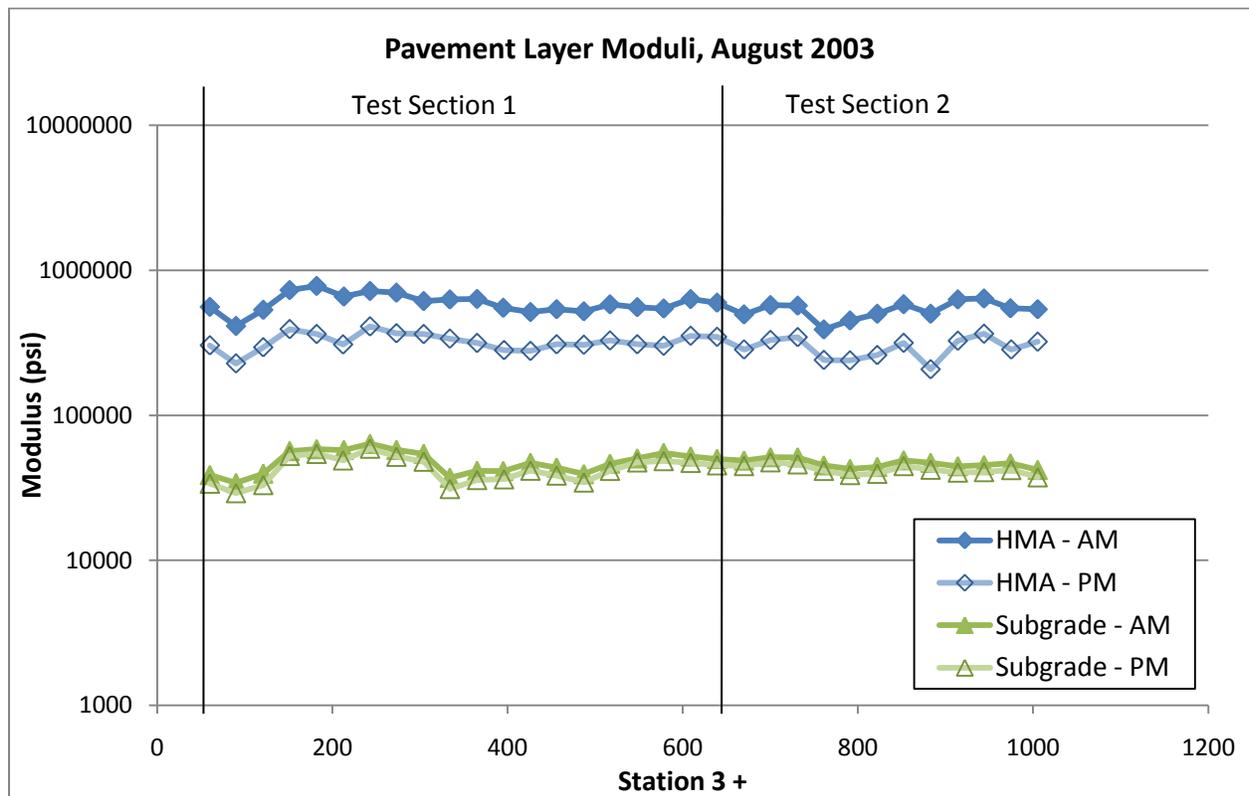
Figure 23. Pavement layer moduli from FWD testing, August 2003 morning and afternoon.
