Evaluation of a Hot Mix Asphalt Perpetual Pavement

FINAL REPORT

Research Study # FEP-02-02

Report # FEP-01-10

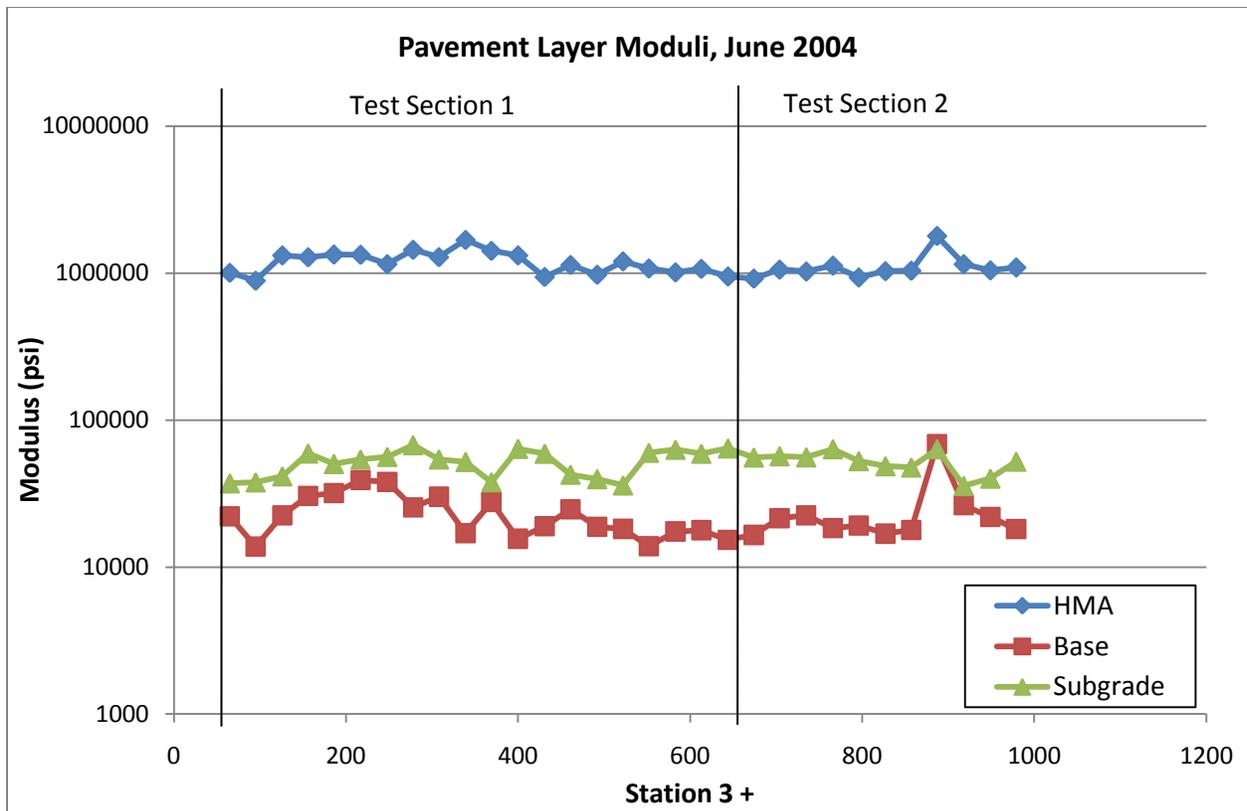
Figure 24. Pavement layer moduli from FWD testing, June 2004.

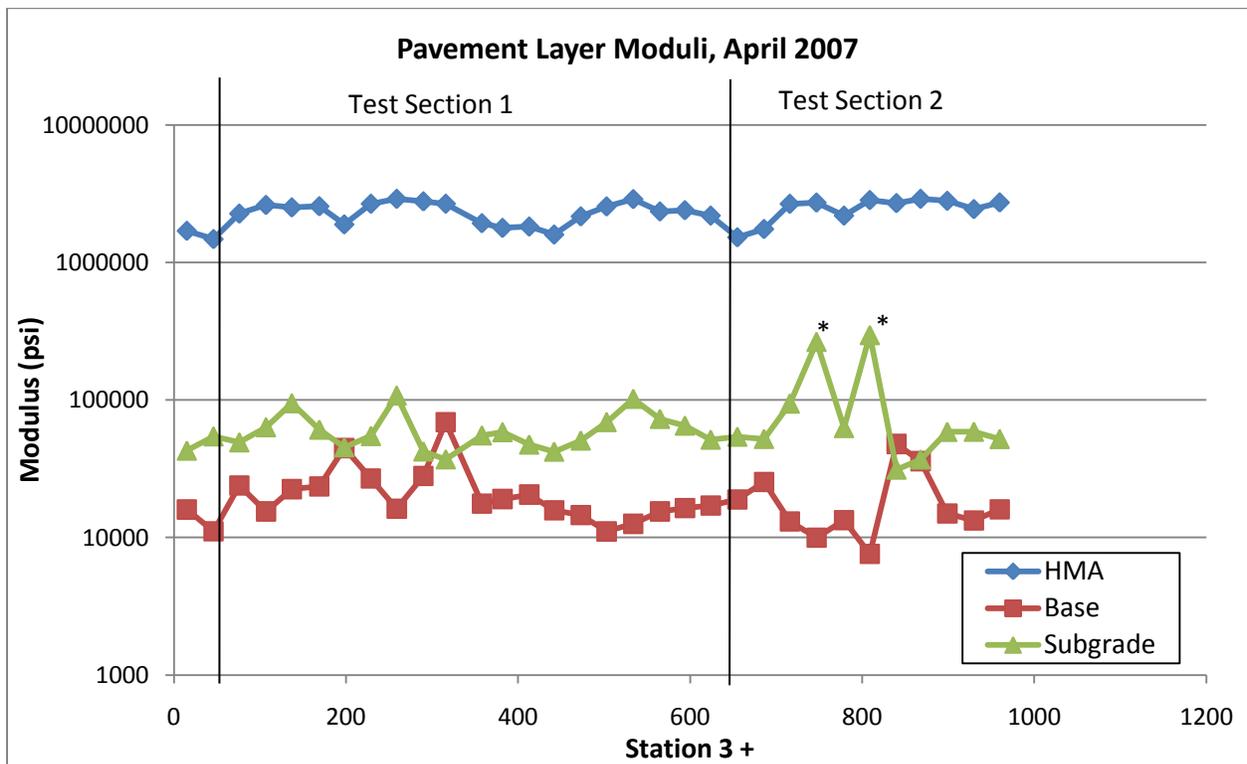
Figure 25. Pavement layer moduli from FWD testing, April 2007. * Denotes outliers.

data were collected at the end of the spring thaw, when the base and subgrade could still have been saturated; the April 2007 base and subgrade moduli were in the same range as the 2003 and 2004 values, but results were more variable along the length of the test sections (Figure 25). Average HMA moduli were highest in April 2007, when the air and pavement temperatures were lowest. The range of moduli (0.3×10^6 to 2.5×10^6 psi) were typical for uncracked HMA pavement at the various temperatures tested. Base layer moduli (approx. 20,000 psi) were somewhat low for a well-drained crushed aggregate base course. Subgrade moduli were higher than expected for a silty-clay soil, which are usually in the 12,000 to 20,000 psi range.

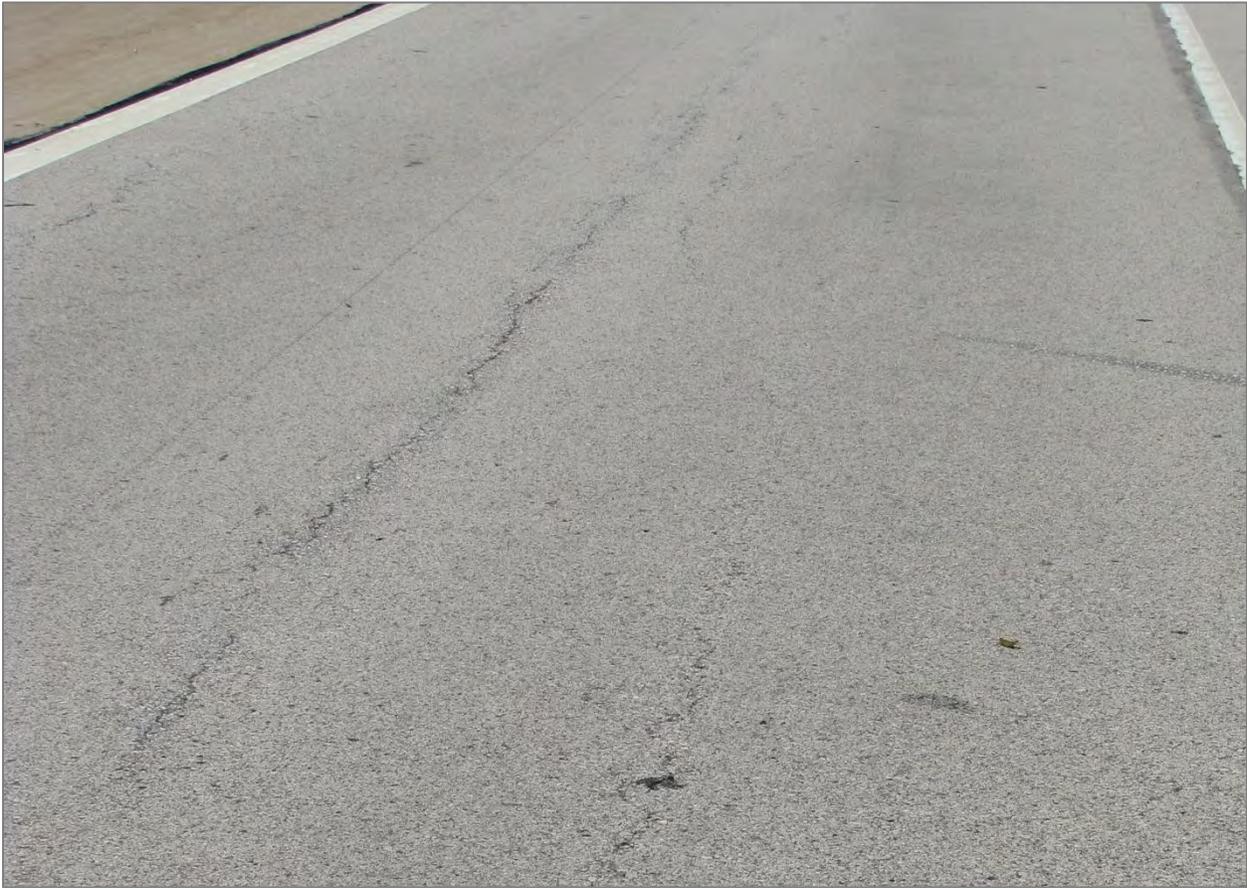
Figure 26. Distress in test section 1, station 3+362, 2008.

The most frequent distresses noted were early alligator cracking in the wheel paths, and longitudinal cracking at the center of the pavement. Other distresses included transverse and longitudinal cracking in the wheel paths, and areas where surface aggregate was missing (aggregate popouts). The presence of these distresses were surprising, as the pavement had only been in service for four years when many were first noted.

Test section 1 exhibited slightly more distress than test section 2, although the latter section still had several areas of cracking. An area of particularly poor performance was noted in test section 1, between stations 3+360 and 3+440 (see Appendix F). In this area, extensive alligator cracking was present in the wheel paths, and several center-of-pavement longitudinal cracks were developing. Photographs of these areas in 2008 and 2009 are shown in Figures 26 and 27, respectively.

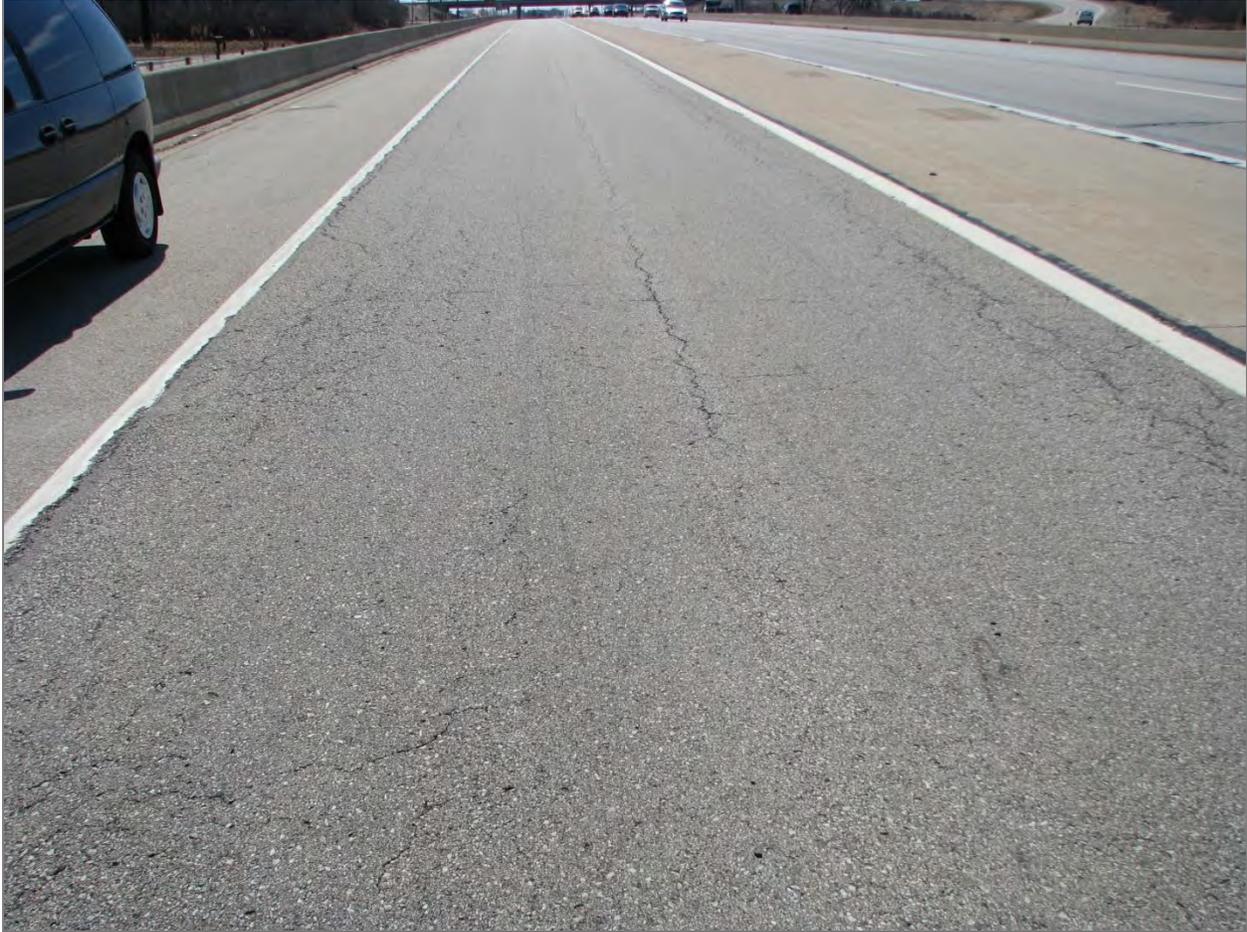
Figure 27. Distress in test section 1, approximate station 3+375, 2009.

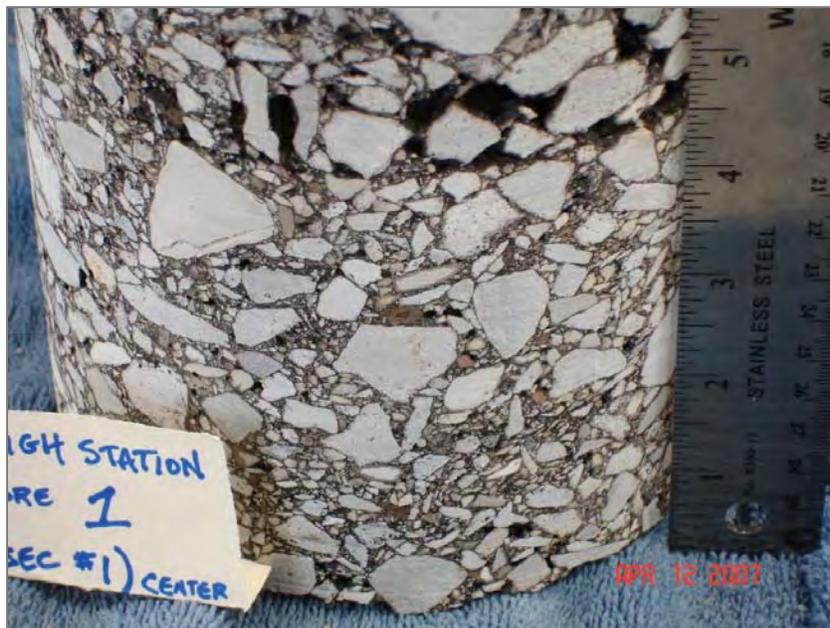
Figure 28. Concentrated asphalt binder pockets noted in the middle HMA layer of core 1.

Core 1 was taken directly over a longitudinal crack in test section 1. The crack initiated at the surface and extended halfway through the surface HMA layer on one side of the core and less than an inch downward on the other side of the core. Large pockets of asphalt binder were present in the middle HMA layer; most of the pockets were located at the bottom of this layer (Figure 28). Coarse and fine aggregate distribution was uniform in all layers.

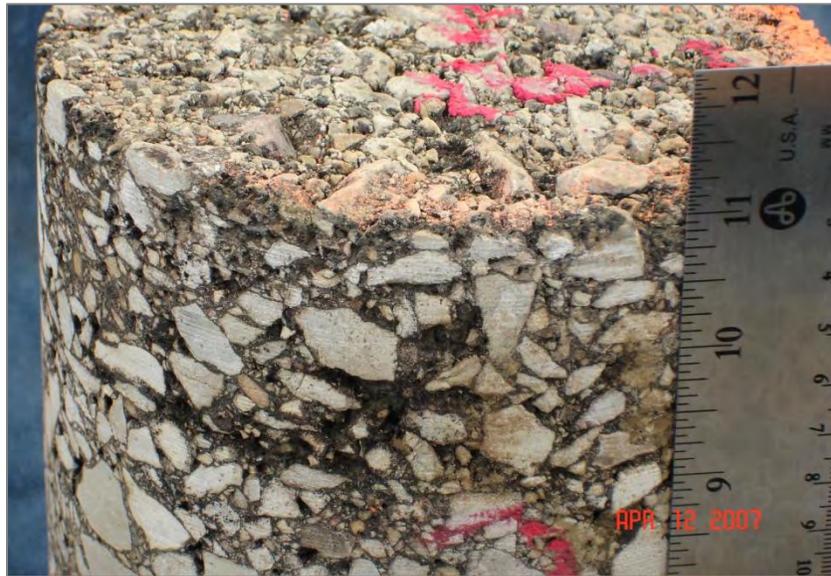
Figure 29. Void noted in surface HMA layer of core 2.

Core 2 was extracted over an area of early alligator cracking in test section 1. Cracking initiated at the surface and did not extend far into the top layer of HMA. Voids were present in the surface layer (Figure 29). Aggregate distribution was not as uniform as in core 1.

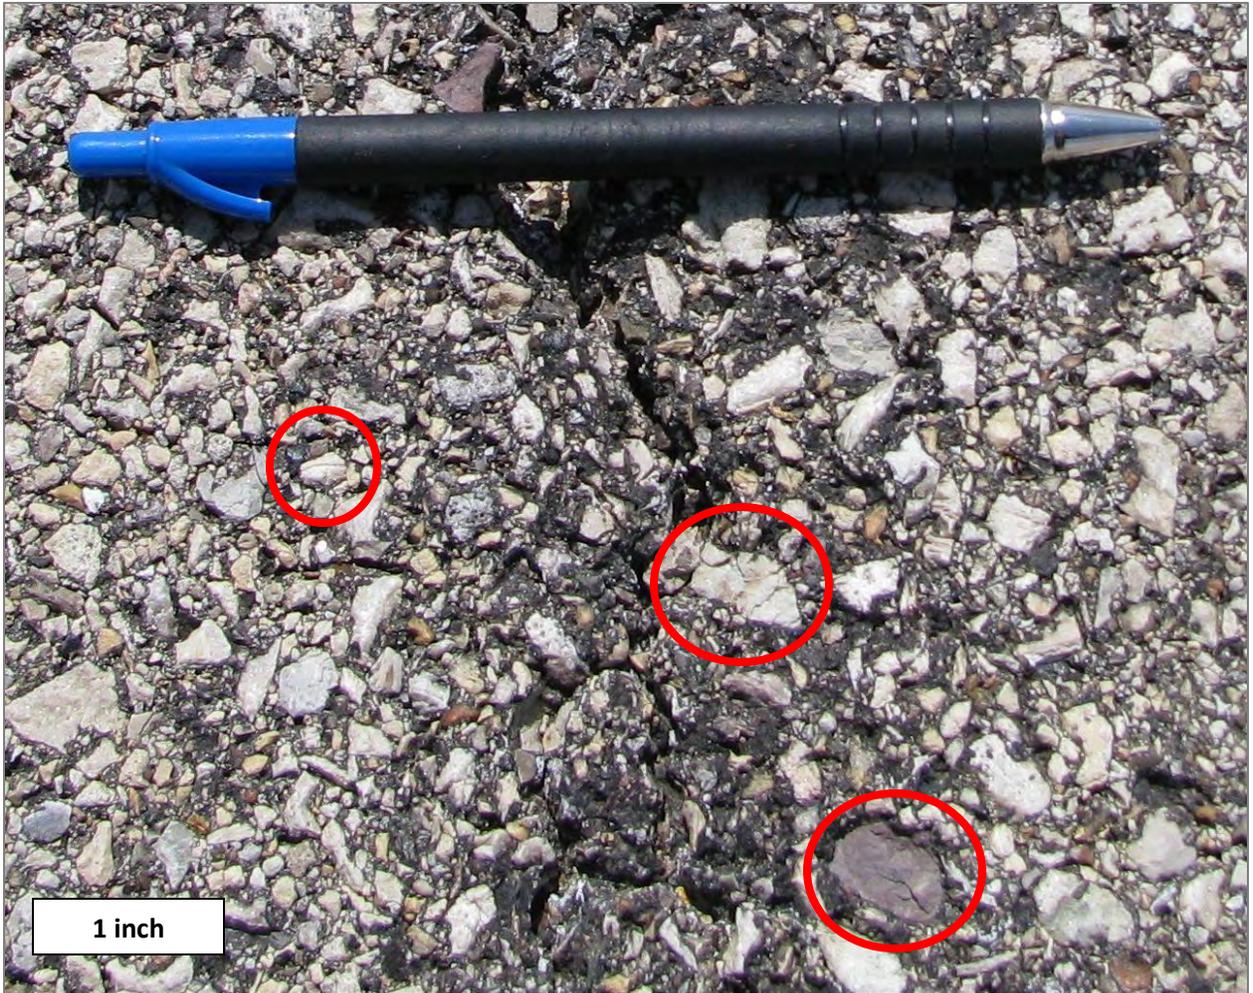
Figure 30. Shattered aggregate noted in a distressed area.

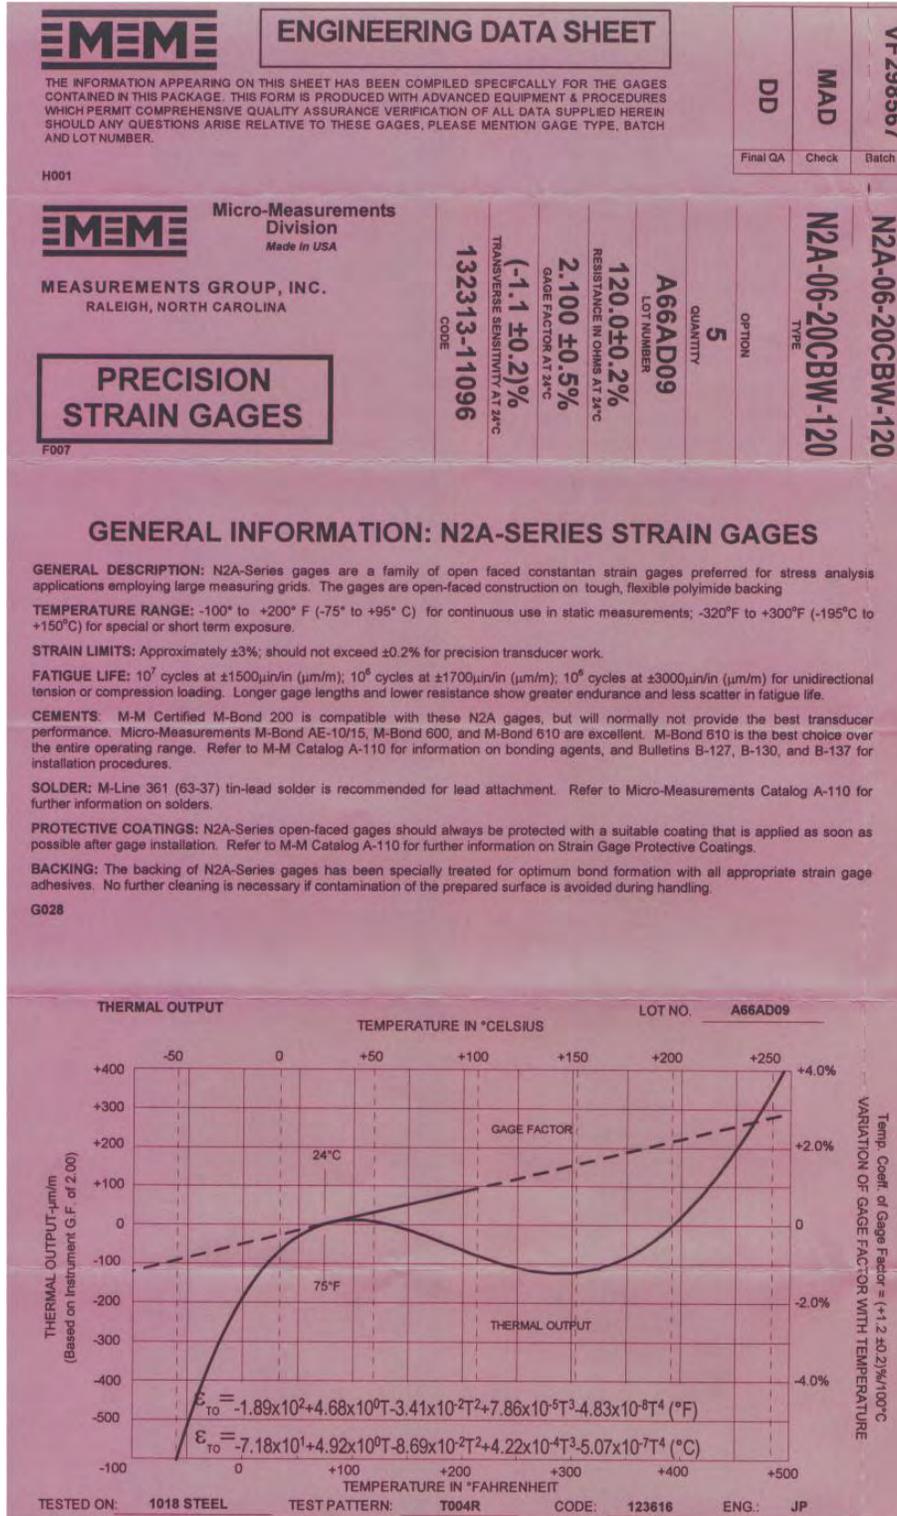
Figure C-1. Strain gage engineering data sheet.

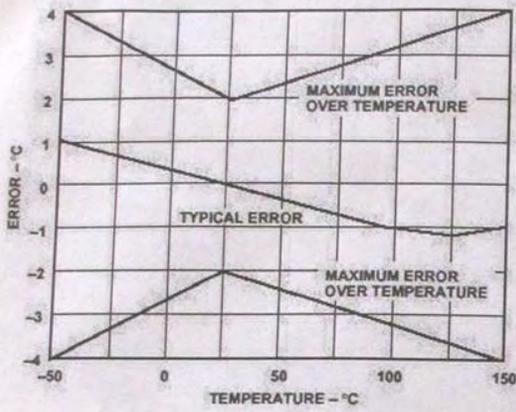
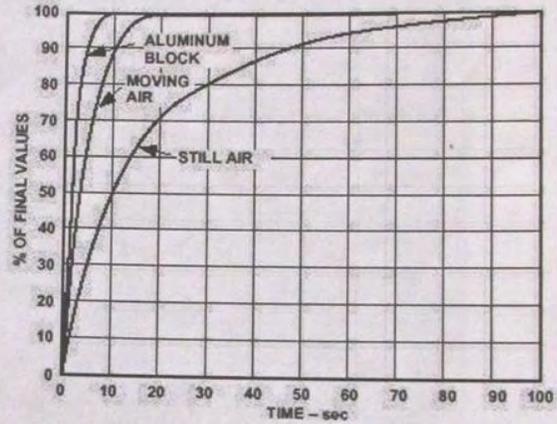
Parameter		Units
Transfer Function	$V_{OUT} = (V+5 V) \times [1.375 V + (22.5mV/^{\circ}C \times T_A)]$	V
Coefficient	$(V+5 V) \times 22.5$	mV/ $^{\circ}C$
Initial Error $T_A = +25^{\circ}C$	± 1.0	$^{\circ}C$
Nonlinearity	1.0	%FS
Output		
$V+5.0 V, T_A = -50^{\circ}C$	0.250	V
$V+5.0 V, T_A = +150^{\circ}C$	4.750	V
Temperature Range	-50 to +150	$^{\circ}C$

Figure C-2. Temperature sensor data sheet.

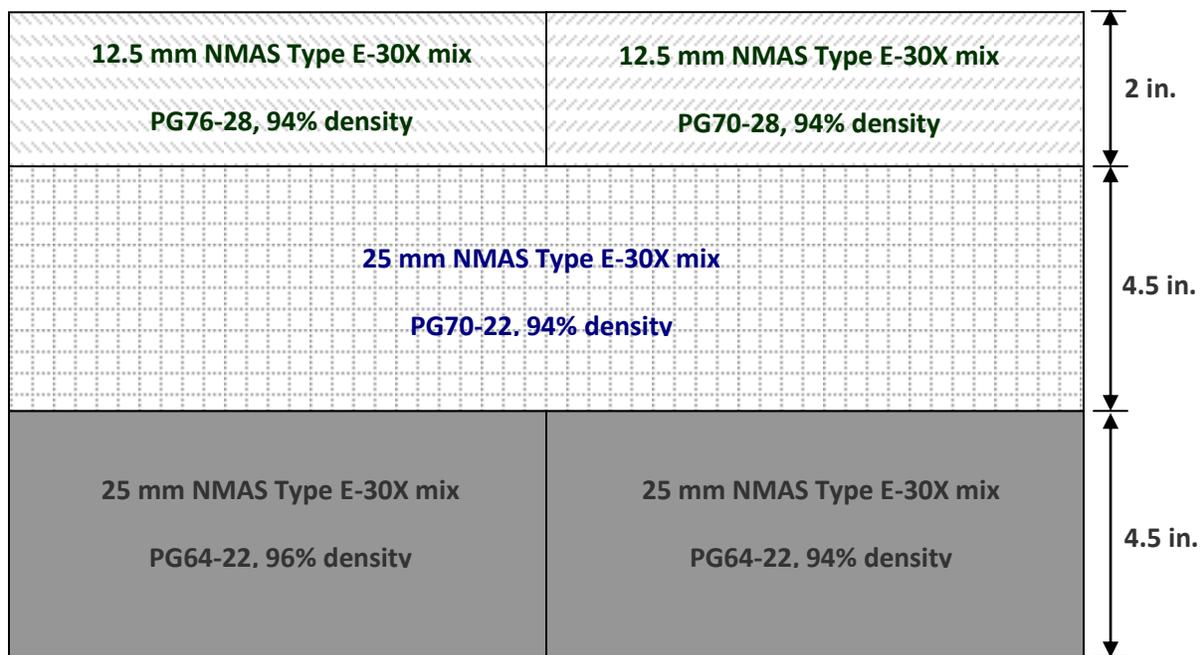
Figure 1 Cross-sectional layout of the pavement

This report summarizes the results from some of the tests that were conducted on hot mix asphalt (HMA) samples that were collected from different layers of a pavement section in Wisconsin. The two test sections were constructed as a part of the Kenosha Weigh Station Perpetual Pavement Project. Each section consisted of three layers; surface, middle and base. The only difference between the two surface layers was the binder grade used in the mix. The middle HMA layer was common to both test sections, while the two base layers were compacted to different densities. Figure 1 below shows a cross-section schematic of the pavement.

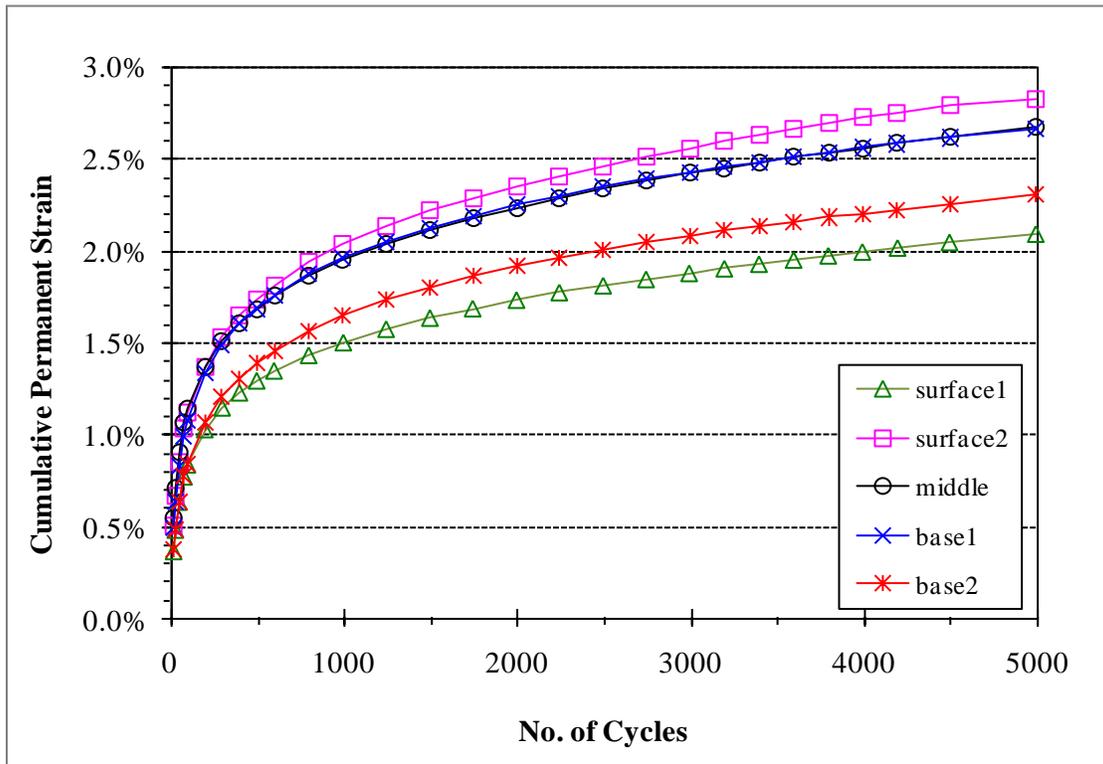
Figure 2 Cumulative permanent strain at 58°C

Figure 2 shows the average plots of the cumulative permanent strain for the mixes studied. Four to five replicates per mix were tested. The maximum permanent cumulative strains of the samples, along with mean and standard deviation are shown in Table 1. No data points were deleted in calculations.

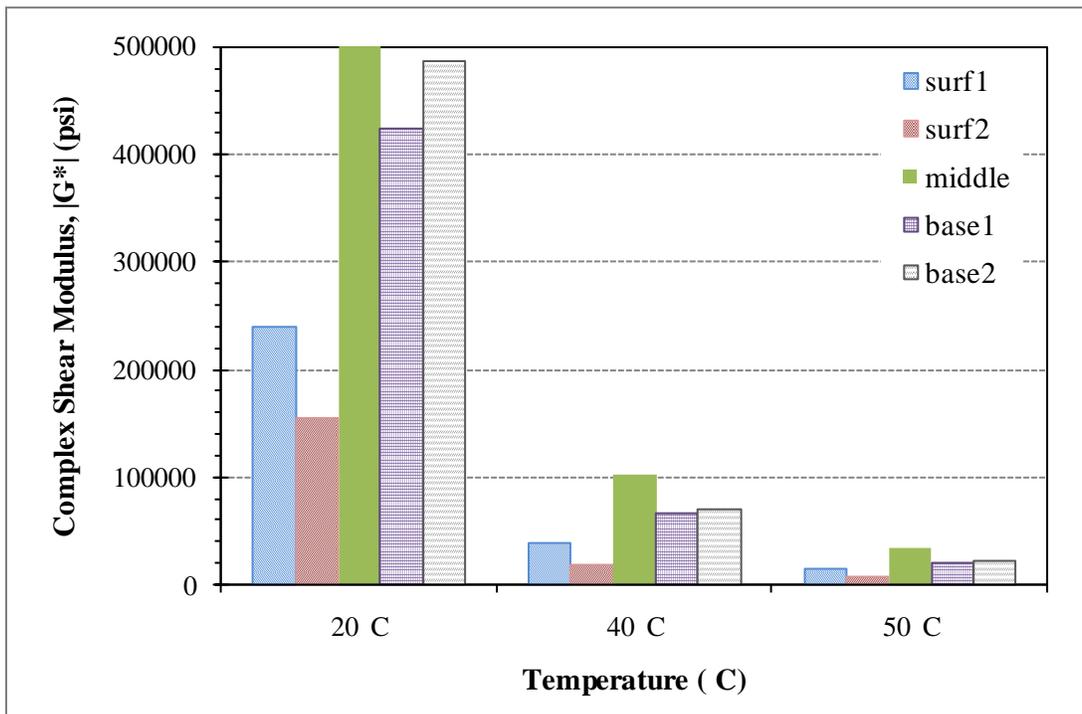
Figure 3 Complex shear modulus at different test temperatures

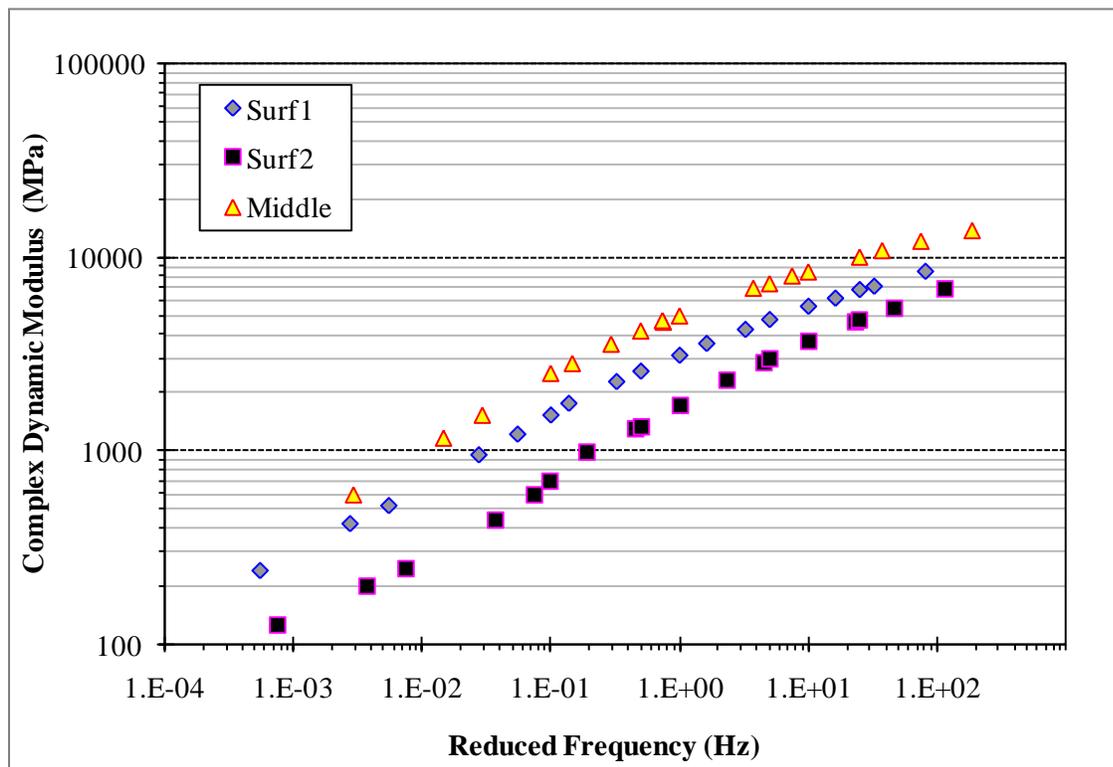
Figure 4 Master curves for complex dynamic modulus of the Surface and Middle layers

The moduli of the Middle layer were found to be higher than those of the two Surface mixes at all frequencies and temperatures. Between the two Surface layers, the mix from the Surface 1 was found to be stiffer than the mix from Surface 2, as expected, due to the stiffer binder grade used in Surface 1.
