**REPORT NUMBER: WI-04-08**

**INVESTIGATIVE STUDY OF THE  
ITALGRIP™ SYSTEM**

**FINAL REPORT**

WisDOT Research Study # WI-99-01  
SPR # 0092-00-20

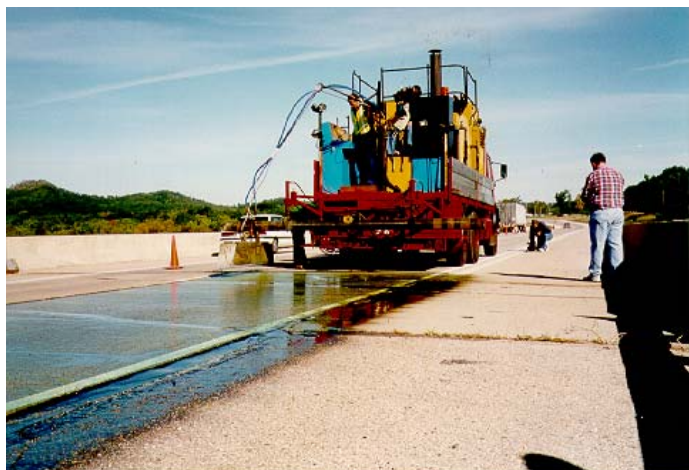
Photo 1: Italgrip™ resin applicator

WisDOT became the first agency in the United States to install the Italgrip™ System. The Italgrip™ application process involved several steps. First, the existing pavement was swept to remove any existing debris from the surface. Secondly, the two-part polymer resin was sprayed onto the pavement surface with a special piece of equipment provided by Italgrip USA (see Photograph 1). The resin was applied in a side-to-side repetitive sweeping motion. The exact amount of resin applied varied based on pavement surface characteristics. The resin was green in color and can be seen in Photograph 2. Immediately after the resin was sprayed on the surface, the steel slag was applied

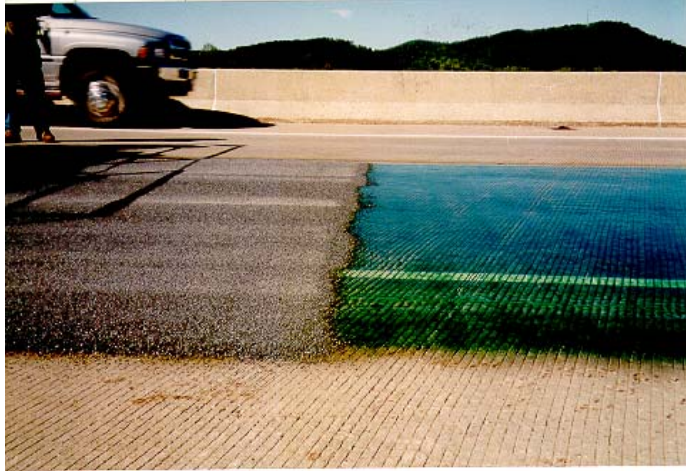
Photo 2: Italgrip® resin before and after aggregate application

using a typical chip spreader. Lastly, after the resin was completely dry and hard (Italgrip™ specifications stipulate an eight-hour curing period, or the minimum cure, which is temperature dependent and usually varies from three to ten hours), the excess aggregate was removed from the pavement surface with a vacuum sweeper. After sweeping was completed, the site was opened to traffic.

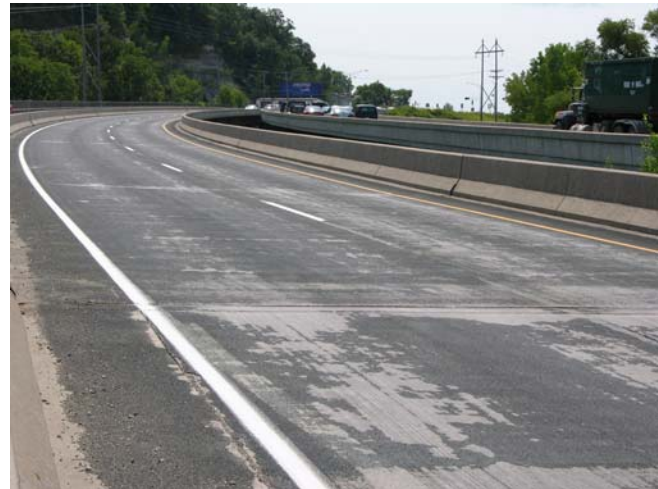
Photo 3: WB on STH 16 in La Crosse County

Table 7 shows that in 2005, after six years in service, both STH 16 structures in La Crosse County were performing the worst in both directions. These structures are on a curve and could be experiencing more lateral stresses than the other sites. In addition, these structures had the highest average daily traffic of all the sites. Although the total loss of STH 16 in Waukesha County was performing the best, with a surface loss of only six percent, it should be reiterated that the estimate for that site was based on 2004 videotapes, thus represents results after five years in service. It can be assumed that six-year results for that site would be slightly higher. Overall, after six years in service, the average surface loss of the La Crosse County bridge sites was 23 percent.

It should be noted that additional wear and surface loss has occurred from 2005 until the time this report was written. However, estimating the amount of surface loss was a time consuming effort; therefore, up-to-date estimates were not recalculated. Photos 3 and 4 were taken from La Crosse County during a site review conducted in 2007, after Italgrip™ had eight years in service. Photo 3 was taken of the westbound lanes of STH 16 over the CMSP & PRR tracks and shows moderate surface loss of Italgrip™. Photo 4 was taken on

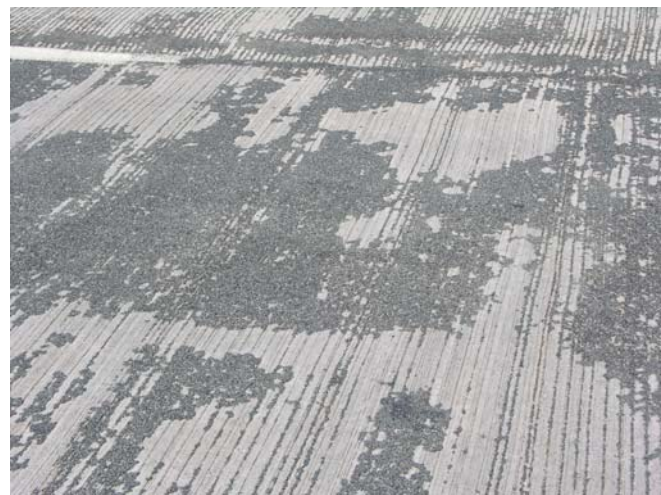
Photo 4: Area of extreme surface loss on STH 35

the northbound lane of STH 35 over the BNRR tracks and shows a close-up of an area with extreme surface loss.
