# Highway 13 and Blueberry Road

Road Safety Audit/Assessment

Red Cliff, Wisconsin

May 20 – 21, 2009

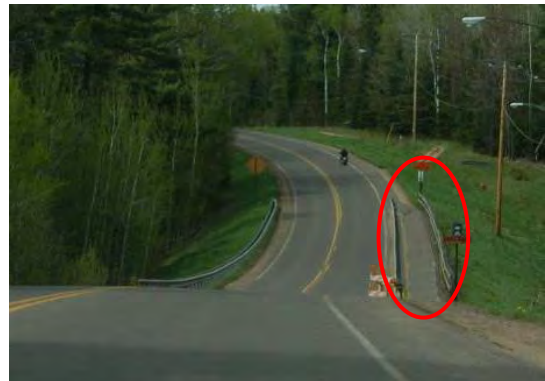
**Designated Walkway along Bridge –** A separate pedestrian/bicycle facility is provided at the bridge along Blueberry Rd. connecting to the paved shoulder (see photo, right). A w-beam barrier

provides positive separation between vehicles and the pedestrians/bicyclists. This is noteworthy because bridges on rural roadways often create choke points along the roadway, causing pedestrians and bicyclists to travel in the roadway with vehicles; in this case separation is maintained for pedestrians and bicyclists.

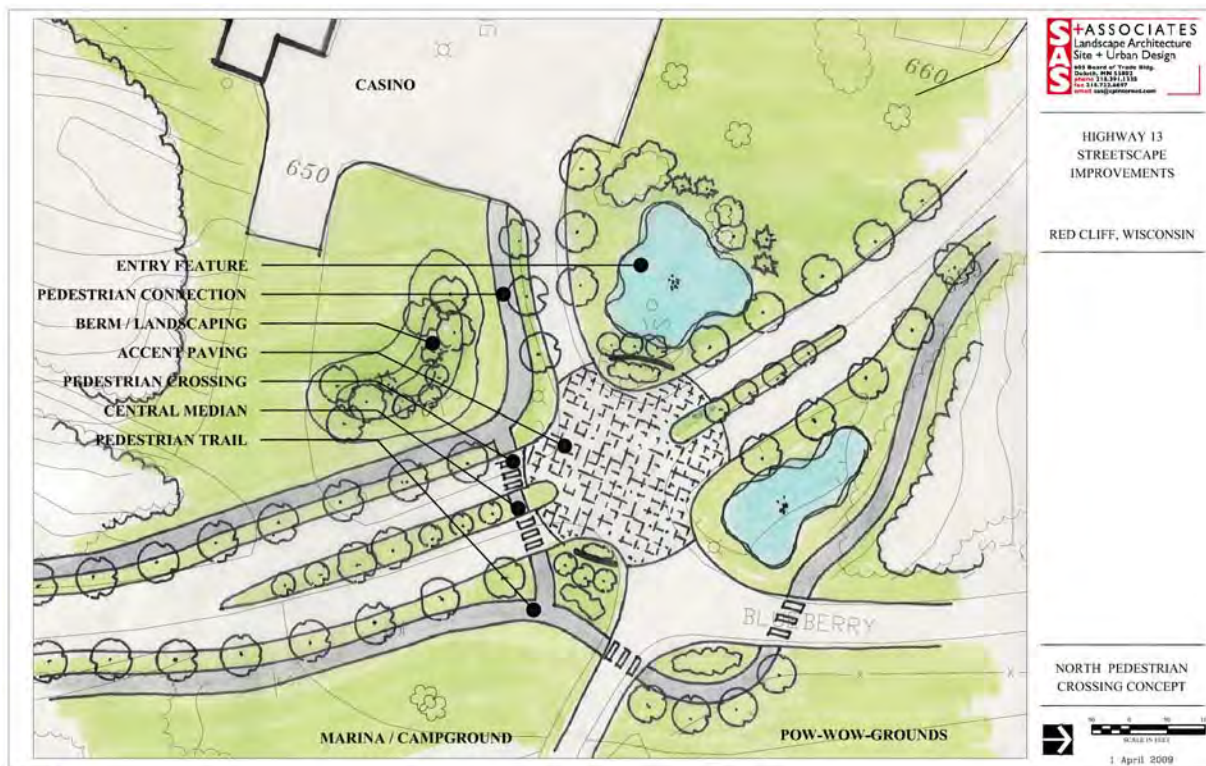
Figure 2. Conceptual Design for Highway 13 at Blueberry Rd.

- **Installation of Medians** – The Transportation Enhancement Application includes concept drawings for a raised median along Highway 13 at the intersections of Pike Rd. and Blueberry Rd. There are currently pedestrian crossings located at or near these intersections. Raised medians will provide refuge for pedestrians crossing and may help with traffic calming (speed reduction).
- **Focused Crossing Locations** – The Transportation Enhancement Application includes concepts for pedestrian crossings at the intersections of Highway 13 and Blueberry Rd. (Figure 2) and Highway 13 and Pike Rd. (Figure 3). The proposed crossings provide better continuity and connectivity for pedestrians, but they also help to channelize pedestrian movements. This will hopefully result in less random crossing behaviors and establish locations where drivers can expect to see pedestrians crossing.

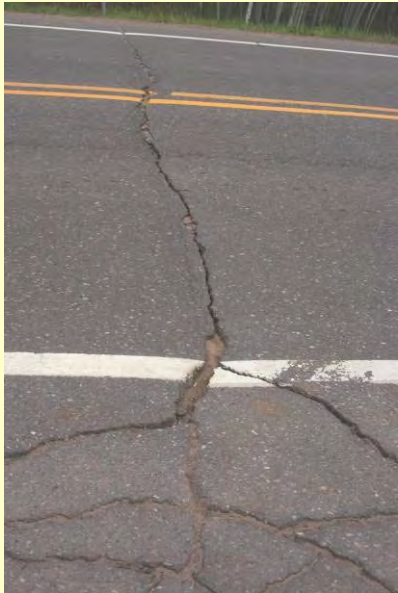
1. Overarching Safety Issues		
Safety Issue	Suggested Improvements	Examples of Issues
<p><b>Pavement and pavement marking maintenance</b>—the pavement on Highway 13 is deteriorating throughout the study area, creating several large cracks, pot holes, and unstable shoulders. These conditions present a hazard to all roadway users, but may especially present a serious hazard for motorcyclists and bicyclists who rely on smooth surfaces for stable travel. The pavement markings are also faded along Highway 13 and Blueberry Rd., which limits conspicuity during nighttime and wet weather conditions.</p>	<p><i>Intermediate</i> – Determine a schedule for the DOT pavement replacement project. If the project is scheduled in the short-term, the pavement surface will be upgraded as part of planned activities. If the pavement replacement project is not scheduled in the short-term, consider scheduling a mill and fill project to maintain the pavement surface. Coordinate restriping of the pavement markings on Highway 13 with the mill and fill or pavement replacement project. Pavement markings should also be enhanced along Blueberry Rd.</p>

<p>Photo shows an example of pavement issues along Highway 13. The pavement is separating, creating a large crack across the entire section of Highway 13.</p>

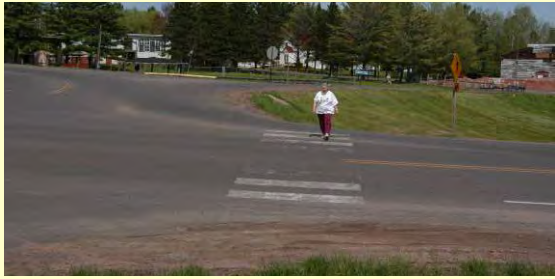
<p><b>Faded crosswalk pavement markings</b>—the crosswalk pavement markings are faded, most notably within the travel lanes. This reduces conspicuity during day and night and limits the effectiveness of the cue to drivers that pedestrians may be present.</p>	<p><i>Short-term</i> – Restripe crosswalk to increase conspicuity.</p>

<p>Photo shows the faded crosswalk at the intersection of Highway 13 and Blueberry Rd.</p>

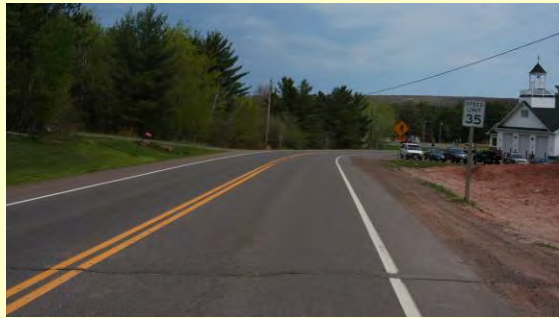
<p><b>Inconsistent cross-section</b>—the cross-section is inconsistent through the study area. On the south end of Highway 13, there is curb-and-gutter with a 6-ft paved shoulder, but the curb and gutter are only present in certain locations. At the north end of Highway 13, there is no curb and gutter and the paved shoulder width is reduced to 3 feet. An inconsistent cross-section can lead to inconsistent driver behaviors due to the lack of expectancy. A more consistent cross-section will help to improve expectancy for drivers.</p> <p>Sample cross-sections are provided in Appendix B.</p>	<p><i>Intermediate</i> – Identify the desired cross-section for Highway 13 and coordinate this vision with the DOT pavement replacement project. Providing a consistent cross-section may help to bring about more uniform speeds and increase driver expectancy, particularly related to pedestrian activity.</p> <p>A cross-section with a median treatment may have a gateway effect and which would enhance the visual appeal through the community and help reduce traffic speeds.</p>

<p>View of Highway 13, north of Blueberry Rd. Photo shows the inconsistent cross-section along Highway 13. The paved shoulder is approximately 3 ft in this section. To the south, the shoulder is approximately 6 ft and curb-and-gutter is installed in some locations.</p>

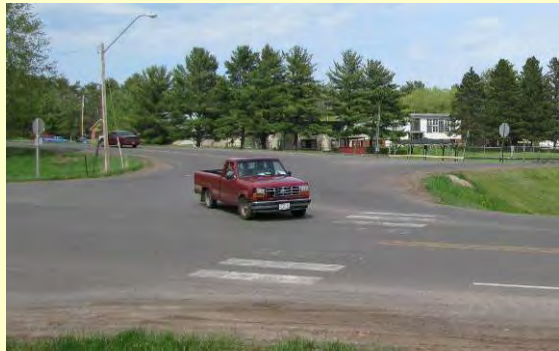
<p><b>Lack of continuity and connectivity for peds, bikes, and ATVs</b>—there is lack of continuity and connectivity for peds, bikes, and ATVs. Pedestrians travel from residential areas along Highway 13 and Blueberry Rd. to several locations along Highway 13, including stores (Peterson’s and Buffalo Bay), the Casino, the lake side, and the medical clinic without continuous, clearly defined paths. There is no paved shoulder along the west side of Blueberry Rd. and the shoulder width on Highway 13 is reduced from 6-ft south of Blueberry Rd. to 3 feet north of Blueberry Rd. This limits the separation between vehicles and pedestrians.</p> <p>There are several marked pedestrian crossings along Highway 13, but there are no designated facilities to provide safe connections to the crossings. For ATVs, there are trails along Highway 13, but the trail is discontinuous forcing riders to cross Highway 13 in several locations to stay on the trail.</p>	<p><i>Long-term</i> – Consider developing an overall ped/bike/ATV plan. An origin-destination study should be conducted to identify the major attractors and preferred routes. Facilities for pedestrians, bikes, and ATVs should be considered to provide continuity and connectivity between residential areas and the major attractors.</p> <p>There is also an opportunity to identify parking areas for ATVs prior to Peterson’s Store. This may help to limit the number of ATVs crossing Highway 13 and reduce the amount of ATV traffic traveling along Highway 13 to Peterson’s Store.</p>

<p>Photo illustrates the lack of continuity and connectivity at the intersection of Highway 13 and Blueberry Rd. The marked crosswalk leads pedestrians across Highway 13, but there are no pedestrian facilities provided on either side.</p>

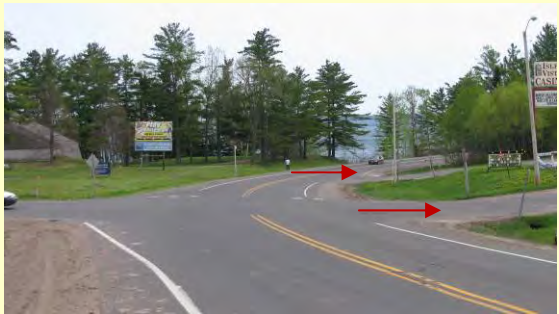
<p><b>Vehicles turning into/out of Isle Vista Casino</b>—there are multiple access points for the Isle Vista Casino, which create several safety issues.</p> <ul style="list-style-type: none"> <li>• When vehicles are exiting from both access points at the same time, they create sight obstructions for each other.</li> <li>• The location of the access points along the inside of a horizontal curve creates additional sight distance issues to the north and south.</li> <li>• Multiple access points within close proximity also create several conflicting movements and increases driver workload.</li> </ul>	<p><i>Intermediate</i> – Consider consolidating the access points at Isle Vista Casino to provide access at the intersection of Blueberry Rd.</p>

<p>View of access points to Isle Vista Casino from Highway 13 looking southbound.</p>
<p><b>Multiple intersections in close proximity</b>—the intersection of Blueberry Rd. and Highway 13 is in close proximity to the intersection of Blueberry Rd. and Church Rd. This creates a very wide pavement surface. To compound the issue, there are few pavement markings to channelize vehicles and pedestrians.</p>	<p><i>Short-term</i> – Provide better channelization through the intersections of 1) Blueberry Rd. and Church Rd. and 2) Highway 13 and Blueberry Rd. through the use of pavement markings.</p>

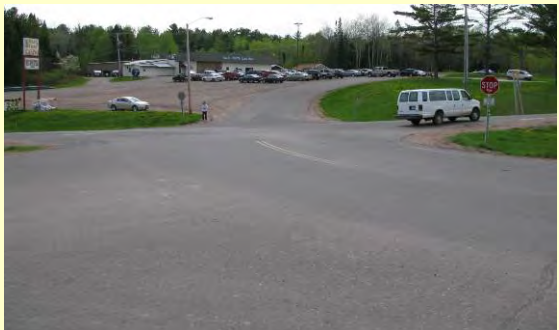
<p>View from the east side of the intersection of Blueberry Rd. and Church Rd. looking west toward Highway 13. Photo shows the close proximity of the intersections and lack of pavement markings.</p>

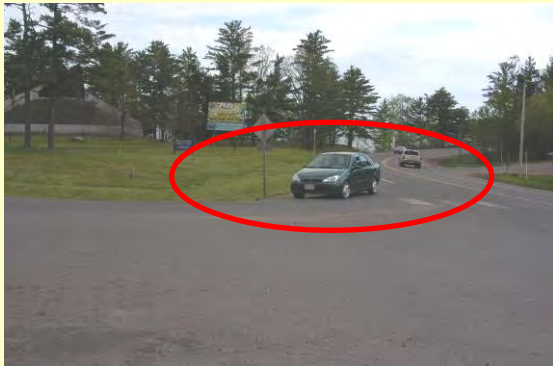
<p><b>Drivers using shoulder as turn lane</b>—drivers traveling northbound on Highway 13 are using the shoulder as a deceleration/turn lane to Blueberry Rd. This creates a safety issue because a crosswalk is located on the southern leg of the intersection and pedestrians stand in this area while waiting for a gap in traffic.</p>	<p><i>Short-term</i> – Provide better delineation of the edge of roadway by installing pavement markings and designate refuge areas for pedestrians at waiting areas. The shoulder should be designated as a continuous walkable shoulder with connection to the north along Blueberry Rd.</p> <p><i>Intermediate</i> – As discussed previously, there is an opportunity to create a consistent cross-section through the community. Consider installing curb and gutter as part of the community cross-section. A curb will help to separate pedestrians from vehicular traffic. Curb ramps would also need to be installed at crossing locations as part of this option.</p>

<p>View of intersection of Highway 13 and Blueberry Rd. Photo shows a driver using the shoulder as a right-turn lane. There is a crosswalk at this location and pedestrians are often waiting on the corner.</p>

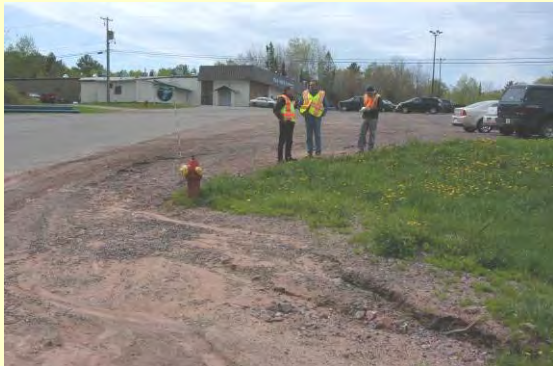
<p><b>Run-off/washout</b>—the slope of the driveway and lack of drainage control in the Isle Vista Casino parking lot creates drainage issues, including run-off into the roadway and washout from the parking lot into the ditch.</p>	<p><i>Intermediate</i> – There is an opportunity to mitigate run-off issues if the access points at Isle Vista Casino are consolidated and the southern access point is closed.</p>

<p>View of the southern access point at the Isle Vista Casino. Photo shows where debris from the parking lot has washed out into the ditch.</p>

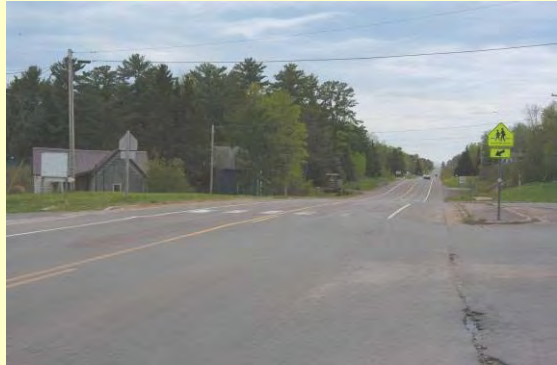
2. Intersection: Highway 13 and Pike Rd.		
Safety Issue	Suggested Improvements	Examples of Issues
<p><b>Location and condition of crosswalk</b>—the crosswalk is located in a passing zone, which creates a major safety issue for pedestrians. With this configuration, drivers slowing for a crossing pedestrian may be passed by a driver who is unaware of the pedestrian. To compound the issue, the pavement markings are faded, most notably within the travel lanes. This reduces conspicuity during day and night and limits the effectiveness of the cue to drivers that pedestrians may be present.</p>	<p><i>Short-term</i> – Restripe the centerline, changing the markings from a passing zone to a no passing zone. Also, restripe the crosswalk to increase the conspicuity of the pavement markings.</p> <p>Consider installing an advance pedestrian warning sign along Highway 13 to warn southbound drivers of the upcoming crosswalk.</p> <p><i>Intermediate</i> – As discussed in the Overarching Issues (<i>Inconsistent cross-section</i>), there is an opportunity to install a median along Highway 13. If it is not desirable to install a raised median throughout the community, a painted two-way left-turn lane can be painted between the gateway locations with a raised median at critical pedestrian crossing locations, including the intersection at Pike Rd. Raised medians provide a pedestrian refuge and increase driver expectancy, particularly related to pedestrian activity. This is discussed further in Appendix B.</p>

<p>Photo shows the location and condition of the crosswalk at the intersection of Highway 13 and Pike Rd.</p>

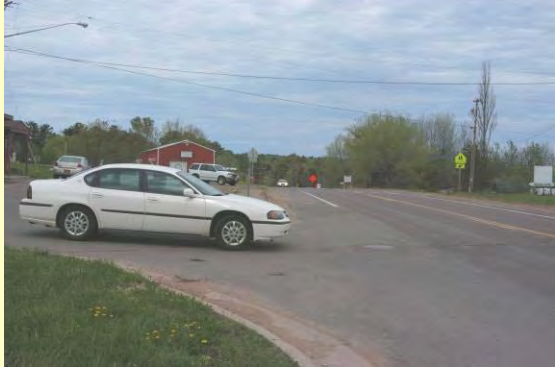
<p><b>Vehicles turning into/out of access points</b>—there are multiple access points at this location as well as a bus stop and pedestrian crossing. This increases driver workload and creates several potential conflict points.</p> <ul style="list-style-type: none"> <li>• When vehicles are exiting from both roads at the same time, they create sight obstructions for each other.</li> <li>• The access points are also located just south of a vertical curve, which creates additional sight distance issues, particularly for drivers on Community Rd.</li> </ul>	<p><i>Intermediate</i> – Consider consolidating the access points, closing the intersection of Highway 13 and Community Rd. This will direct drivers to the intersection at Pike Rd., which has better sight distance over the vertical curve to the north.</p>

<p>View of Community Rd. and Highway 13 looking north toward the intersection of Pike Rd. and Highway 13. Photo shows where two vehicles are creating sight obstruction for each other.</p>

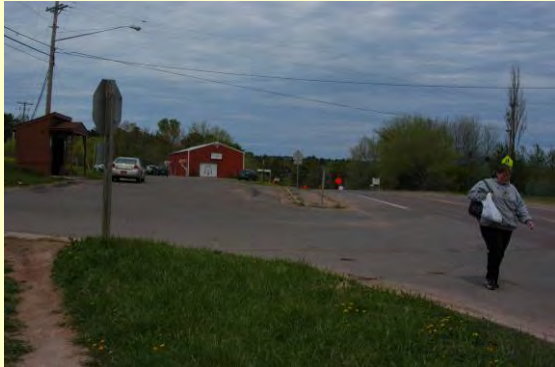
<p><b>Multiple intersections in close proximity</b>—the intersection of Pike Rd. and Highway 13 is in close proximity to the intersection of Community Rd. and Highway 13. There is also a paved road parallel to Highway 13, connecting the two access points. This creates a very wide pavement surface and several conflicting movements. To compound the issue, there are few pavement markings to channelize vehicles and pedestrians.</p>	<p><i>Short-term</i> – Provide better channelization through the intersections of 1) Pike Rd. and Highway 13 and 2) Community Rd. and Highway 13 through the use of stop bars, centerlines, and edgelines. Appendix C illustrates one option for enhancing delineation.</p> <p><i>Intermediate</i> – Consider consolidating the access points as discussed previously.</p>

<p>View the intersections of Community Rd. and Highway 13 and Pike Rd. and Highway 13, looking north along Highway 13. Photo shows the close proximity of the intersections and lack of pavement markings.</p>

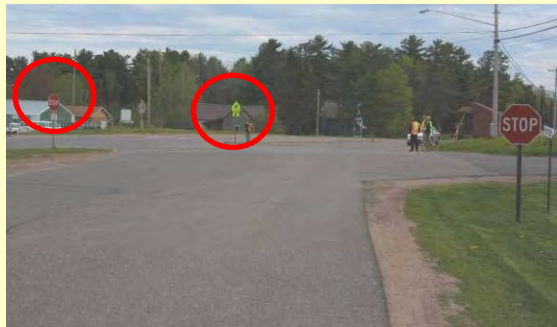
<p><b>Traffic Control Issues</b>—there are a lack of pavement markings through the intersections of Pike Rd. and Highway 13 and Community Rd. and Highway 13. The STOP sign at the intersection of Pike Rd. and Highway 13 is improperly located on the left side of the intersection.</p>	<p><i>Short-term</i> – Provide better channelization (STOP bars, centerlines, and edge lines) through the intersections of 1) Pike Rd. and Highway 13 and 2) Community Rd. and Highway 13. A schematic drawing is provided in Appendix C to illustrate the placement of pavement markings and STOP signs.</p> <p>Relocate the STOP sign to the right side of the intersection of Pike Rd. and Highway 13.</p>

<p>View of the intersection of Highway 13 and Pike Rd., looking south on Pike Rd. Photo shows the lack of pavement markings, improper location of the STOP sign on the left side of the road, and the inconsistent school crossing sign.</p>

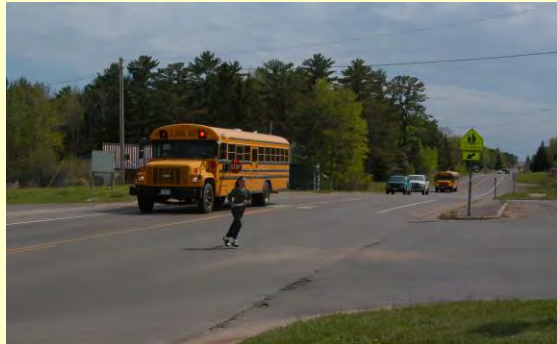
<p><b>Inconsistent bus activity</b>—the team observed three buses stopping at the intersection of Pike Rd. and Highway 13 in the afternoon to drop-off students. The drivers were inconsistent when stopping:</p> <ul style="list-style-type: none"> <li>• Bus 1: pulled into the access point and used the bus shelter as a stopping location. Students walked west into the community.</li> <li>• Bus 2: pulled into the access point and used the bus shelter as a stopping location. Students walked west into the community, but some students crossed Highway 13 and walked east toward the lake. This creates a safety issue because the bus is not stopping traffic on Highway 13 to provide a safe crossing for eastbound pedestrians.</li> <li>• Bus 3: stopped on Highway 13. The bus parked on the crosswalk, forcing the student to cross into the intersection of Pike Rd.</li> </ul>	<p><i>Short-term</i> – Work with the schools to better coordinate bus activity. A plan could be developed to minimize the number of children crossing Highway 13. For children heading west into the community, the buses should use the bus shelter as the drop-off point. For children traveling east, the bus should stop on Highway 13.</p> <p><i>Intermediate</i> – Consider the potential to install sidewalks or trails along Highway 13. This may enable bus stops to be consolidated and reduce delays for other vehicles.</p>

<p>Photo shows a bus dropping a student off at Pike Rd. along Highway 13. The bus stopped in the crosswalk, forcing the student to cross the road into the center of the intersection.</p>

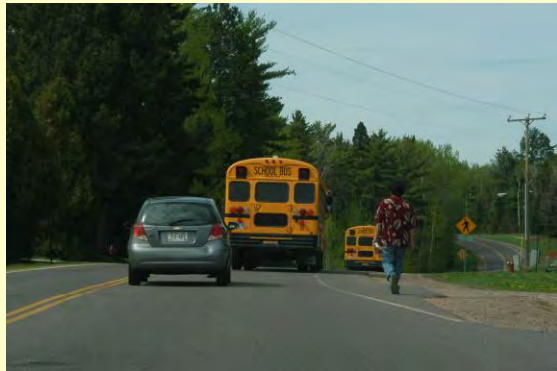
3. Segments: Blueberry Rd.		
Safety Issue	Suggested Improvements	Examples of Issues
<p><b>Lack of paved shoulder</b>—there is a paved shoulder along the east side of Blueberry Rd., but not along the west side. Pedestrians choosing to use the paved shoulder must travel with their back to traffic in the northbound direction, increasing the risk of a crash. Furthermore, bicyclists use this shoulder to travel northbound and southbound conflicting with pedestrian traffic on the shoulder. The risks of walking along the roadway in the same direction as traffic are far greater than the risks of walking against traffic. A 1995 statewide study of pedestrian fatalities in Florida found that pedestrian fatalities were four times more likely to occur when the pedestrian was walking with traffic as opposed to against traffic. Another study conducted in Australia showed that, in three states, walking with traffic crashes were between 1.5 and 3.5 times greater than walking against traffic crashes (Cairney).</p>	<p><i>Intermediate</i> – Consider installing a 4’ paved shoulder along the west side of Blueberry Rd.</p> <p><i>Long-term</i> – Consider opportunities to provide a separate mixed-use trail parallel to Blueberry Rd.</p>

<p>View of Blueberry Rd. looking northbound. Photo shows a pedestrian traveling with their back to traffic because they chose to use the 4-ft paved shoulder.</p>

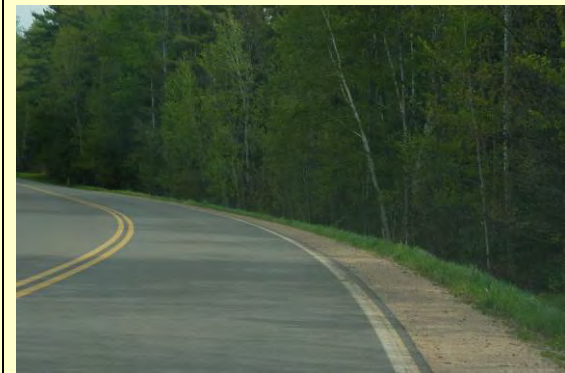
**Clear zone issues**—traveling southbound on Blueberry Rd., there is a horizontal curve to the left (south of Bishop Ln). There is a limited unpaved shoulder, steep embankment, and trees at the bottom of the slope, which create a safety issue.

View of Blueberry Rd. looking southbound. Photo shows the horizontal curve to the left with a steep embankment on the right.

*Short-term* – Consider installing post-mounted delineators along the outside of the curve on Blueberry Rd.

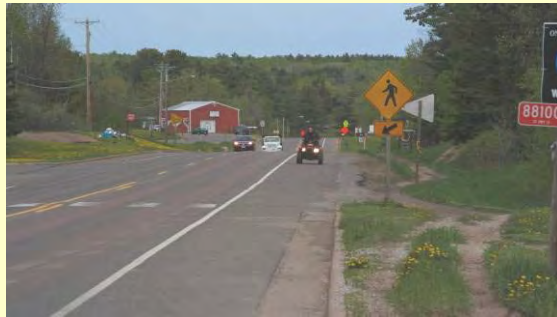
Safety Issue	Suggested Improvements	Examples of Issues
<p><b>Location and condition of midblock crosswalk</b>—there is a midblock pedestrian crossing just north of the entrance to Peterson's store. Drivers traveling northbound are just transitioning from a 45 mph section into the 35 mph zone and there is a general lack of expectancy for pedestrians in this area due to the rural cross-section. In addition, the pavement markings are faded, which reduces the visibility of the crosswalk.</p> <p>Aside from the lack of expectancy, the crossing is located in a passing zone. The crossing should not be located in a passing zone for reasons discussed previously in #3: <i>Highway 13 and Pike Rd. (location and condition of crosswalk)</i>.</p> <p>The crosswalk is also located to the north of Peterson's store. Pedestrians traveling from the south to Peterson's store are not likely to go out of their way to use the crossing. The RSA team observed such behaviors where pedestrians were crossing at the driveway to Peterson's store (not at the crosswalk) when walking from the south.</p>	<p><i>Short-term</i> – Consider relocating the crosswalk further south to better align with Peterson's store and provide a more convenient crossing location for pedestrians walking northbound.</p> <p>Consider upgrading the signs to fluorescent yellow green and upgrade pavement markings (better retroreflectivity) to increase the visibility and conspicuity of the crossing.</p> <p>Restripe the centerline to make the area a no passing zone.</p> <p>Place post-mounted delineators on shoulders between shoulders and travel lanes at crossing to discourage vehicle encroachments of shoulder where pedestrians may wait to cross.</p> <p><i>Intermediate</i> - Consider installing lighting in coordination with the planned improvement projects to increase visibility of pedestrians at night. Consider installing a median refuge with the application of a median treatment as discussed in Issue 3 (<i>Location and condition of crosswalk</i>). This is discussed further in Appendix B.</p>

<p>View of crosswalk along Highway 13 traveling northbound (near Peterson's store). Photo shows the condition of the crosswalk markings and the location in a passing zone.</p>

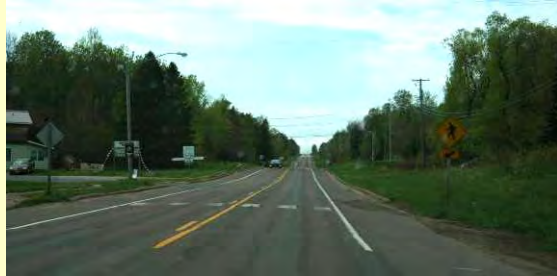
<p>View of Highway 13 looking southbound near Peterson's store. Photo shows the similar look and feel to the cross-section as drivers enter the 35 mph zone (traveling northbound) and the lack of expectancy for pedestrians.</p>

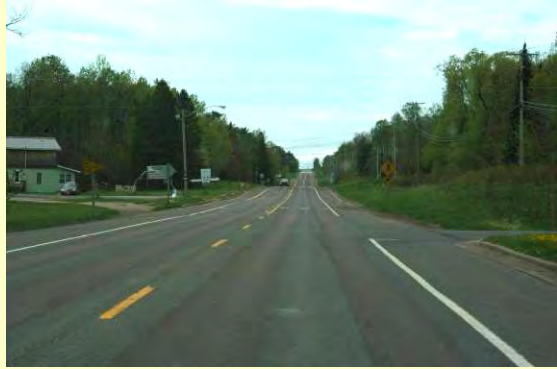
<p><b>ATVs riding along Highway 13</b>—the team observed ATVs riding along the shoulders of Highway 13 (with and against traffic) during the day and night. ATVs are prohibited from riding on Highway 13, and this creates a specific issue at night; drivers can become confused when ATVs are riding against traffic (on the right side of the road) with their headlights on.</p>	<p><i>Short-term</i> – Increase enforcement to limit ATV traffic on Highway 13.</p> <p><i>Intermediate</i> – Consider opportunities for ATV parking lots where riders can park and then walk along Highway 13 to Peterson’s store or other locations that are not accessible from existing trails.</p>	<p>The previous photo shows an ATV riding against traffic on Highway 13. A similar situation was observed at night.</p>
<p><b>Inconsistent cross-section</b>—there is an inconsistent cross-section along Highway 13 near Peterson’s store. The edge of roadway changes intermittently from curb-and-gutter to an open ditch. This creates a safety issue from a driver expectancy standpoint. Specifically, drivers cannot develop expectations and associate certain design features with the presence of pedestrians, a lower speed limit, and the entrance to a community.</p>	<p><i>Intermediate</i> – Develop a consistent cross-section for Highway 13 through the Red Cliff community and incorporate this concept with planned improvement projects. There are also opportunities to include design features to create a gateway to the community (e.g., a raised median at the community limits, curb and gutter through the section, a painted two-way left-turn lane or raised median through the community). These design features are also consistent with lower speed limits and may help to reduce speeds through the area. An example cross-section is provided in Appendix B.</p>

<p>View of Highway 13 looking southbound near Peterson’s store. Photo shows the inconsistent cross-section, where the edge of roadway transitions intermittently from curb-and-gutter to an open ditch.</p>

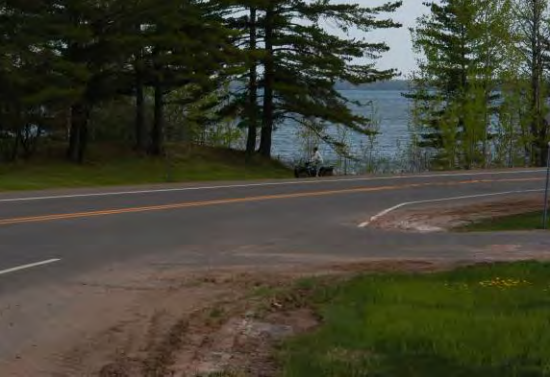
5. Segment: Highway 13 from Pike Rd. to Blueberry Rd.		
Safety Issue	Suggested Improvements	Examples of Issues
<p><b>Inconsistent cross-section</b>—the cross-section along Highway 13 is not consistent with the sections to the north and south. In this section there is an open ditch rather than a curb-and-gutter. The shoulder width is also 6 feet, which is wider than the 3-ft shoulder to the north. The inconsistent cross-section prevents drivers from developing expectations and they may be less likely to expect pedestrians as discussed previously.</p>	<p><i>Intermediate</i> – Develop and construct a consistent cross-section as per previous discussion.</p>

<p>View of Highway 13 between Pike Rd. and Blueberry Rd. Photo shows the relatively wide shoulders and open ditch. These design features are more consistent with a rural area that is not within a community.</p>
<p><b>ATVs crossing Highway 13</b>—ATVs are not permitted to ride on Highway 13 and the existing trails are discontinuous along the road. As such, ATVs must cross Highway 13 in multiple locations to remain on the trail instead of riding along the road. These crossings increase the potential for conflict between vehicles and ATVs.</p>	<p><i>Intermediate</i> – Consider opportunities to create ATV parking areas so that riders may park and walk to destinations.</p> <p>As discussed previously, there is an opportunity to create a curbed cross-section through the community. This may help to deter midblock ATV crossings; the RSA team noted that midblock ATV crossings appear to occur in uncurbed sections.</p>

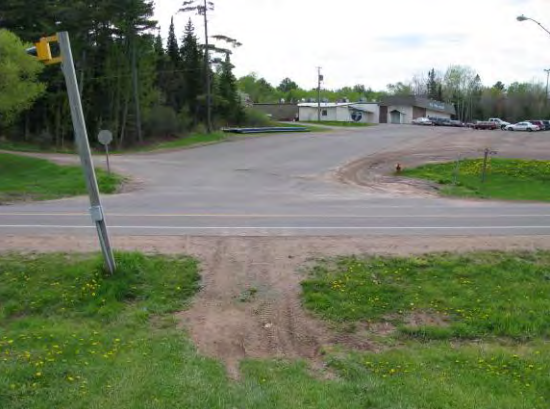
<p>Photo shows an ATV crossing near the southern entrance to the Isle Vista Casino.</p>

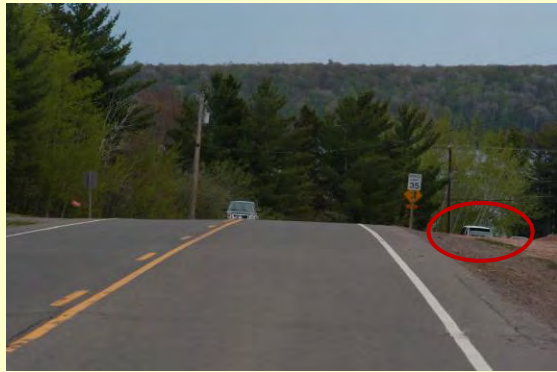
6. Segment: Highway 13 from Blueberry Rd. to Buffalo Bay Store		
Safety Issue	Suggested Improvements	Examples of Issues
<p><b>Location of access point to fire station</b>—the access point at the fire station is relatively wide with limited sight distance to the north and to the access point for drivers traveling southbound on Highway 13 due to a crest curve. Vehicles parked along the north side of the fire station may create further sight obstructions for vehicles exiting the Casino/Blueberry Rd. due to the location of the parking on the inside of a horizontal curve.</p>	<p><i>Short-term</i> – Designate a parking area at the fire station so that vehicles do not park close to Highway 13 where they will obstruct sight distance.</p>

<p>View of Highway 13 looking southbound near the fire station. Photo shows a crest curve to the north of the fire station, which limits sight distance to the driveway shown on the right.</p>

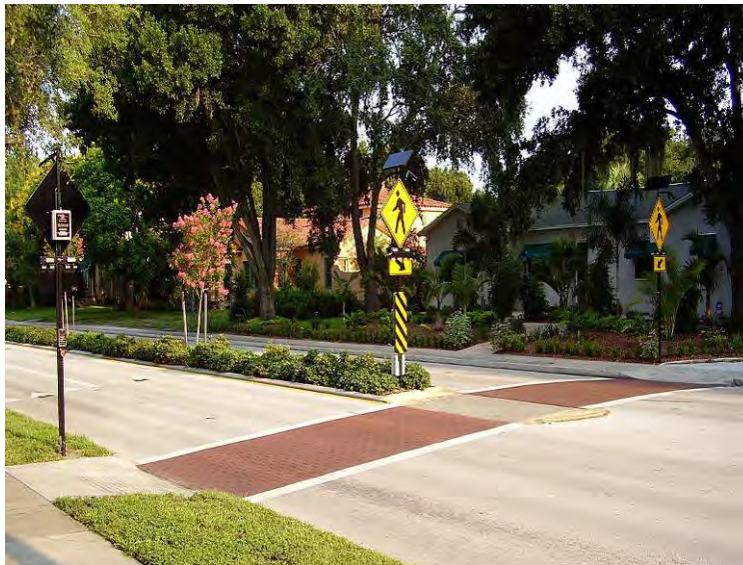
**Figure B.1. Example Gateway Effect in Urban Community**

There are several opportunities to improve the cross-section and create a “community feel”. For example, a gateway effect can be created by installing curb-and-gutter with a raised median at the entrances to the community along Highway 13. Figure B.1 shows an example of a community gateway created in an urban area. Note that plantings can be included in the median, but vegetation should be less than 24” so as not to create sight obstructions. If it is not desirable to install a raised median throughout the community, a painted two-way left-turn lane can be installed between the gateway locations. Raised medians provide a pedestrian refuge, so if a raised median is not installed through the entire community, it may be desirable to install raised medians at critical pedestrian crossing locations. The crossing locations should also include a marked crosswalk, advance pedestrian warning signs, and pedestrian crossing signs at the crosswalk.

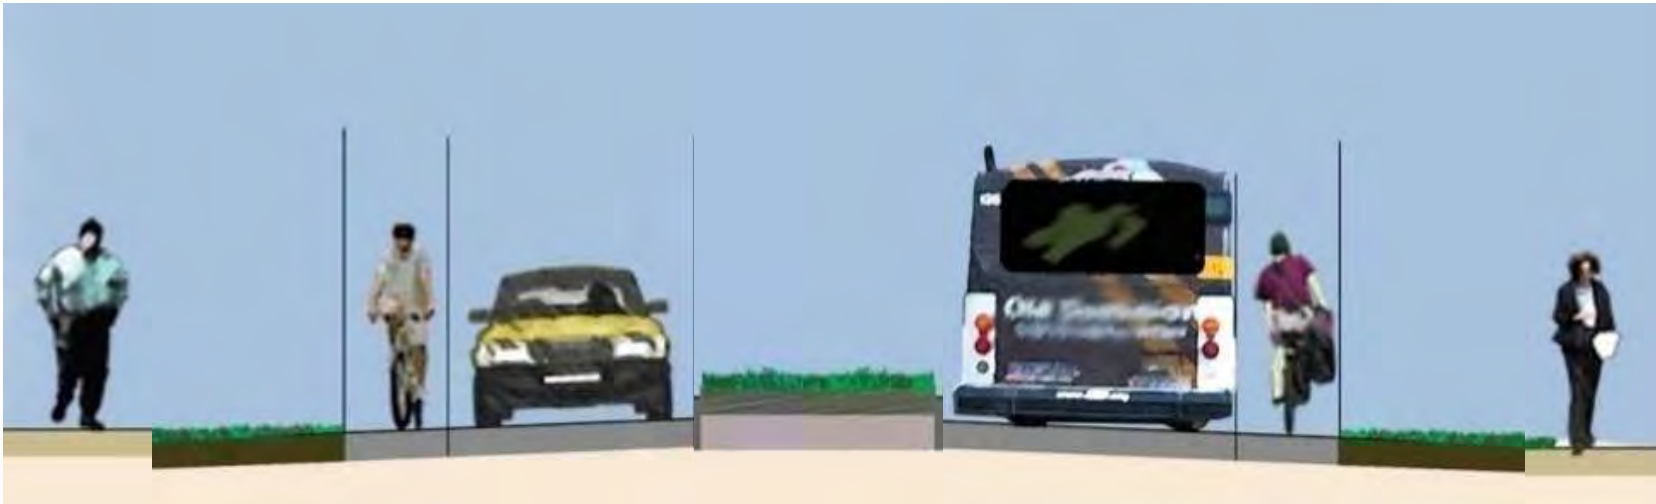
**Figure B.3. Sample Cross-Section with Open Ditch**

Sidewalk	Buffer	Shld	Outside Lane	Median	Outside Lane	Shld	Buffer	Sidewalk
5'	5'	2'	12'	8'	12'	2'	5'	5'

Note: This option maintains the existing cross-section width of 36 ft as measured from the outside edge of the shoulders. While the median is labeled as 8 feet, this is the striped width and any raised portions would be 6 feet wide, maintaining the 8-ft striped width. The shoulder width (2 ft) is not sufficient for pedestrian and bicycle travel; therefore, the sample cross-section includes a buffer and sidewalks along Highway 13. The total width, including the buffer and sidewalk, is approximately 56 ft, which appears to be feasible given the information provided to the RSA team. Another variation of the sample cross-section could include curb-and-gutter rather than an open ditch. The total width would include an additional 2.5-ft standard curb on each side (between the shoulder and buffer) if the open ditch is replaced with curb-and-gutter.

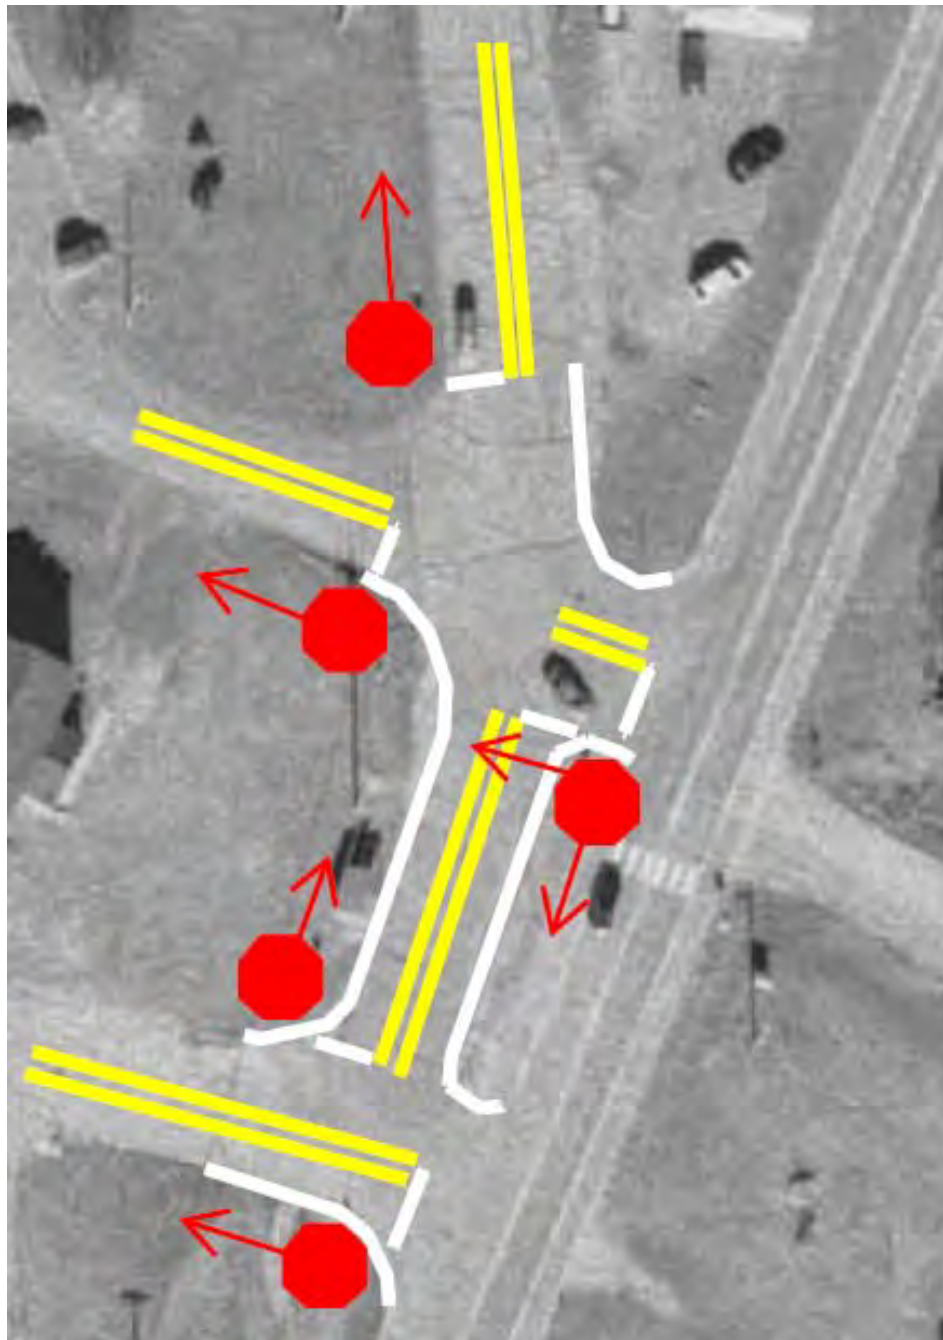
## Appendix C: Schematic Diagram of Highway 13 and Pike Rd/Community Rd

The following figure illustrates one option for enhancing delineation and guidance through the intersections of Community Rd and Pike Rd along Highway 13. Note the red octagons represent STOP signs and the red arrows point to the direction for which the sign is controlling. Also note that these are interim improvements until the southern access point (Community Rd) is closed as discussed in Table 3 (Issue 2).
