# I-39/90/94 Route Importance

# Purpose and Need

The purpose of the I-39/90/94 Wisconsin River Bridge Project is to address the needs of the aging I-39/90/94 structures and maintain vehicular traffic across the Wisconsin River in the towns of Dekorra and Caledonia located in Columbia County.

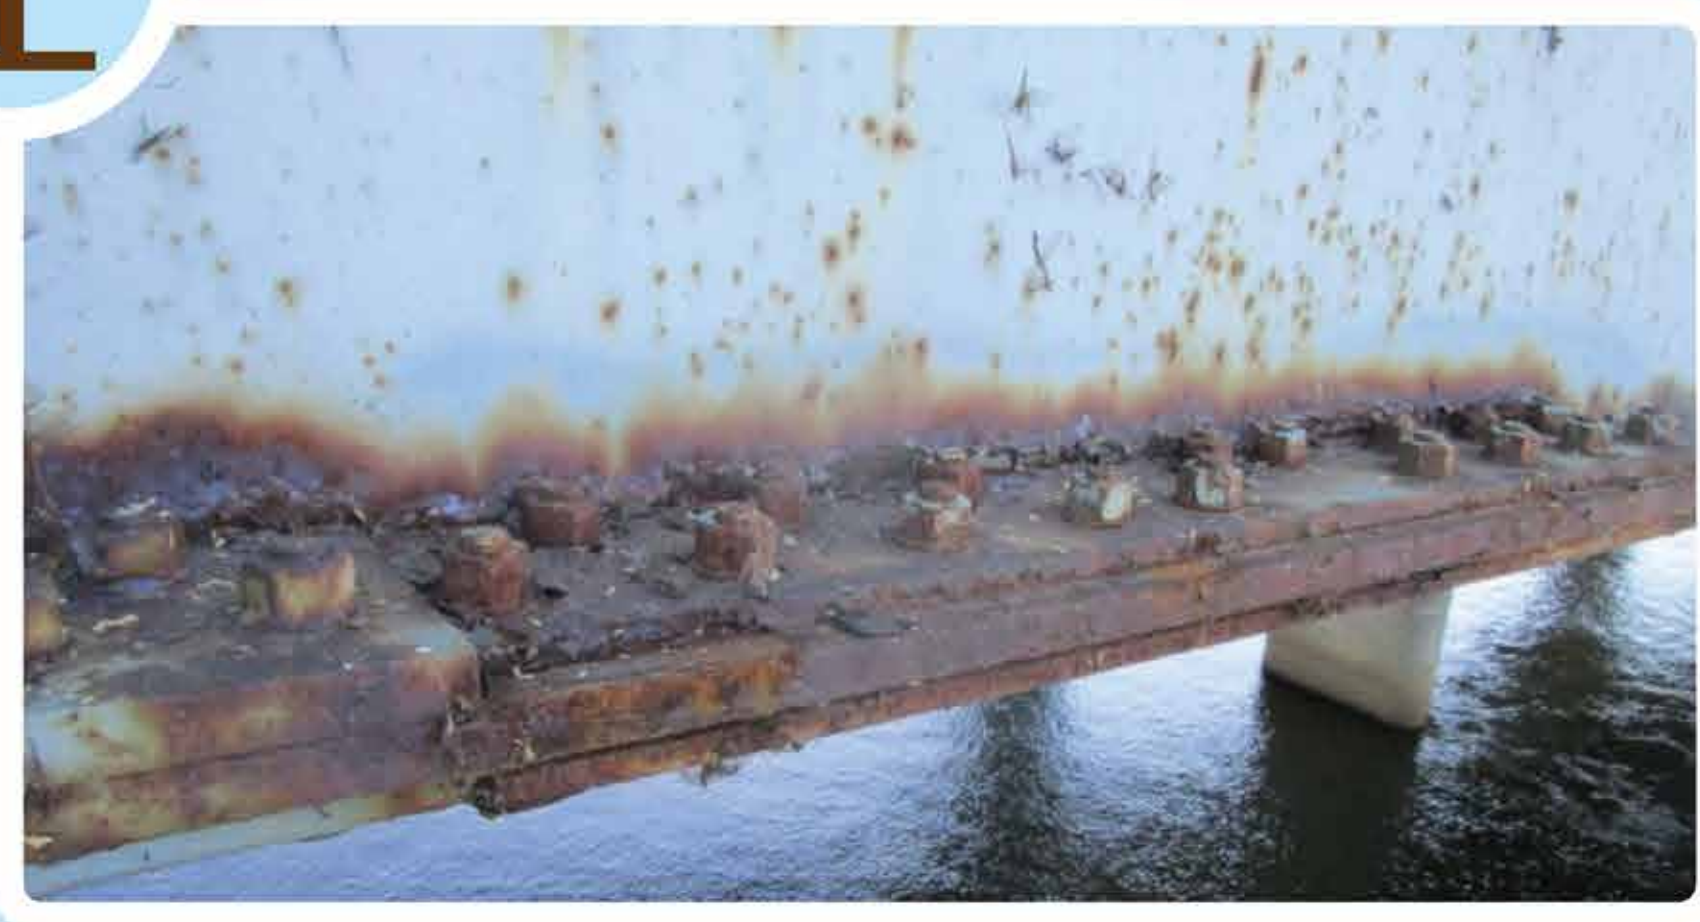
Severe condition

Loss of protective coating over steel elements and connections.

- Heavy rust
- Loss of the protective coating over the steel

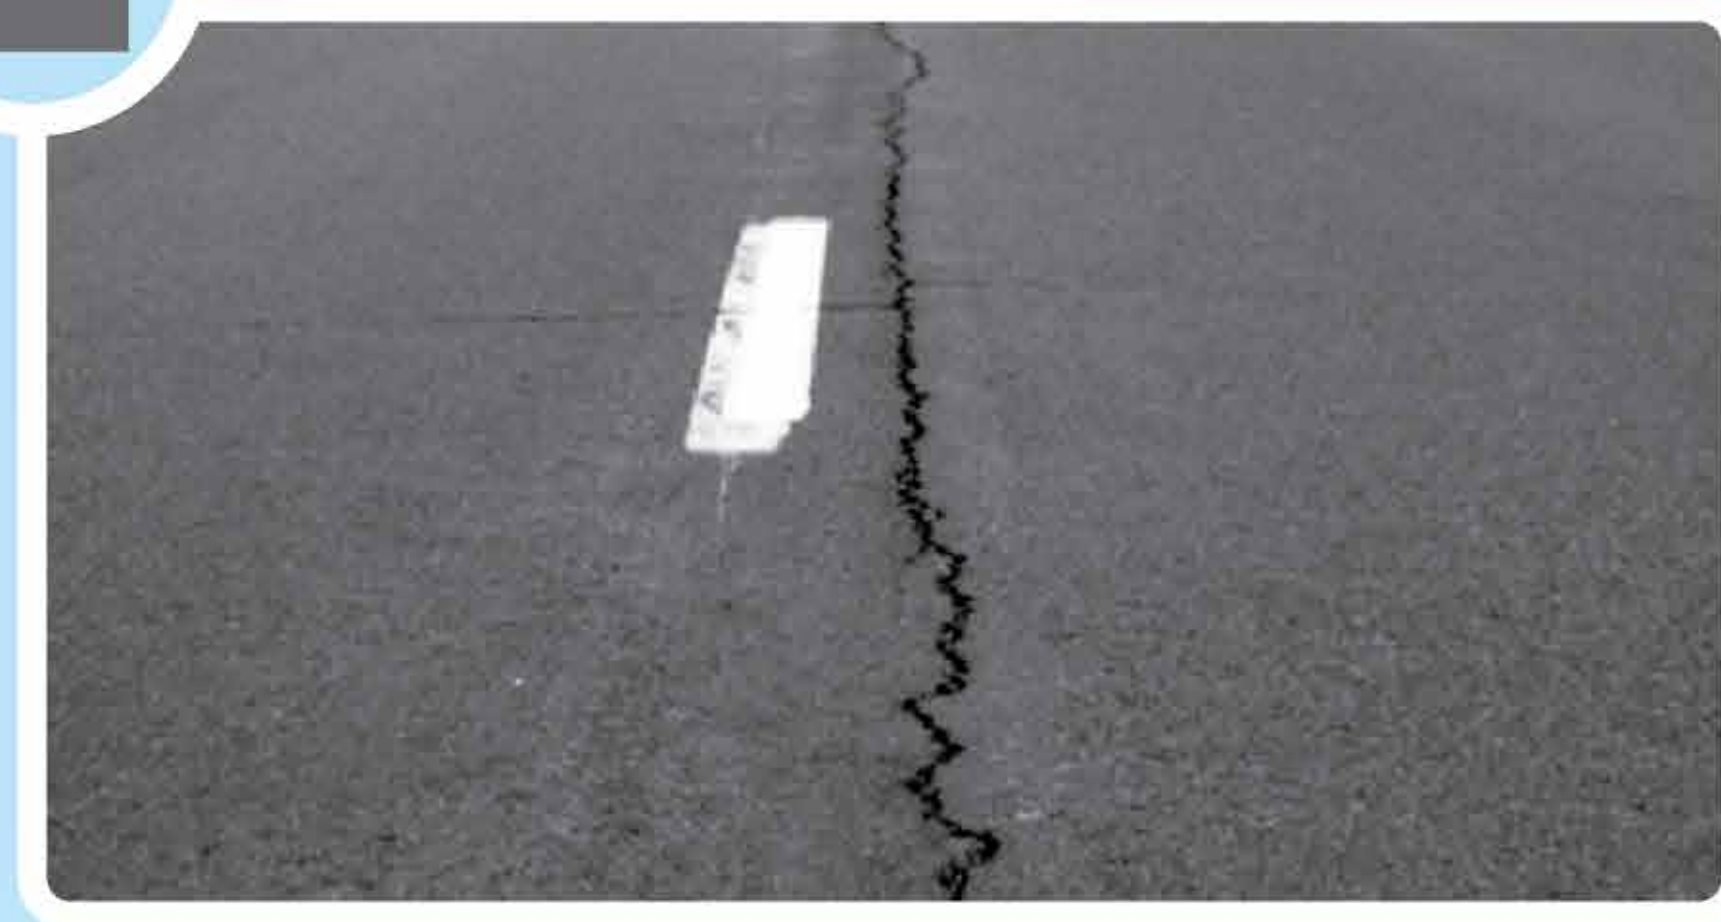
Poor condition

Cracking of the asphalt overlay causes deterioration of the bridge deck.

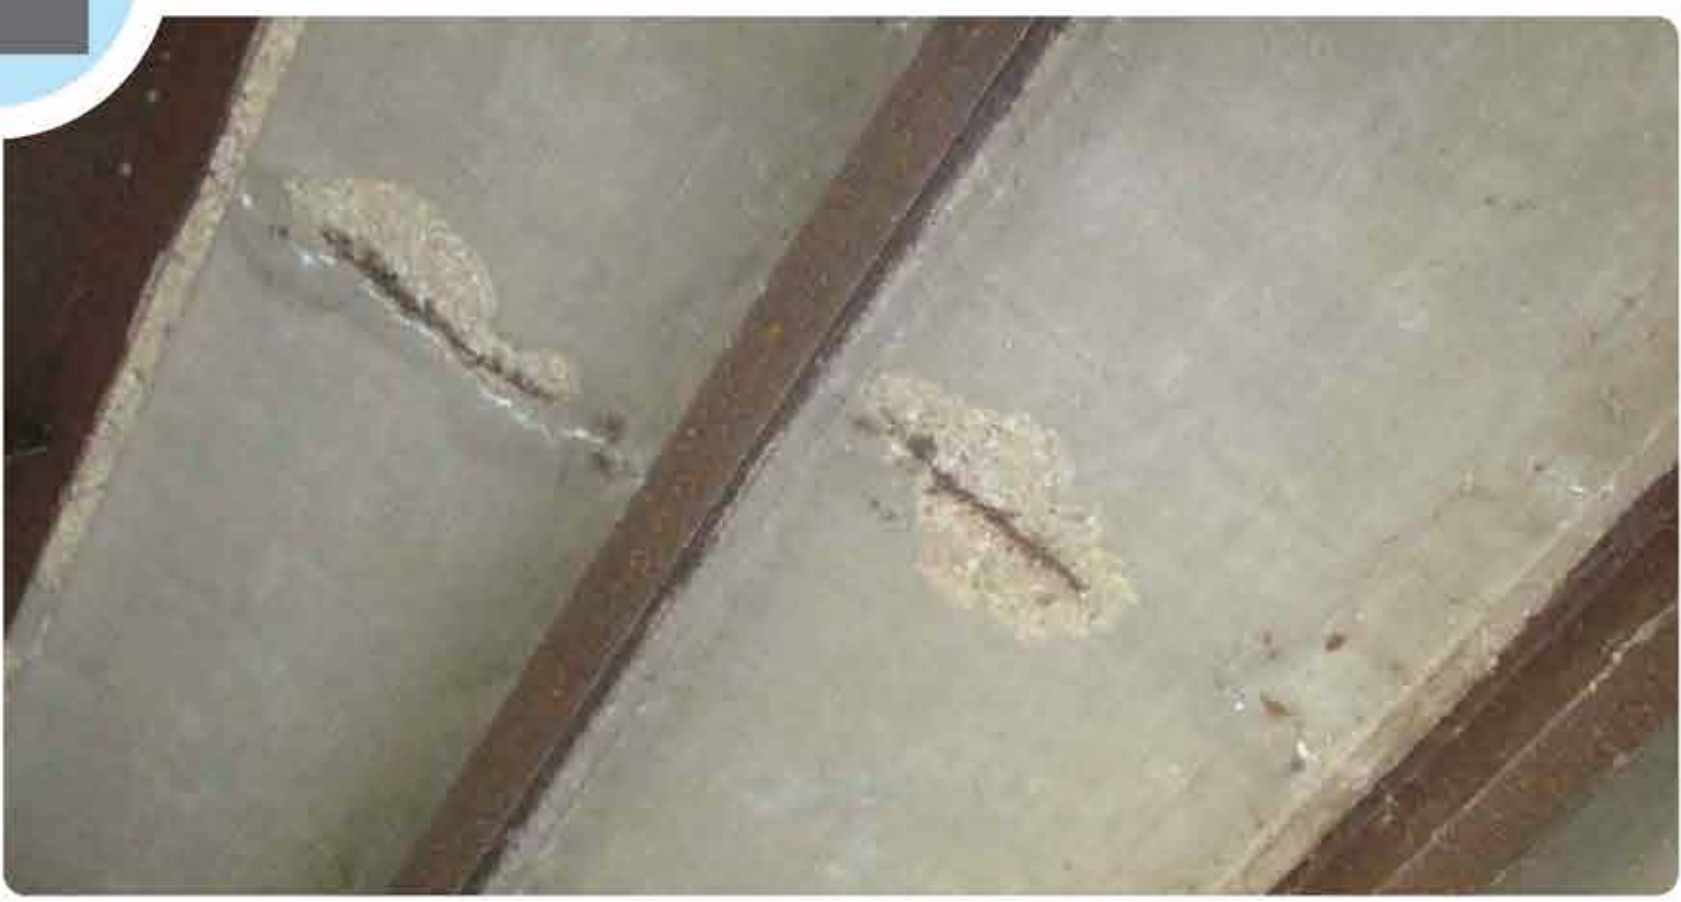
Poor condition

Concrete on the bottom of the bridge deck is cracking and chipping off, exposing the reinforcing steel.

- Cracks in the concrete
- Pieces of concrete chipping off
- Rusting of the reinforcing steel

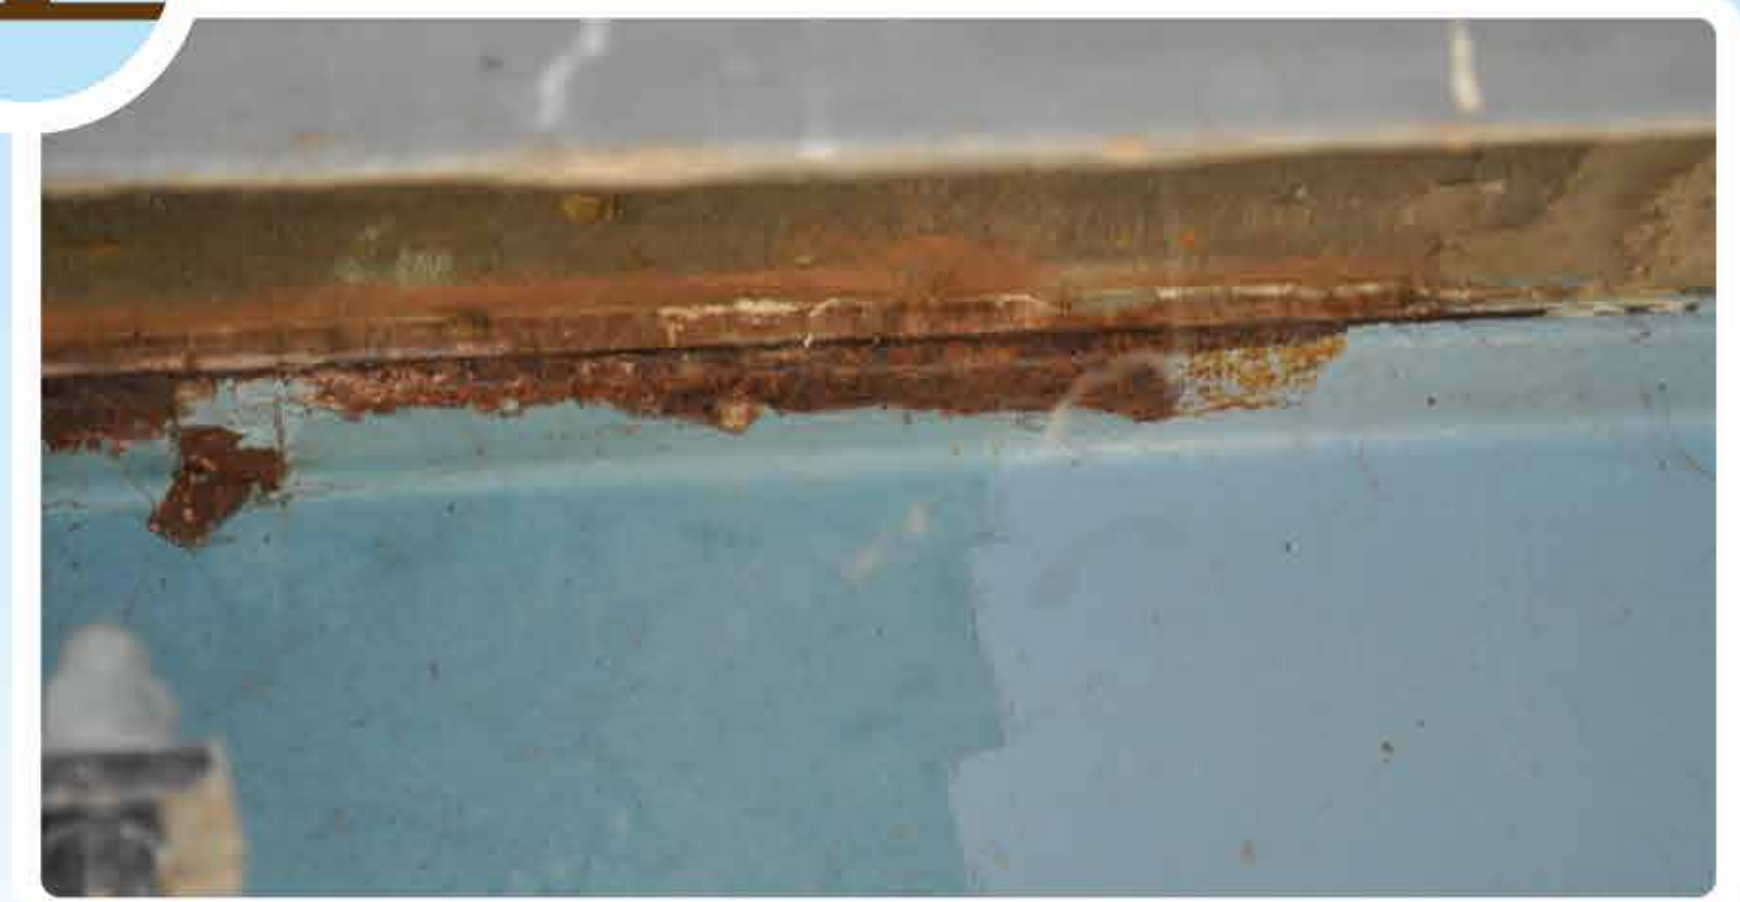
Poor condition

Pack rust has formed between steel elements causing bulging and distortion, leading to added stress and cracking in the concrete deck.

- Heavy rust
- Warping at the connections
- Deterioration of the steel
- Loss of protective coating over the steel

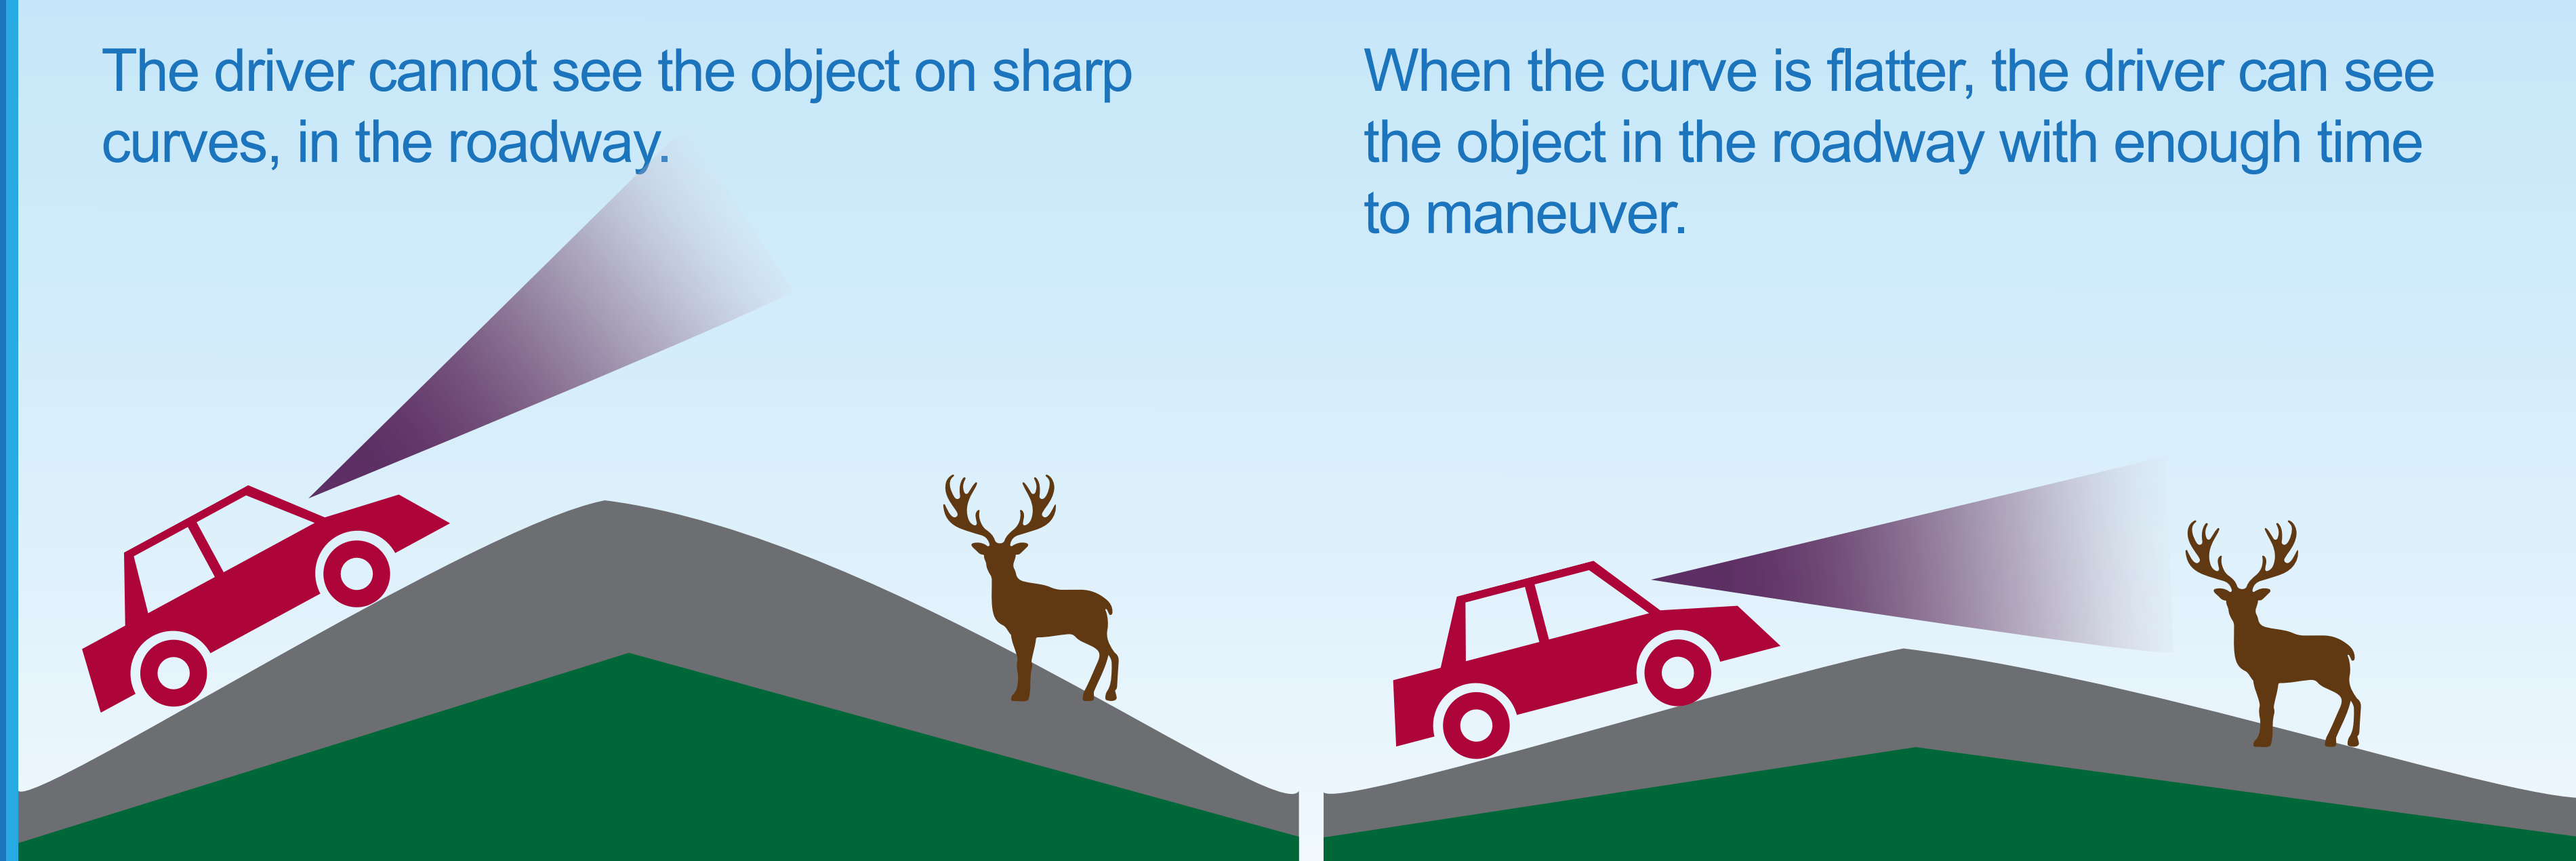
**Decision Sight Distance**

Decision sight distance is needed for a driver to:

- (1) detect a condition in a roadway and recognize its threat
- (2) select and complete appropriate avoidance maneuver

Three I-39/90/94 vertical curves in the project area do not meet decision sight distance standards

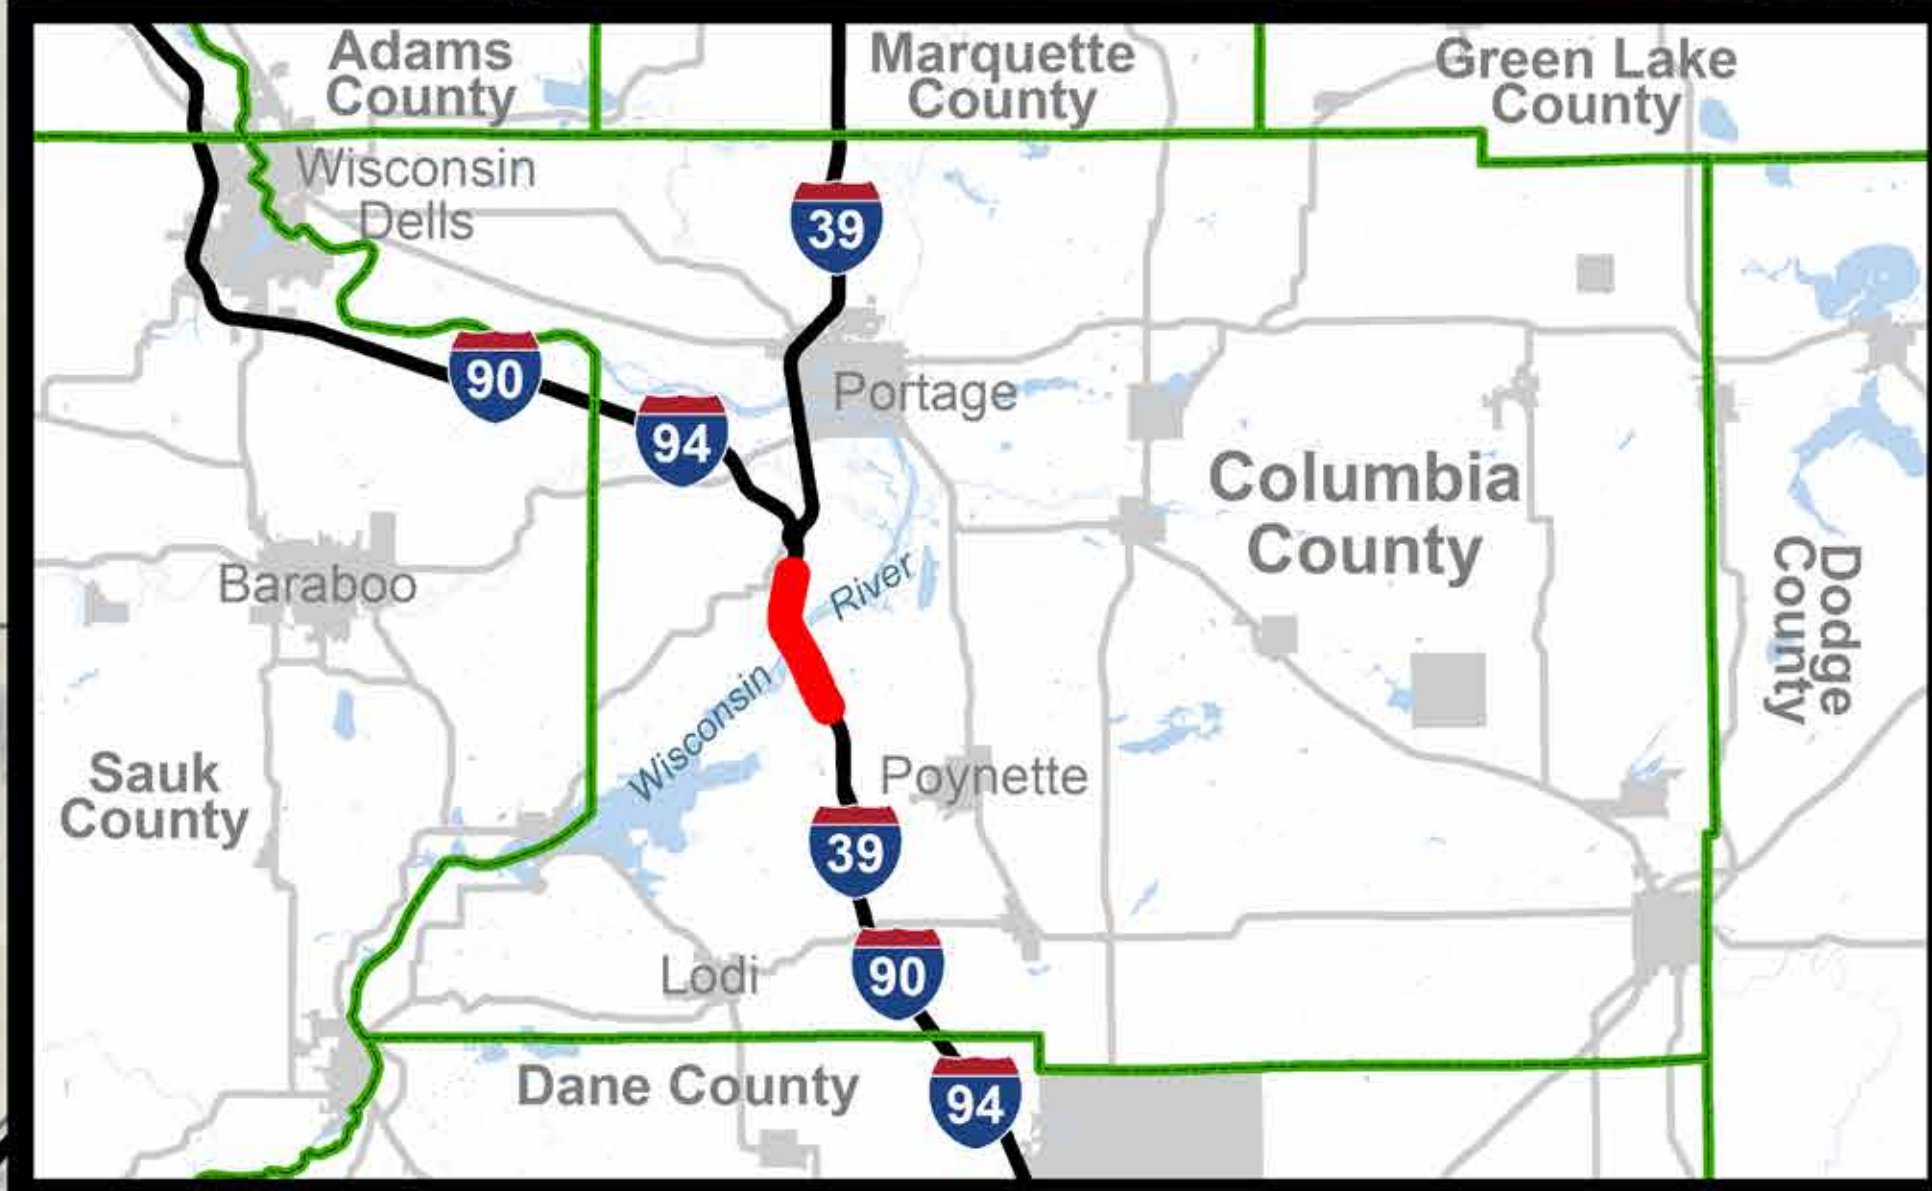
East and West Alternative Overlap

**East Alternative**

- Construct a new bridge just east of the existing bridge
- Shift I-39/90/94 to east to match the new bridge
- Evaluate County U and V bridges for possible replacement

**Rehabilitation Alternative**

- Repair the bridge in its current location
- Replace the concrete deck and repair steel supports

**West Alternative**

- Construct a new bridge just west of the existing bridge
- Shift I-39/90/94 to west to match the new bridge
- Evaluate County U and V bridges for possible replacement

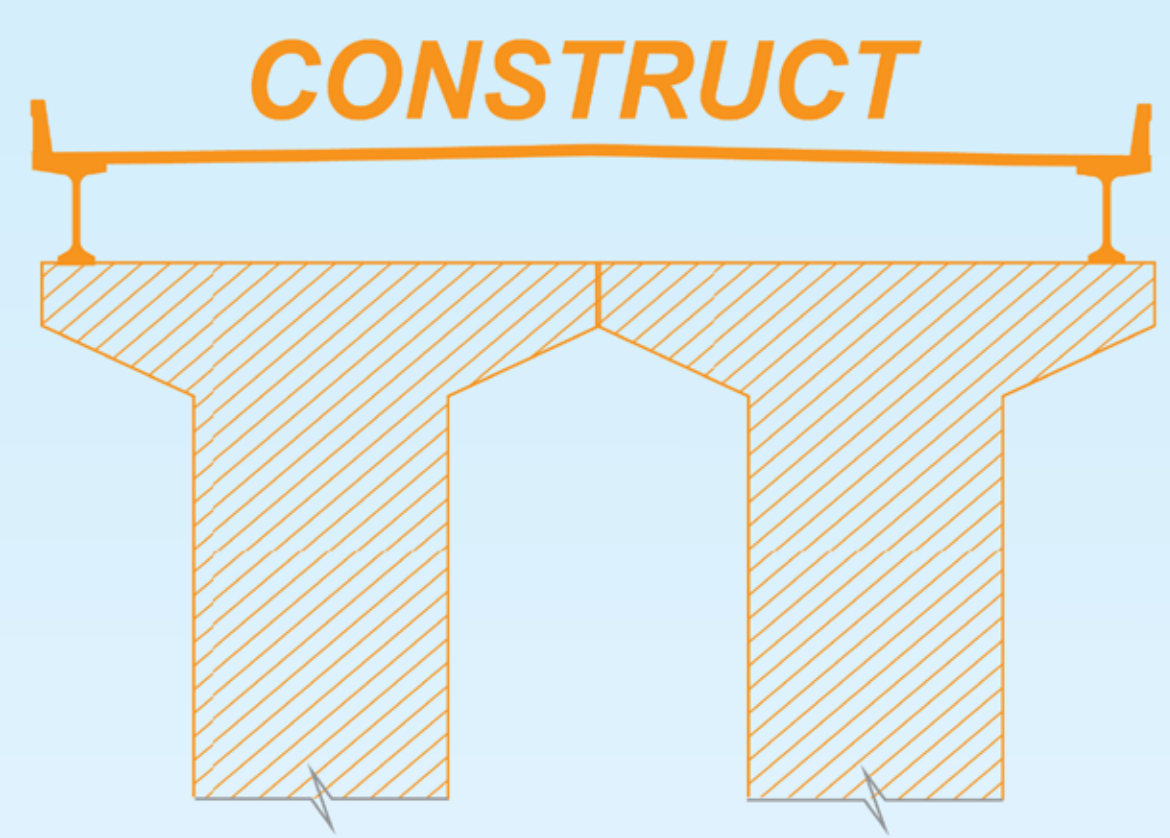
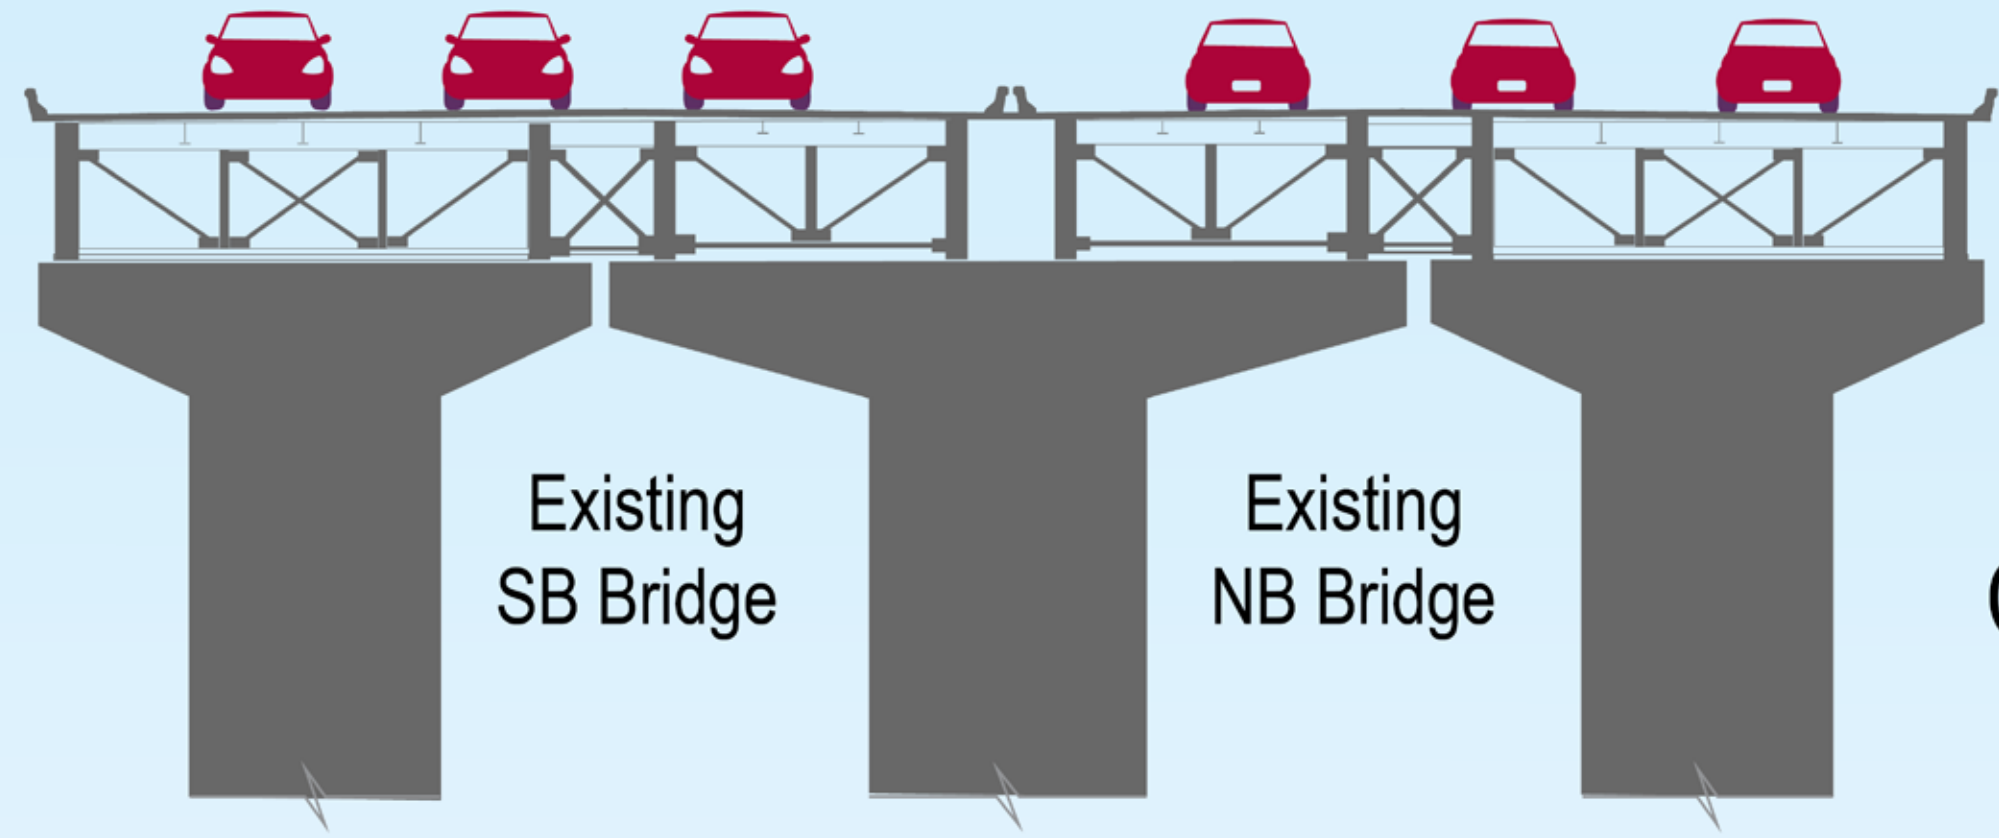
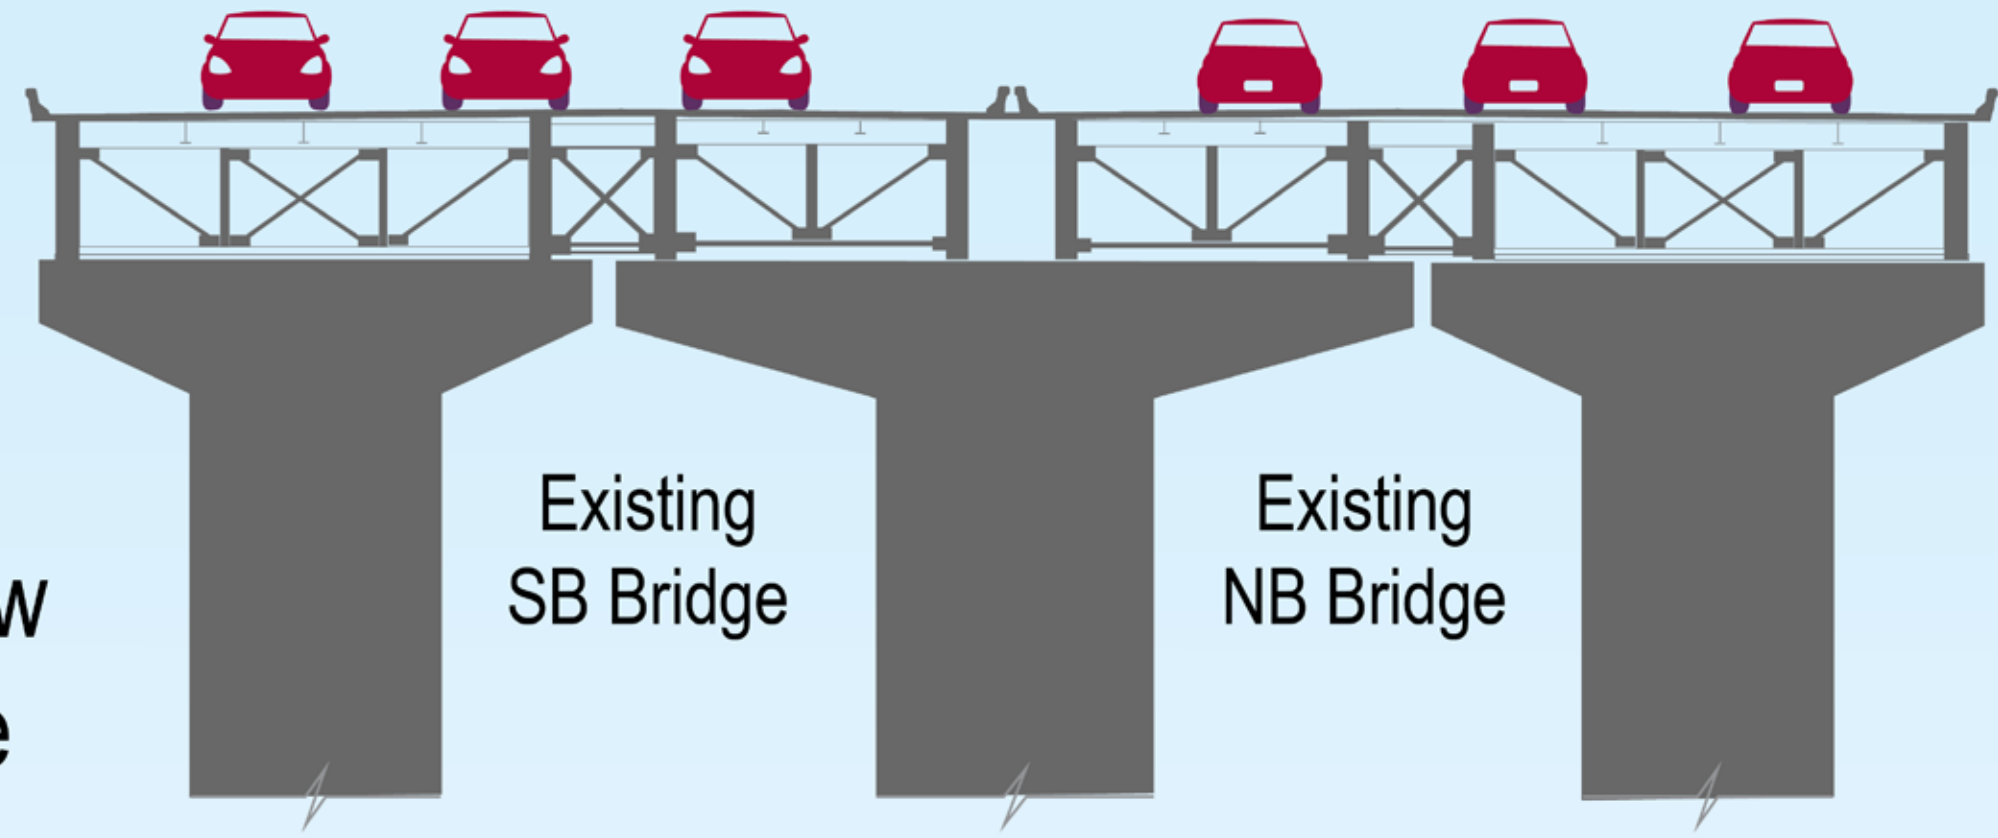
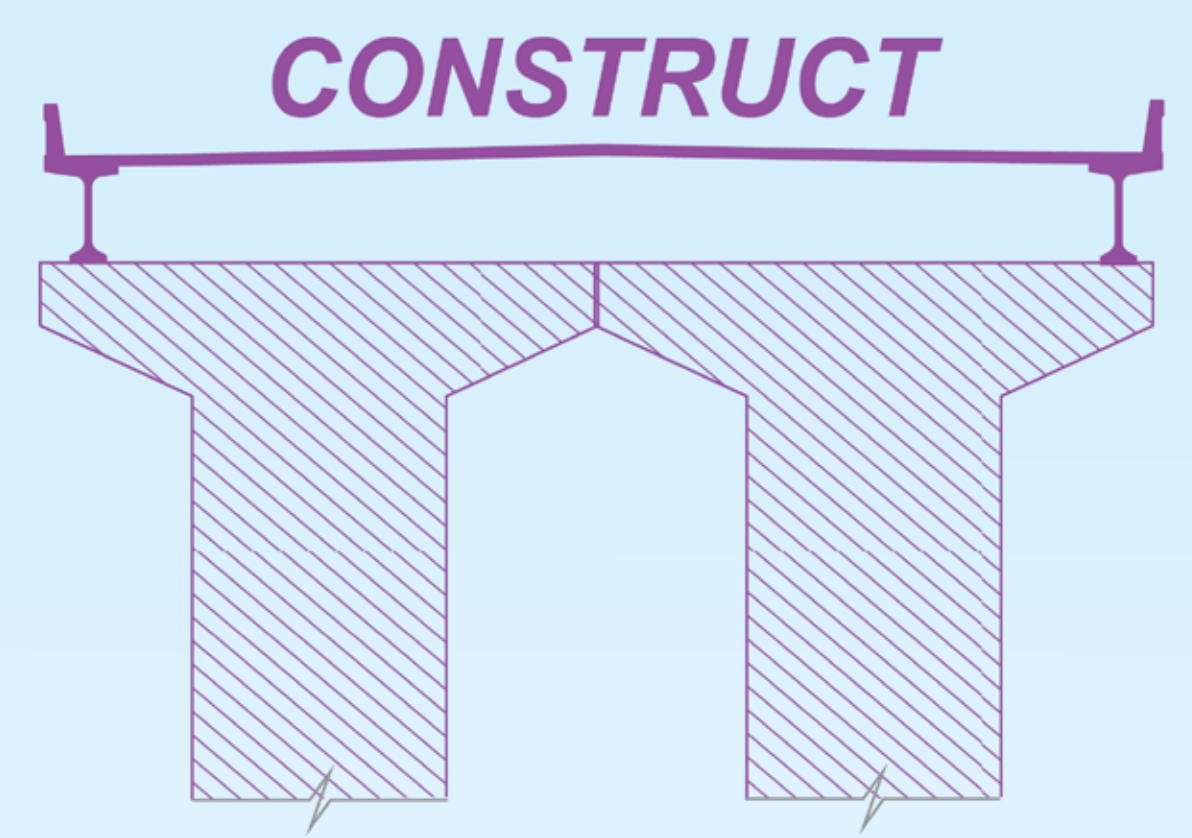
**STAGE 1**  
Construct new bridge to the outside

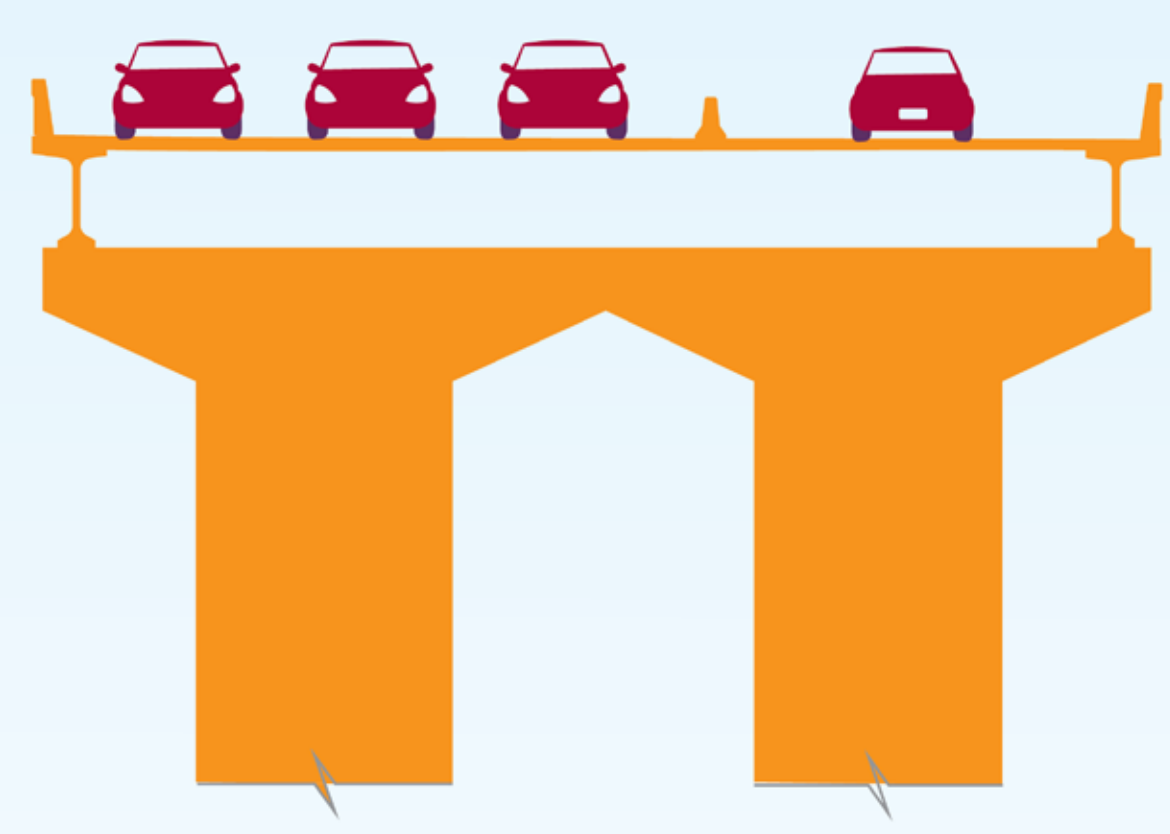
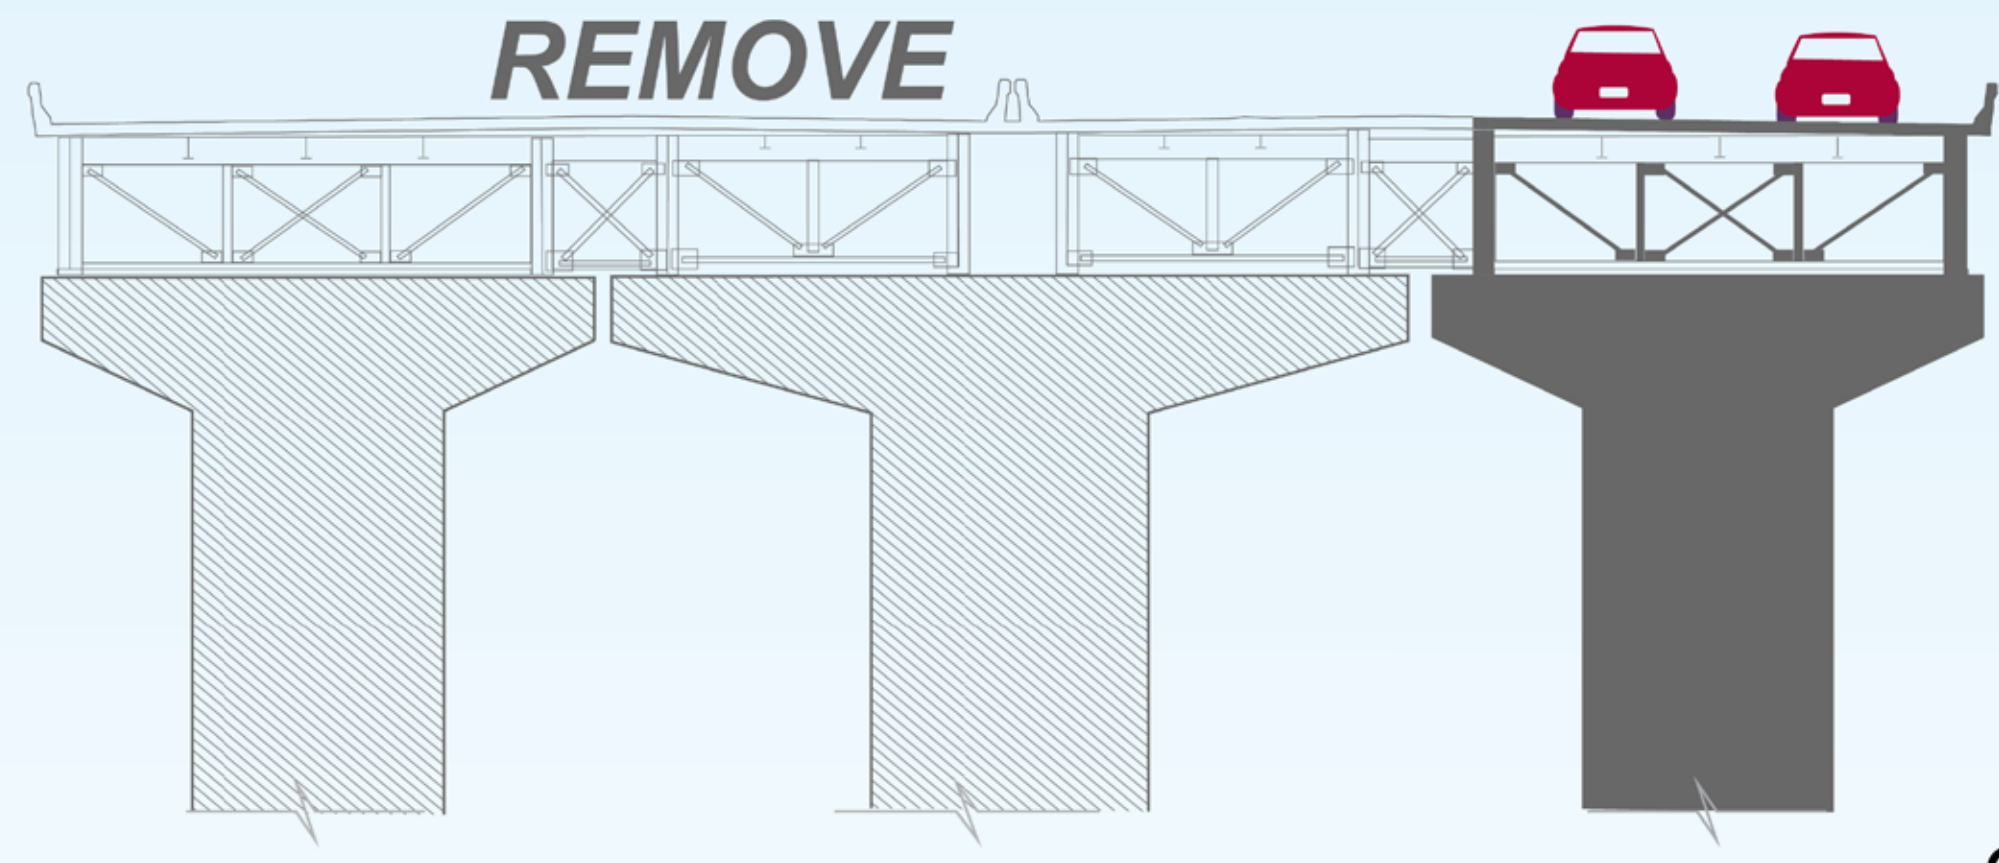
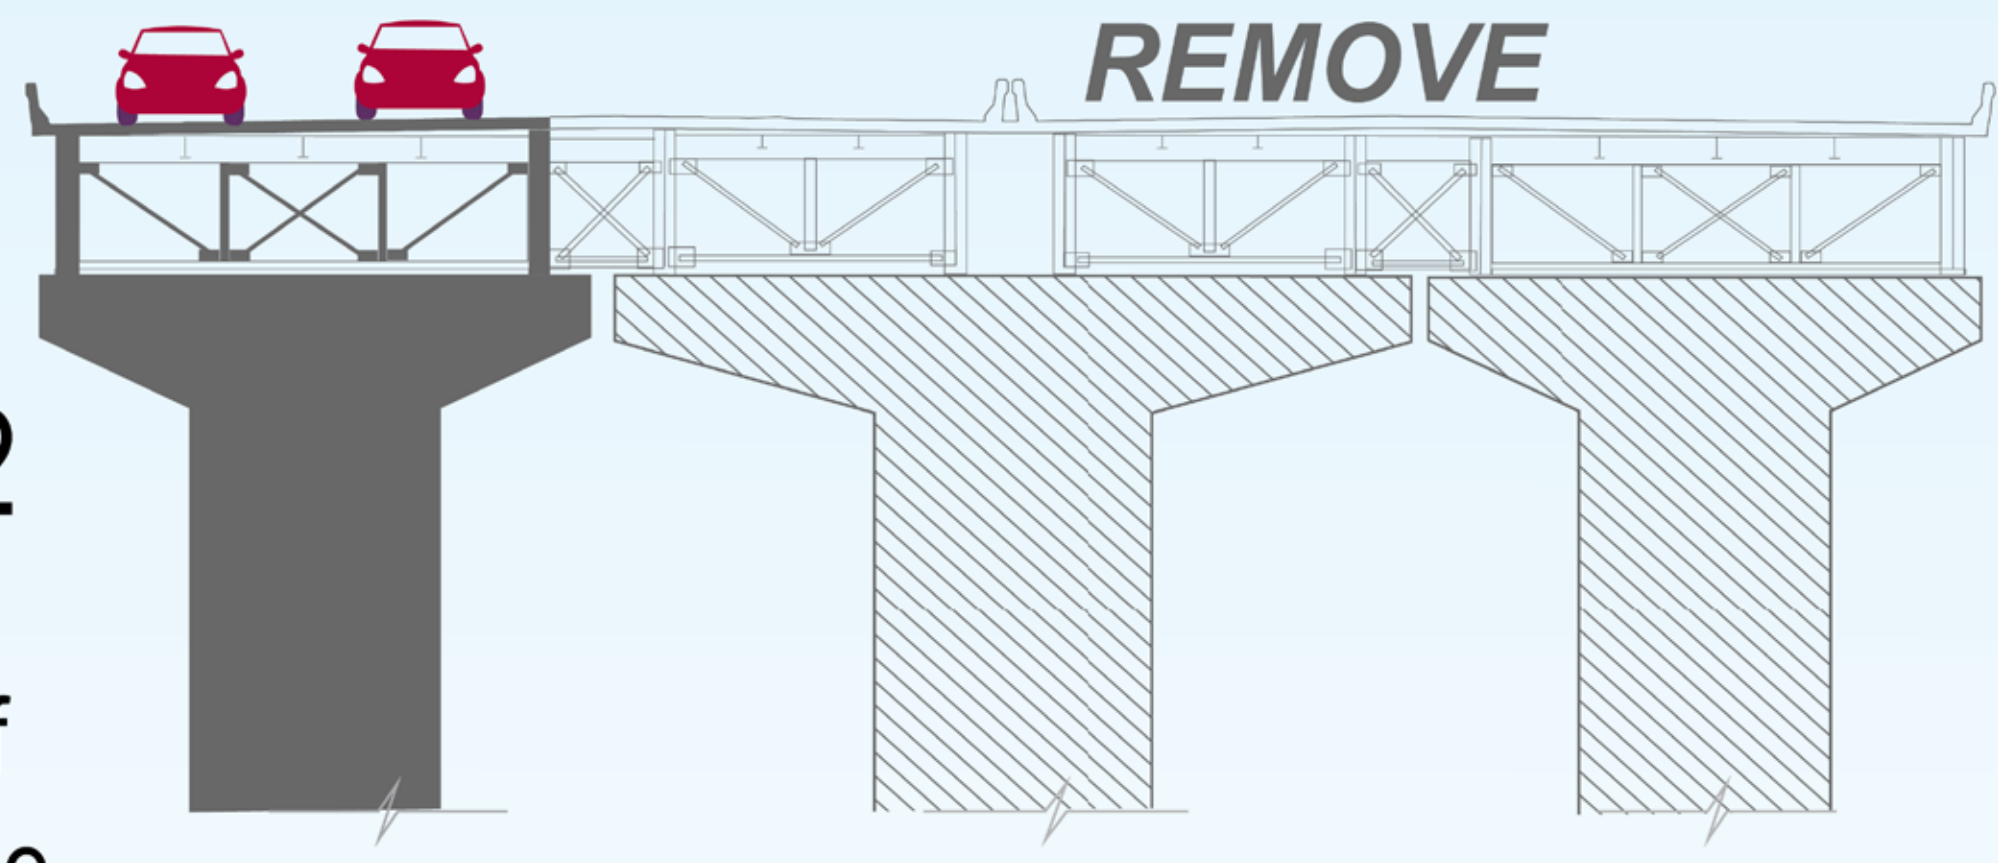
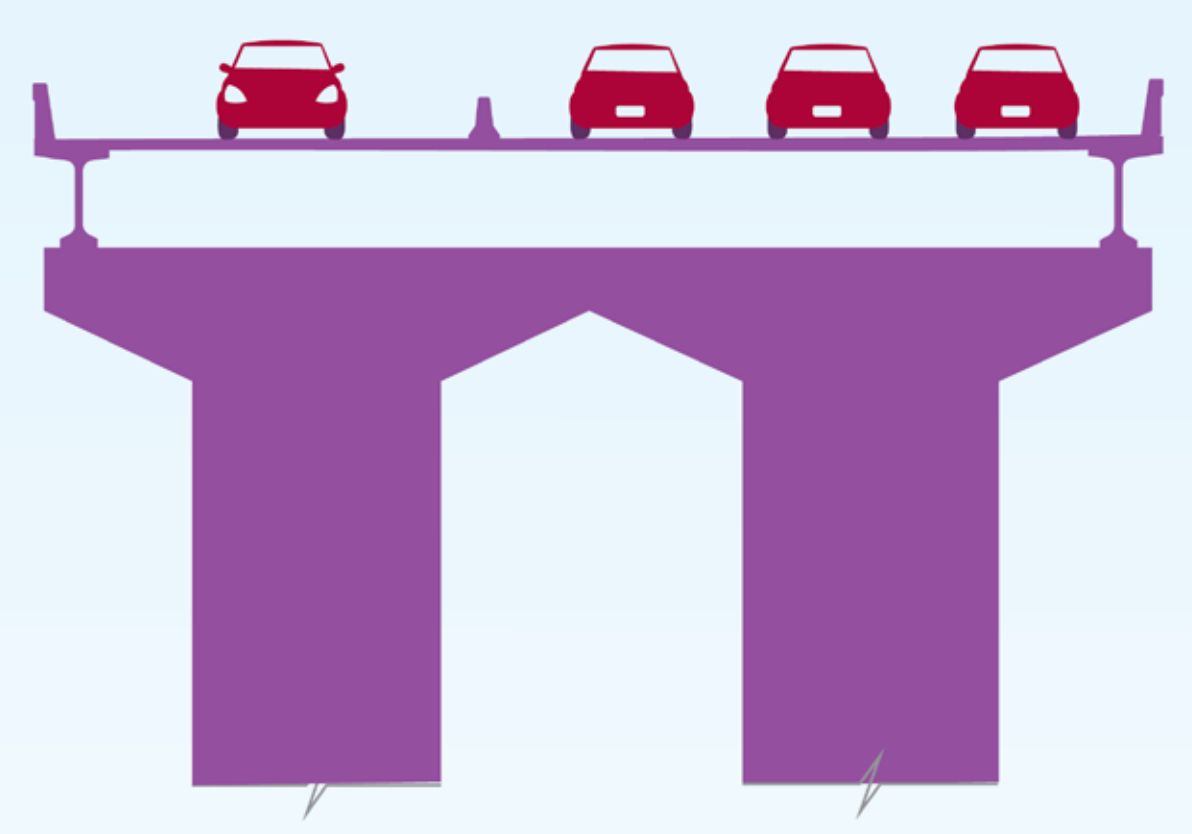
**STAGE 2**  
Remove two-thirds of existing bridge
