# I-39/90/94 Route Importance

# Purpose and Need

The purpose of the I-39/90/94 Wisconsin River Bridge Project is to address the needs of the aging I-39/90/94 structures and maintain vehicular traffic across the Wisconsin River in the towns of Dekorra and Caledonia located in Columbia County.

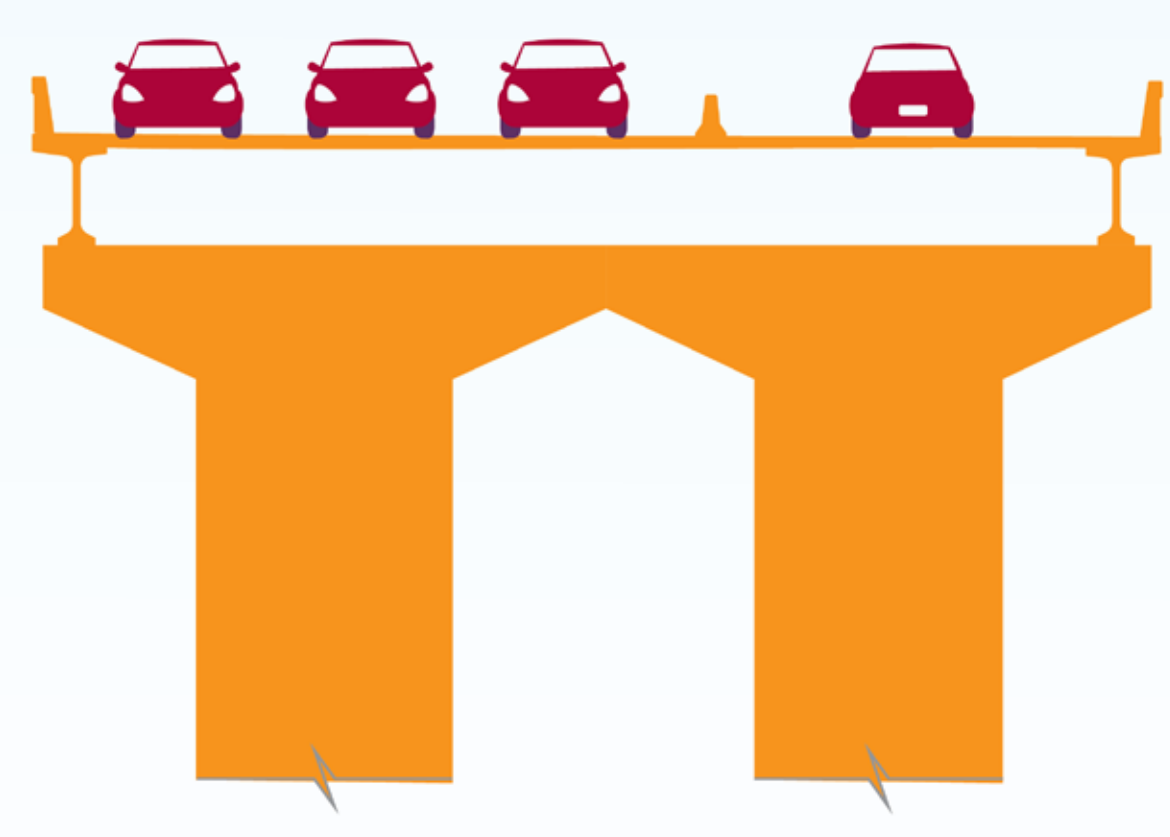
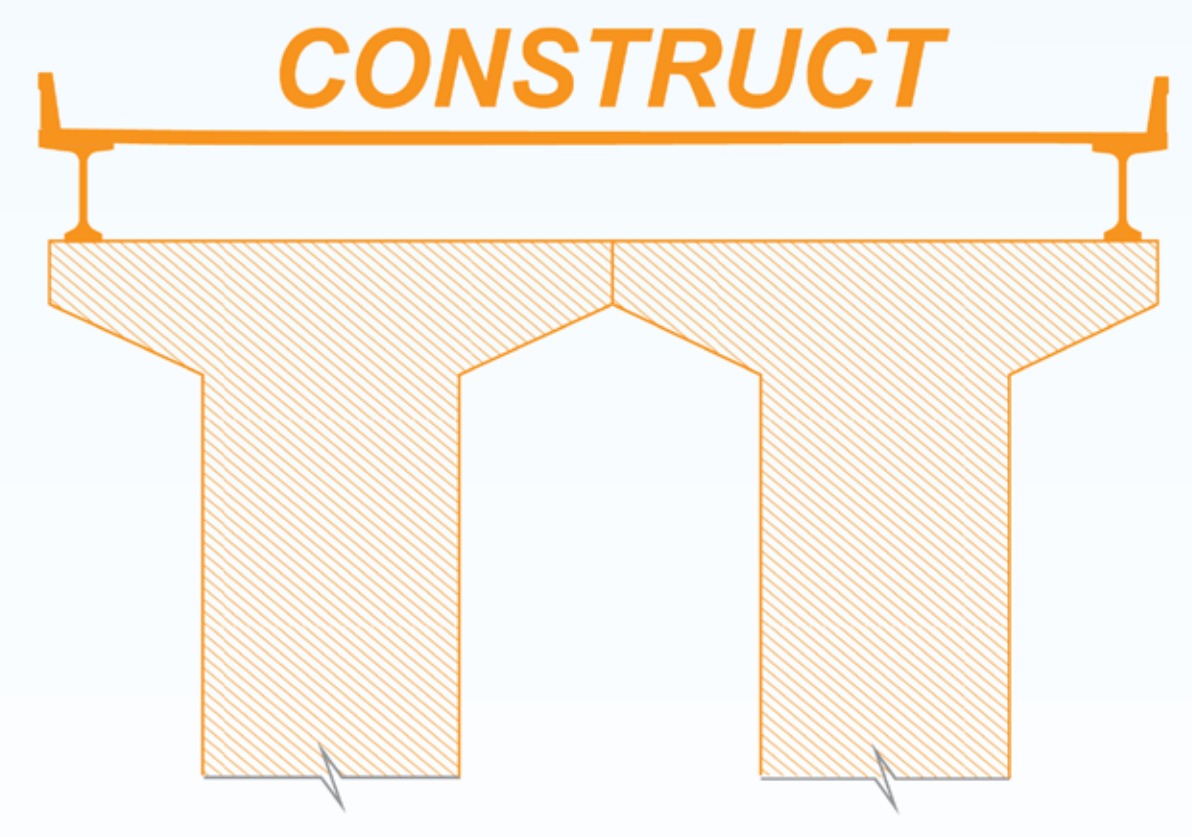
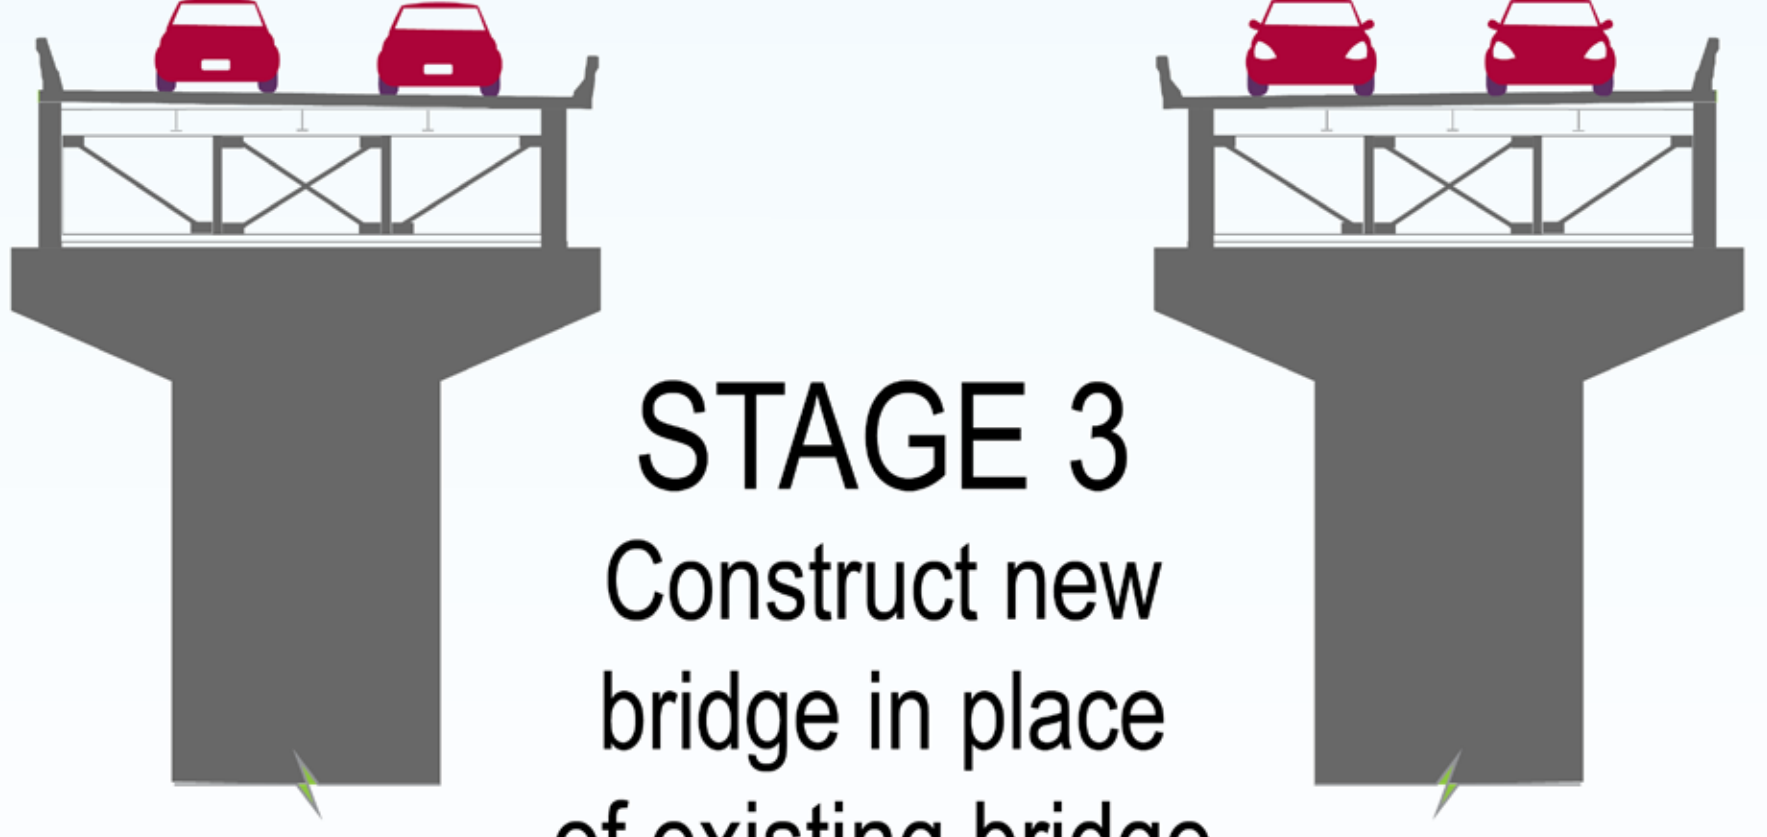
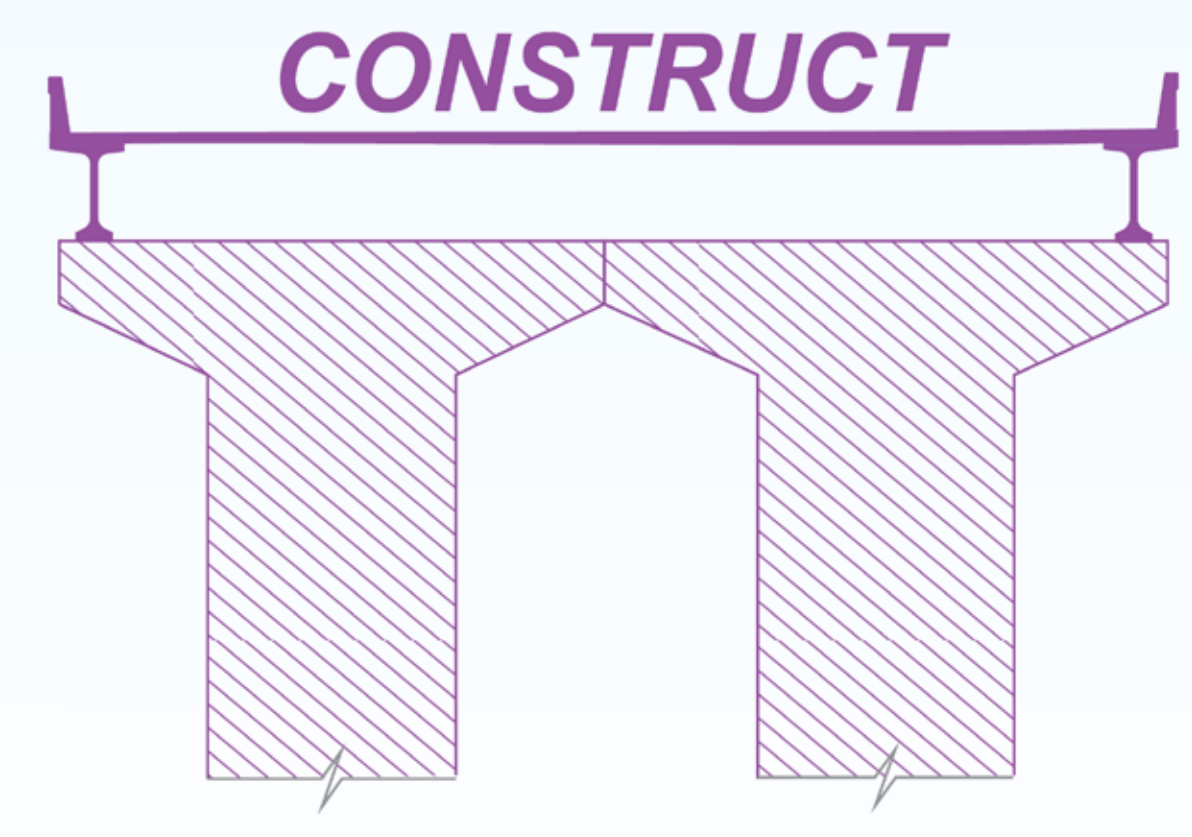
**STAGE 3**  
Construct new bridge in place of existing bridge

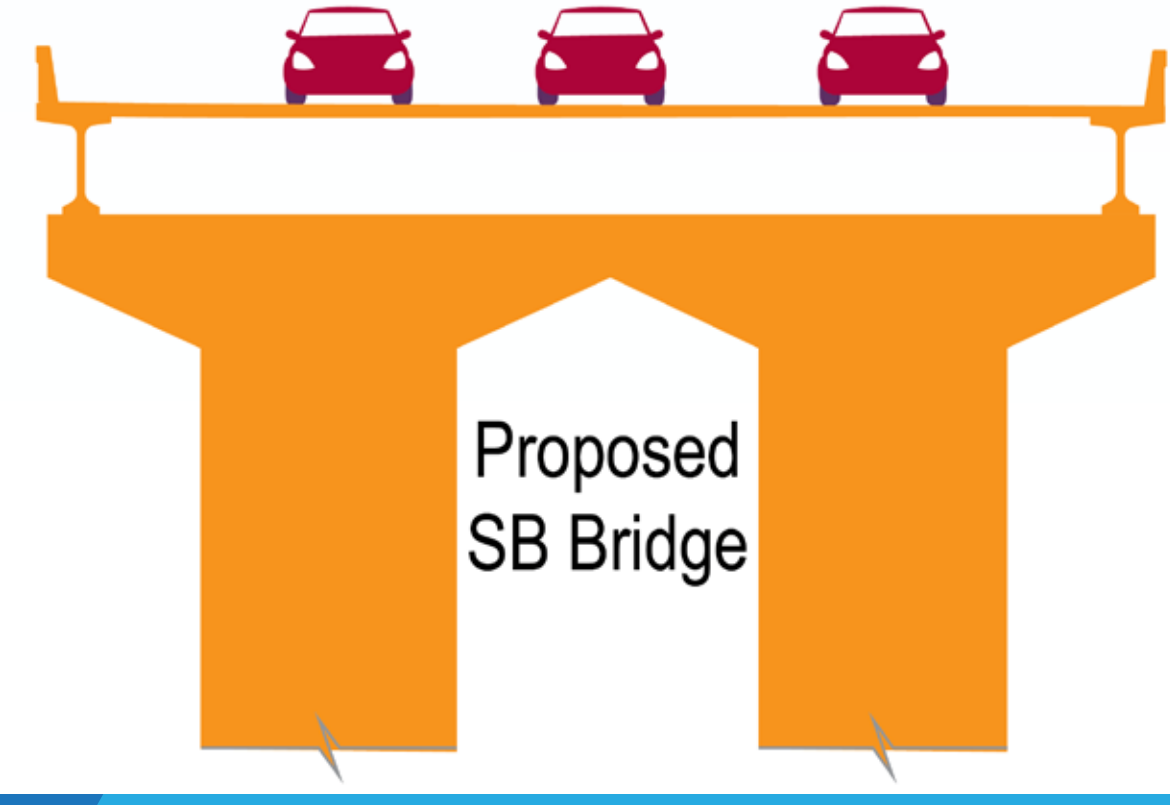
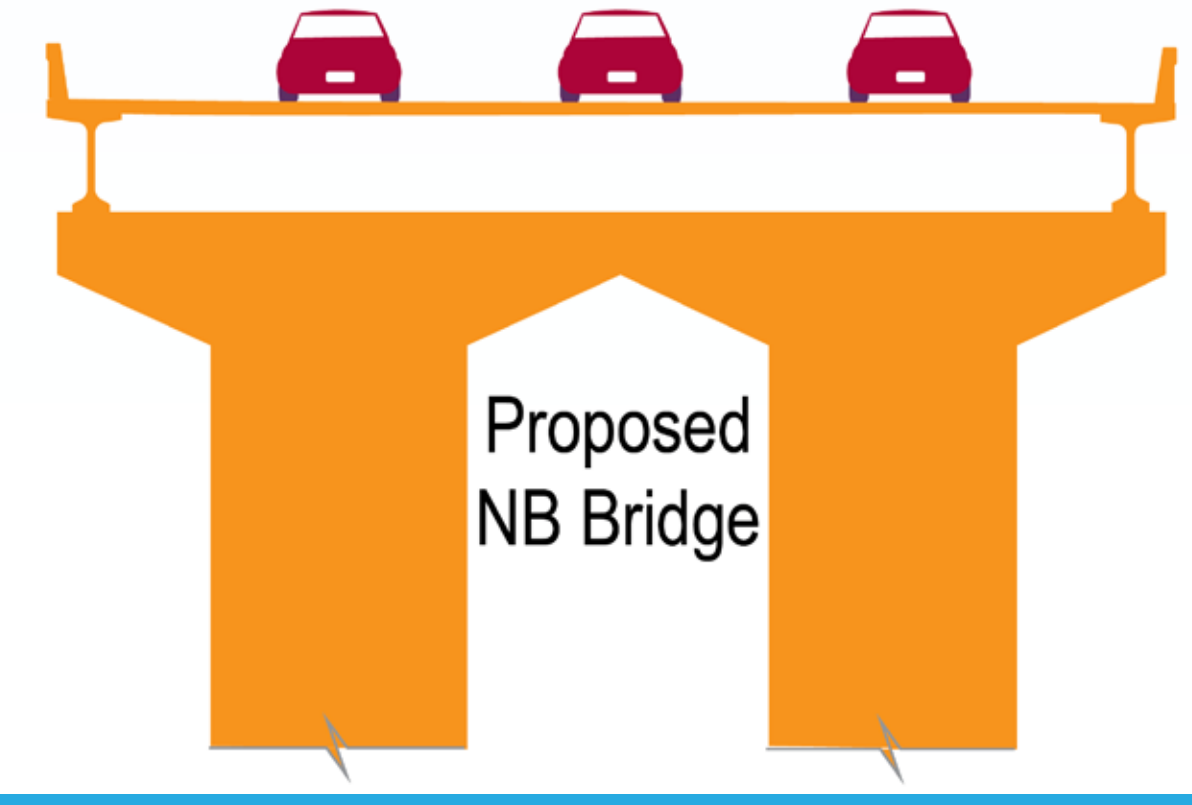
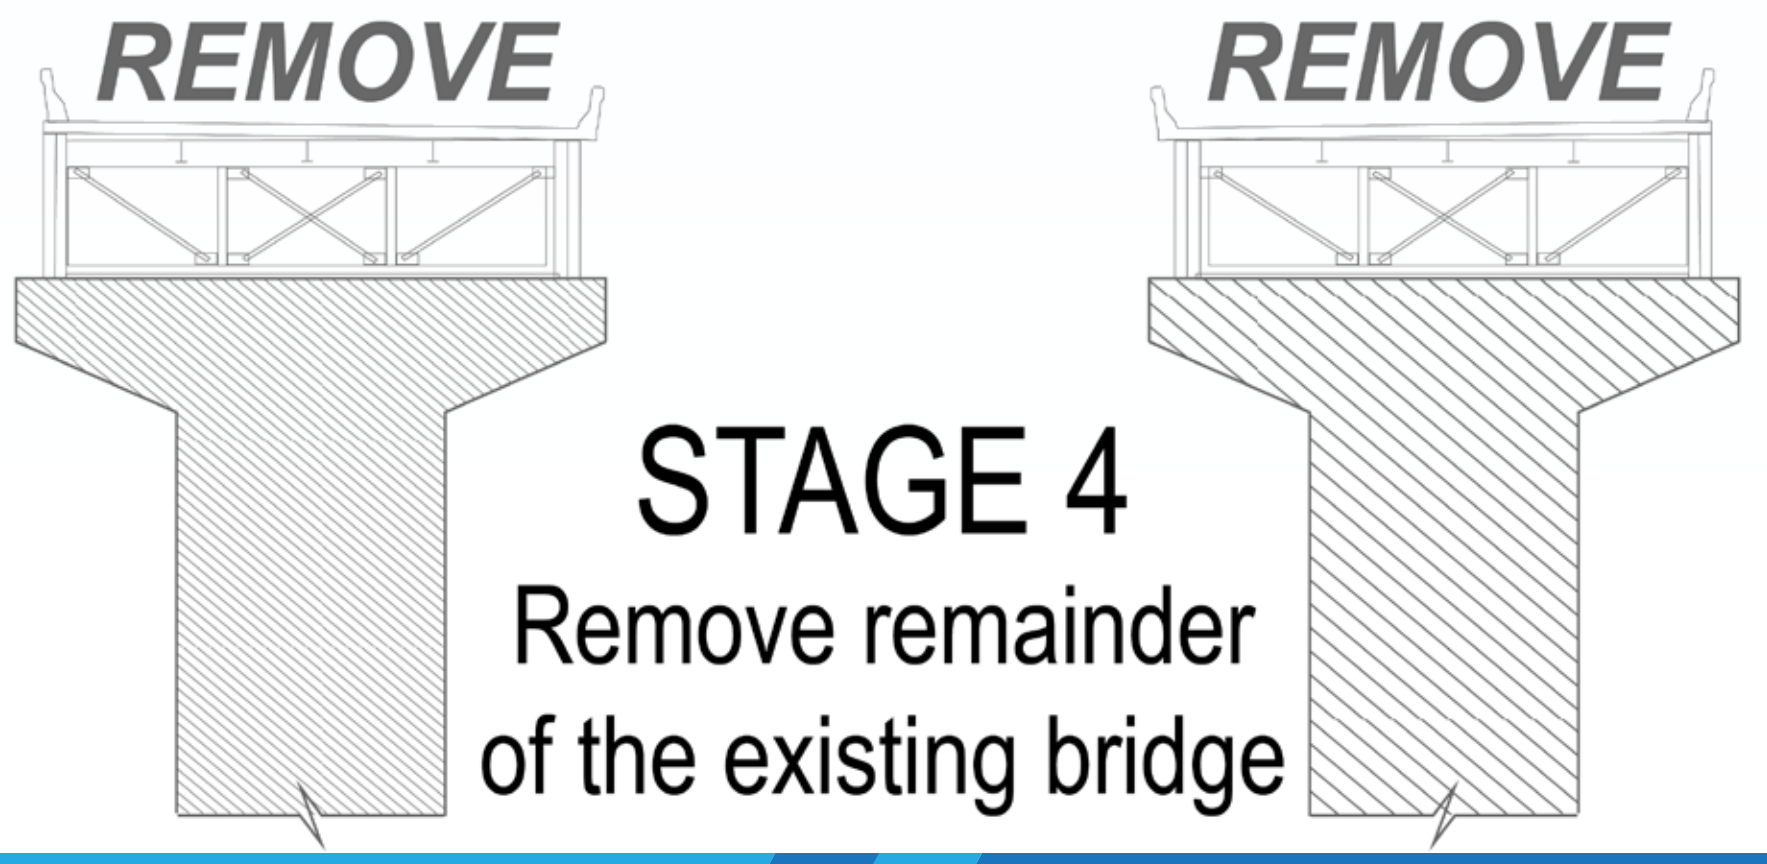
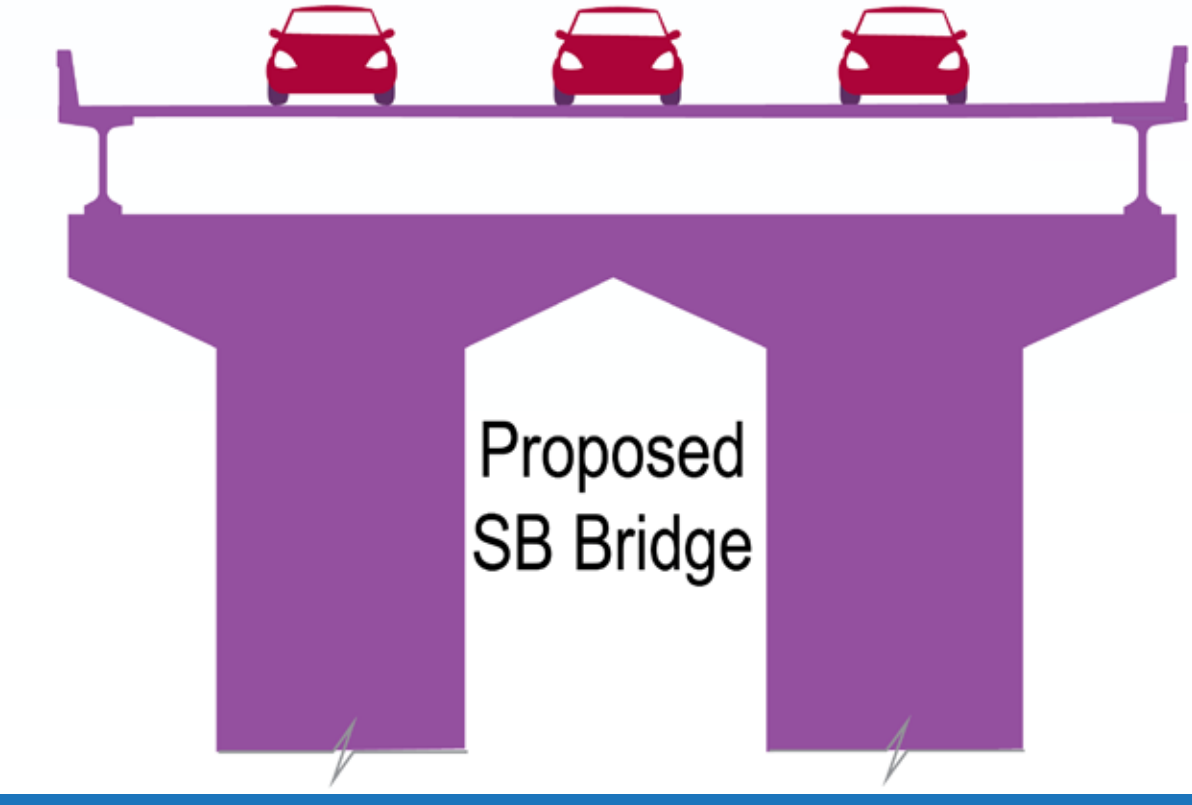
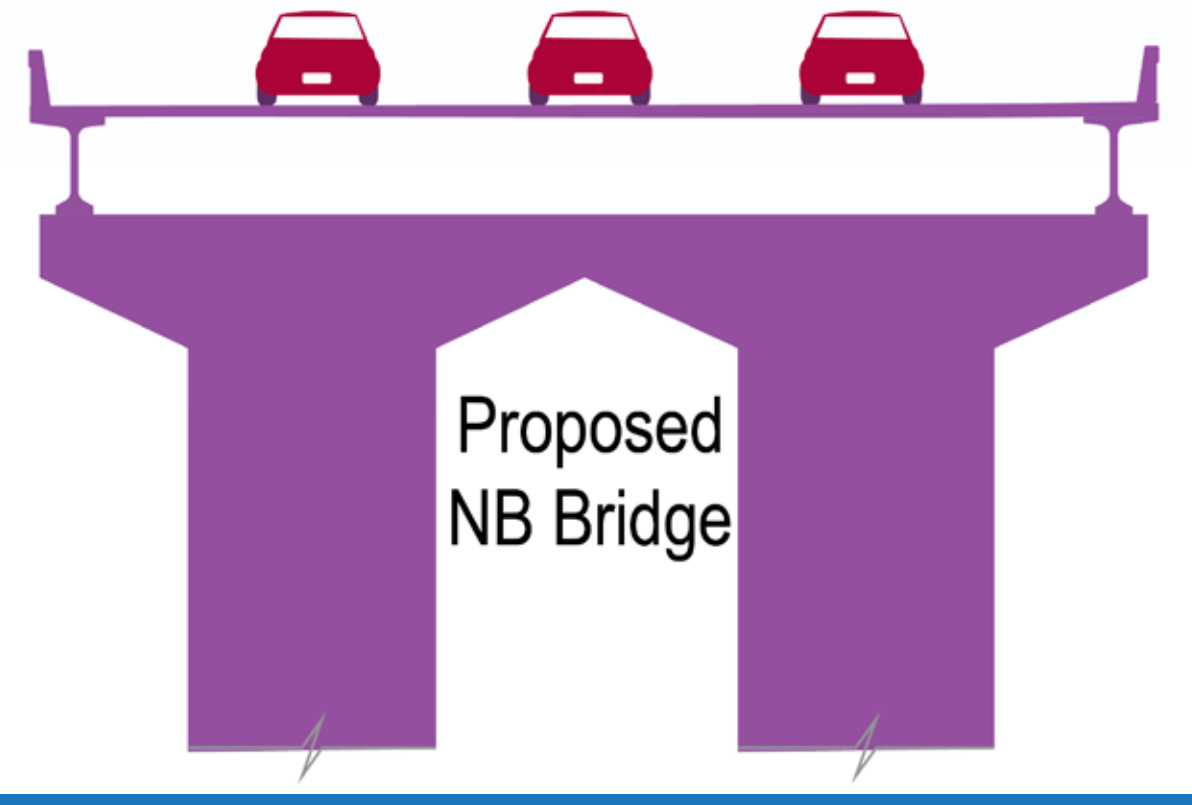
**STAGE 4**  
Remove remainder of the existing bridge
