Better Concrete Mixes for Rapid Repair in Wisconsin

University of Wisconsin - Madison

WisDOT ID no. 0092-15-08

April 2017

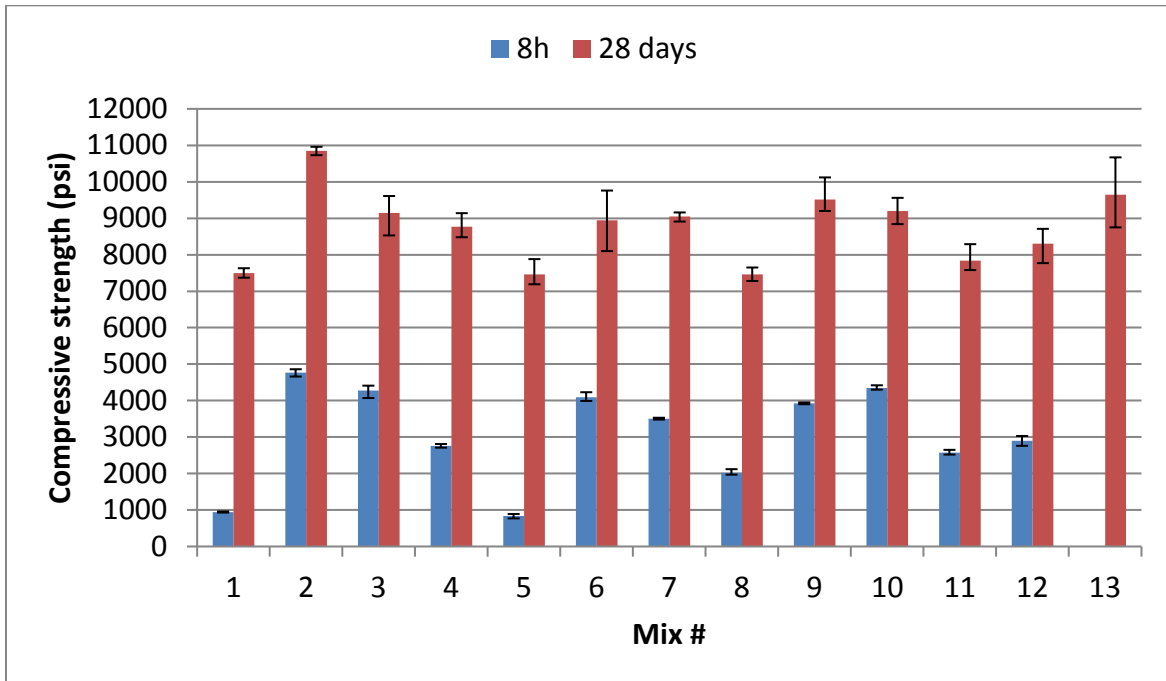
Figure 1. Concrete average compressive strengths (with max and min values) after 8 hours and 28 days

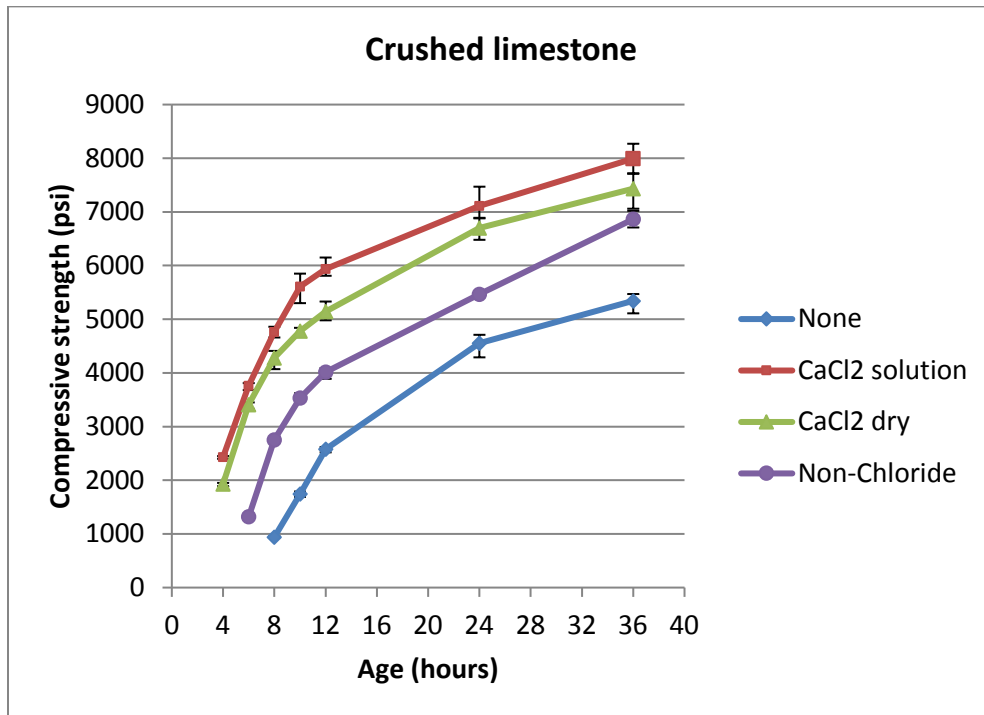
Effect of accelerator type and addition method on concrete strength development in the first 36 hours is shown in Figure 2 for crushed limestone and Figure 3 for gravel mixes. In both cases, calcium chloride, dry or in solution, was more effective than the calcium nitrate based non-chloride accelerator. In the crushed limestone mixes, calcium chloride solution resulted in slightly faster strength gain than using dry flakes. In the gravel mixes, the difference in strength gain between the two addition methods was insignificant.

Figure 2. Effect of accelerator on concrete strength development, crushed limestone mixes 1-4, each data point shows average and range

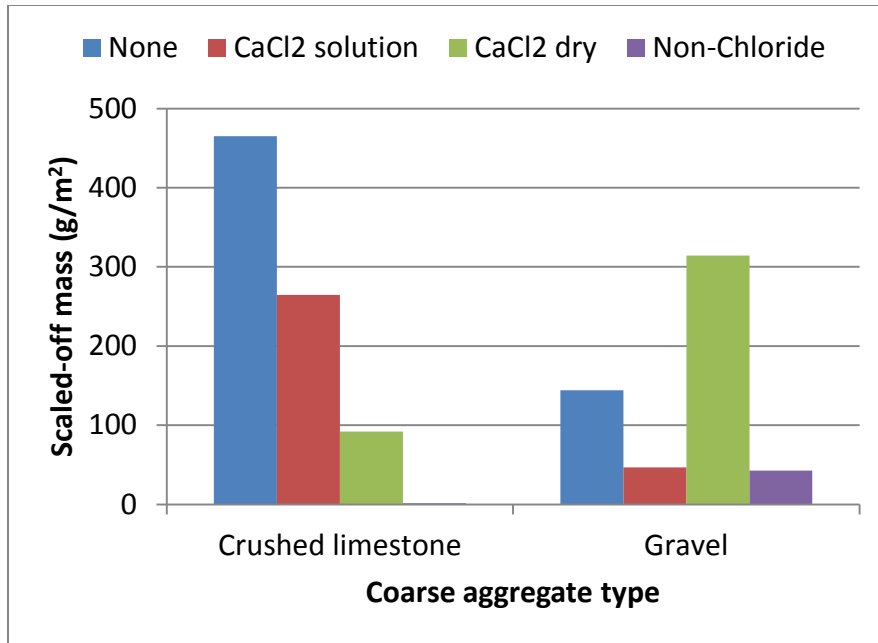
Scaling mass loss values after 60 cycles for different accelerator and coarse aggregate types are compared in Figure 5. Overall, the use of accelerators improved concrete scaling resistance. The concrete using non-chloride accelerator had the best performance for both crushed limestone and gravel mixes, with scaling mass losses of less than 50 g/m². Compared with concrete with no accelerator, liquid-based calcium chloride increased scaling resistance for both coarse aggregate types; whereas calcium chloride added in a dry form increased scaling resistance in the crushed limestone mix, but decreased the scaling resistance in the gravel mix. It is not clear why the concrete using dry calcium chloride performed worst among the gravel mixes.

Figure 5. ASTM C672 average test results after 60 cycles, mixes 1-8

Effect of aggregate type on concrete scaling resistance in this study was mixed. For concrete without accelerator or with calcium chloride solution, gravel mixes performed better than crushed limestone ones; whereas for concrete using dry calcium chloride or non-chloride accelerator, the trend was opposite (Figure 5).

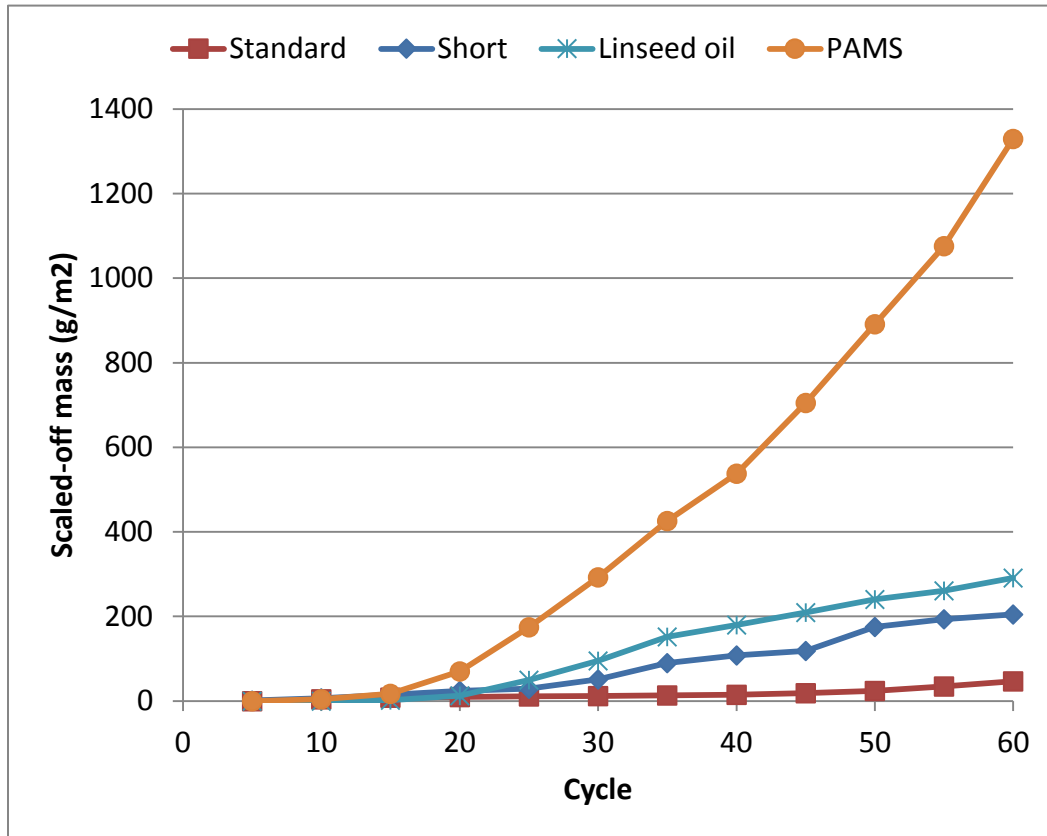
Effect of curing regime is presented in Figure 6, which shows the cumulative scaling mass loss for mix 6 (standard curing), mix 9 (short curing), mix 13-L (linseed oil curing compound), and mix 13-P (PAMS curing compound). All these mixes used gravel coarse aggregate and calcium chloride solution. Each value is the average of 3 samples. The data shows that standard-cured samples (14 days of wet curing) had the best performance. It is interesting that short-cured samples, which were covered by sheeting for only 4 hours, also exhibited good scaling resistance with scaling mass loss of about 200 g/m² after 60 cycles. Performances of the samples using linseed oil and PAMS curing compounds were remarkably different. While linseed oil was effective with scaling mass loss of 291 g/m², PAMS specimens performed poorly with scaling mass loss of 1329 g/m². PAMS curing compound has been used in many studies at UW Madison^{23 24}. This compound had high solid fraction and was highly effective in restricting water loss and improving concrete scaling resistance in comparison with other curing compounds such as linseed oil and wax^{23 24}.

Figure 6. Effect of curing on scaling resistance, mixes 6, 9, 13-L, and 13-P

The poor performance of PAMS specimens in this study suggests that an incompatibility between PAMS and calcium chloride or other mixture constituents may exist although other causes are not excluded.

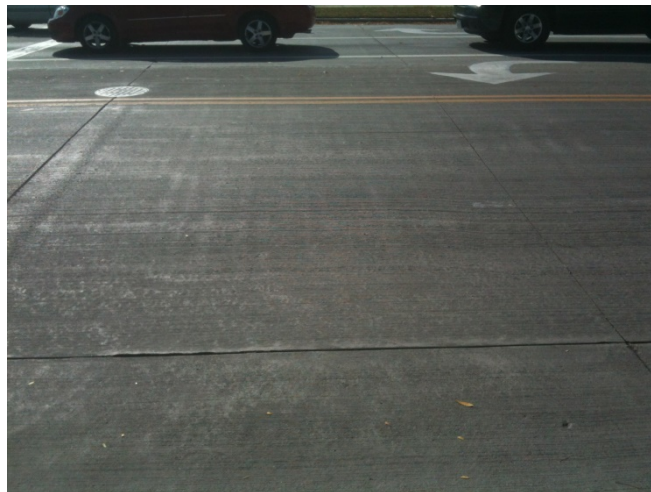
The entire length of this project is 2800 ft in which 100-yd² SHES concrete was used at the intersection of USH 45 and Scott Street. This SHES concrete repair section was not discernible from surrounding pavement. The entire pavement at the intersection was in good condition with no distress.

Figure 13. Pictures of typical repaired segments – Project 5 (1420-11-70)

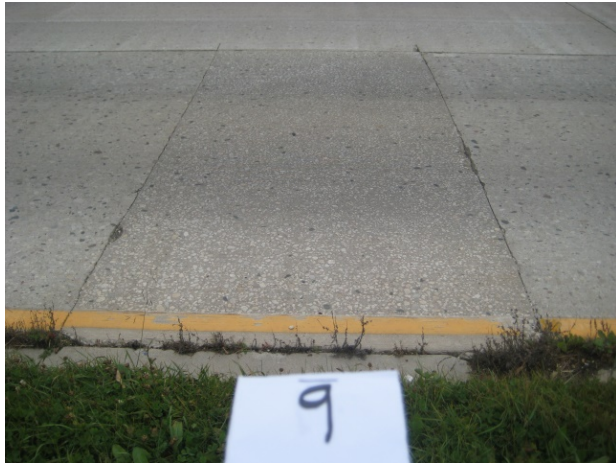
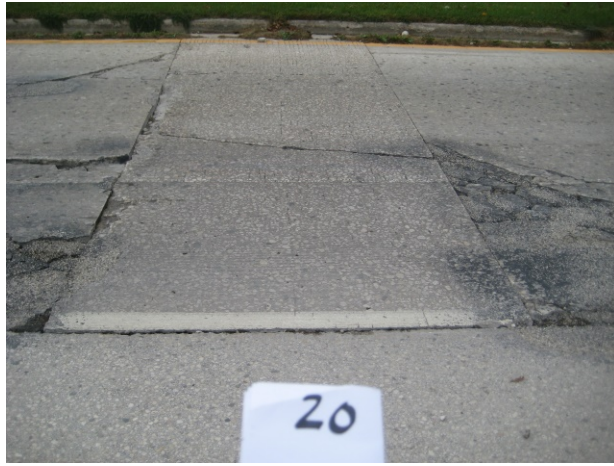
Typical patch	Medium-severity longitudinal crack

Figure 14. Pictures of typical repaired segments – Project 6 (1440-16-60)

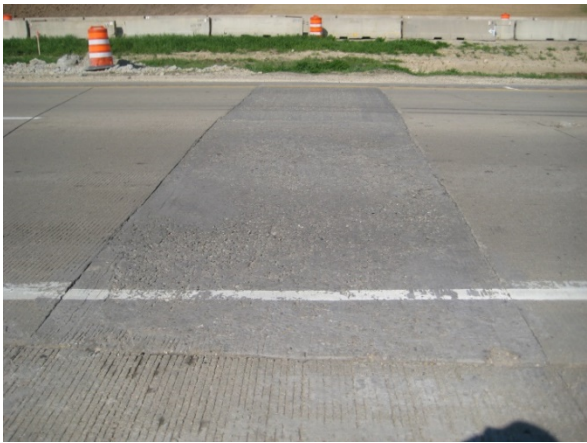
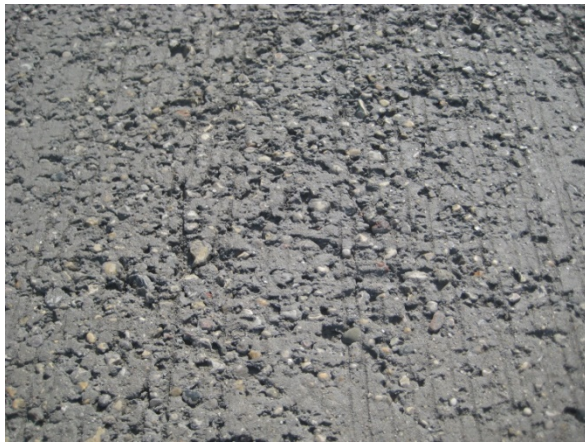
The WisDOT Project ID is 1003-10-86 or 1001-01-62. The repairs were done in 2014 and surface scaling with visible coarse aggregate was observed in patches near the intersection of I90 with State Hwy 59 (Figure 15). These mixes used gravel coarse aggregates.

Typical patch	Scaled-off surface

Figure 15. Pictures of typical repaired segments – Project 7 (I39/90)
