Staged Concrete Bridge Deck Pours Adjacent to Live Traffic

WisDOT ID no. 0092-16-04

November 2018

WISCONSIN HIGHWAY RESEARCH PROGRAM

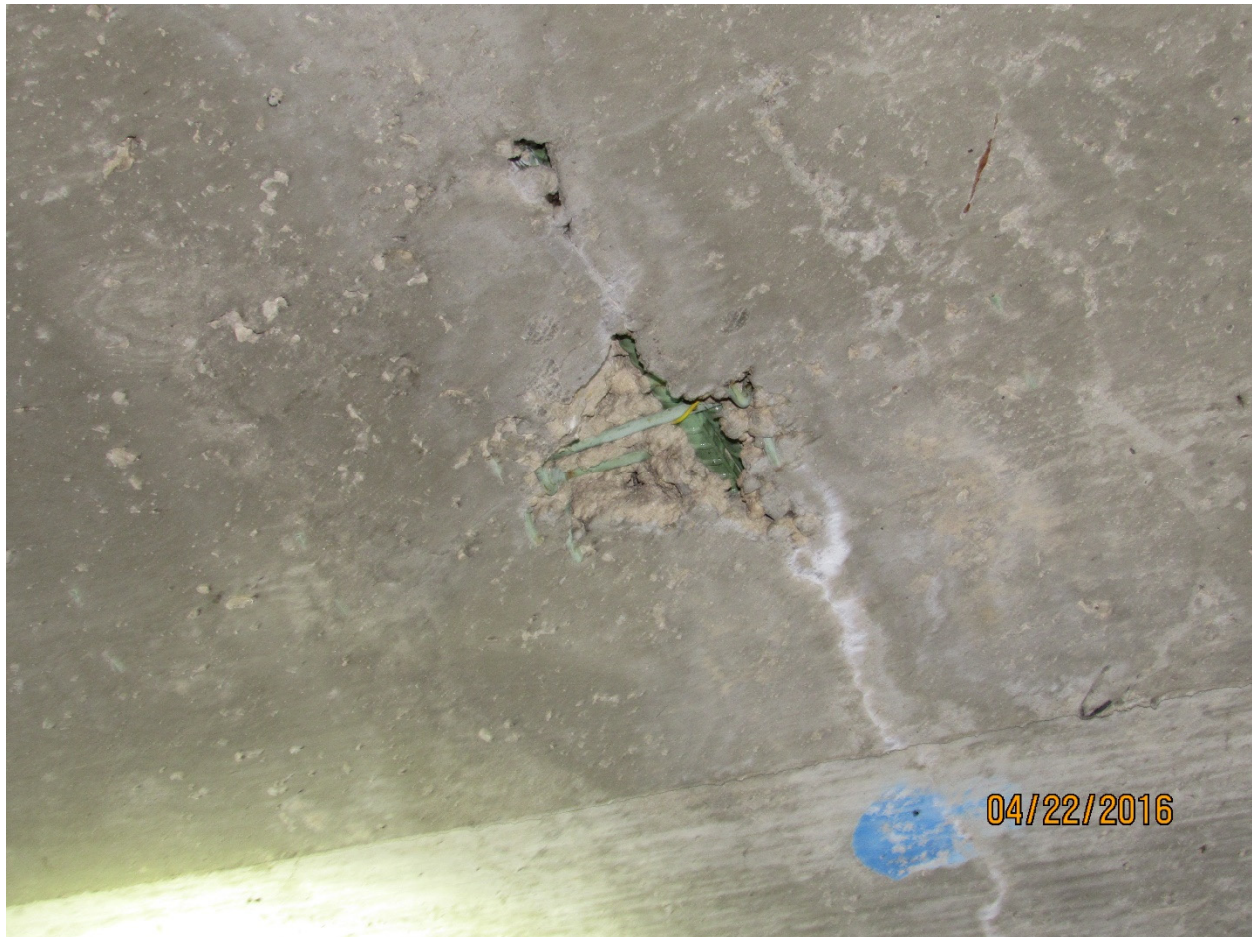
Figure 4.2- Inadequate concrete consolidation exposing reinforcement in the longitudinal joint region. (B-40-216 – Dowel bar splicer, detail B per Figure 4.1)

Visual inspections did not prove one detail to be preferable over the others. Bridge decks with each detail were seen that were free of defects and performing well. One issue often encountered was under-consolidated concrete in the longitudinal joint region. The presence of spliced bars and shear keys in this region results in more congestion, which often makes it more difficult to properly consolidate concrete into these tight areas. Couple this with the medium slump concrete that is required for bridge decks and underconsolidation in this area becomes common. An example of inadequate consolidation can be seen in Figure 4.2. To prevent this, workers should use extra effort to ensure the concrete in the longitudinal joint region is properly consolidated by internal vibration. Alternatively, using one-piece bar couplers (Figure 4.1– Detail C) will result in the least amount of congestion and should improve this issue.

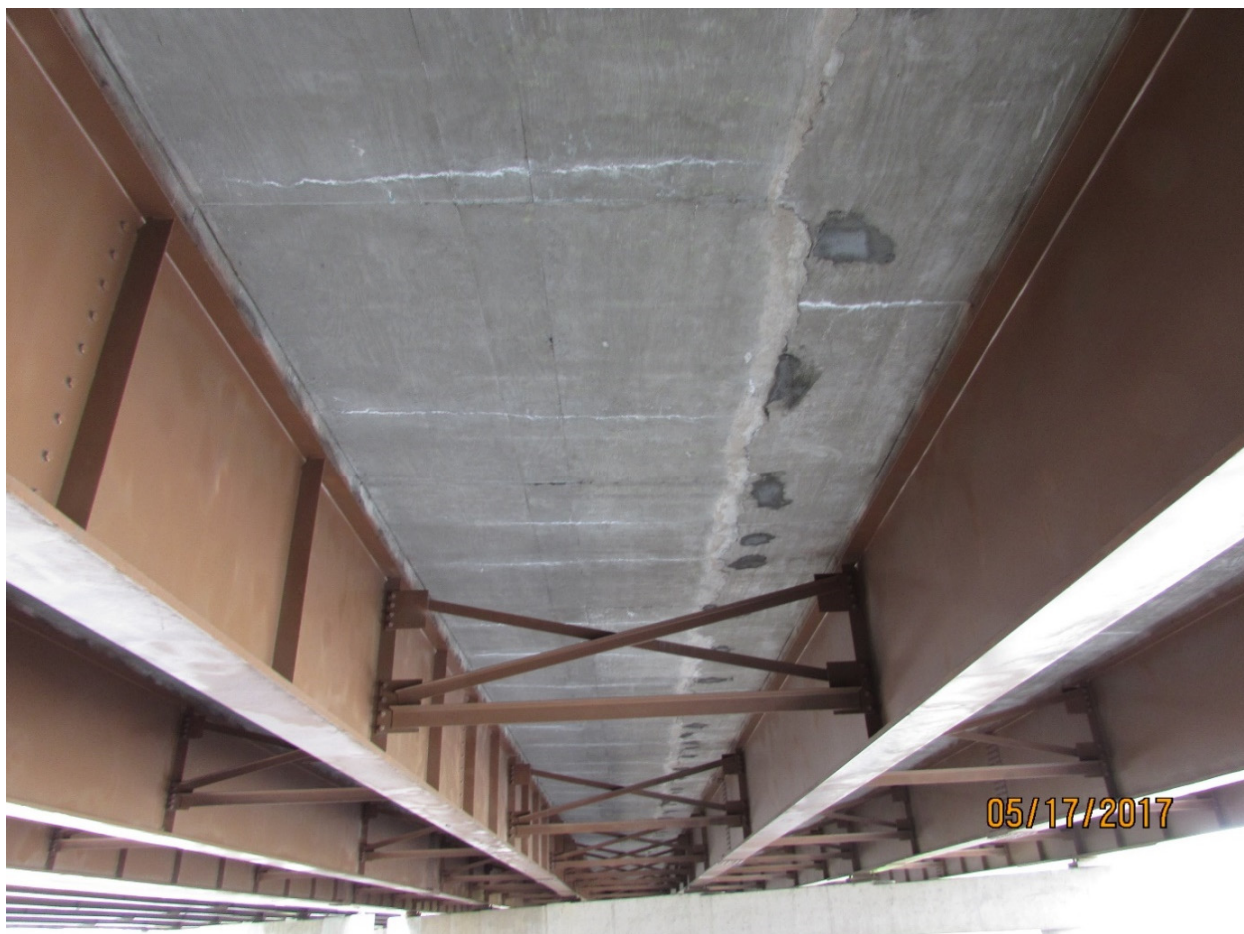
Figure 4.3- Typical regularly spaced transverse cracks with efflorescence (B-70-176)

Nearly every bridge exhibited transverse cracking with efflorescence to some extent. These cracks were typically widely spaced in the midspan region, and were most likely flexural cracks. In some cases, these transverse cracks were concentrated more in one side of the deck (i.e. Stage 1 or Stage 2) but there was no evidence to suggest they were related to differential deflections during construction. If differential movement between concrete and reinforcement were to cause transverse cracking, it would be expected to be more closely spaced, at approximately the same spacing as the transverse reinforcement. Typical transverse flexural cracks with efflorescence can be seen in Figure 4.3.

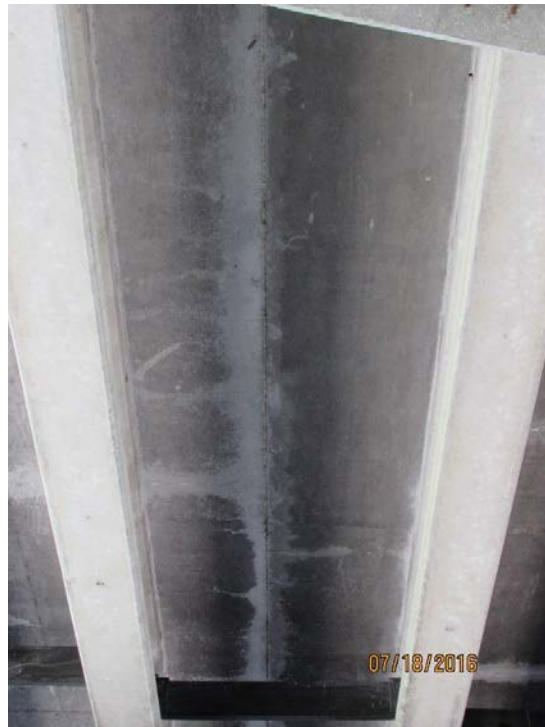
Figure 4.4 - Typical leakage through a longitudinal construction joint (B-53-083)

Signs of leakage through the longitudinal construction joint were also commonly observed. This should be avoided; if water, deicing chemicals, road salt and other corrosive agents can seep through the construction joint and reach the reinforcement, the steel crossing the construction joint will be vulnerable to premature degradation. A typical leaking construction joint can be seen in Figure 4.4. This was typical for many of the inspected bridges. The Wisconsin DOT has a standard detail (Figure 4.5) to prevent this type of leakage, in which the top of the construction joint is saw-cut and sealed after construction of both adjoining decks. It is possible that this was not performed on the bridges that showed leakage through the joint. Bridges that utilized this sealant showed minimal signs of leakage through the joint, suggesting that this detail is adequate when used.

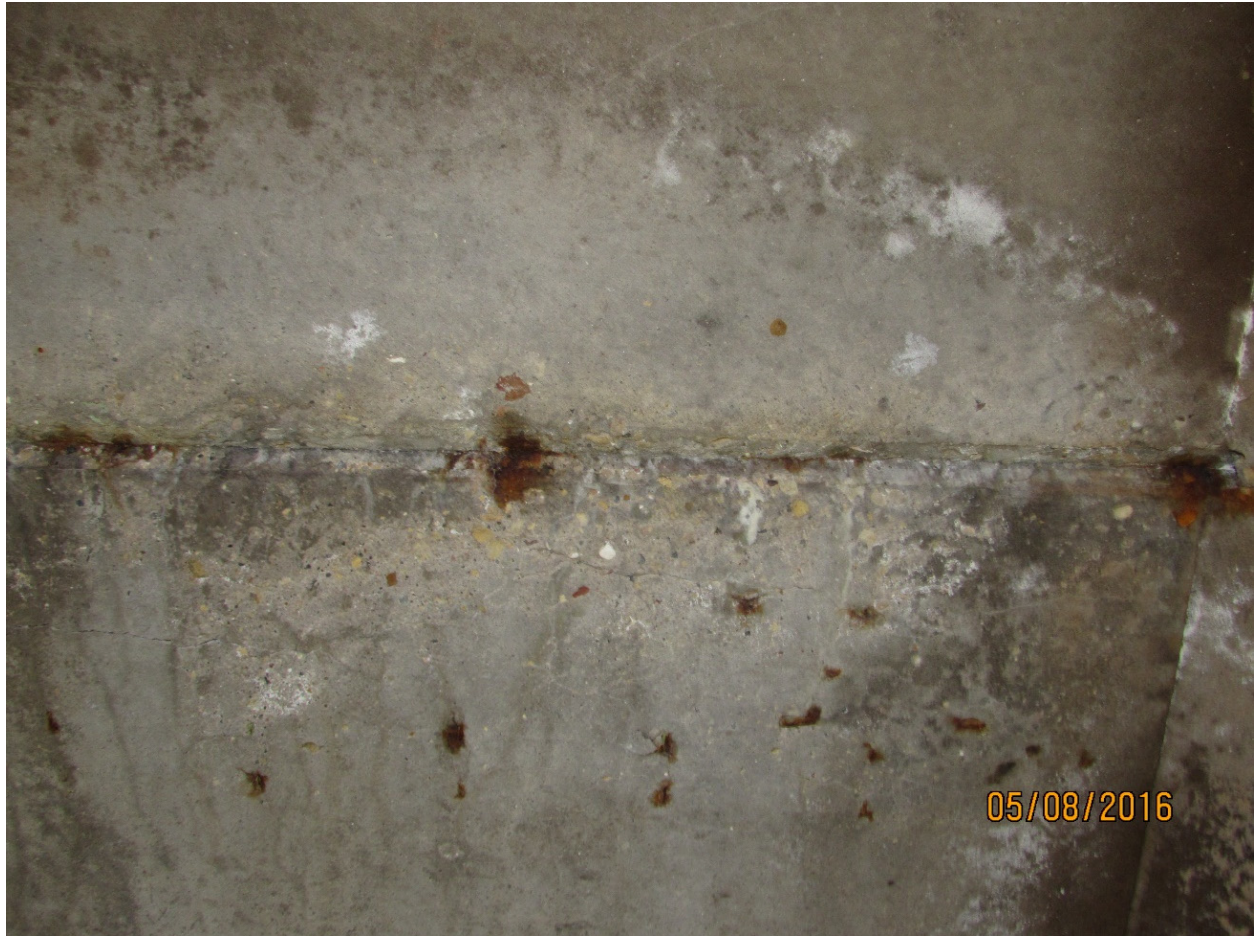
Figure 4.6 - Typical spots of corrosion on the underside of the longitudinal construction joint (B-56-022)

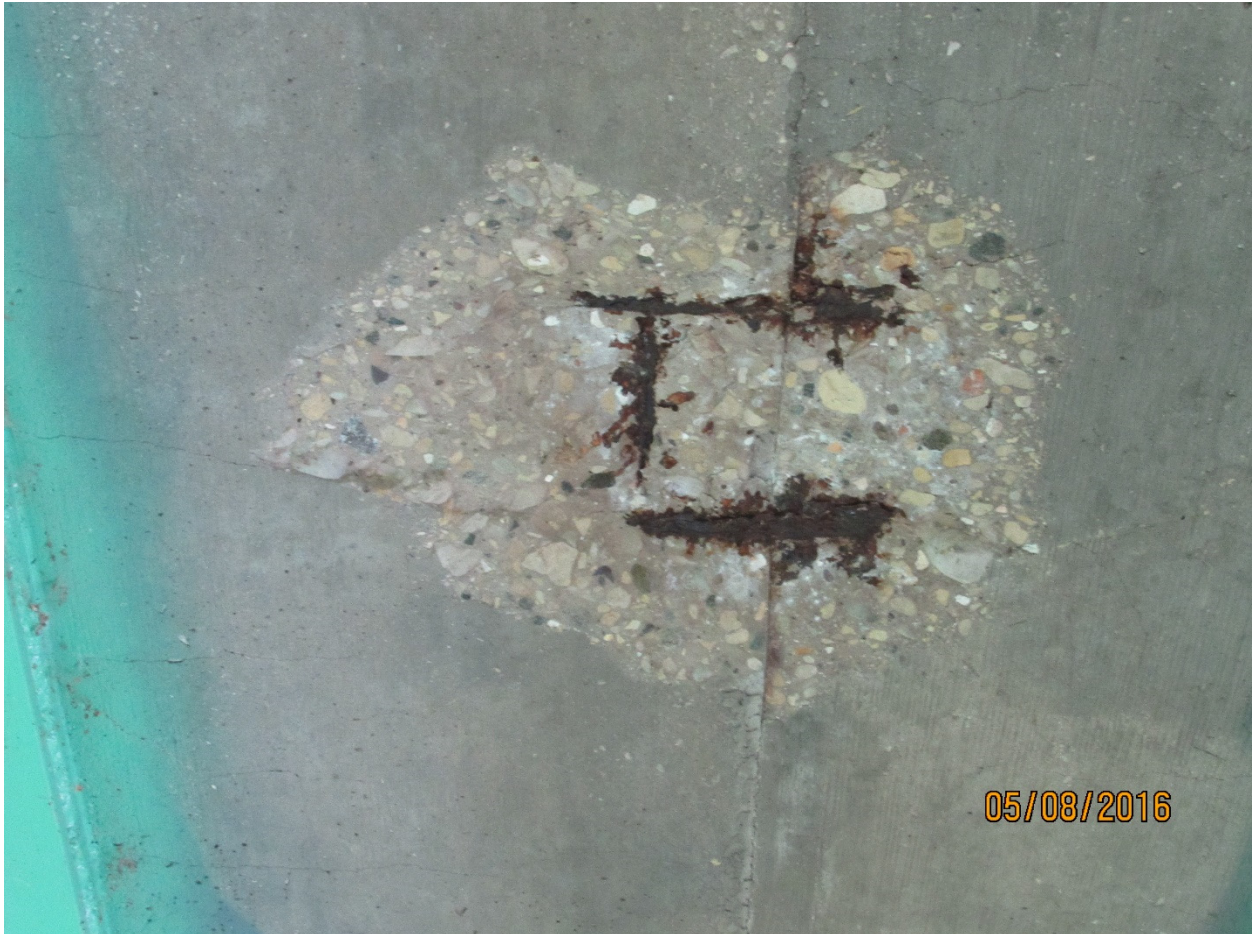
Figure 4.7- Spalled concrete and corroded reinforcement. Transverse cracking at approx. same spacing as transverse reinforcement (B-13-593)

One specific bridge deck constructed in stages that was determined to be in poor condition was on bridge B-13-593. This Dane County bridge was on State Highway 19 over Halfway Prairie Creek. This single-span, 58.9 ft simply-supported steel girder bridge was built in 1939, and then had a deck replacement in stages in 1989. Extensive transverse cracking at approximately the same spacing as the transverse reinforcement was seen in this bridge, extending from both sides of the construction joint. There were also delaminations in the longitudinal joint region, and two locations with spalled concrete exposing corroded reinforcing bars (Figure 4.7). The integrated wearing surface was in decent condition, with a few transverse cracks that had been recently sealed. The staged construction joint also appeared to have been sealed recently.

The only known design details for this bridge that may have contributed to this degradation were that the concrete deck was thin (only 7 in.), and the bottom layer of reinforcement in the slab was not epoxy coated. The plain steel bars are more susceptible to corrosion, which would then lead to the spalled patches of concrete seen in the underside of the deck. Although the deterioration in this bridge seems compelling, it is difficult to definitively attribute it to staged construction practices. At the time of the inspection, this bridge deck was 27 years old and approaching the end of its service life. It is therefore difficult to classify this damage as premature, which is the main concern of this research.

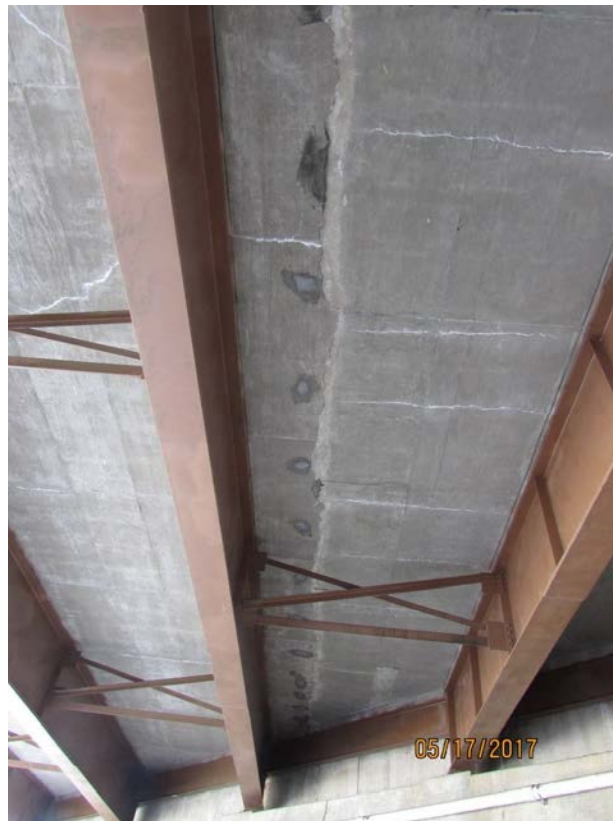
Figure 4.8- Transverse cracks extending to abutment in Stage 2 deck (right side). Transverse cracks in Stage 1 deck (left side) only near midspan region. (B-70-176)

widened deck portion. However, the widened portion of the deck had regularly spaced transverse cracks with light efflorescence throughout the length of the bridge, where the existing deck only had similar cracks in the midspan regions (see Figure 4.8). The transverse cracks in the widened portion of the bridge deck are likely shrinkage cracks. The two deck portions were constructed 16 years apart, so they were likely subjected to different environmental conditions during curing and would therefore have varying distributions of shrinkage cracks. Additionally, these transverse cracks were mainly observed in the widened portion of the deck directly adjacent to the longitudinal construction joint. Shrinkage cracks would be more prevalent in this area because the hardened deck adjacent to the curing concrete provided some restraint against shrinkage. The adjacent bridge (B-70-177), which was identical, was chosen to be a subject for the analytical modeling portion of this research as discussed in Section 6.4.

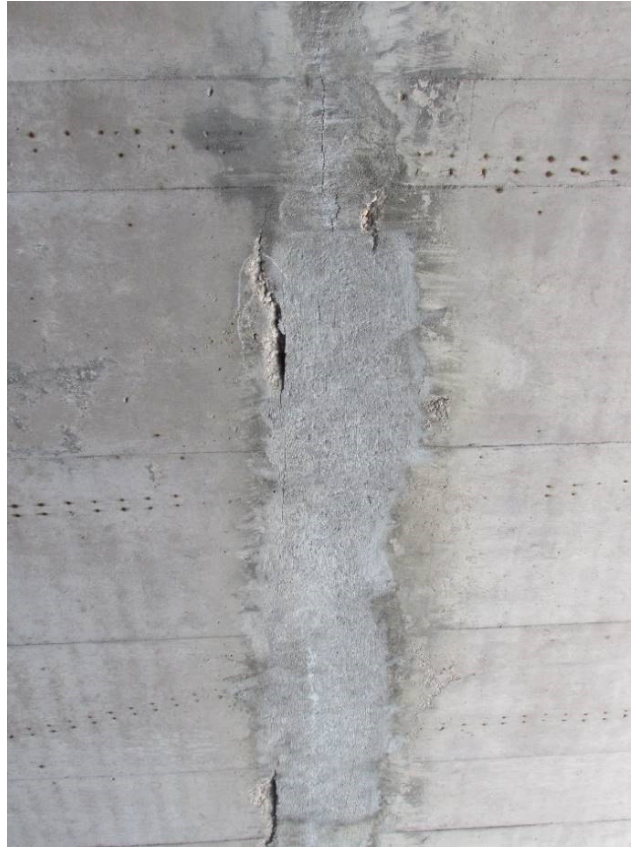
Figure 4.9- Patching of previously spalled concrete at longitudinal construction joint in haunched slab bridge. (B-30-026)

In 1970, when these bridges were widened, epoxy coated steel reinforcement was not being used in Wisconsin, which explains why such severe corrosion of the reinforcement was seen. Due to the overlays in place, the original wearing surface could not be inspected, but based on the condition of the underside of the slab, it may be inferred that cracks and other defects in the longitudinal construction joint region allowed for the corrosion of the underlying steel reinforcement, resulting in the eventual defects seen in this region.

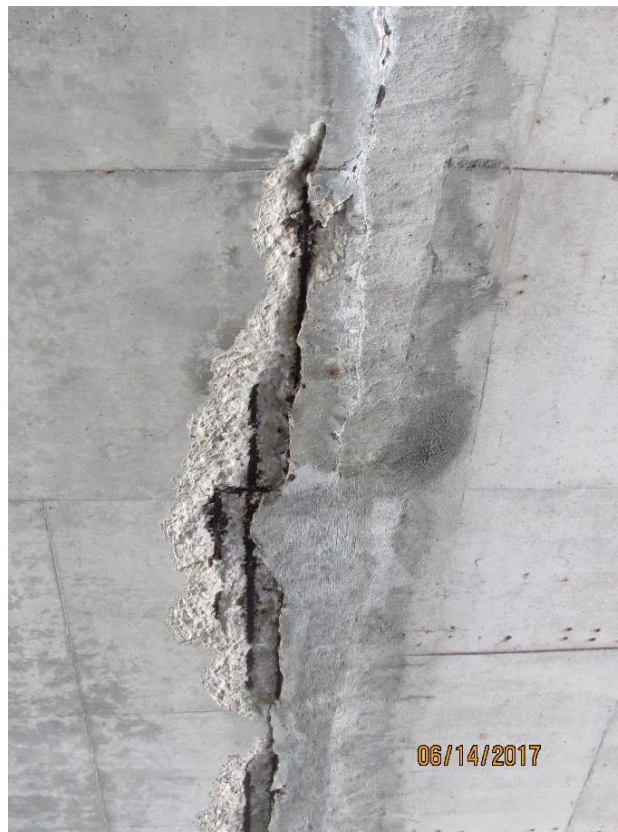
Figure 4.10- Spalled concrete at longitudinal construction joint exposing corroded reinforcement. (B-30-014)

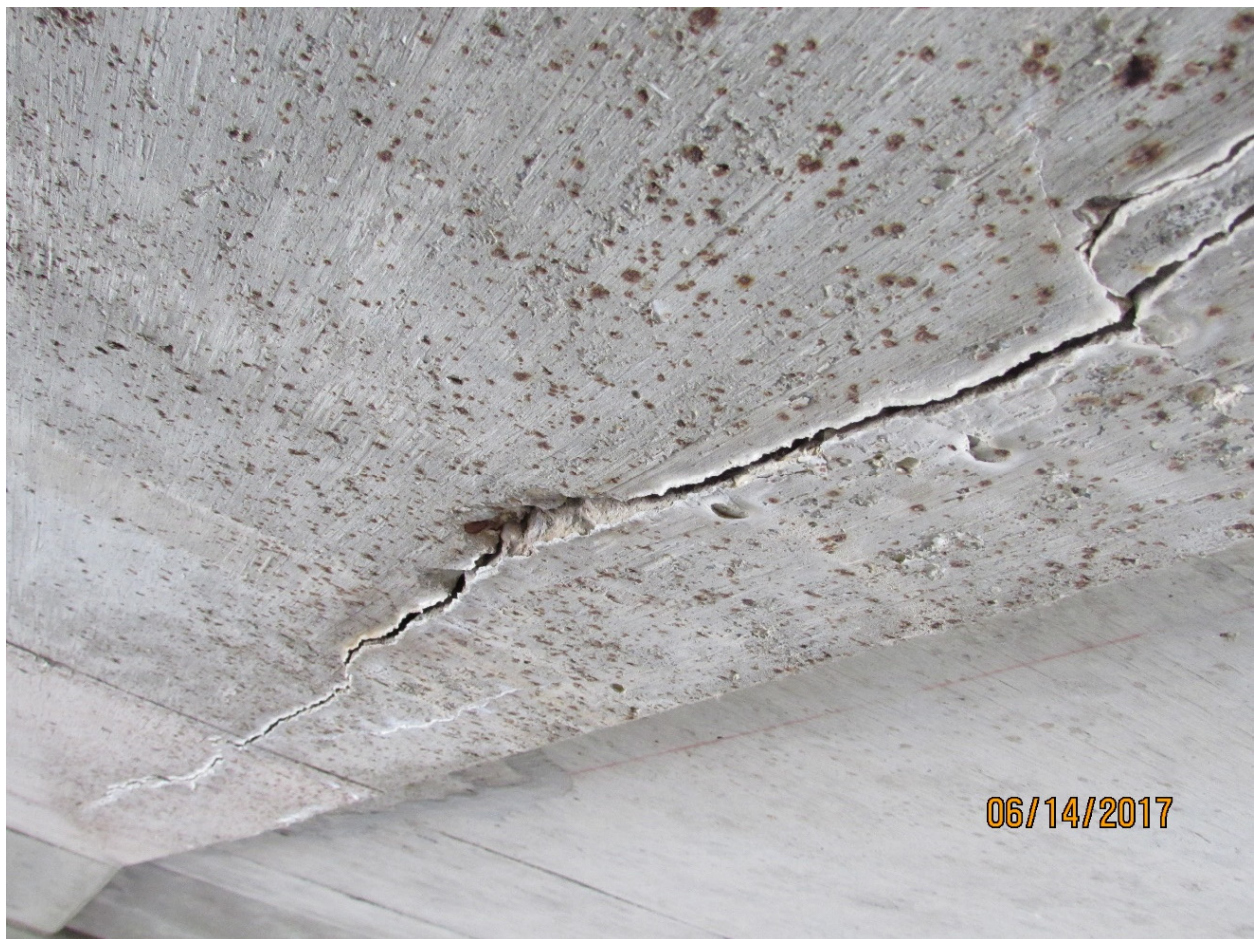
Figure 4.11- Large longitudinal crack adjacent to construction joint. (B-51-017)

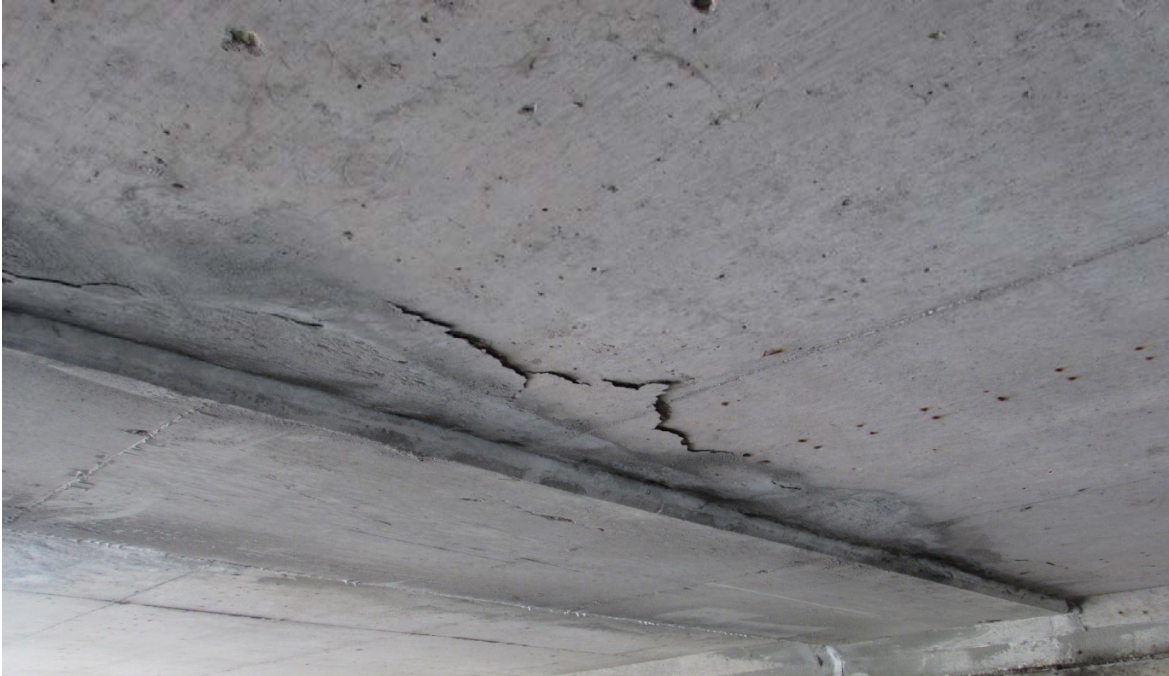
Figure 4.12 - Delaminated area adjacent to longitudinal construction joint in widened portion of deck. (B-30-014)

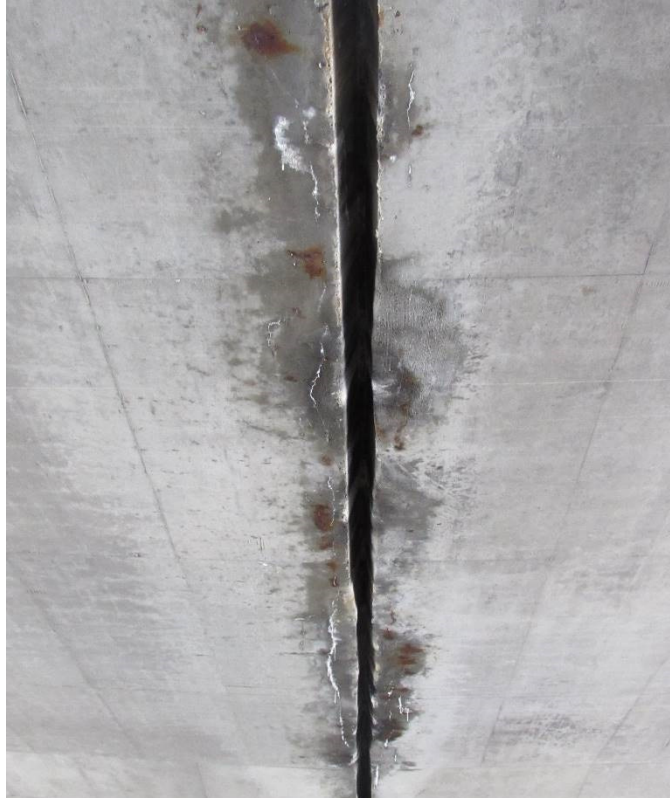
Figure 4.13 - Efflorescence and corrosion due to retained moisture at waterstop joint between adjacent bridges. (B-30-025/026)

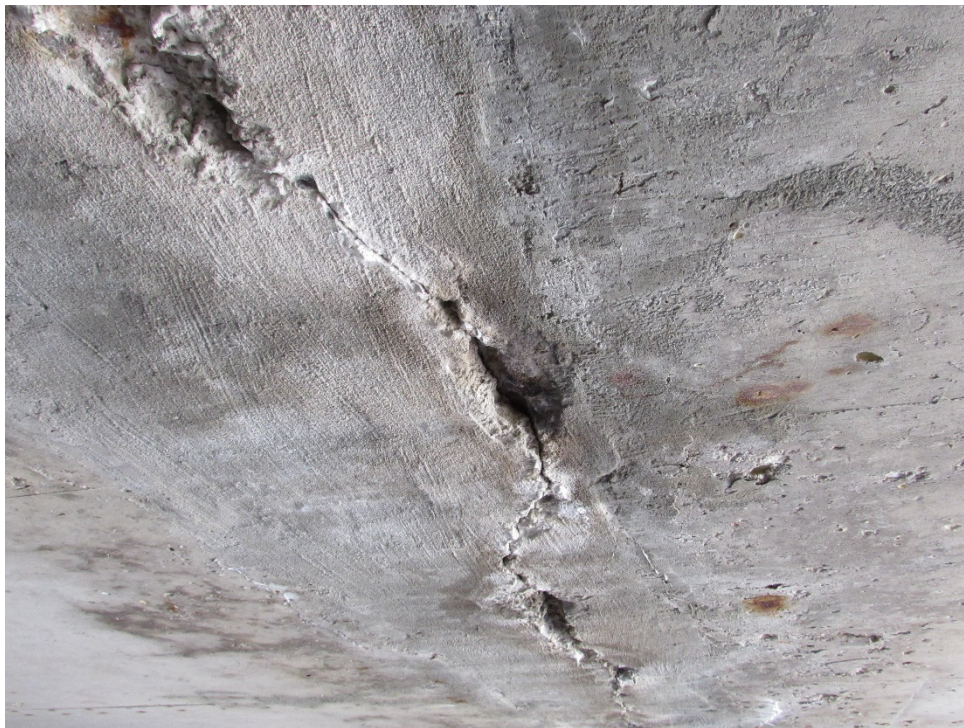
Figure 4.14 - Large longitudinal crack opening approximately 1/4" during the passage of large trucks. (B-30-015)

opened under traffic loading. This differential movement at the construction joint was measured to be approximately $\frac{1}{4}$ in., and occurred in the construction joint from the original 1959 construction (Figure 4.14). This repeated opening and closing of large cracks was slowly wearing away the concrete, which was piling up on the embankment underneath. Visible differential movement at the longitudinal construction joint verified that the continuity across the joint had been severely degraded. This likely meant the concrete-rebar bond across the joint had been compromised, possibly due to corrosion of the steel, damage to the surrounding concrete, or other factors.

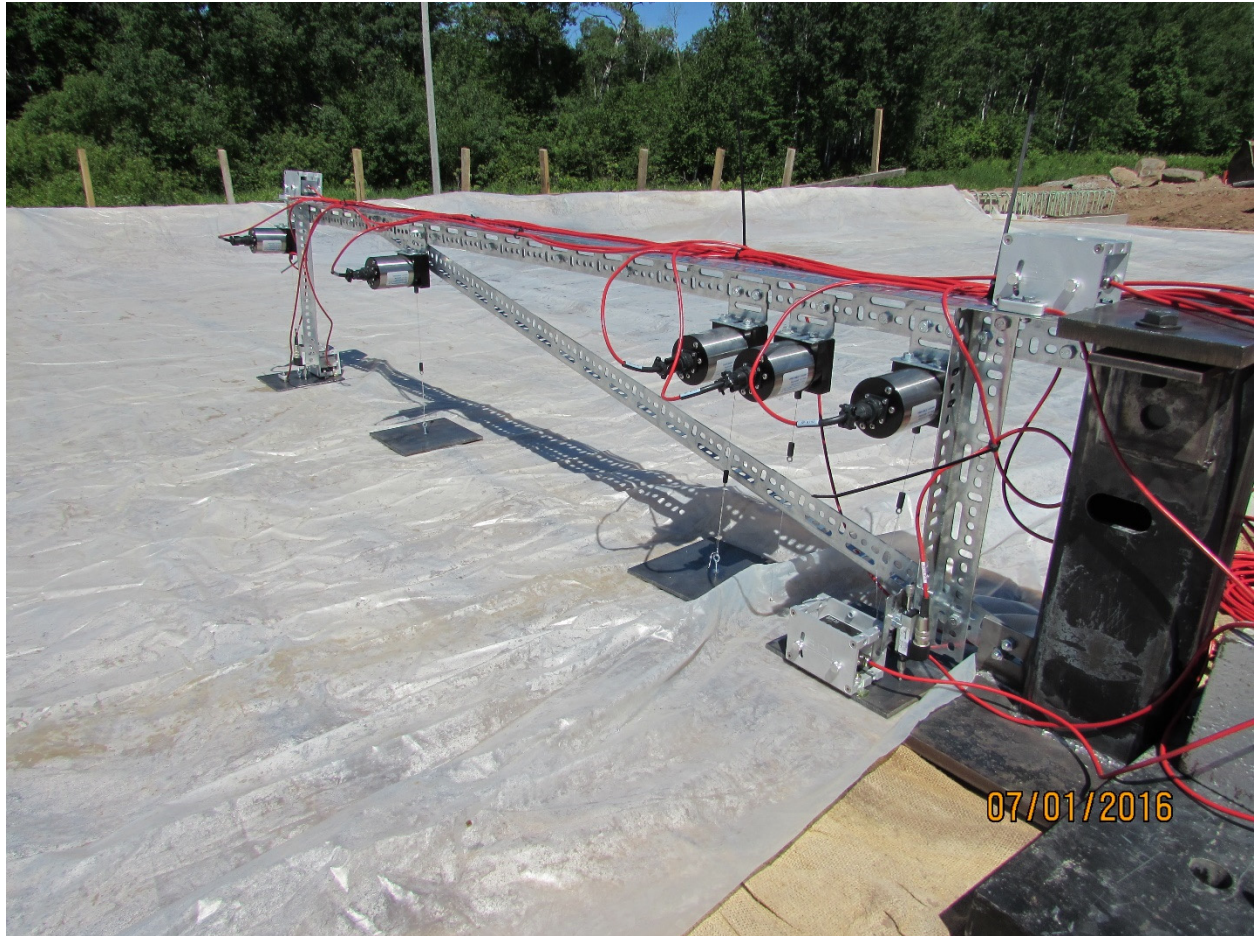
Figure 5.2- Field monitoring instrumentation setup after casting of Stage 2 deck (B-16-136)

These sensors measured displacements at points on the fresh concrete surface as well as on the instrumentation arm itself, which then allowed for the calculation of differential deflections between the two adjacent girders. Two different methods were used to compute differential deflections. They are discussed further in Sections 5.1.3 and 5.1.4. A collection frequency of 100 Hz was used for all field monitoring.

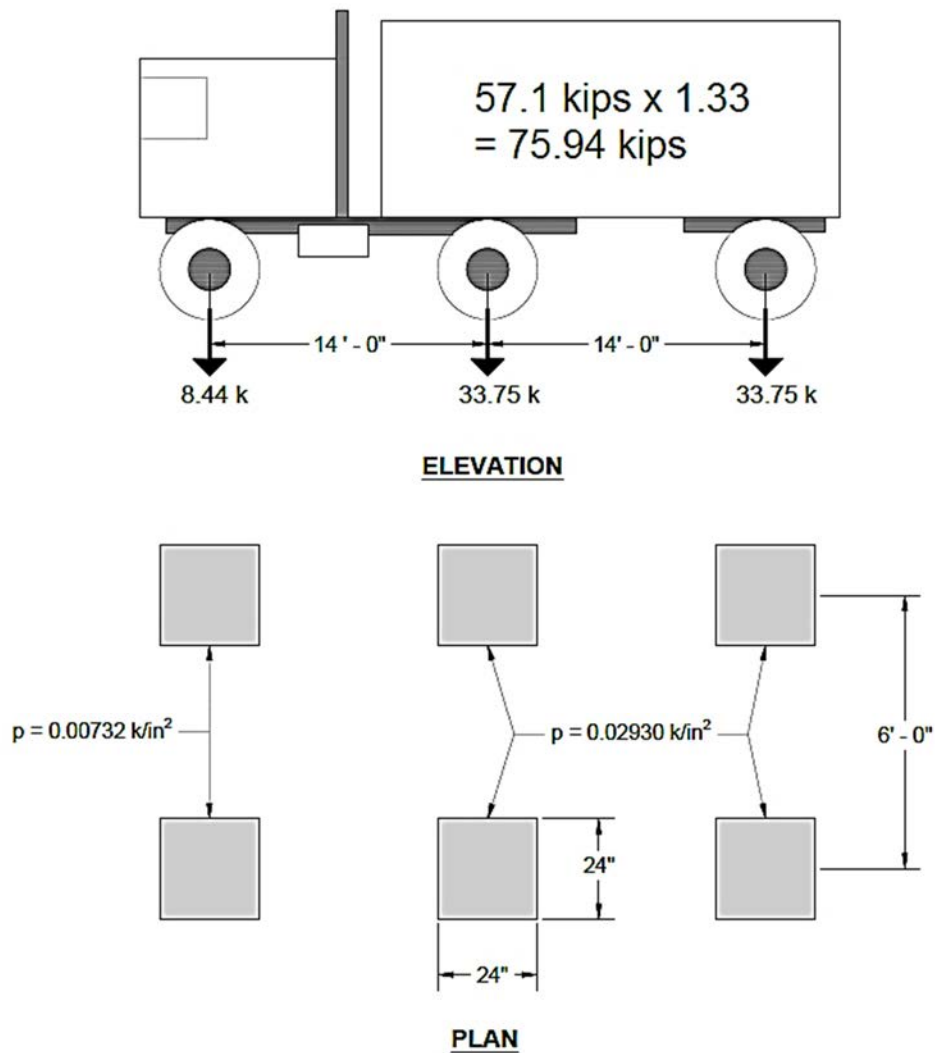
Figure 6.1 - Details of truck loading used in all finite element models

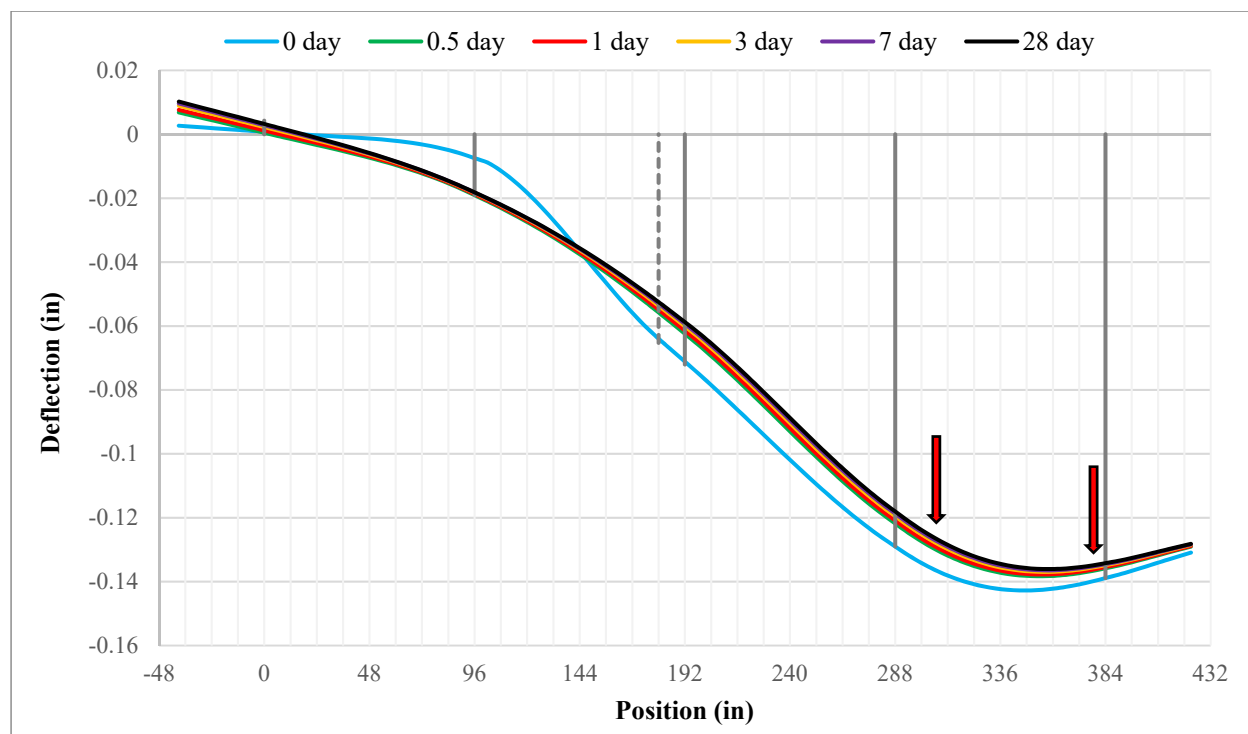
Figure 6.4 - B-16-136 deflected cross section at different ages of Stage 2 deck

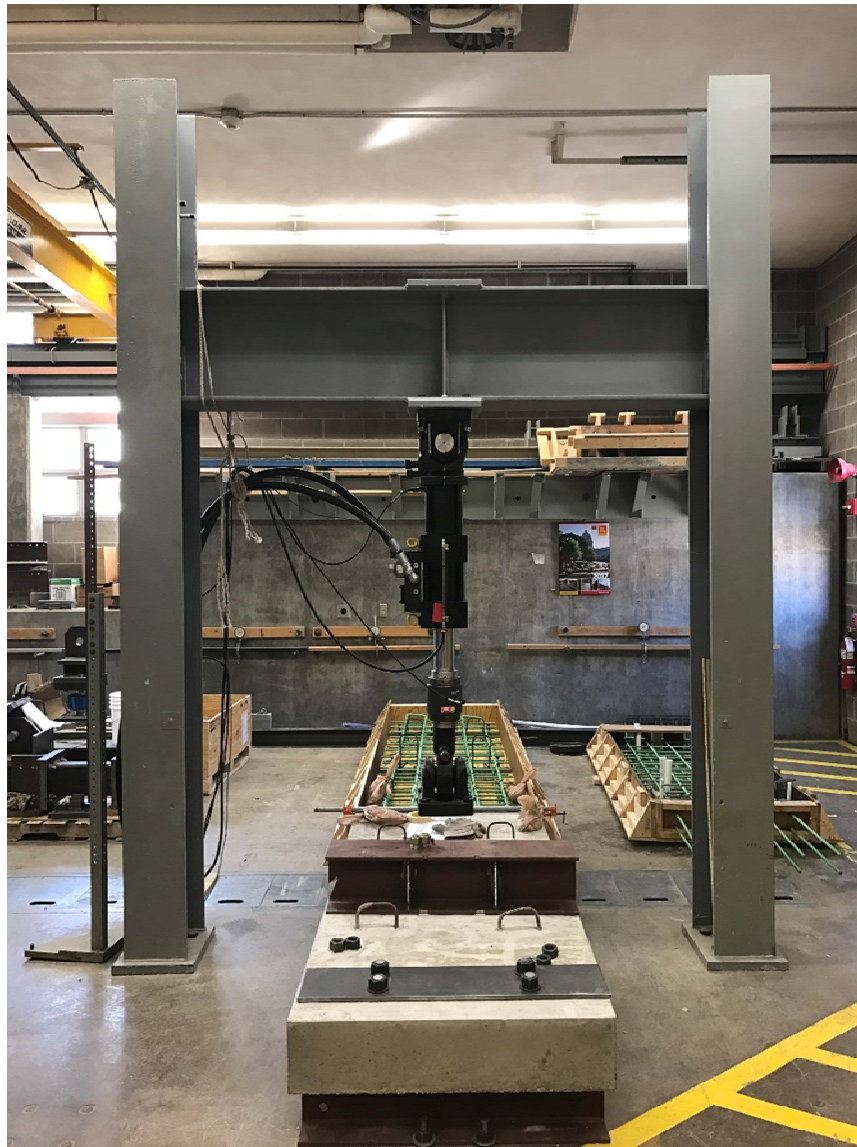
Figure 7.2 - Specimen in place underneath loading frame prior to casting of Stage 2 portion.

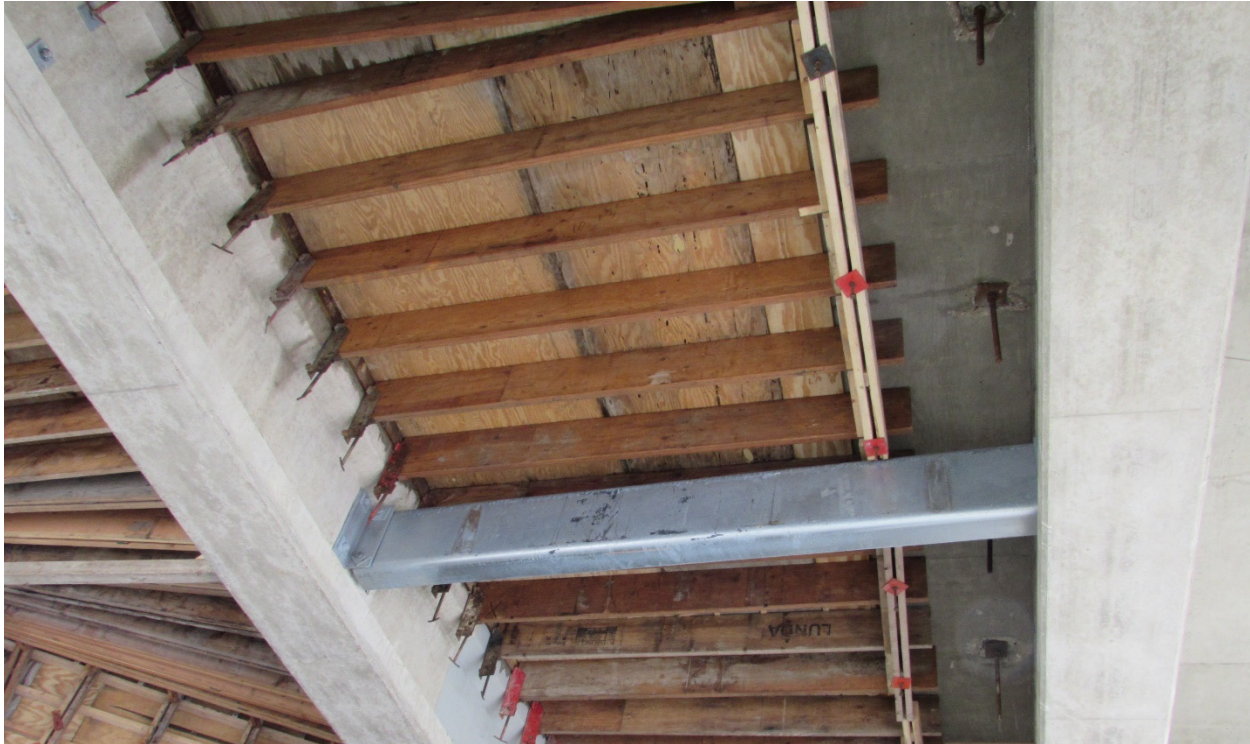
Figure 7.9 - Formwork system as seen in staged construction of bridge B-64-123. Wood beams are supported by top flange of left girder and rods are drilled through Stage 1 hardened deck on right side.

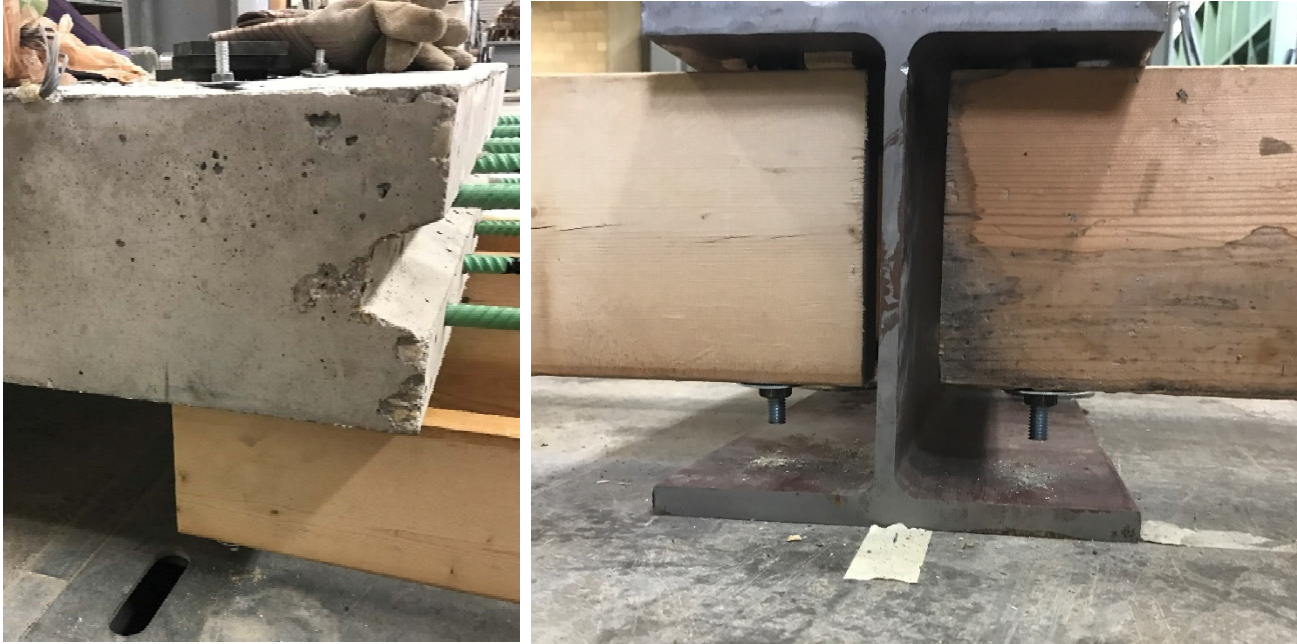
Figure 7.12 - Formwork supporting system connections. Left: steel rod passing through hardened slab. Right: steel rod threaded into nut welded to steel supporting beam.

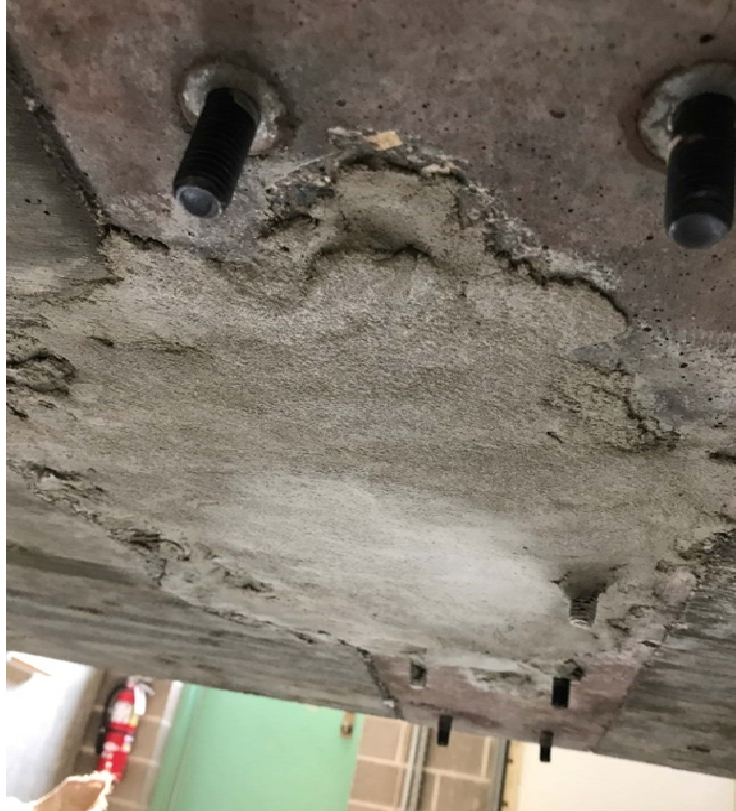
Figure 7.28 - High strength grout repair patch where a shear connector had accidentally been pulled from the underside of the specimen.

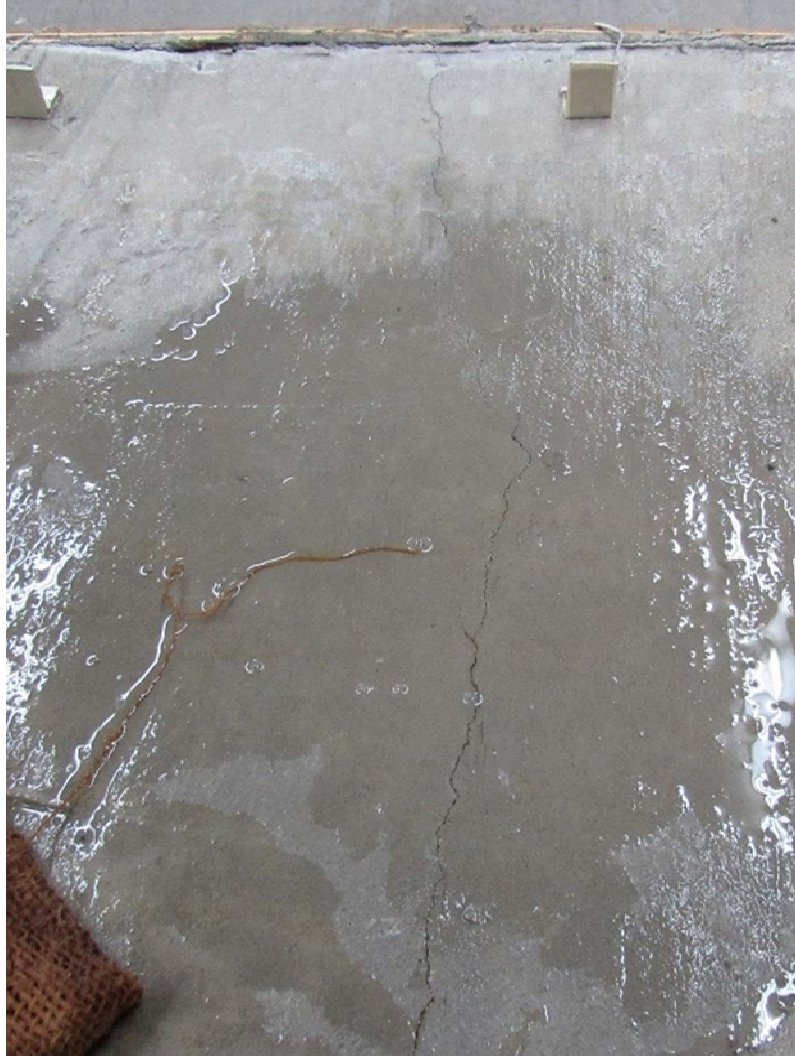
Figure 7.29 - Flexural crack resulting from deflections applied during curing of Stage 2 segment.

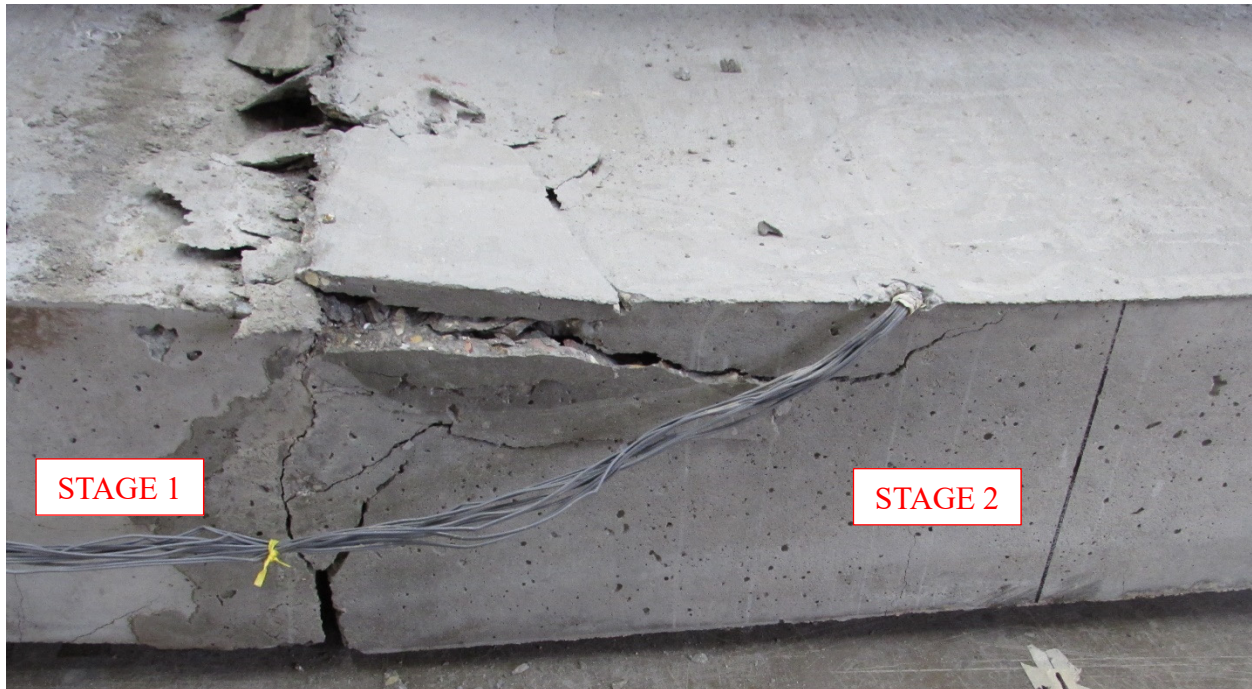
Figure 7.31 - Specimen 2 compression block failure at construction joint.

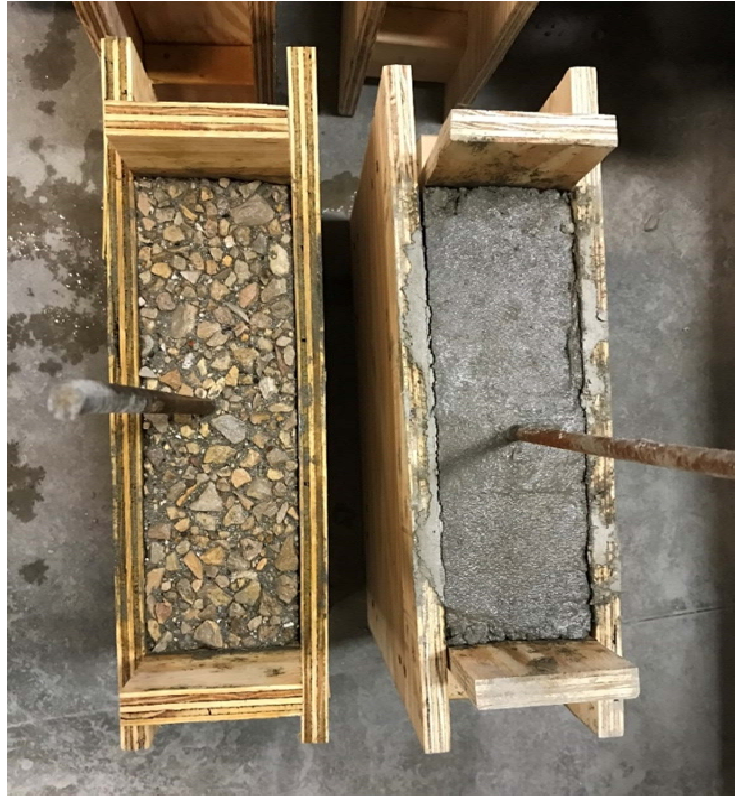
Figure 7.42 – Treated (left) versus untreated (right) joint surface

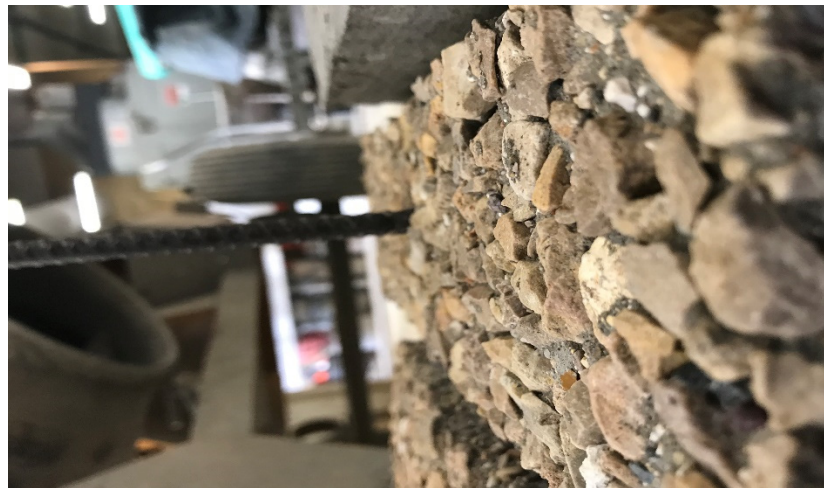
Figure 7.43 – Condition of treated joint surface

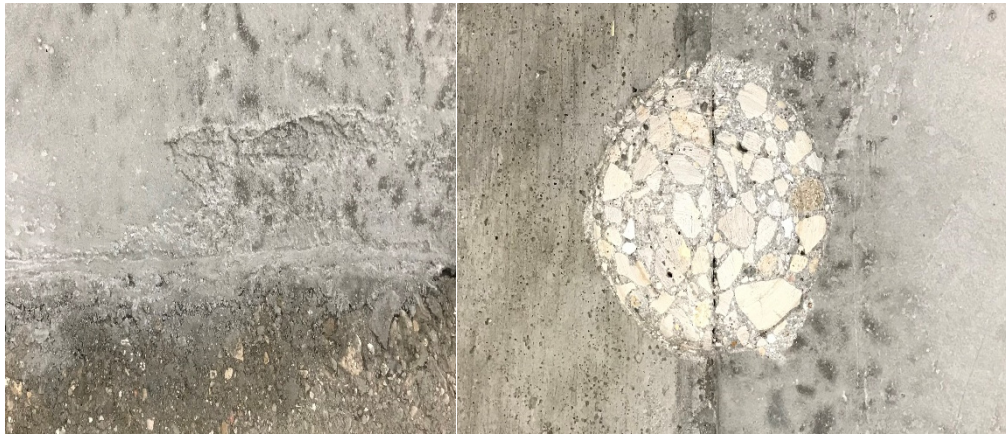
Figure 7.44 – Joint surface prior to (left) and after (right) grinding

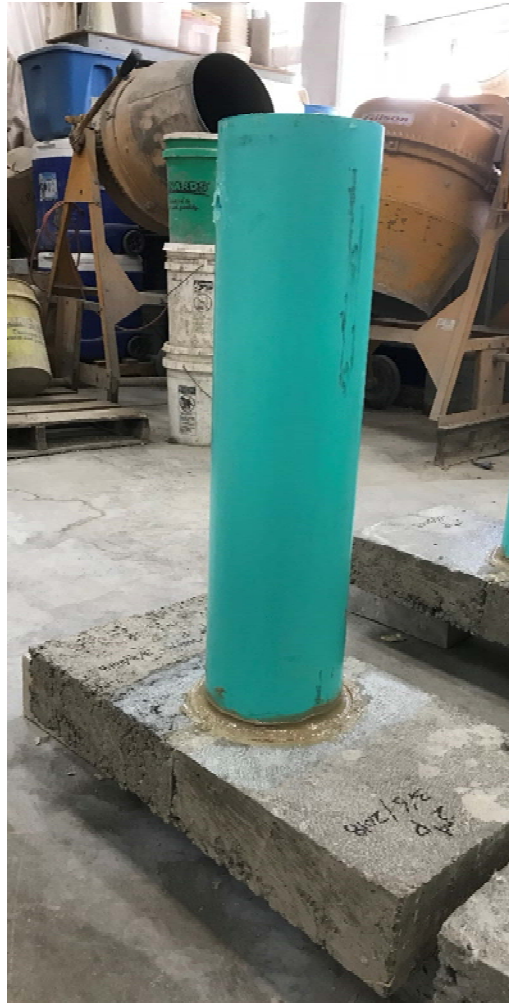
Figure 7.45 – Joint leakage specimen prior to being subjected to a water head
