## Concrete Pavement Buckling in Wisconsin

.....  
This brief summarizes Project 0092-20-02,  
“Evaluation of Concrete Pavement Buckling in Wisconsin”  
Wisconsin Highway Research Program

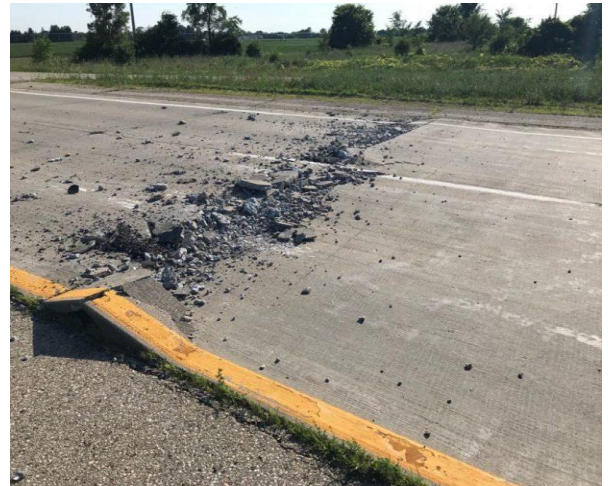
*Blowup on Hwy 14 in Rock County*
