## Improving Bridge Concrete Overlay Performance

### Research Objectives

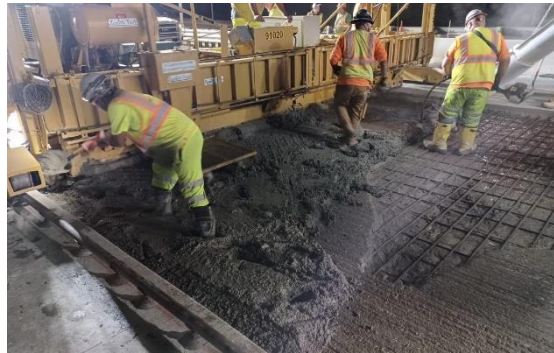
Placement of overlay using double vibrating screed.
