Wisconsin Highway Research Program

# Evaluation of Bridge Approach Settlement Mitigation Methods

Final Report

October, 2007

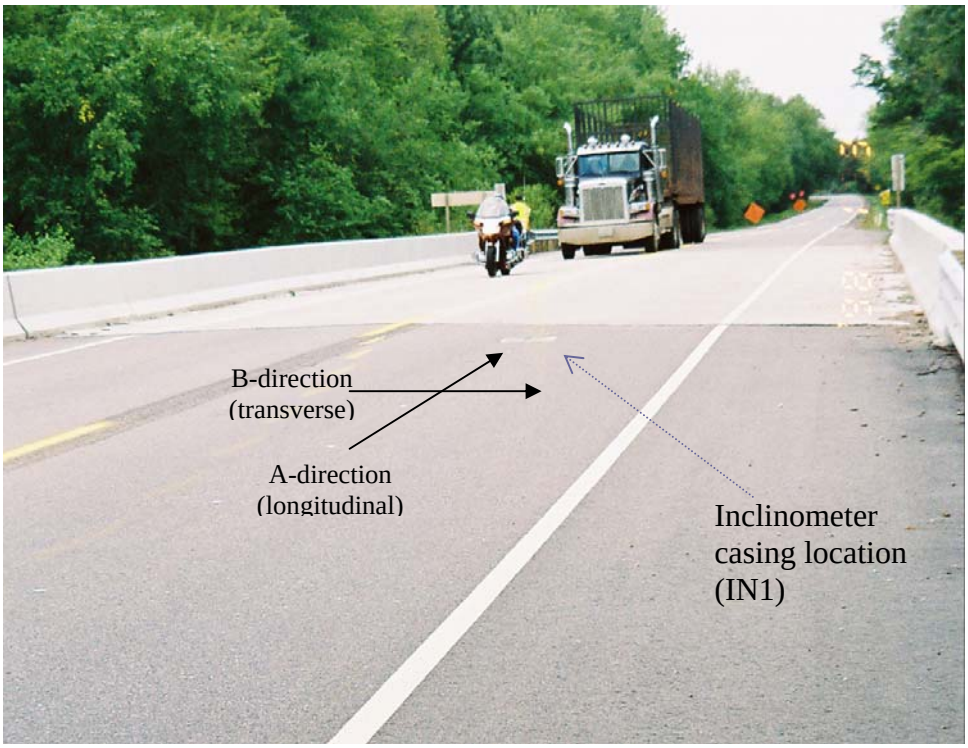
Figure 61: Looking East at Hemlock Bridge

Numerous site visits have been carried out to all four bridges since they were constructed. Up to the date of this report preparation (June 2007), the Hemlock Creek bridge and its approaches appear to be in very good condition. On August 31, 2004, a site visit was conducted at the same time of the 3rd inclinometer readings. The bridge appeared to be in good condition with no observable cracking or movement. Photos of the bridge taken at the site visit are presented in Figures 61 and 62.

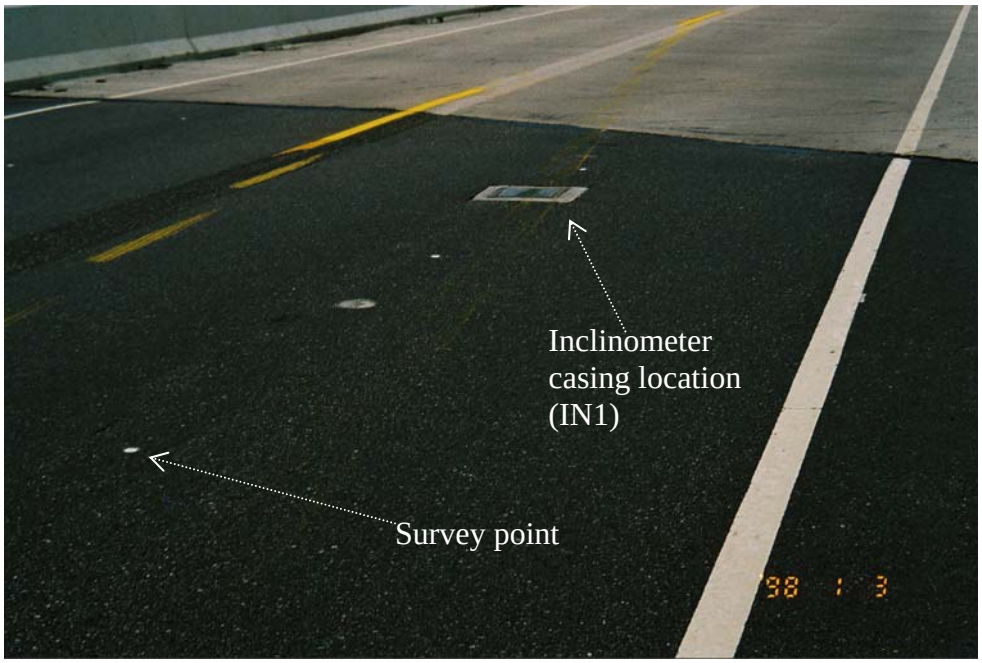
Figure 62: Approach at East Abutment of Hemlock Bridge

Visual inspection carried out in October 2006 indicated very small differential settlements (less than 0.1 inches) at the interface between the approach fills and bridge. Survey elevations were taken over a 4-year period from the end of bridge construction on both the eastbound and westbound approaches. Survey elevations of the eastbound lanes approaching the west abutment and the westbound lanes approaching the east abutment are presented in Figures 63 and 64, respectively. The survey indicated differential settlement (see Appendix G) of about 0.3 to 0.5 inches near both abutments (within 7 feet). The differential settlement decreased further away from the abutment until the differential movement was positive. The point where the differential movement changed from negative to positive was about 27 feet from the east abutment (Structure Fill) and 47 feet from the west abutment (Flowable Fill). The transition slope (differential settlement divided by approach length) was calculated to be about 0.015 inches per foot for the westbound lanes and about 0.015 inches per foot for the eastbound lanes.
