**Wisconsin Highway Research Program**

Project No. 0092-04-15

**Bridge Integrated Analysis and Decision Support:  
Case Histories**

**Final Report**

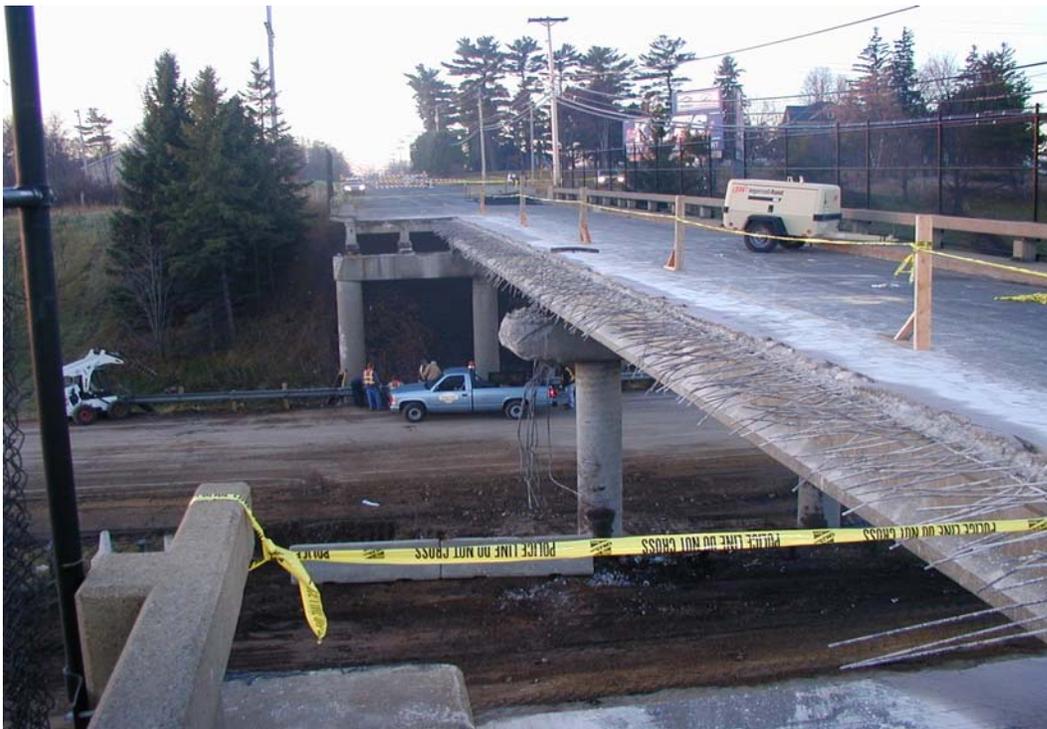
**Figure 2: Wilson Street Bridge after Completion of Sawing and Pulverizing.**

The severe damage to the bridge and closure of all lanes on I-94 prompted the use of an outside contractor (Lunda Construction Company) to begin immediate site cleanup and repairs. A contractor's representative arrived at the site at 3:45 p.m. and equipment began arriving at 5:00 p.m. Sawing operations on the bridge began at 6:00 p.m. The damaged portion of span #2 was dropped at 10:00 p.m. and the damaged portion of span #3 at 10:45 p.m. Pulverizing of damaged concrete started at 11:30 p.m. and continued through the night. On Friday, November 16, all debris was removed from I-94 by 7:00 a.m. The westbound lanes of I-94 were opened at 8:00 a.m. and the eastbound lanes were opened at 9:00 a.m. (See Figure 2.)

On Tuesday, November 20, substructure plans from the WisDOT Central Office were received at the Eau Claire district office and alternative repair options were discussed on Wednesday, November 21. Traffic control was initiated by the contractor and a barrier wall was placed so as to protect the contractor's employees. The footing for the replacement column was poured on Thursday, November 29, and the column was poured on Friday, November 30. Starting on December 4 the pier cap was formed and poured and the bearing pads were installed.

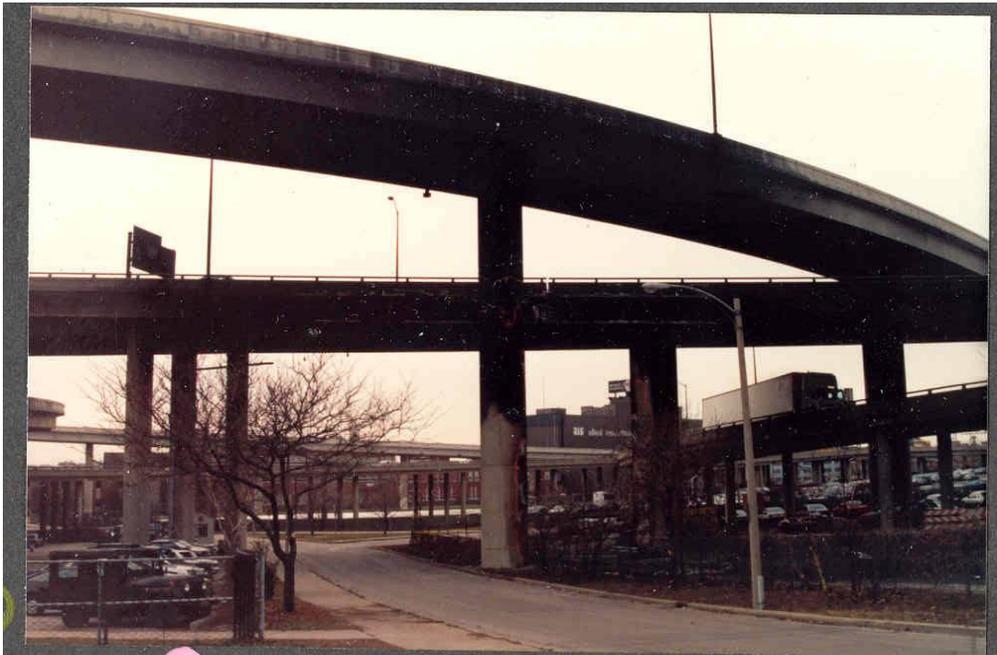
**Figure 1: General View of a Portion of the Marquette Interchange Ramps.**

On Friday, November 27, 1992 a gasoline truck went out of control shortly before 10:00 am while in the Marquette Interchange after exiting eastbound I94 and entering northbound I43. The truck plunged through a concrete guard wall and fell 33 ft. to a parking lot, where it burst into flames and damaged several nearby vehicles. The driver was thrown from the cab, later located, and pronounced dead at the scene. Prior to this incident several cases of minor damage had occurred because of vehicles entering the interchange at too high a speed but no major repair actions were required. In the present incident the fire resulting from the gasoline explosion resulted in heavy scaling and delamination of concrete on unit 4C and other portions of the interchange.
