CONDITION ASSESSMENT OF TREATED-TIMBER GUARDRAIL POSTS

Final Report
October 2010

Sponsored by:
Wisconsin Department of Transportation

Sponsored by
Wisconsin Department of Transportation
(Project No. 0092-43-03)

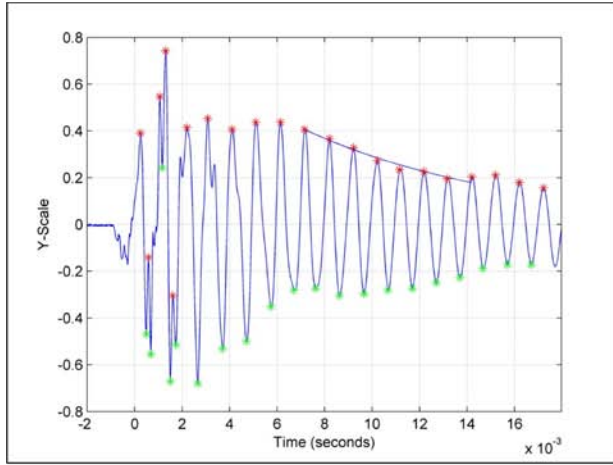
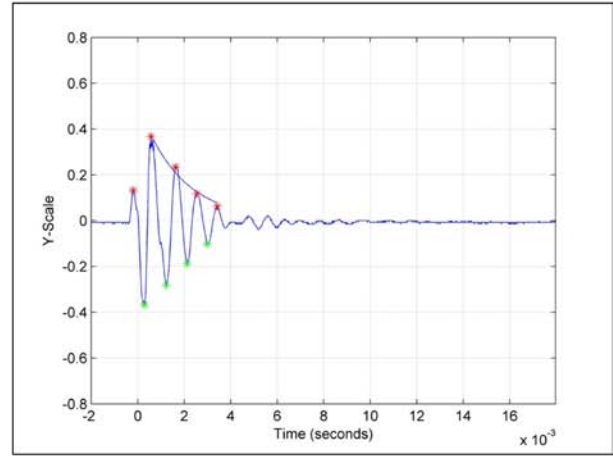
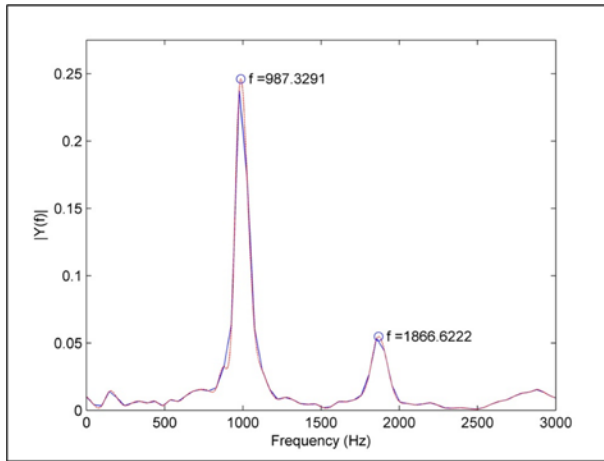
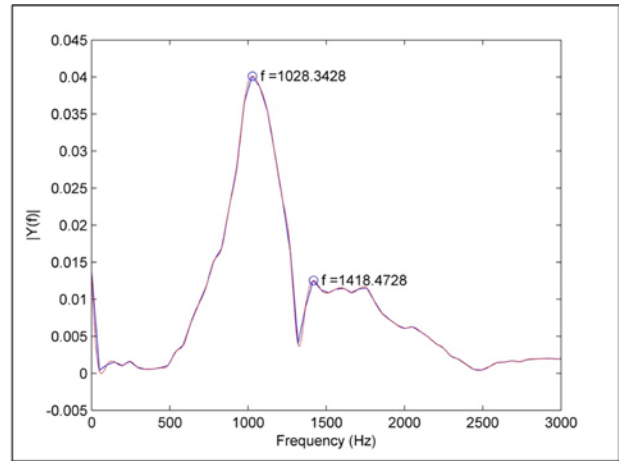
Figure 10 – Summary of impact-echo acoustic response signal (time domain) and their associated Fast Fourier Transformation (FFT) signals (frequency domain) for Merrimac post M10.

To aid interpretation, the response waveforms from the in-ground posts were comparatively analyzed to the out-of-ground test results performed in the laboratory. Figure 10 shows impact-echo acoustic response signals (time domain) and their associated Fast Fourier Transformation (FFT) signals (frequency domain) for Merrimac post M10. As can be observed, the in-ground response wave (between 6 and 14 milliseconds) and out-of-ground response wave (between 0 and 4 milliseconds) contains a portion of uniformly spaced peaks and valleys that gradually dissipate in towards zero energy. The in-ground response wave shows higher signal attenuation, possibly due to the soil contact boundary conditions. In addition, the dominant frequencies are easily interpreted from the frequency spectrum as

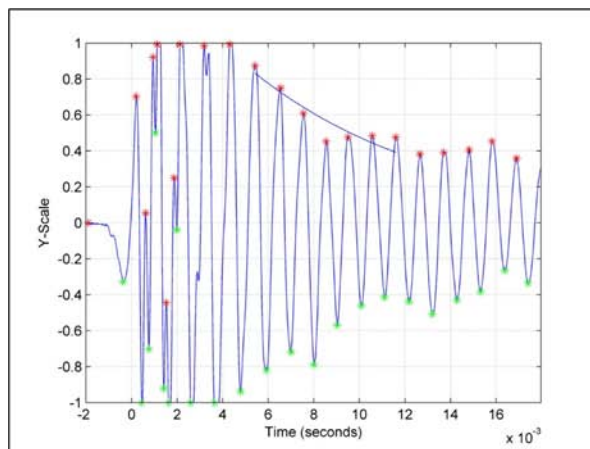
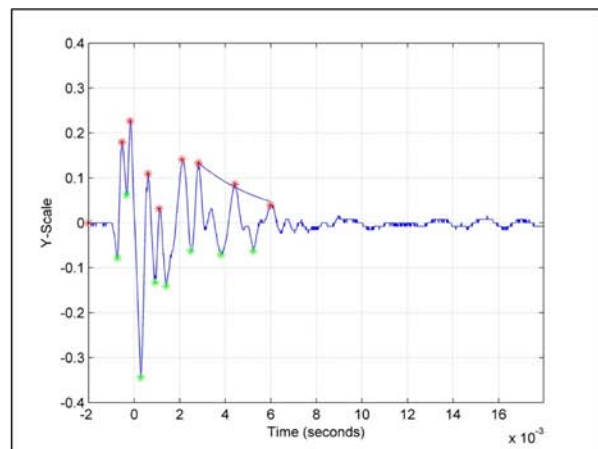
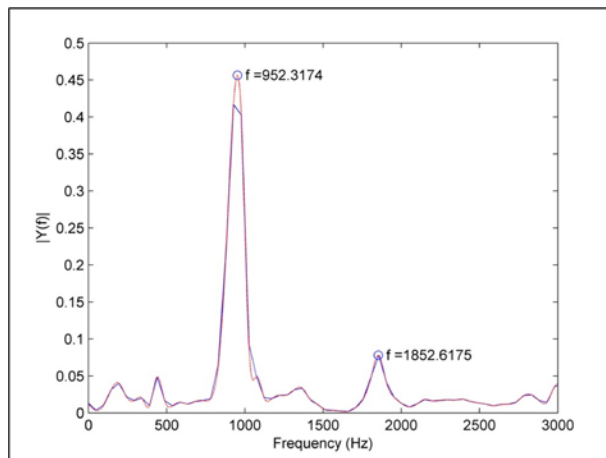
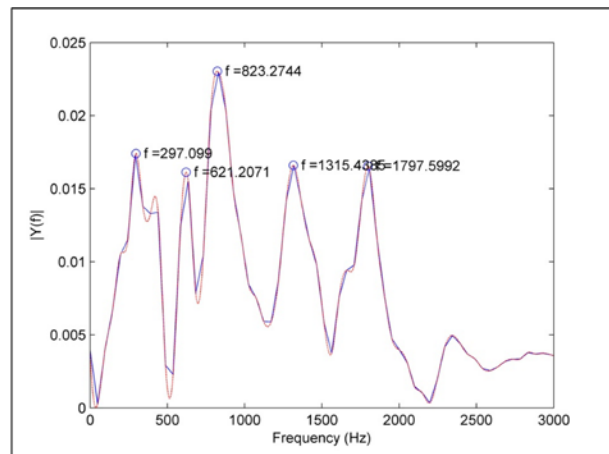
Figure 11 – Summary of impact-echo acoustic response signal (time domain) and the associated Fast Fourier Transformation (FFT) signals (frequency domain) for Merrimac post M13.

Figure 11 shows a challenging case of data interpretation of the wave response for Merrimac guardrail post M13. The out-of-ground wave response (between 7 and 15 milliseconds) contains a portion of uniformly spaced peaks and valleys that gradually dissipate in towards zero energy. When analyzing the out-of-ground wave signal in the frequency domain, the dominant frequency is again easily

interpreted as 952 Hz. The in-ground response (time domain) analysis was more challenging as there was not any consistency present in the wave response peaks or valleys. When analyzed in the frequency domain, there are several peak frequencies present in the wave spectrum and it is not readily clear which value is dominant. In these challenging cases, we relied on the out-of ground frequency and selected an in-ground peak frequency that was slightly higher.

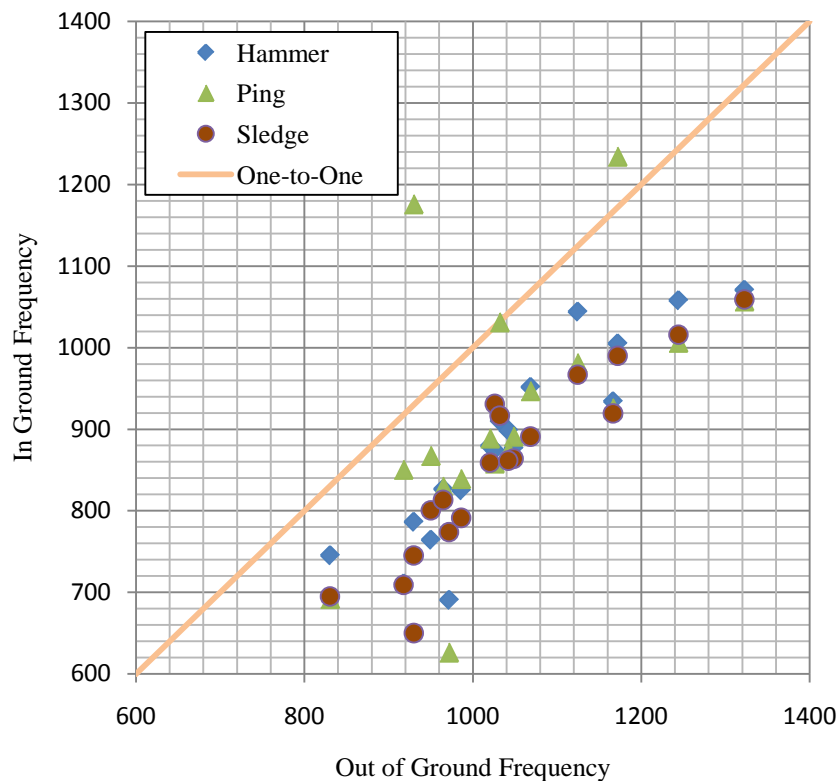
Figure 23 – Impact-echo acoustic NDE testing results using various impact devices at the Royalton site.

Comparisons were made between FFT frequencies identified from the impact-echo acoustic response waveforms. Figure 23 compares the (In-ground vs. Out of ground) FFT frequencies observed from several impact devices utilized in field testing. The data tracks slightly below the “one-to-one” baseline of reference. The hammer and ping-device did not result in the most consistent results. The sledge hammer impact device resulted in the most consistent acoustic response waveforms for the older guardrail posts. The FPL testing on non-deteriorated new guardrail posts also identified the sledge hammer as the best impact device.

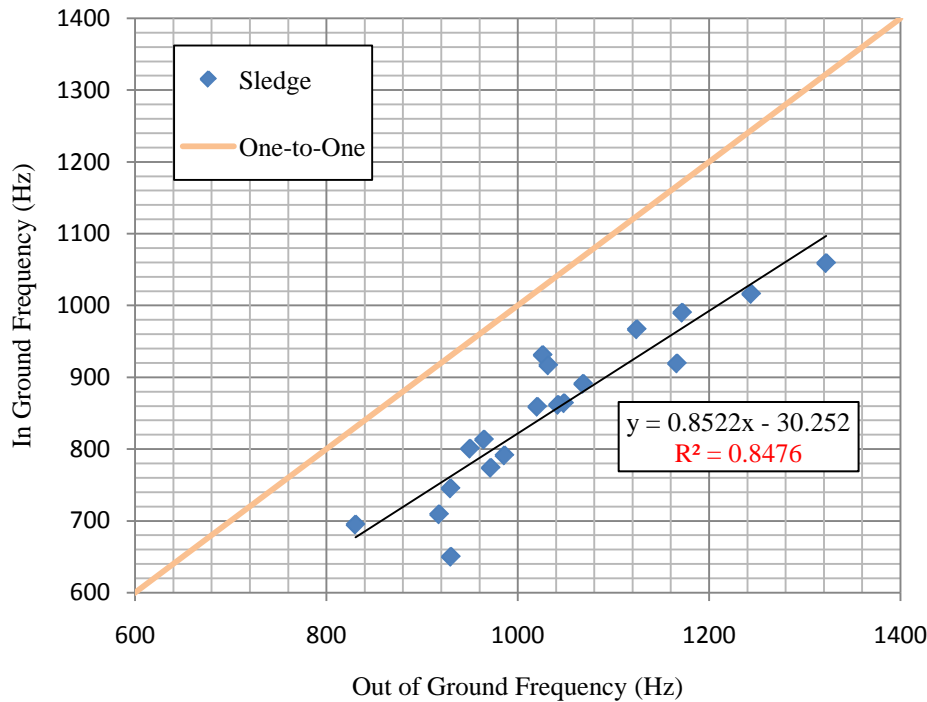
Figure 24 –Impact-echo results from the Royalton site with a sledge hammer impact device.

Figure 24 shows a strong correlation ($r^2 = 0.8476$) exists between in-ground and out-of-ground FFT frequencies for the Royalton guardrail posts. This strong relationship demonstrates that the impact-echo acoustic technique is a feasible inspection approach for timber guardrail posts. However, the correlation between in-ground and out-of-ground FFT frequencies for the Merrimac site was weaker with an $r^2 = 0.5861$ (Figure 25). The Merrimac posts were assumed to be older than the Royalton posts (13 years in-service) and had substantially higher moisture contents levels. The Merrimac posts have an average moisture content of 88 percent with a standard deviation of 38.4 ranging from 28 through 177 percent. While the Royalton posts had an average moisture content of 27.7 percent with a standard deviation of 7.0 ranging from 14.5 through 37.9 percent. It was not clear what caused this dramatic moisture content contrast between the guardrail post test sites, but the super-saturated Merrimac posts

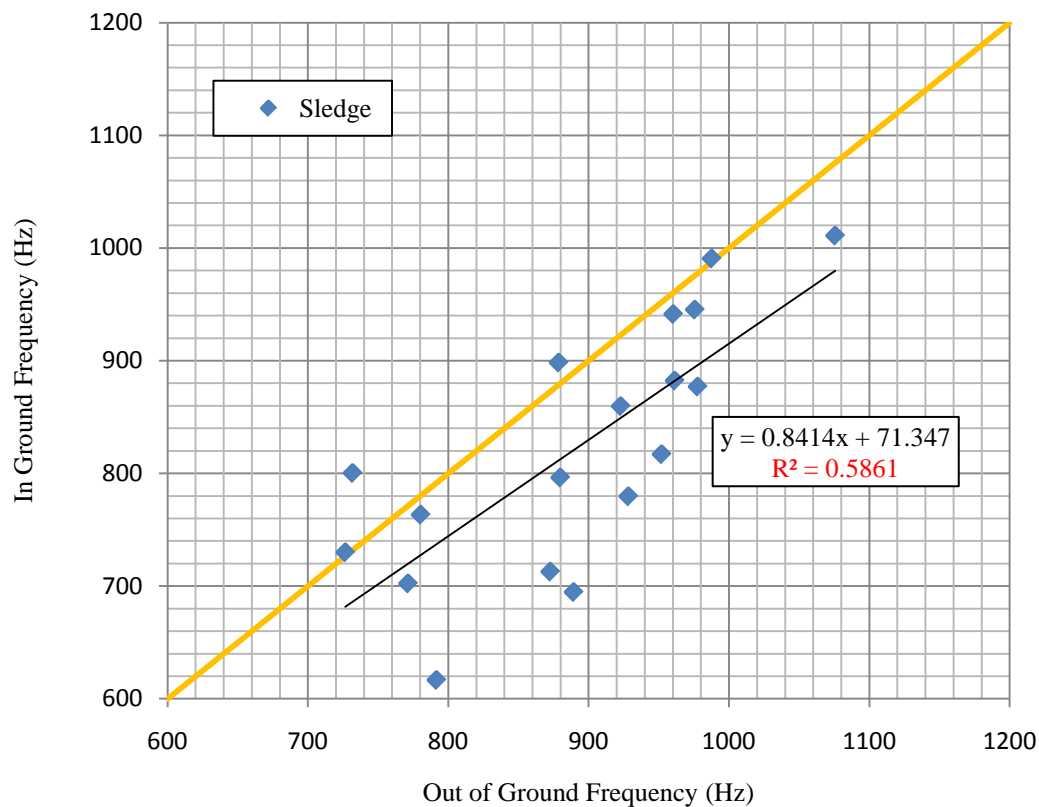
Figure 25 – Merrimac field testing results using sledge hammer impact device.

definitely affected the impact-echo acoustic testing results. A moisture content data summary is provided in Table 2.

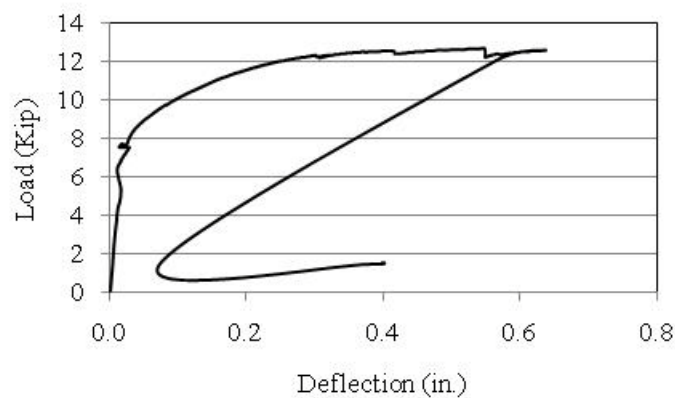
A cantilevered-bending failure for Royalton post specimen number 19 is shown in Figure 26. The failure zone typically occurred near the ground line of the post. In this case, however, the presence of a large edge-knot caused the post to fail prematurely. More stringent visual grading of the posts near the ground line zone could help to achieve more consistent residual post strengths. Figure 27 shows a typical load-displacement curve from Merrimac post specimen number 13. This post failed at a load higher than 12 Kips and with more 0.60 inches of deflection at the cantilevered end. The MOR values are summarized in the following figures: Merrimac posts (Figure 28) and Royalton posts (Figure 29). The

Figure 26 – Failed cantilever bending specimen R19 from the Royalton test site. Note the edge knots at the failure zone near the ground line.

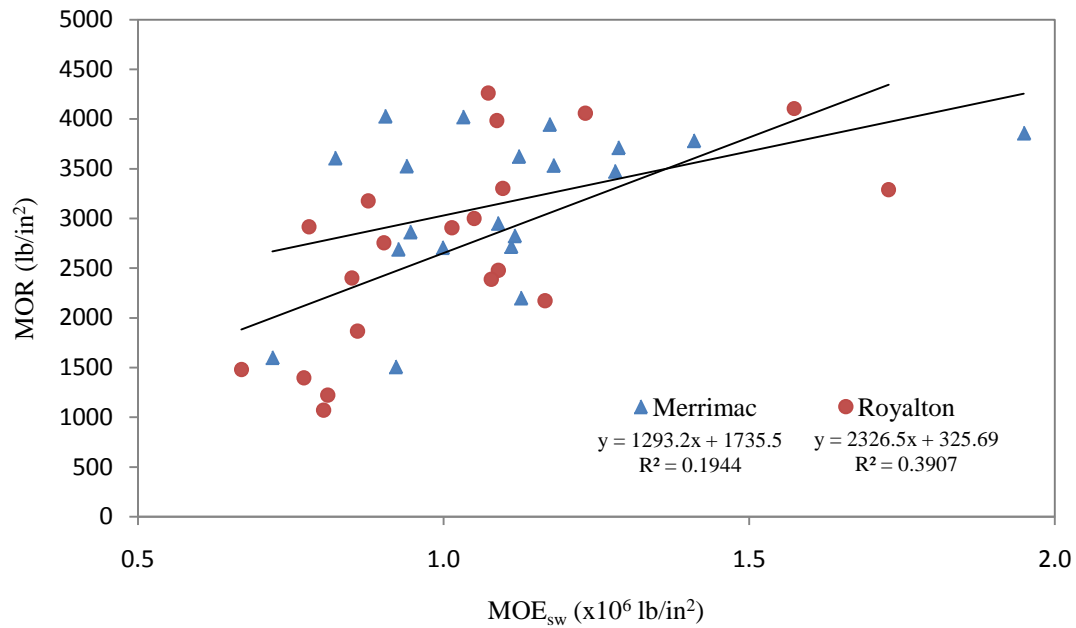
The relationship between MOE and MOR for both sets of guardrail posts is provided in Figure 30. In this case, the MOE was derived from the longitudinal stress-wave data which has been proven to be a reliable method for estimating member stiffness. The correlation for the Merrimac posts was relatively low with an $r^2 = 0.1944$. A stronger correlation was found for the Royalton posts with an $r^2 = 0.3907$. This marked difference is most likely attributed to the vast difference in in-situ moisture contents of the posts.

Figure 30 – Comparison of MOR vs. MOE for both sets of salvaged guardrail posts.

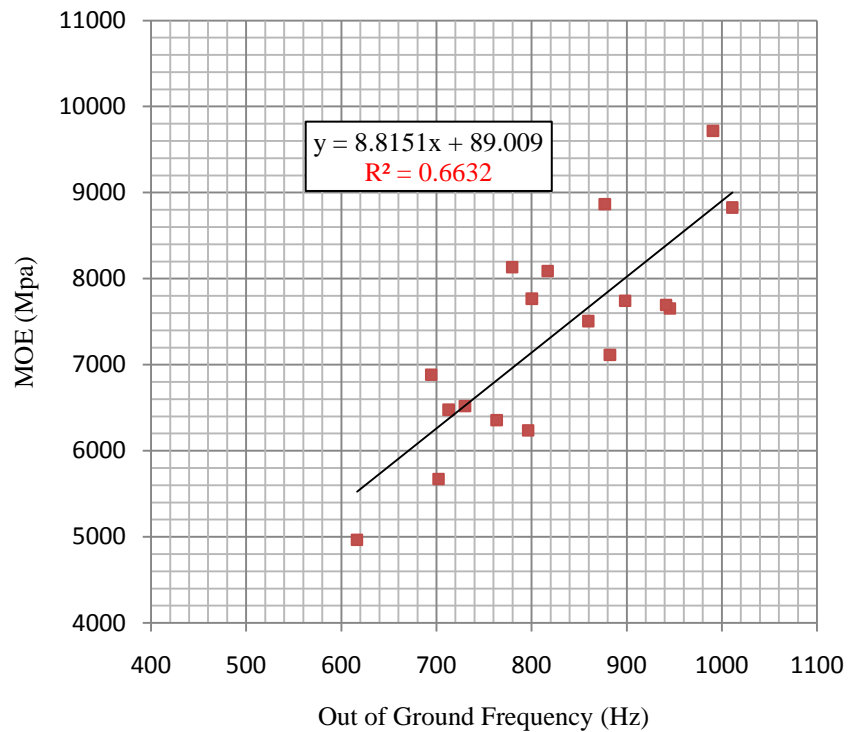
Figure 31 – Comparison of out-of-ground FFT frequency versus the Modulus of Elasticity (MOE) of the salvaged Merrimac guardrail posts.

Figure 31 compares the out-of-ground FFT post frequency with the MOE values for the Merrimac posts. As expected, there is a strong relationship with an r^2 value of 0.6632. As previously noted, longitudinal stress wave velocity has a strong correlation with the member stiffness and density. Figure 32 compares the out-of-ground FFT frequency and the MOR values for both post sets. These relationships are not very strong (Merrimac $r^2 = 0.1506$; Royalton $r^2 = 0.0654$) and is attributed to a number of factors. First, the level and presence of decay activity within the guardrail post section can dramatically affect the residual strength if located in the high stressed zone near ground line. This was the case for many posts. Second,

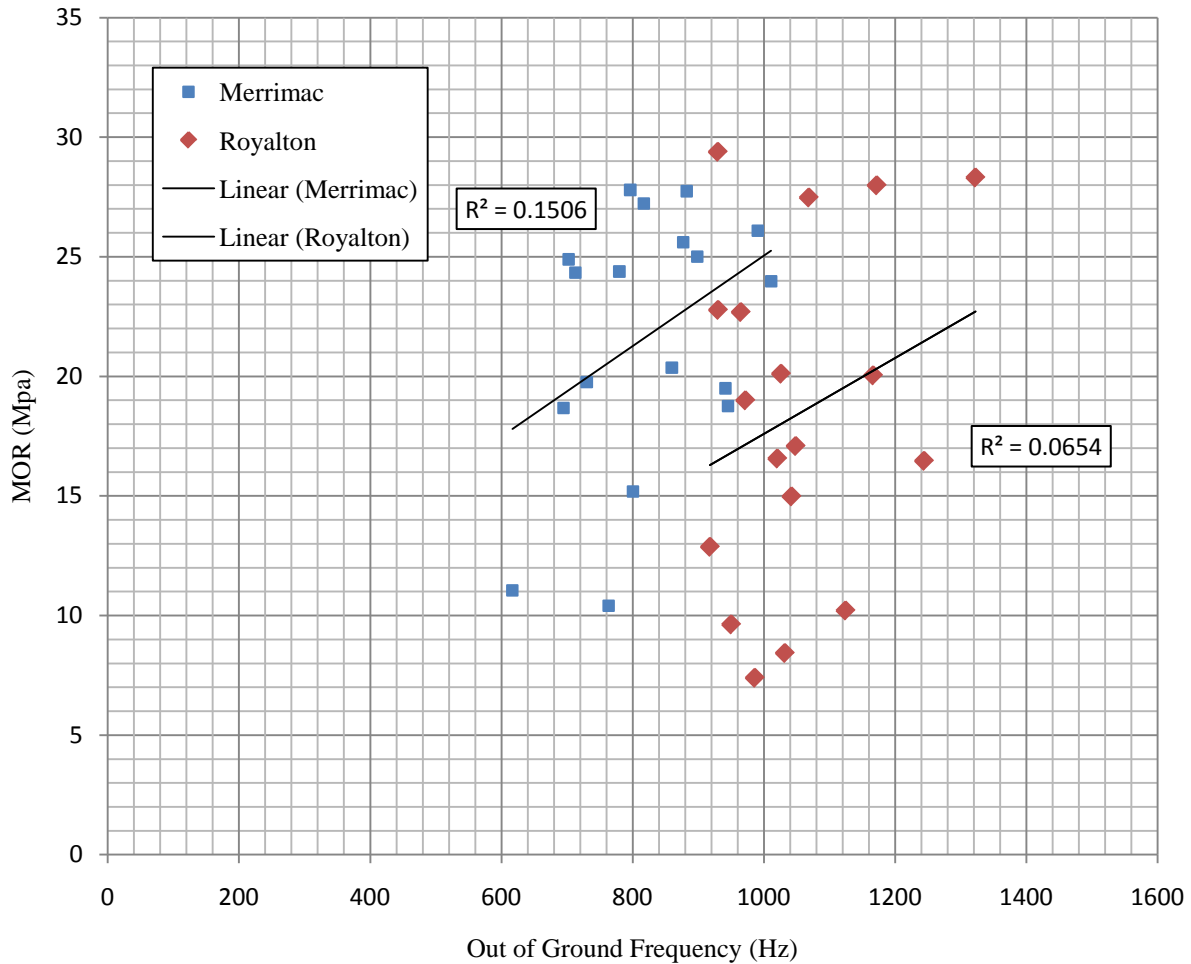
Figure 32 – Comparison of out-of-ground FFT frequency versus the Modulus of Rupture (MOR) of the salvaged guardrail posts.

the occurrence of natural defects (deep checks and knots) near the high stressed zone can also lead to low strength values. Third, the much higher moisture contents found in the Merrimac posts will result in lowering their MOR values.
