Partial Depth Repair of Concrete Pavements in Wisconsin

FINAL REPORT

Partial Depth Repair of
Concrete Pavements in Wisconsin
Research Study # 98-03

Report # WI-05-12

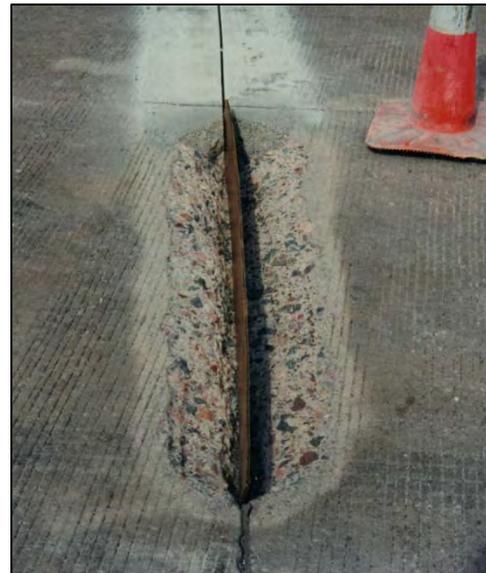
Deteriorated concrete was removed by u-shaped milling. The depth of concrete removal was a minimum of two inches, up to a maximum of half the thickness of the concrete. The exposed surfaces were sandblasted, and the repair area was air blasted to remove loose material. Cardboard was used as a compression relief material to maintain existing cracks (see Figure 1).

Figure 1. Compression relief material.

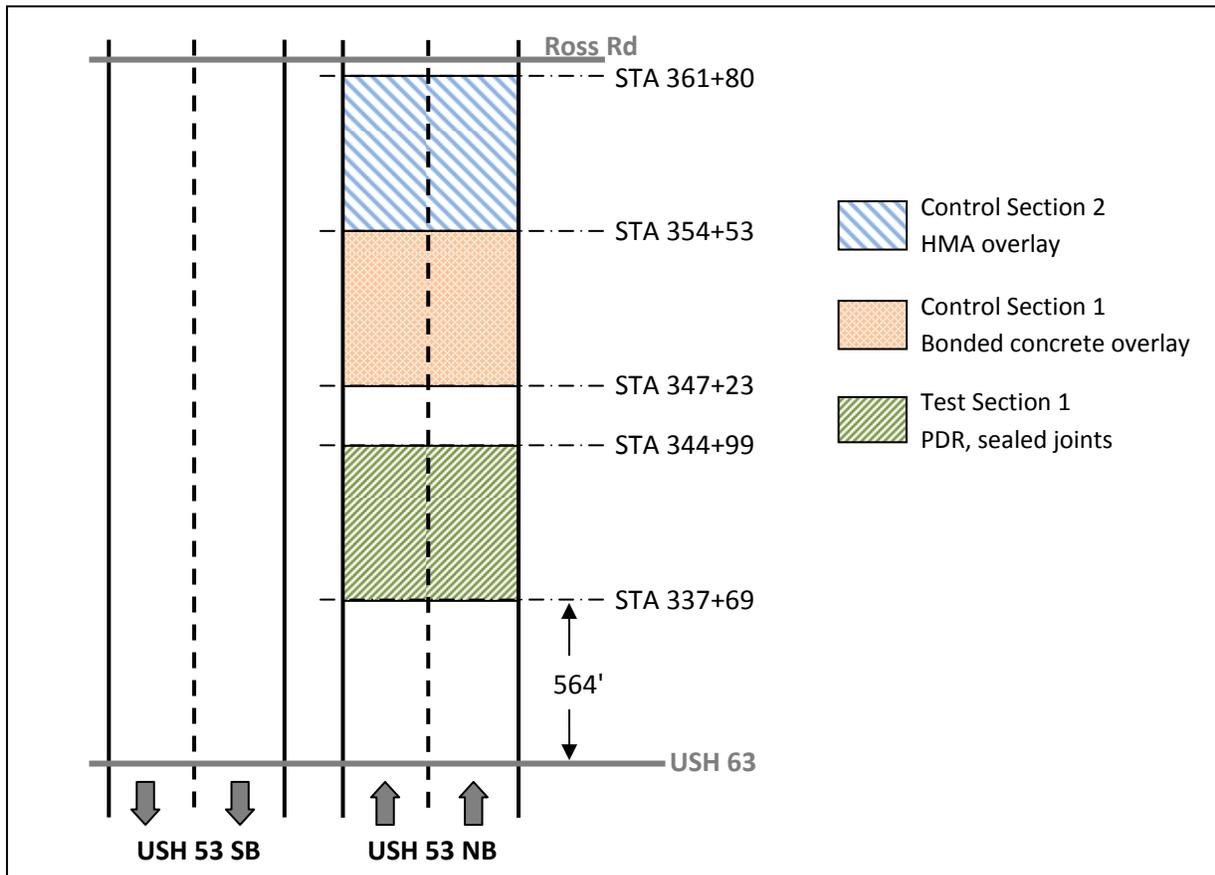
- Test Section 1 - PDR with sealed joints
- Control Section 1 - Bonded concrete overlay
- Control Section 2 - HMA overlay

Figure 2. USH 53 test and control sections.

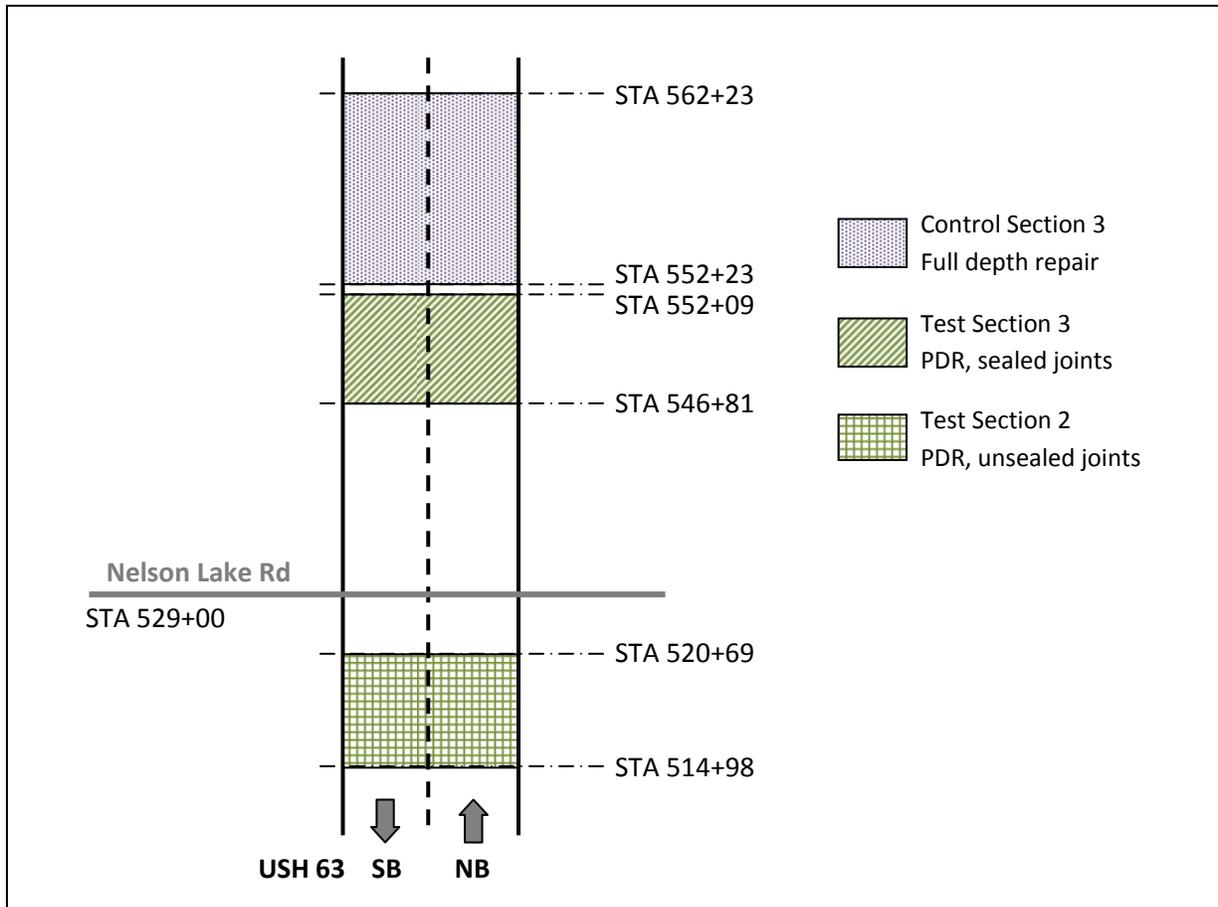
- Test Section 2 - PDR with unsealed joints
- Test Section 3 - PDR with sealed joints
- Control Section 3 - Full depth repair

Figure 3. USH 63 test and control sections.
