Road Safety Audit REPORT

WIS 441 Tri-County Project

Date: Apr 25-26, 2012

Realignment of WIS 441 and reconstruction of five interchanges.

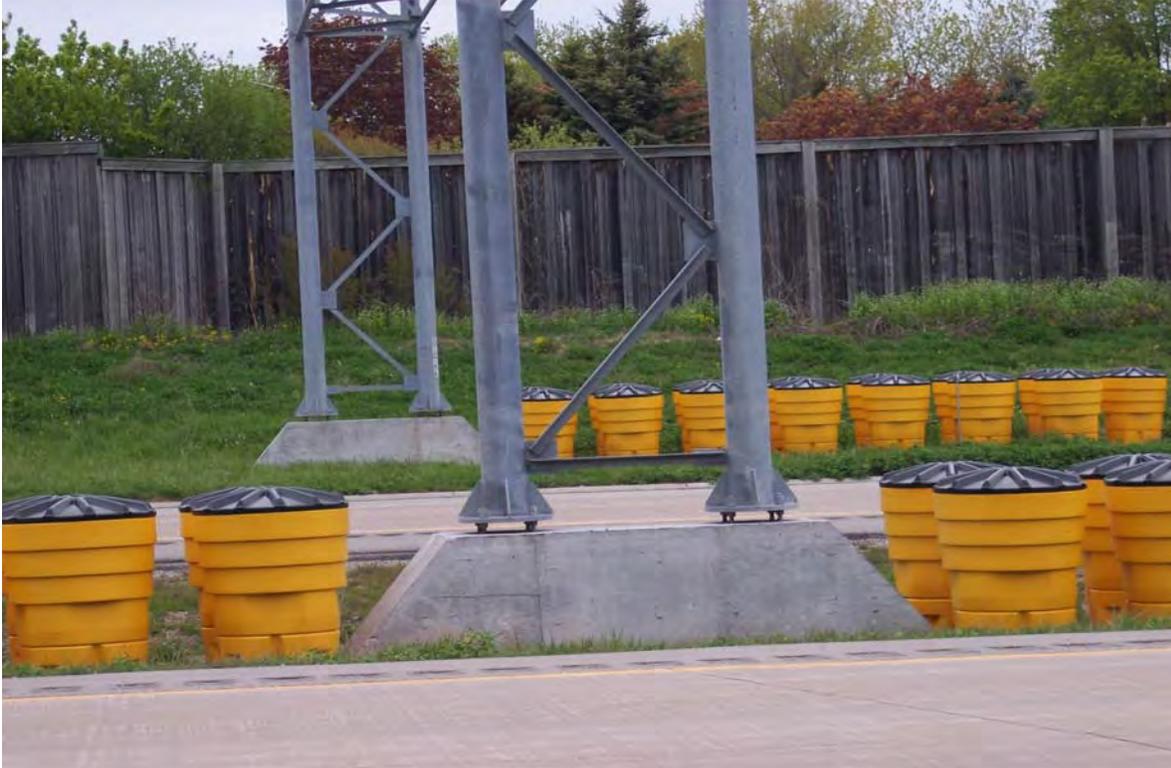
There are large overhead destination guide signs in the median with the sign posts located within the clear zone on WIS 441. These are currently shielded by sand barrels or guardrail.

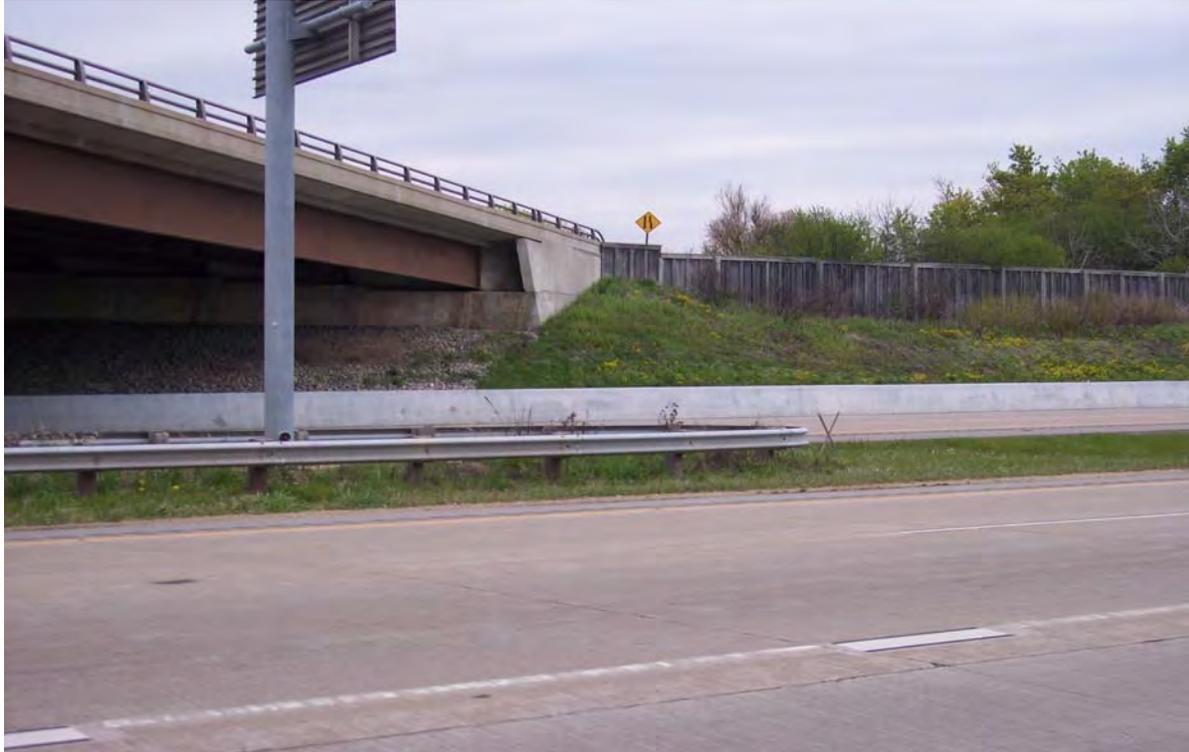
There are large overhead “butterfly” destination guide signs in the median with the sign posts located within the clear zone on WIS 441. These are currently shielded by guardrail. The guardrail wraps around the sign posts without the proper end treatment. Guardrail is not designed to absorb an impact from a vehicle head-on.

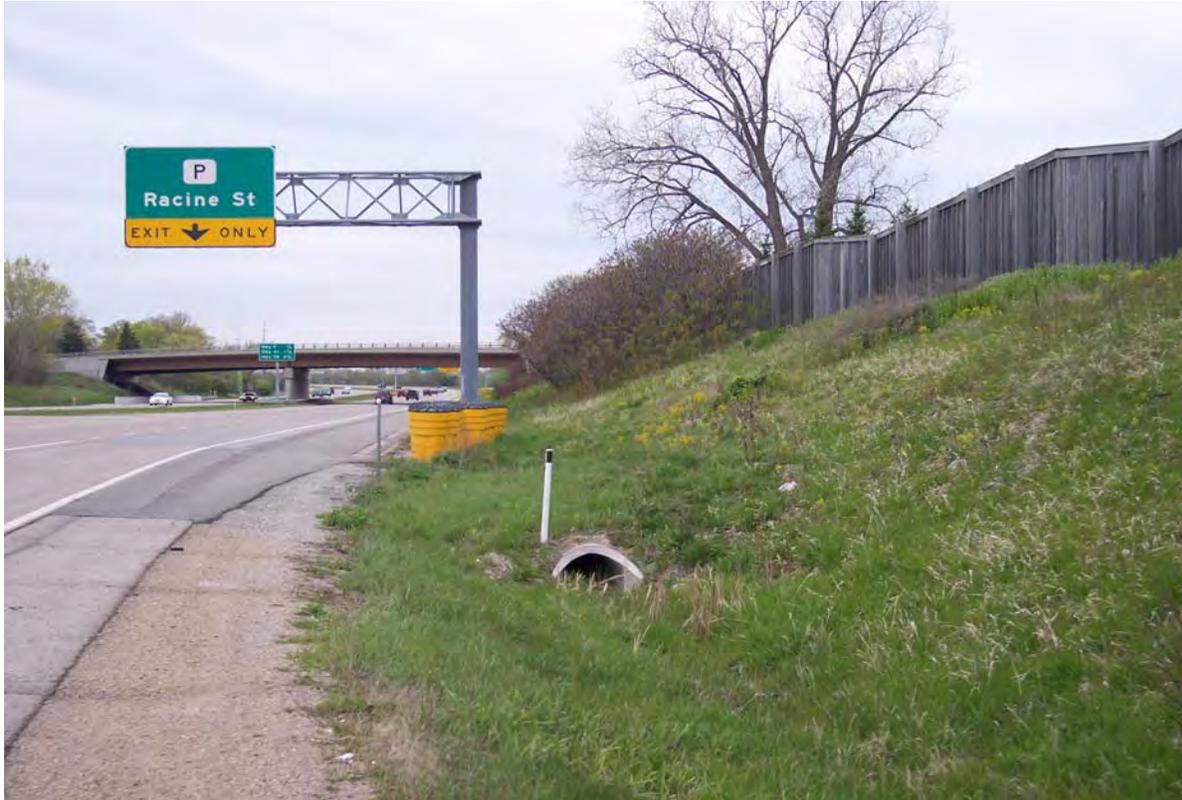
There is a mitered end section in the clear zone on the southeast side of the roadway near the bridge between the Racine Road and Midway Road interchanges.

Relocate mitered end sections outside the clear zone. If this is not possible, shield the hazard with guardrail or other protection.

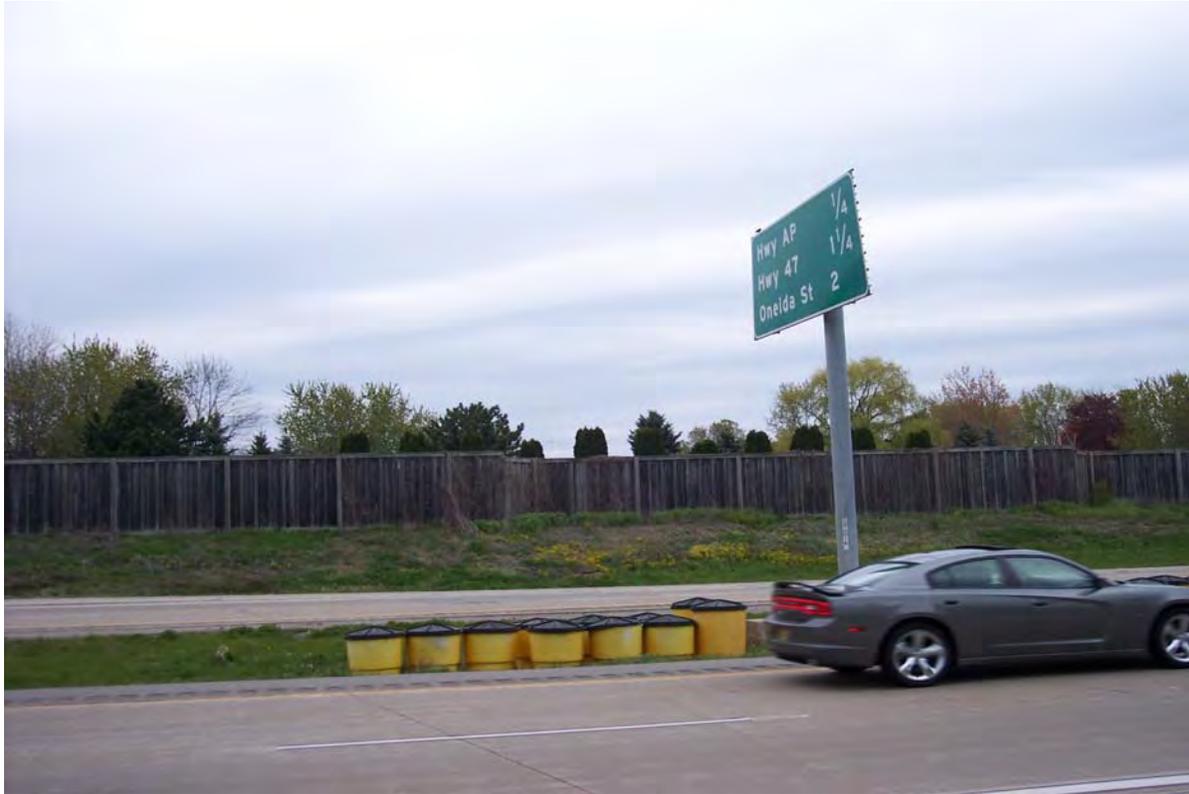
There are large overhead "butterfly" destination guide signs in the median with the sign posts located within the clear zone on WIS 441. These are currently shielded by sand barrels or guardrail.

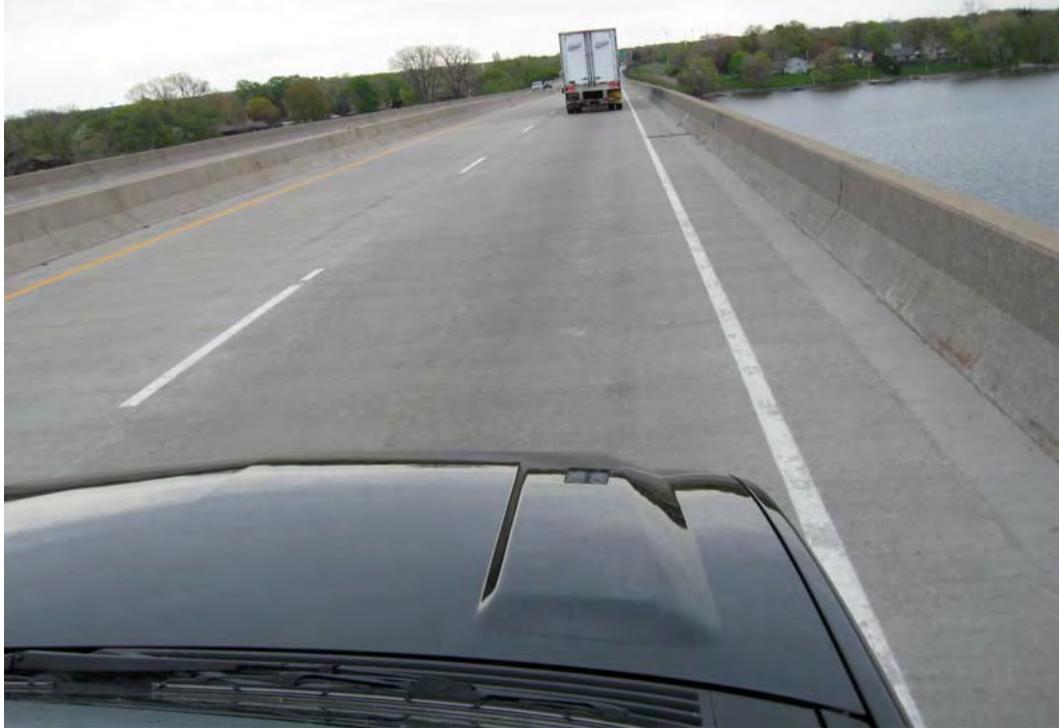
Issue 11: Narrow shoulders

The Roland Kampo Bridge over Little Lake Butte des Morts has narrow shoulders. This does not provide a recovery area for an errant vehicle or for emergency purposes.

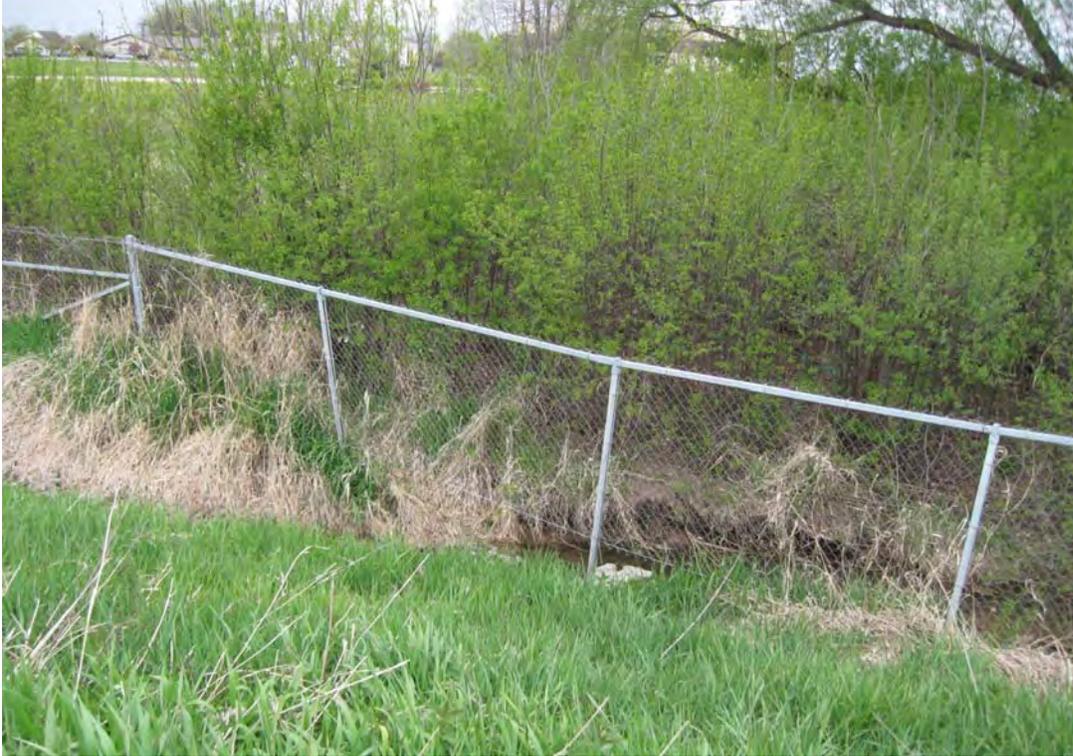
There is a culvert underneath the loop ramp for US 41 southbound to WIS 441 eastbound that is within the clear zone and is not shielded. This could be a safety issue for vehicles that run off the road in this area.

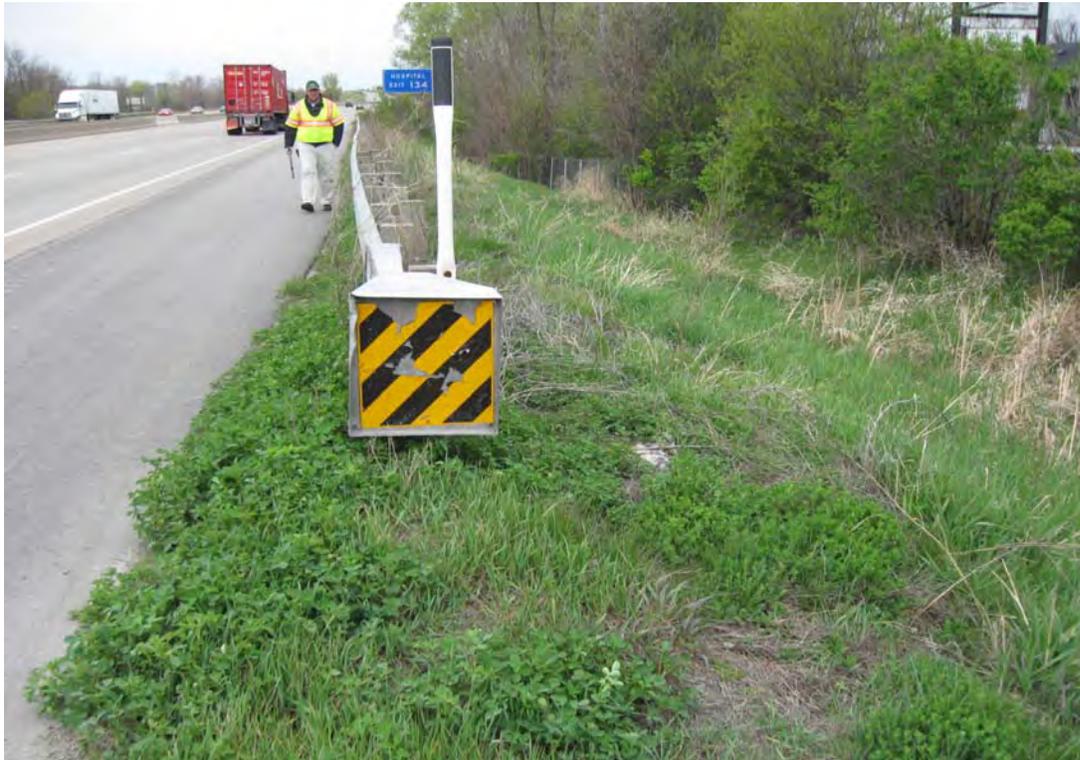
The bridge north of the interchange has a 3:1 slope that is partially shielded by guardrail. The guardrail does not shield the entire unrecoverable area and has a straight end-treatment. The length of advancement of the guardrail is low.

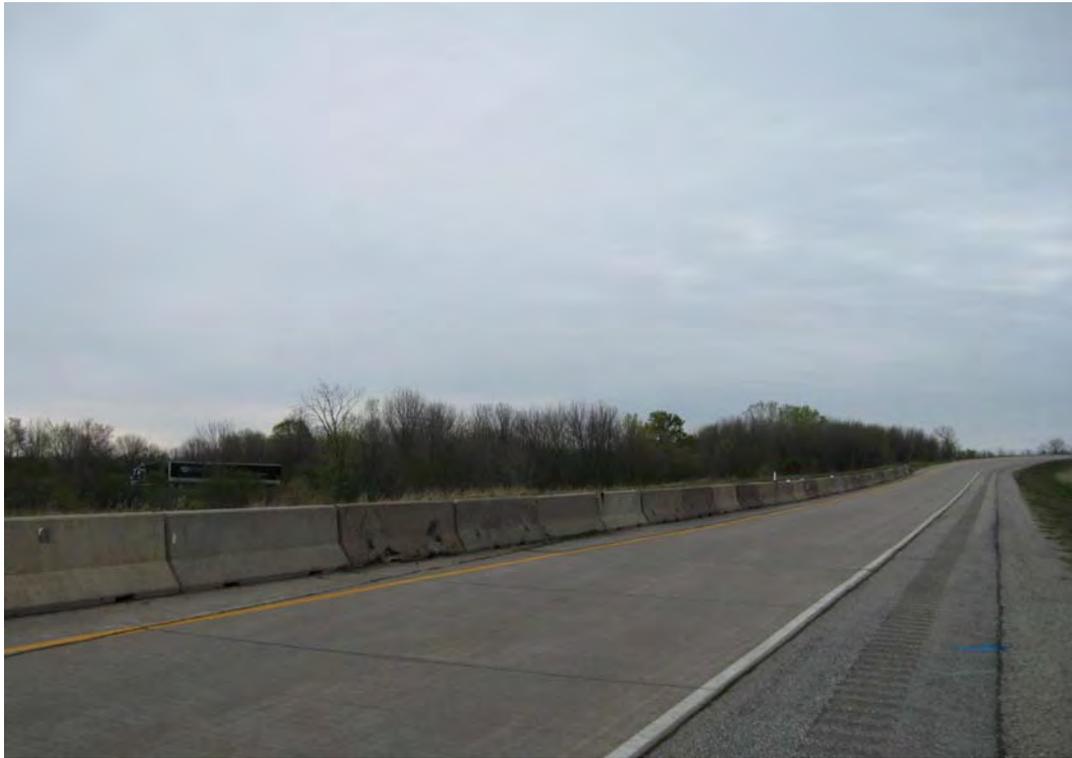
The eastbound WIS 441 to southbound US 41 ramp has extra pavement and temporary barrier wall on the left side without a 3-beam guardrail connection.

Reconstruct the ramp to remove the extra pavement, replace the temporary barrier wall with a permanent solution and tie in any guardrail with a 3-beam connection.

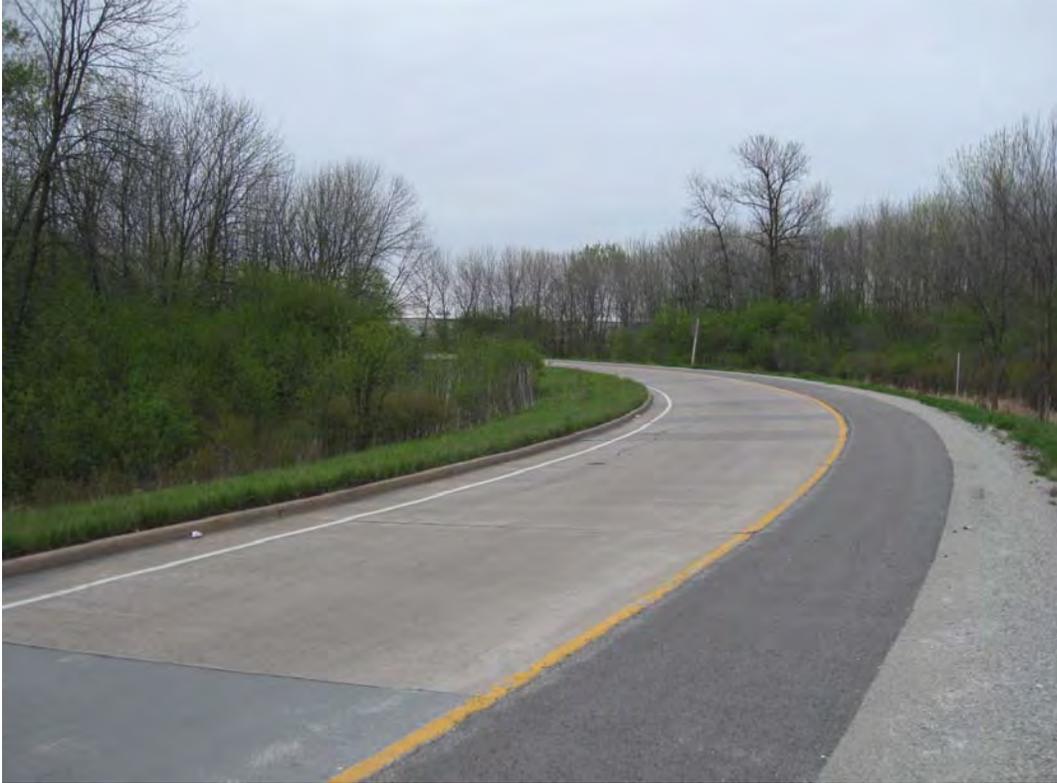
There is vertical face curb in a high speed section on the loop ramp for southbound US 41 to eastbound WIS 441. This can create a safety issue if a vehicle traveling at high speeds strikes the curb.

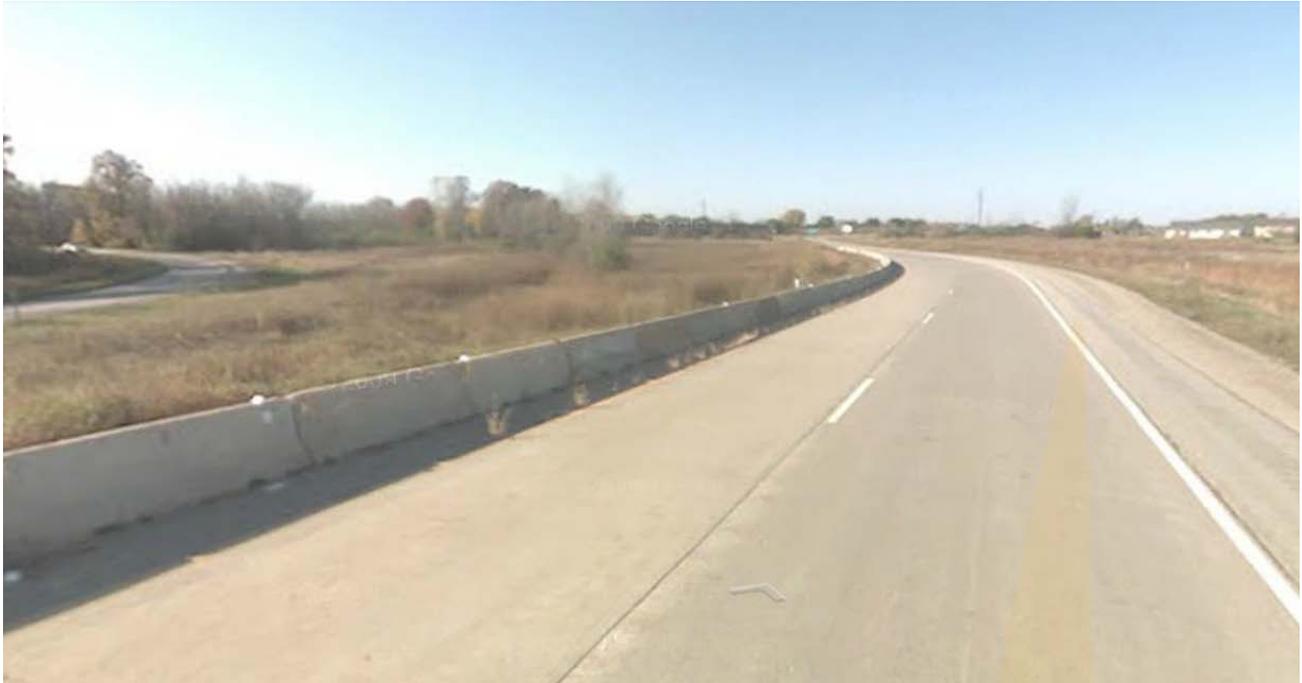
The southbound US 41 to westbound WIS 441 ramp is a broke-back curve. This creates additional changes in horizontal alignment that a motorist must navigate.

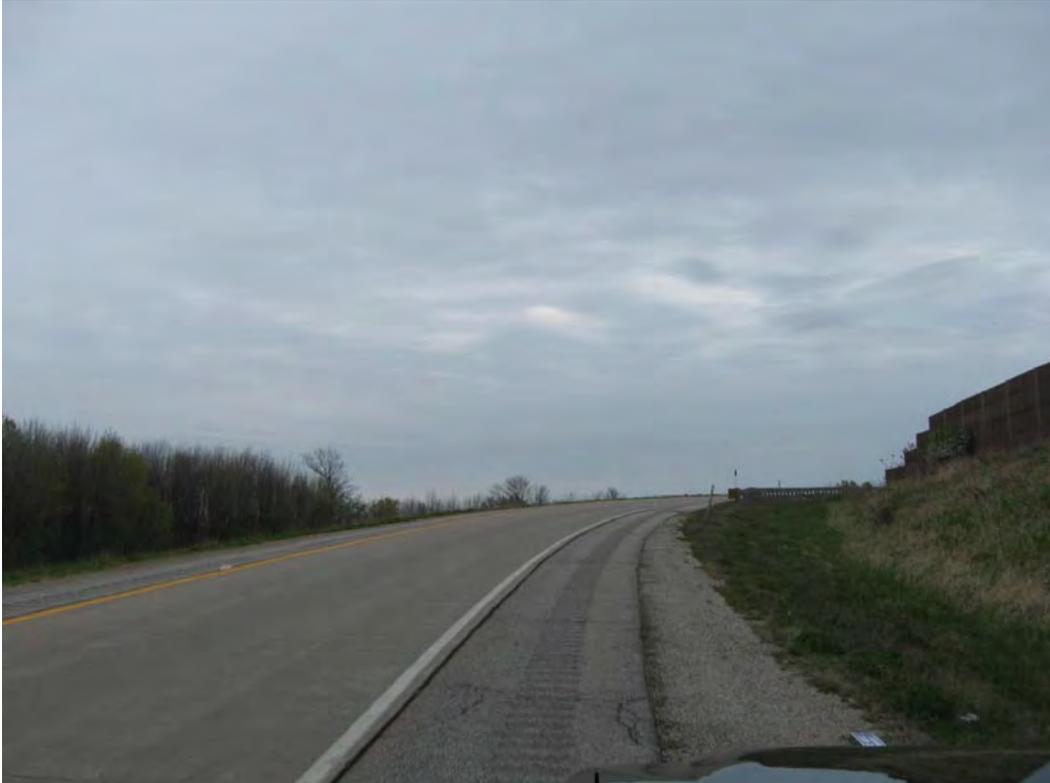
The horizontal and vertical sight distances are low on the eastbound WIS 441 to southbound US 41 ramp.

The ramp from eastbound WIS 441 to southbound US 41 has horizontal and vertical sight distance issues. Low sight distance may contribute to a vehicle not detecting a hazard in time to react and avoid a collision.

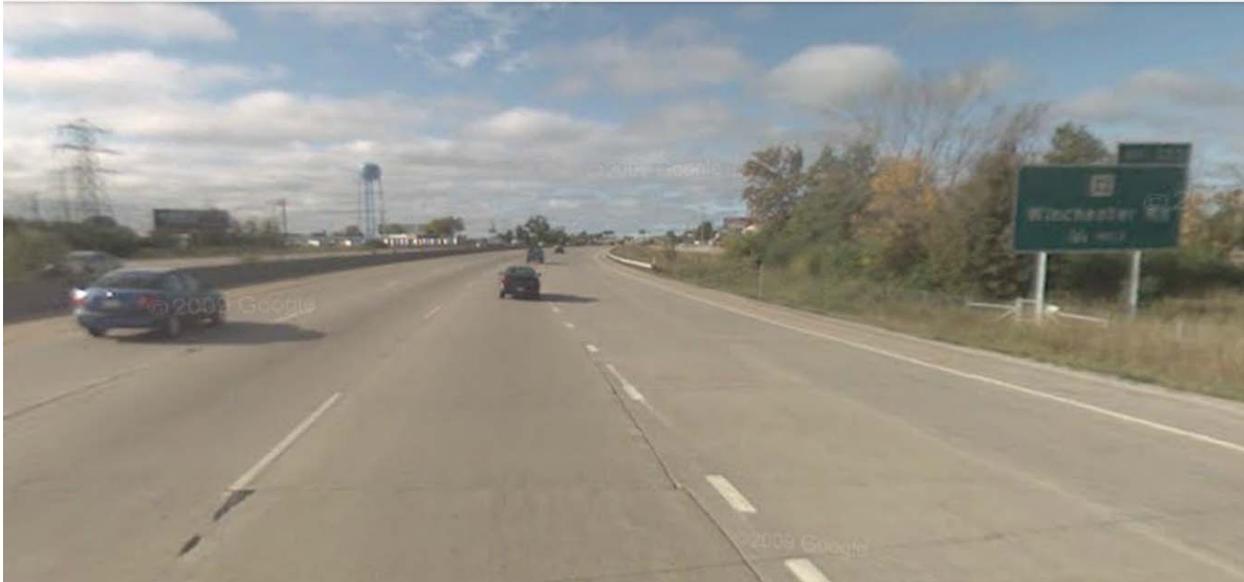
There is tight spacing on US 41 between the WIS 441 interchange and the interchange to the south. This may create a weaving issue for vehicles entering from WIS 441 and vehicles wishing to exit at the next exit.

Maximize the spacing between interchanges and analyze the weaving operations of proposed conditions.

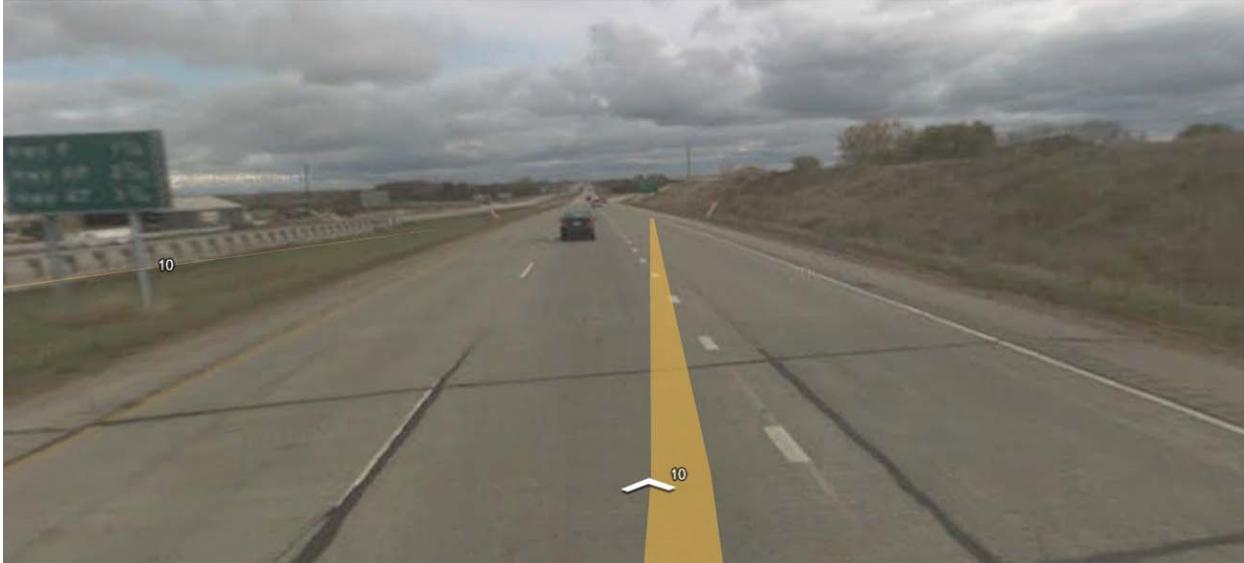
The auxiliary lanes for the eastbound WIS 441 to US 41 southbound ramp do not have overhead signing.

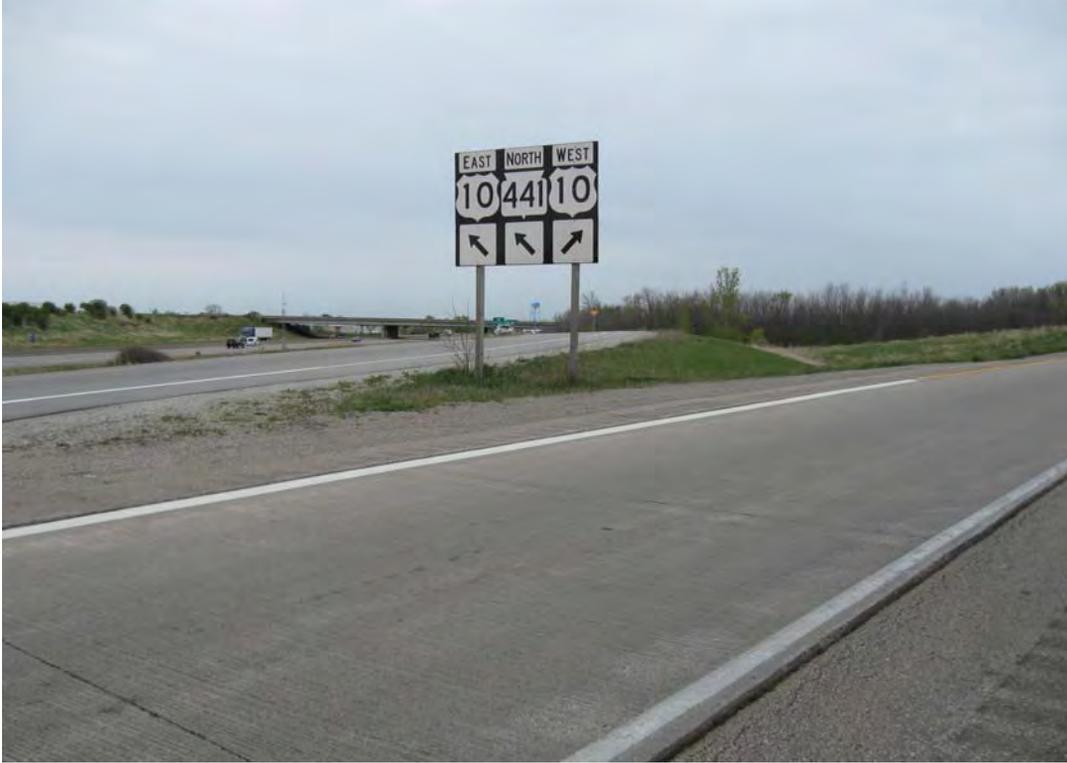
There are no overhead signs for the US 41 southbound to WIS 441 westbound ramp.

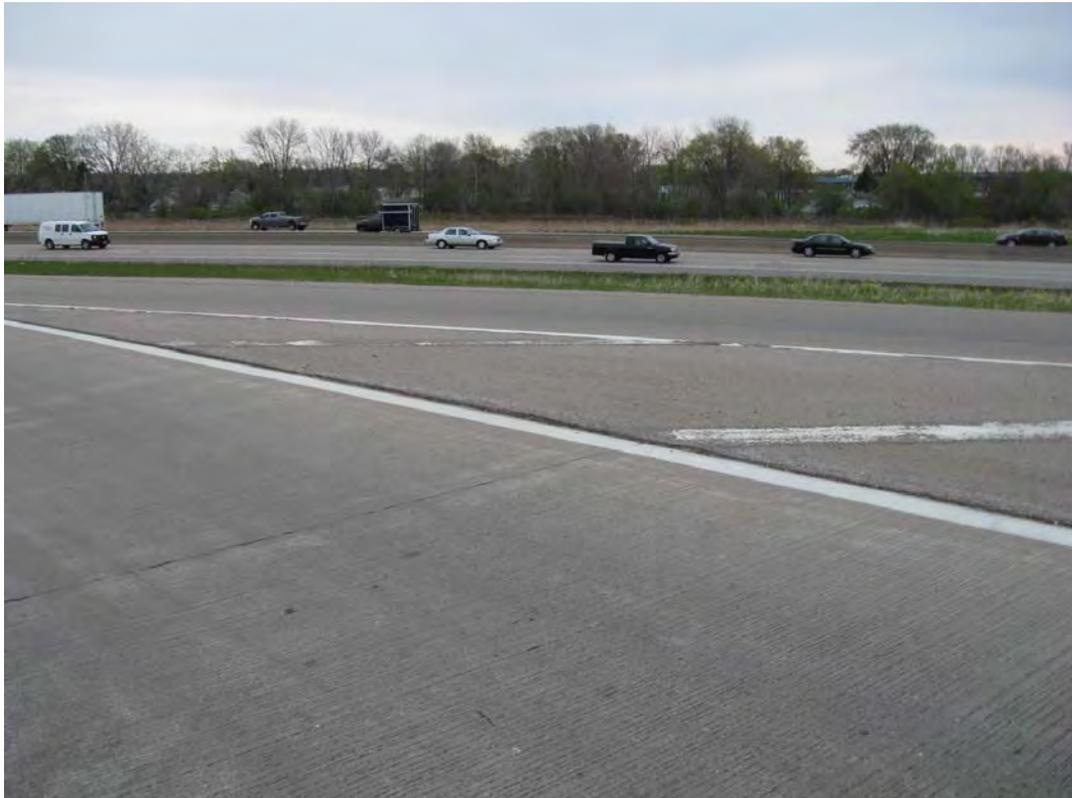
The gore striping within the US 41 southbound to WIS 441 eastbound ramp has 45 degree striping and not chevrons, and no reflective pavement markers. This is not in accordance with current standards.

Replace the 45 degree striping with chevrons and reflective pavement markers in the gore area of the ramp.

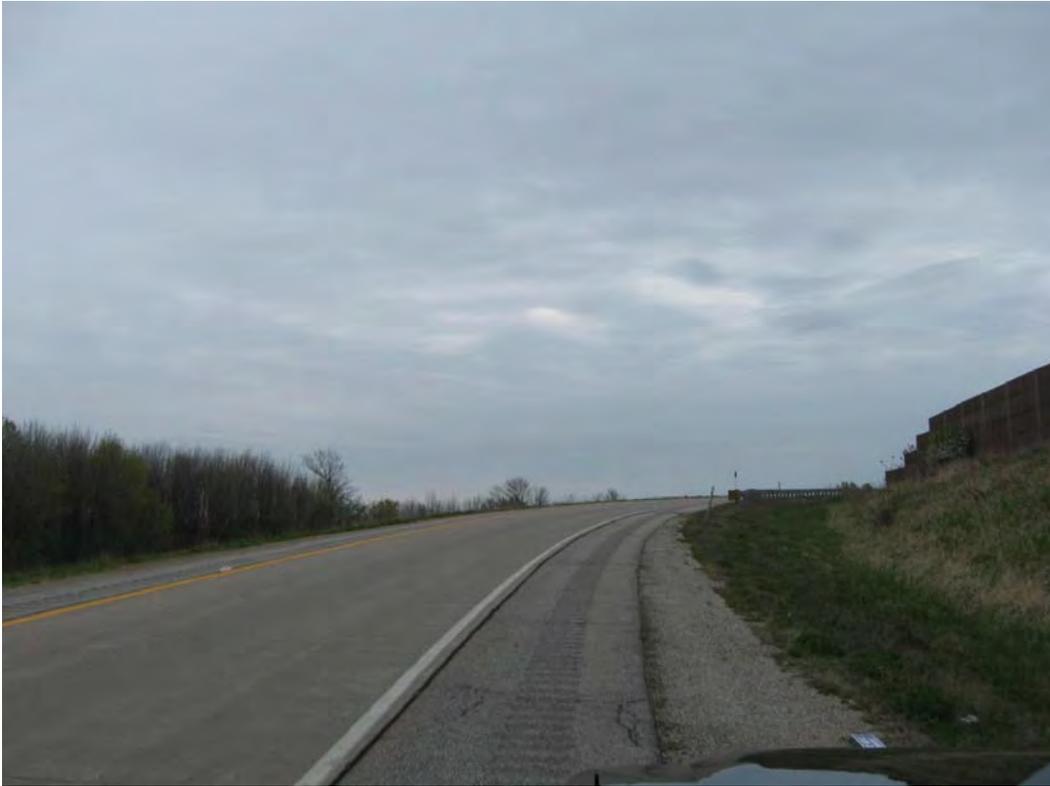
There are no reflective pavement markers in several areas, on the ramps and on mainline WIS 441. Reflective pavement markers help to delineate the roadway for motorists at night and in inclement weather.

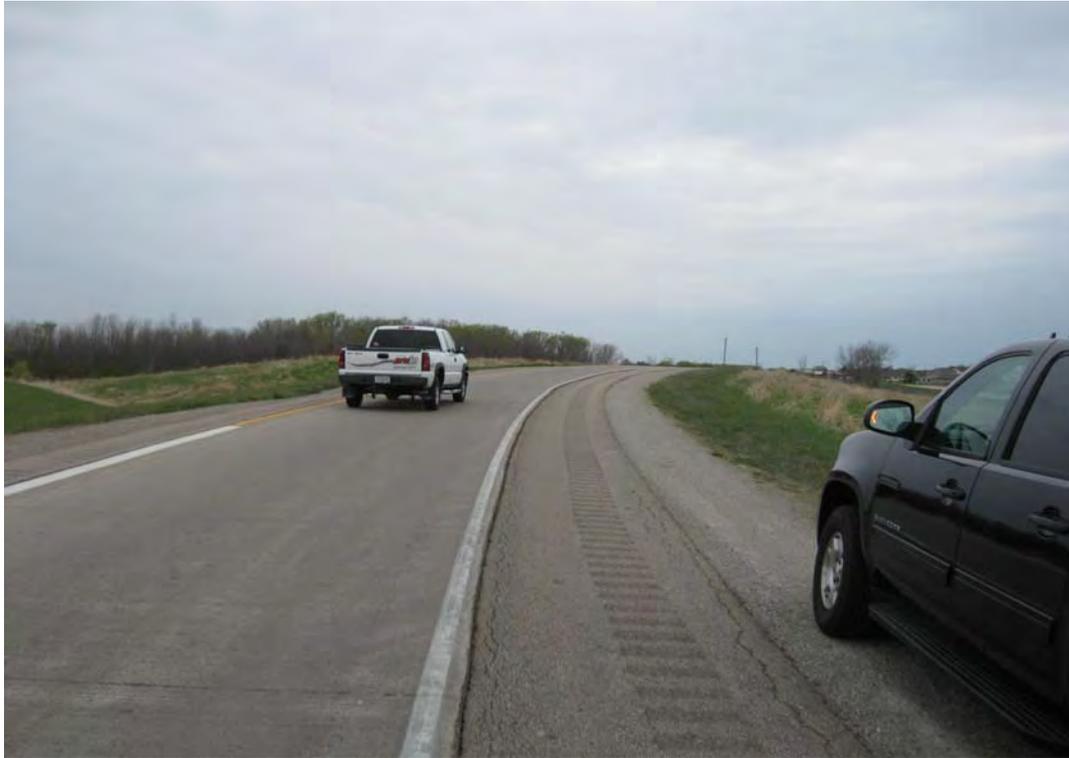
There are no delineators on some of the US 41 at WIS 441 interchange ramps. Delineators are typically placed along the outside of a curve on the ramp to help delineate the roadway.

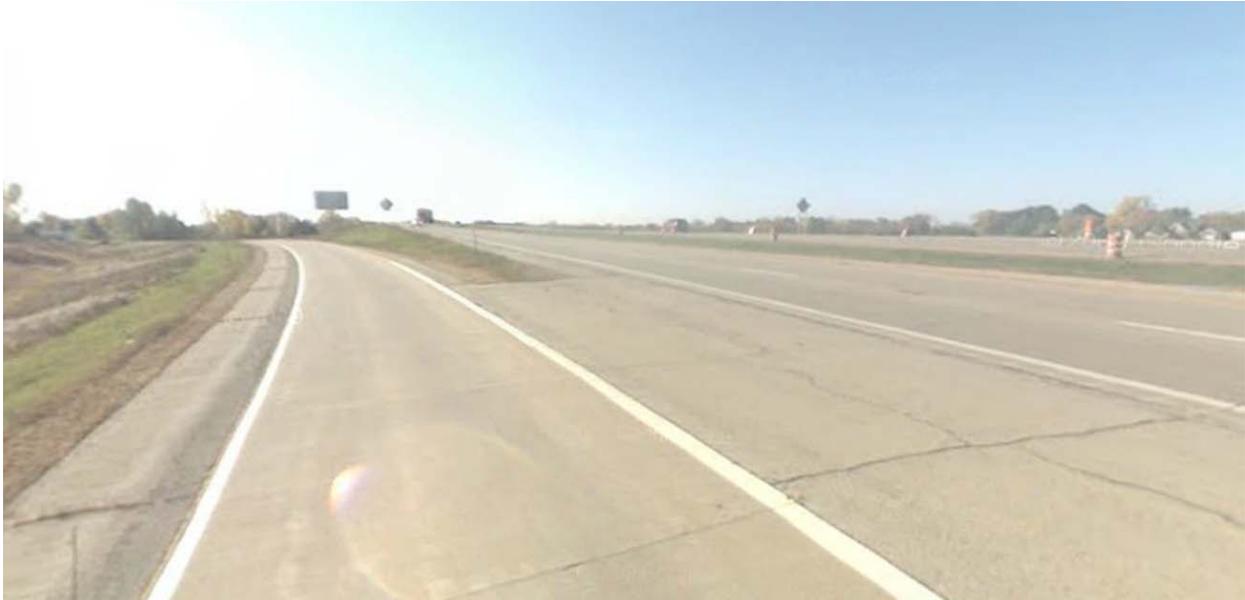
The area behind the gore between the mainline and the Racine Road ramp slopes to one side. If a vehicle were to enter this area it may overturn.

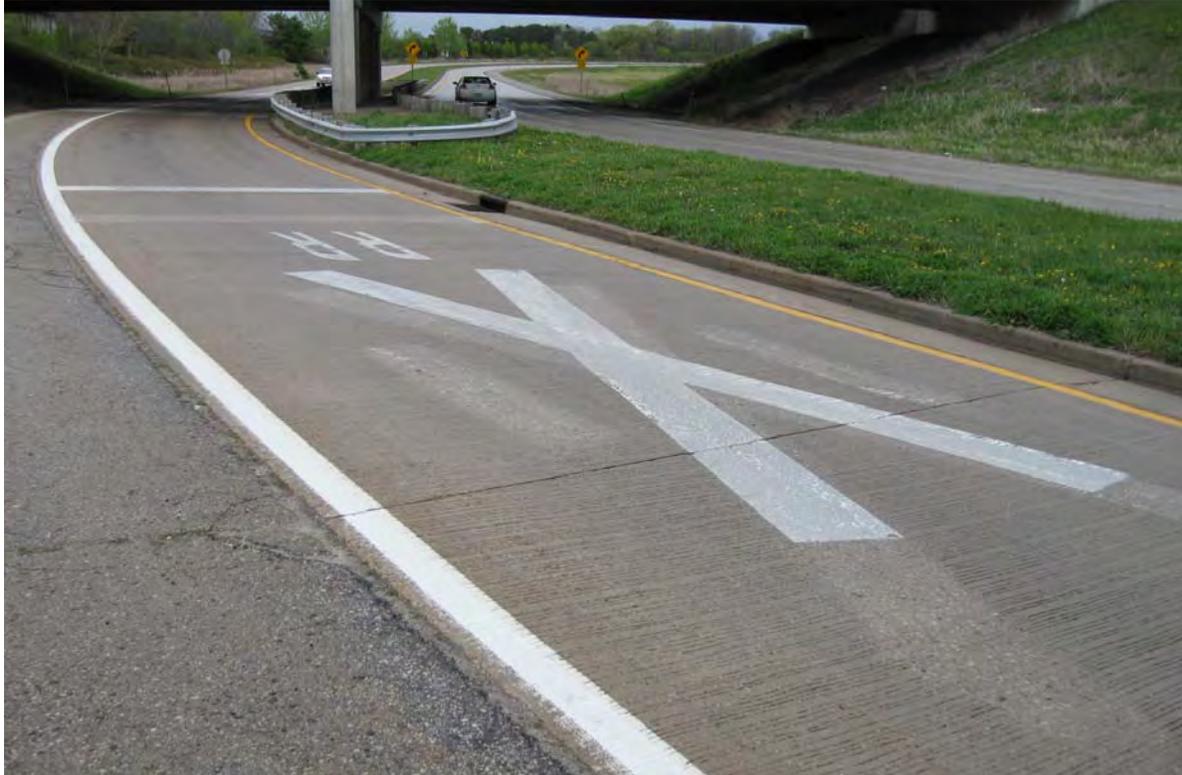
There are bridge piers in the median at the overpass in the Racine Road interchange. There is no end treatment on the guardrail around the bridge piers in the median; the guardrail is wrapped around the pier. Guardrail is not designed to absorb an impact from a vehicle head-on.

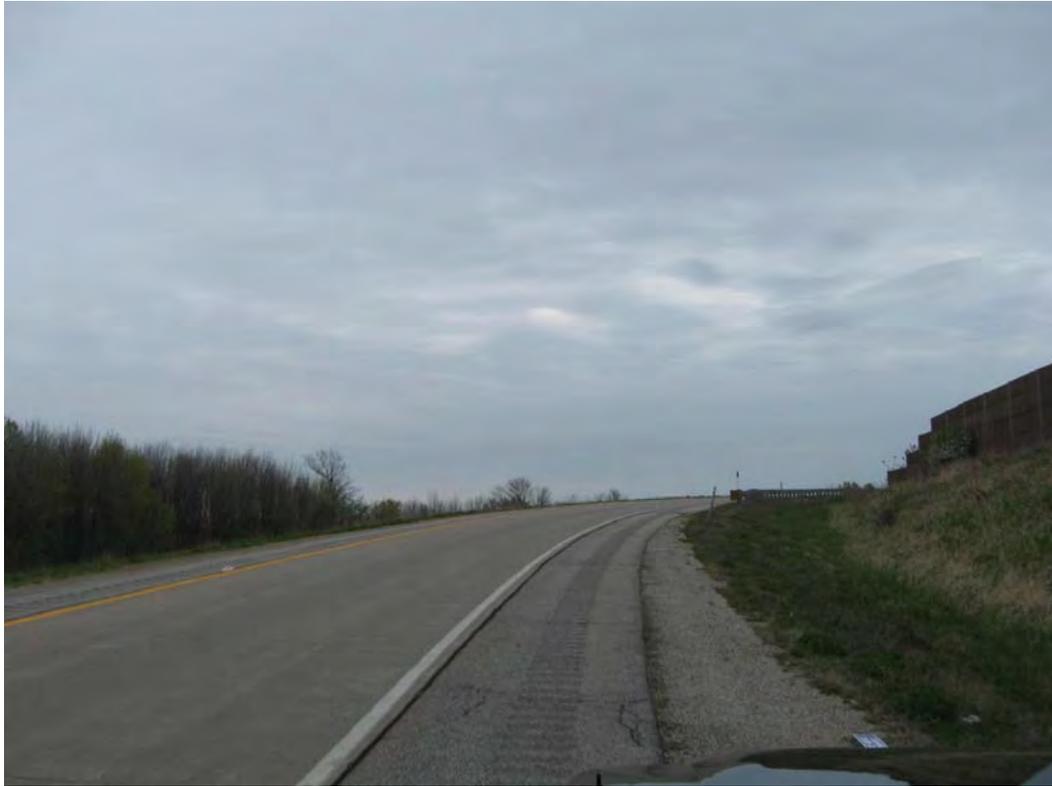
The front slope on the right side of the eastbound WIS 441 off ramp is unrecoverable and is not shielded. This may be a safety issue if an errant vehicle runs off the road in this area.

Reconstruct the shoulder area to remove the slope that is considered to be unrecoverable. If this is not possible, shield the potential hazard.

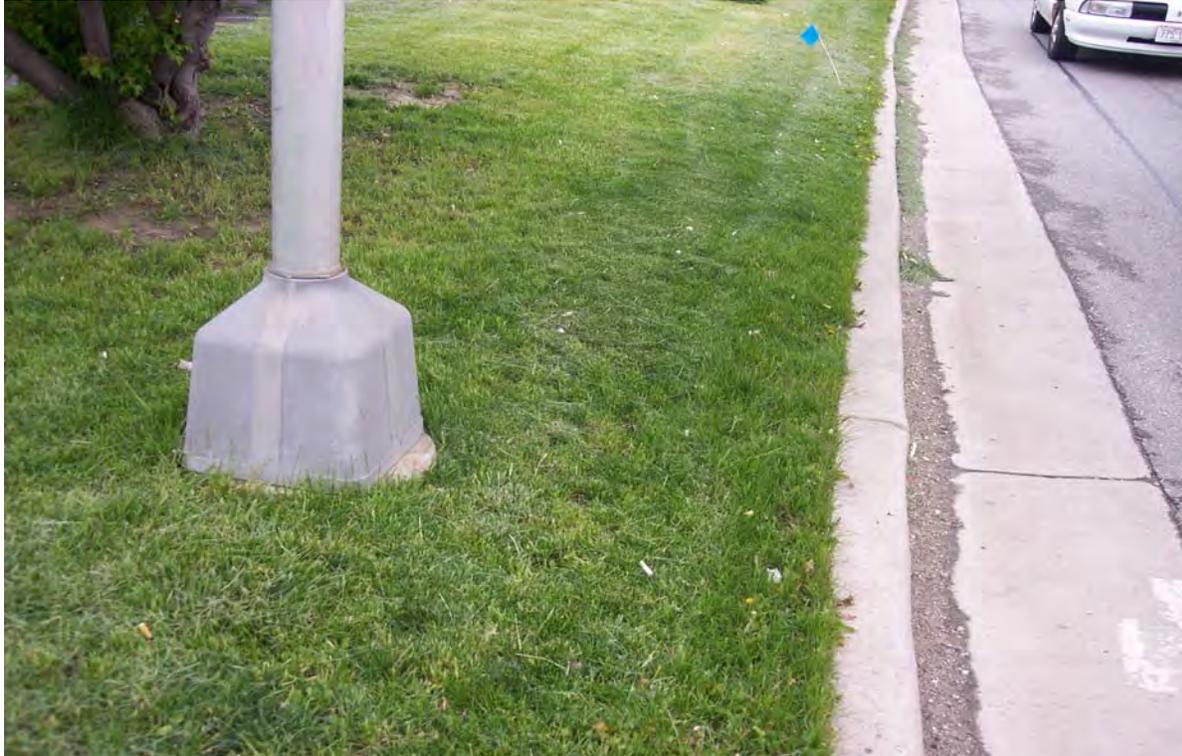
The curb at Racine road and 9th street intersection does not meet minimum height requirements. The curb is less than 6 inches in height. A shorter curb does not shield roadside objects as well.

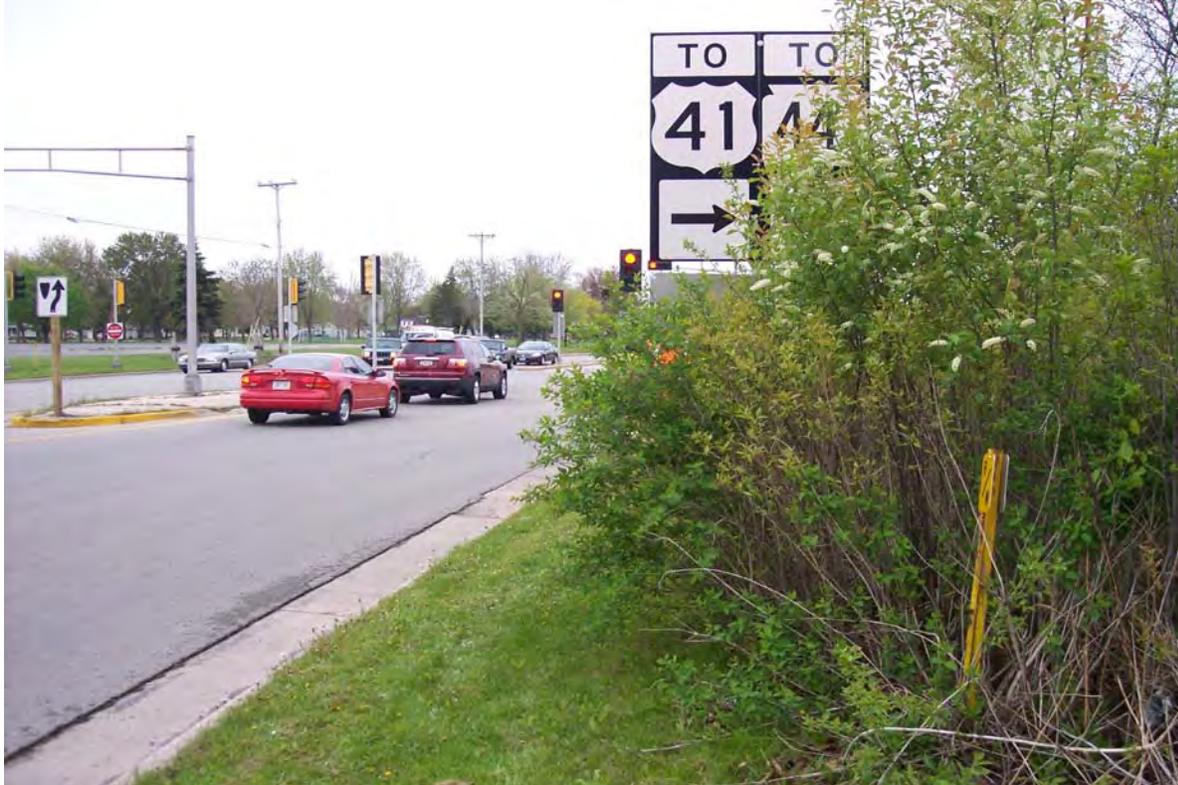
The vegetation lines near the proposed roundabout are close to the roadway and reduce sight distance. The vegetation obstructs the view around the corner of the roadway and any pedestrians in the area.

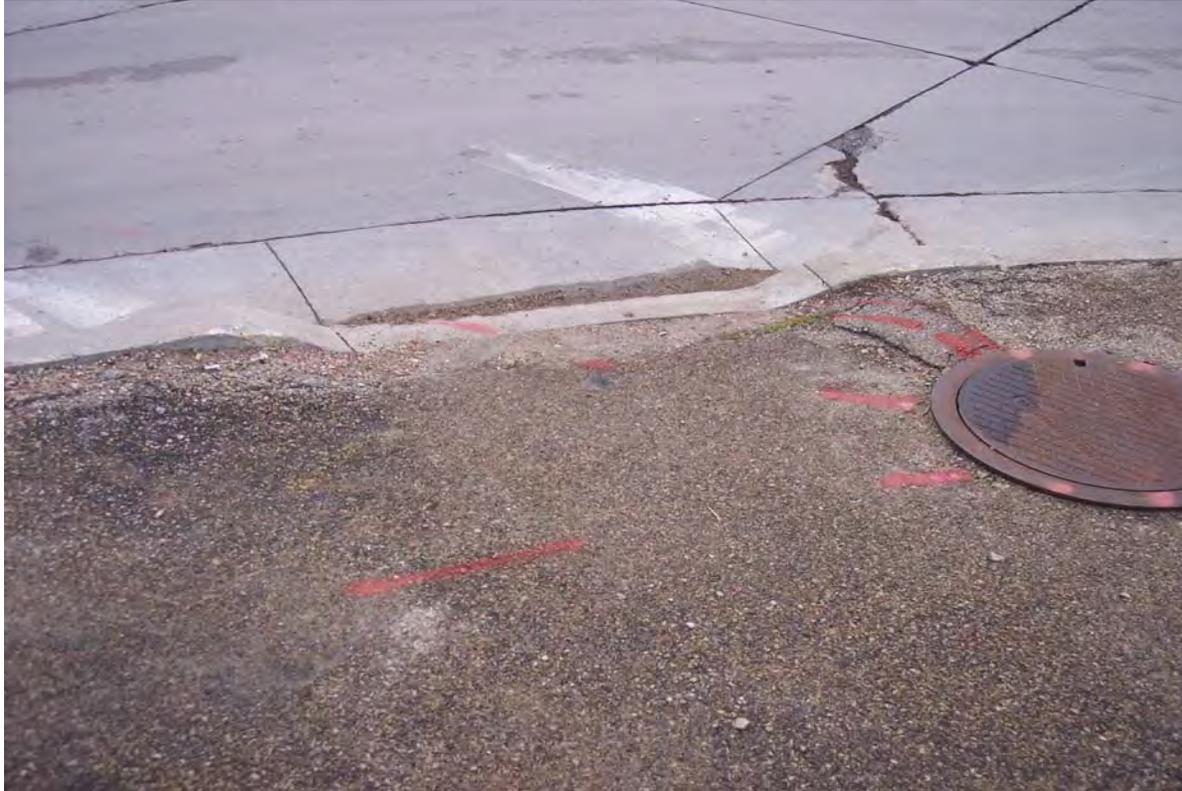
The crosswalk striping at Racine Road and 9th street has faded. The crosswalks designates the area for the pedestrians to cross for both the pedestrians and motorists.

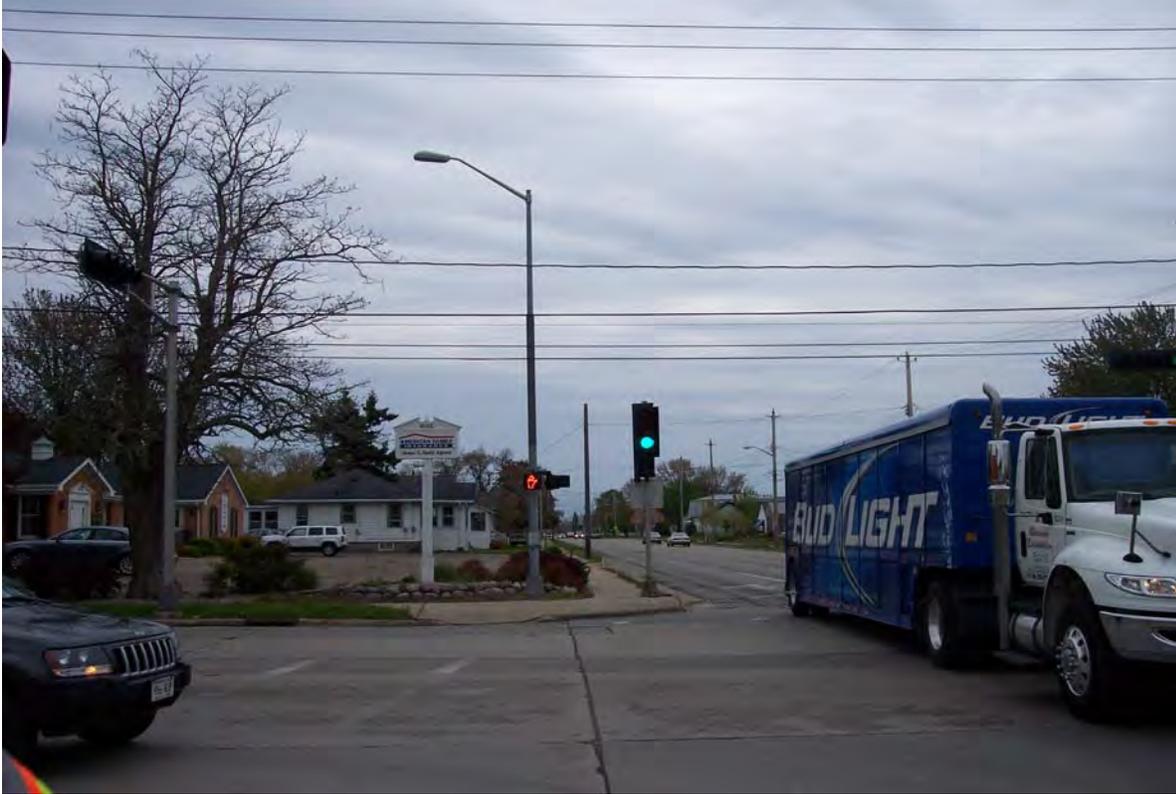
Pedestrian ramps and signals at the intersection of Racine Road with 9th Street are not present on all of the corners.

Recommend 2 separate ramps that are ADA compliant, 2 separate pedestrian push buttons that are ADA accessible, and 2 separate countdown pedestrian signals with countdown pedestrian signing on each corner of the intersection.

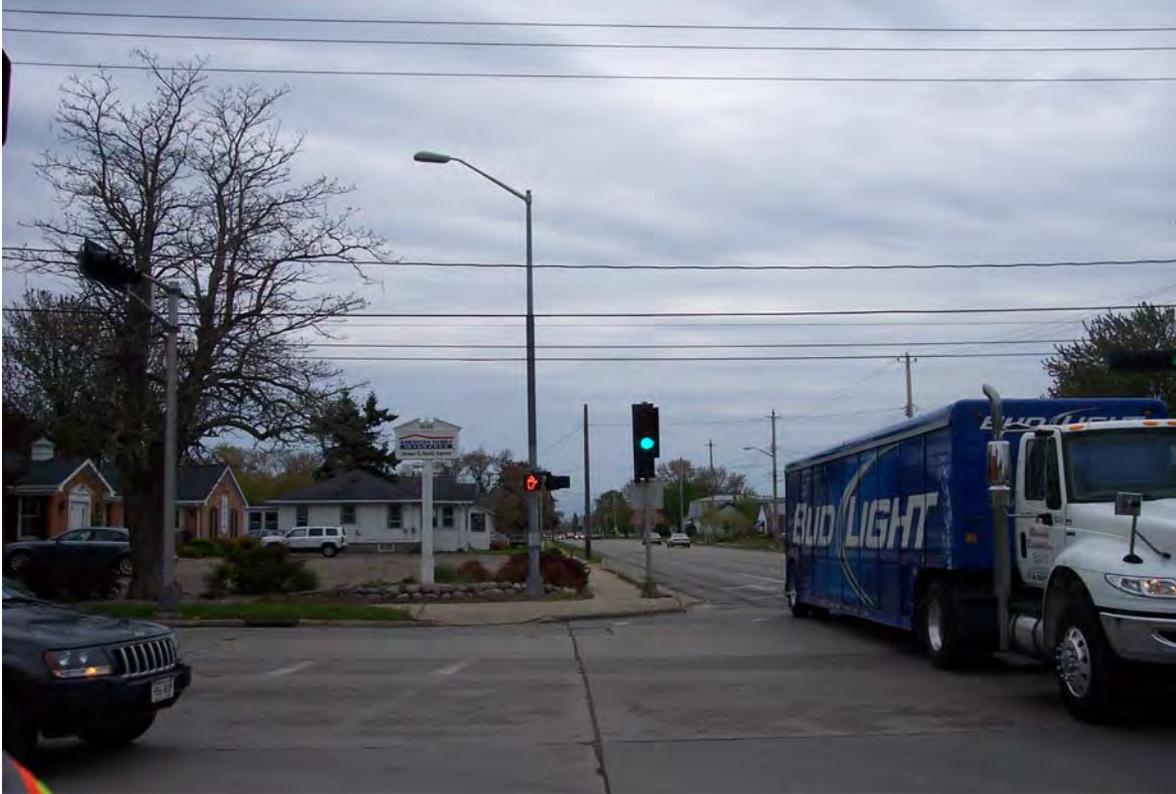
The lighting on the southeast corner of Racine Road and 9th Street has rotated.
