Road Safety Audit REPORT

WIS 441 Tri-County Project

Date: Apr 25-26, 2012

Realignment of WIS 441 and reconstruction of five interchanges.

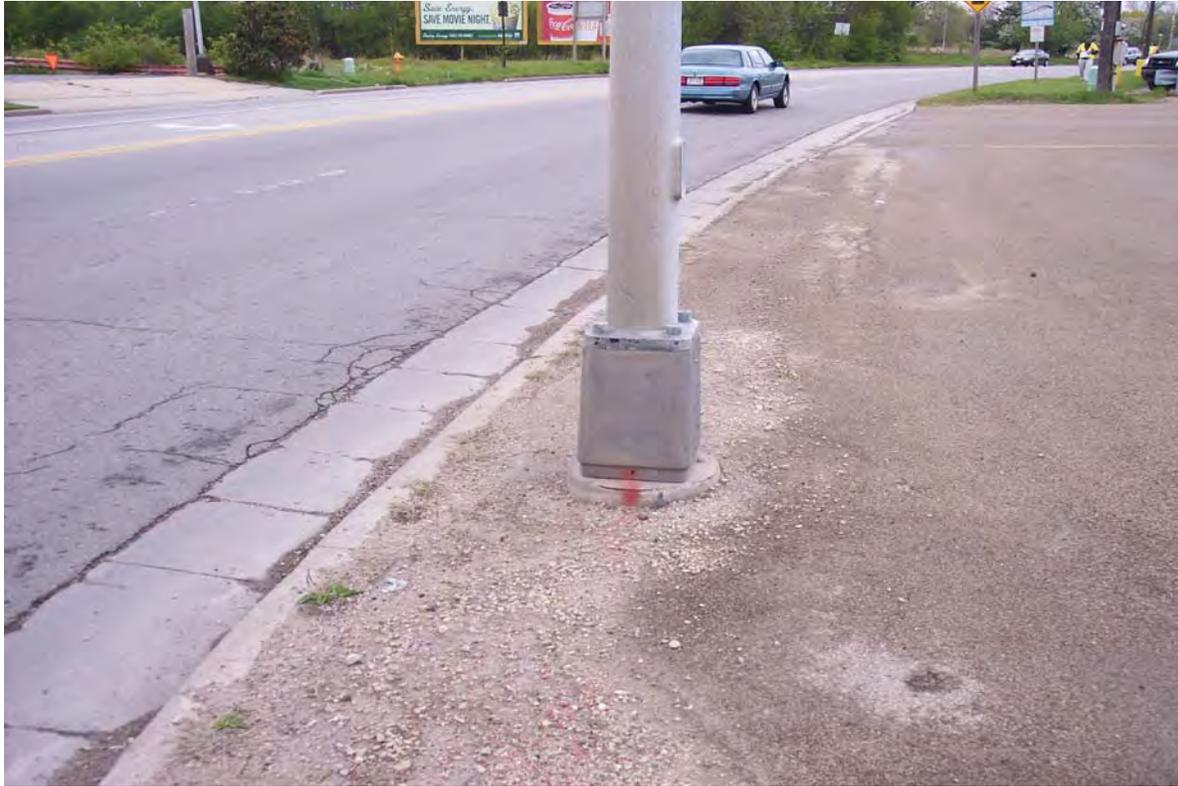
There are several poles near the intersection of Racine Road and 9th Street that are close to the back of curb. This is considered to be within the clear zone area.

Relocate the poles away from the roadway to remove the potential hazard.

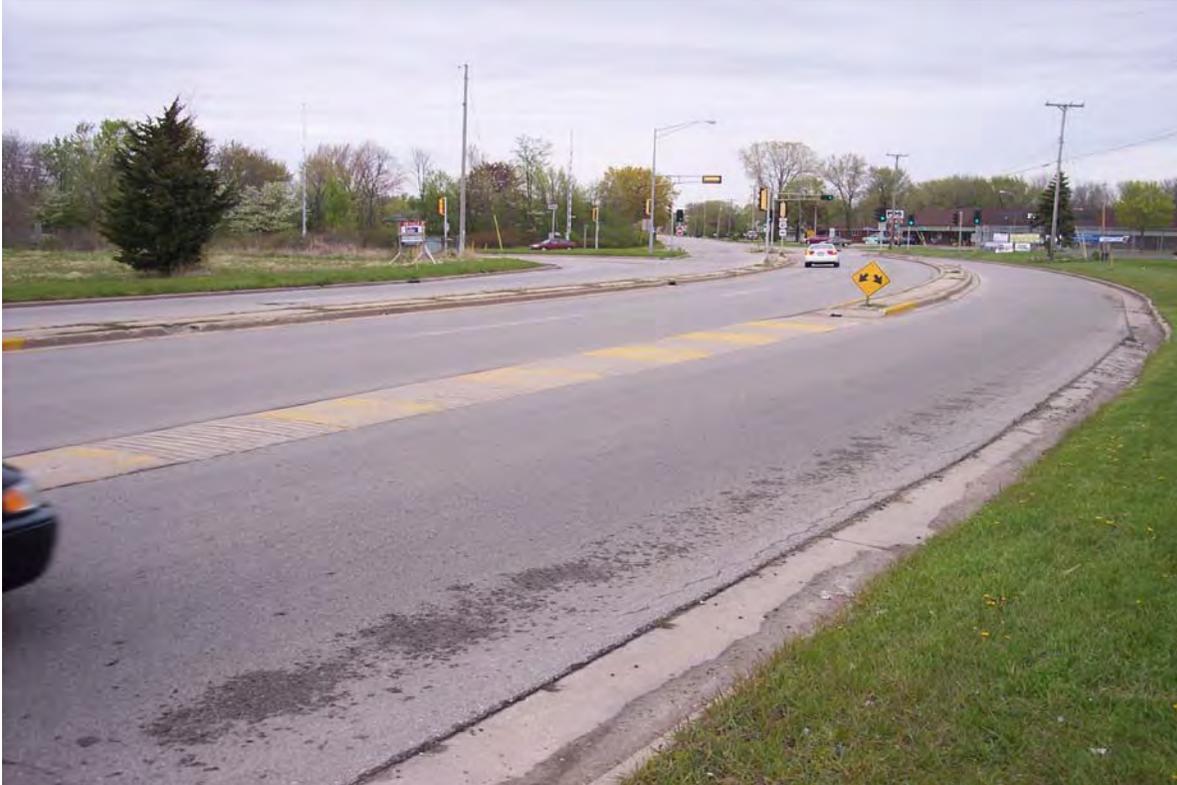
The Racine Road interchange requires lane changing and decision-making for the motorist to navigate through.

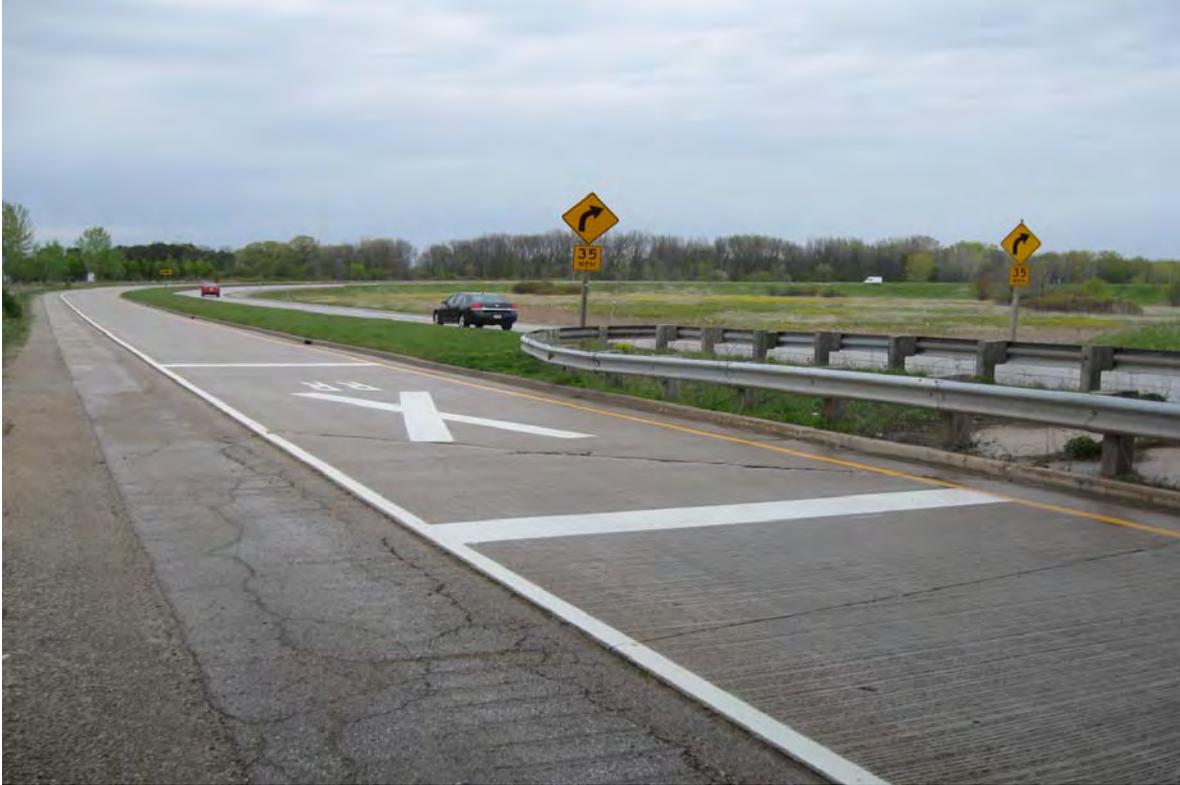
The Racine Road ramp curve has a single W1-6 arrow sign and no W1-8 chevron signs.

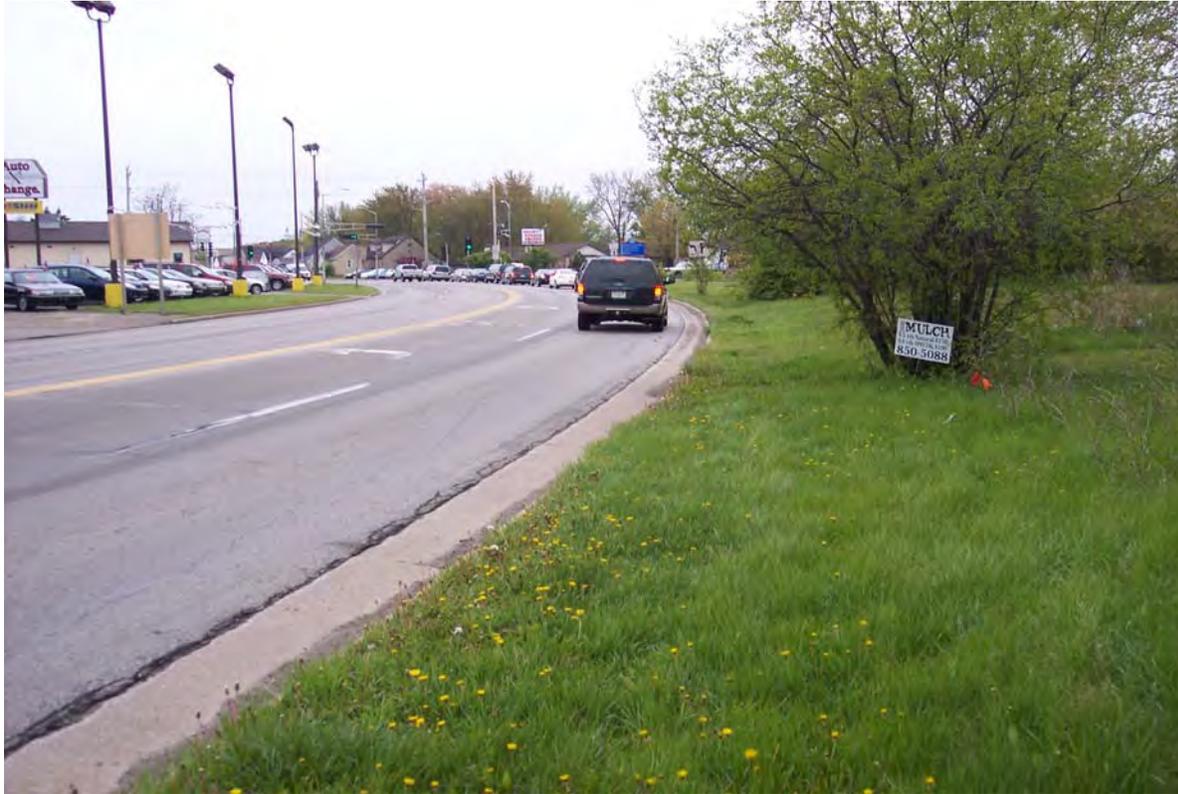
The street name signs at Racine Road and 9th Street are not readily visible. Adequate visibility of the street name signs helps to guide motorists approaching the intersection and allow for advance lane change maneuvers.

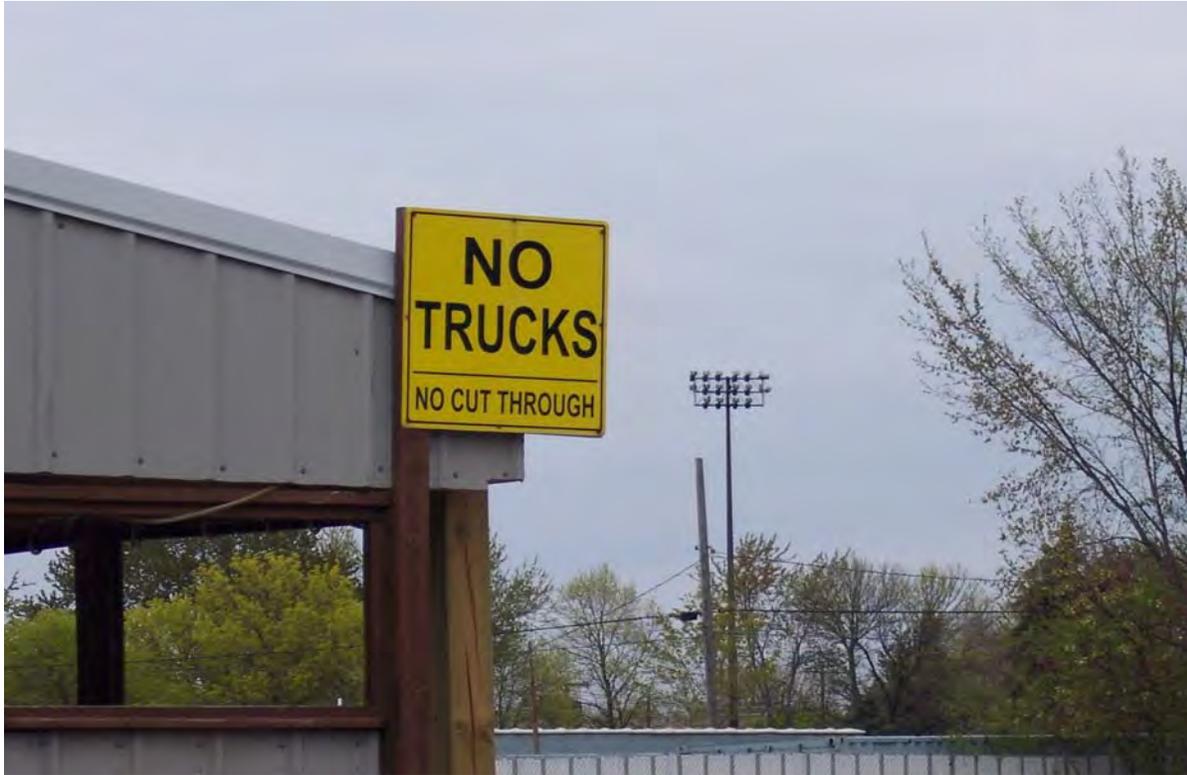
Large trucks are using the driveway at Bubba's Pub to cut through and avoid the intersection of Racine Road and 9th Street.

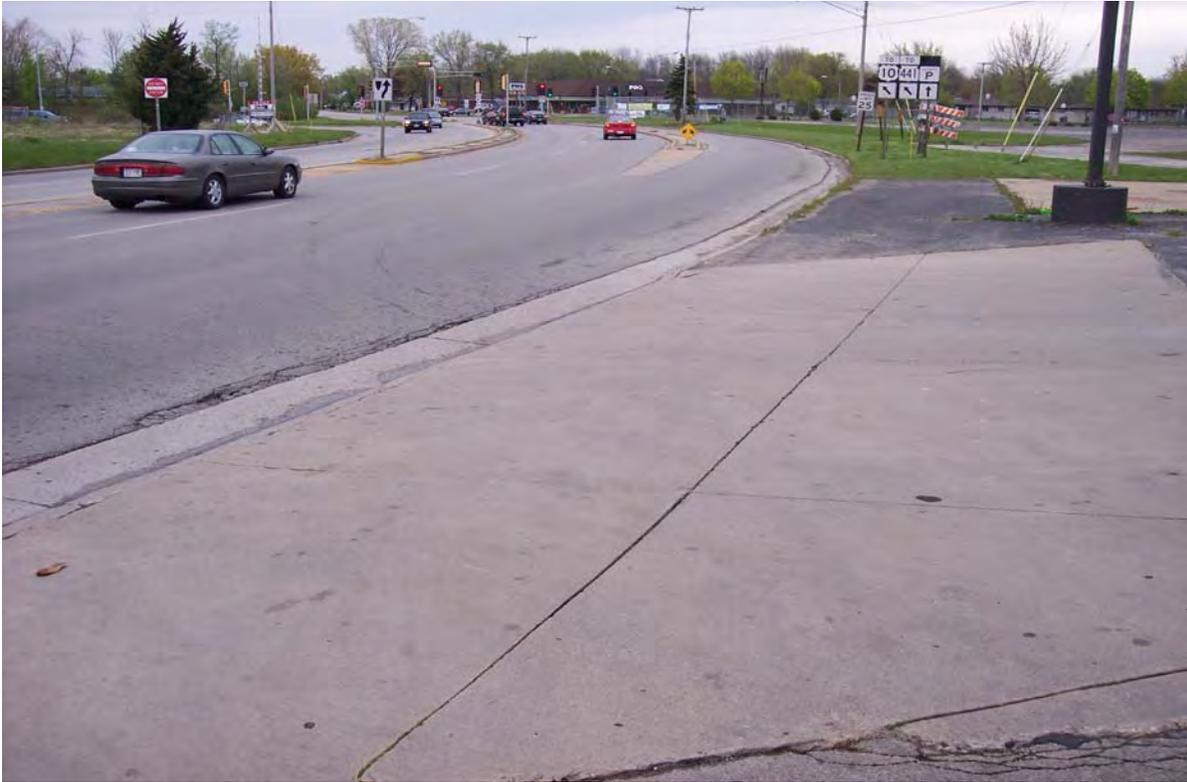
The corners of the driveways from the Auto Exchange and the Citgo gas station onto Racine Road do not have a radius. Overtracking onto the shoulder was visible in these areas.

Recommend reconstructing driveways to provide radial returns.

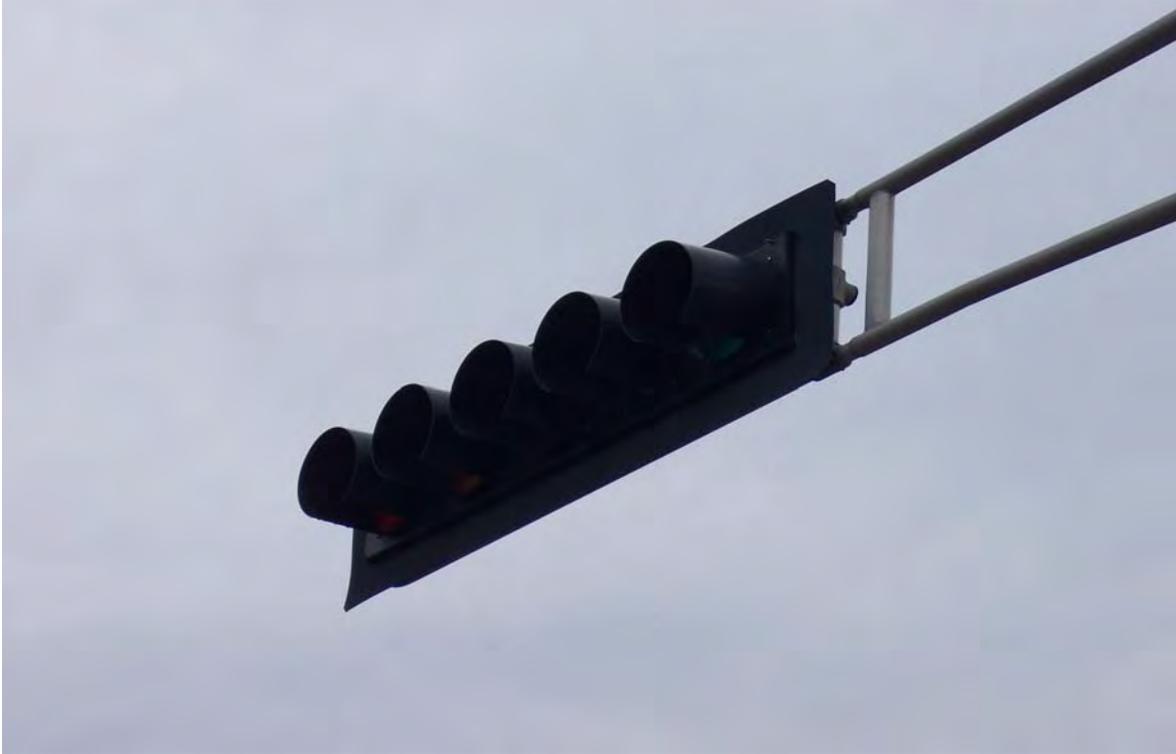
The signals on Racine Road have standard backplates.

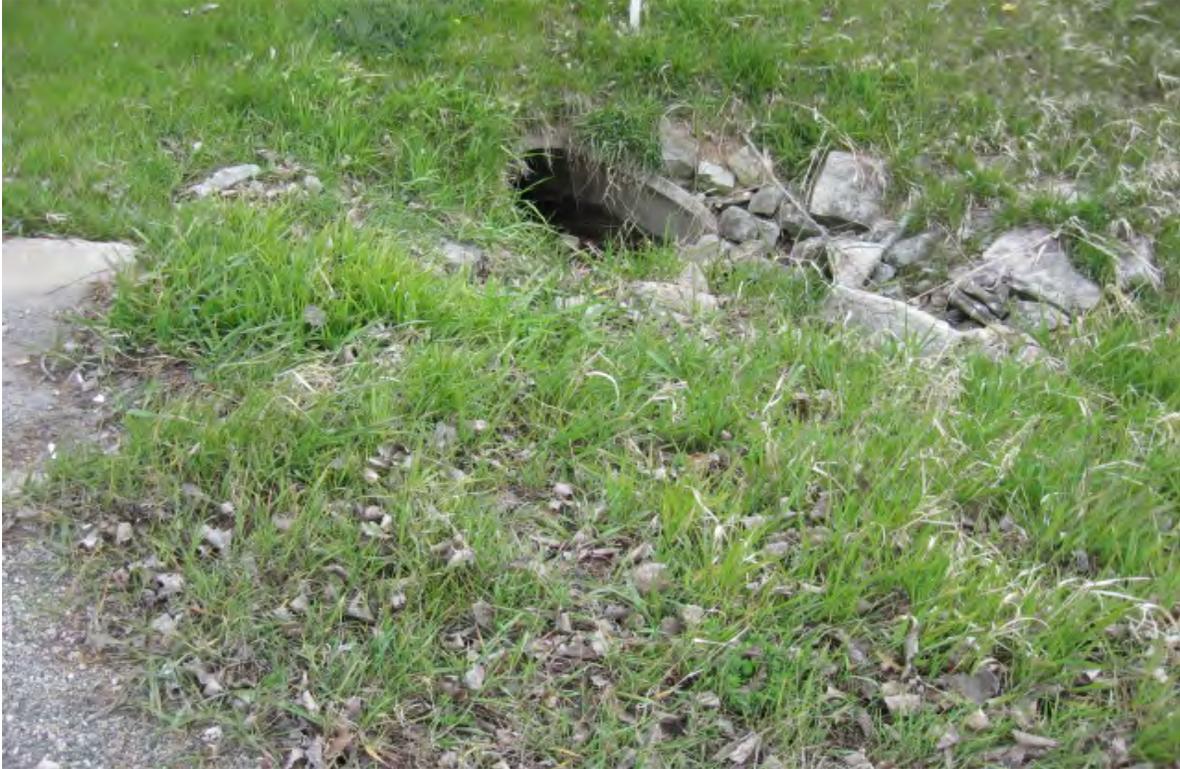
On WIS 441 westbound, west of the Midway Road interchange there are unshielded mitered end sections and steep back slopes within the clear zone.

Remove the potential hazards from the clear zone through reconstruction. If this is not possible, shield the mitered end sections and steep back slopes.

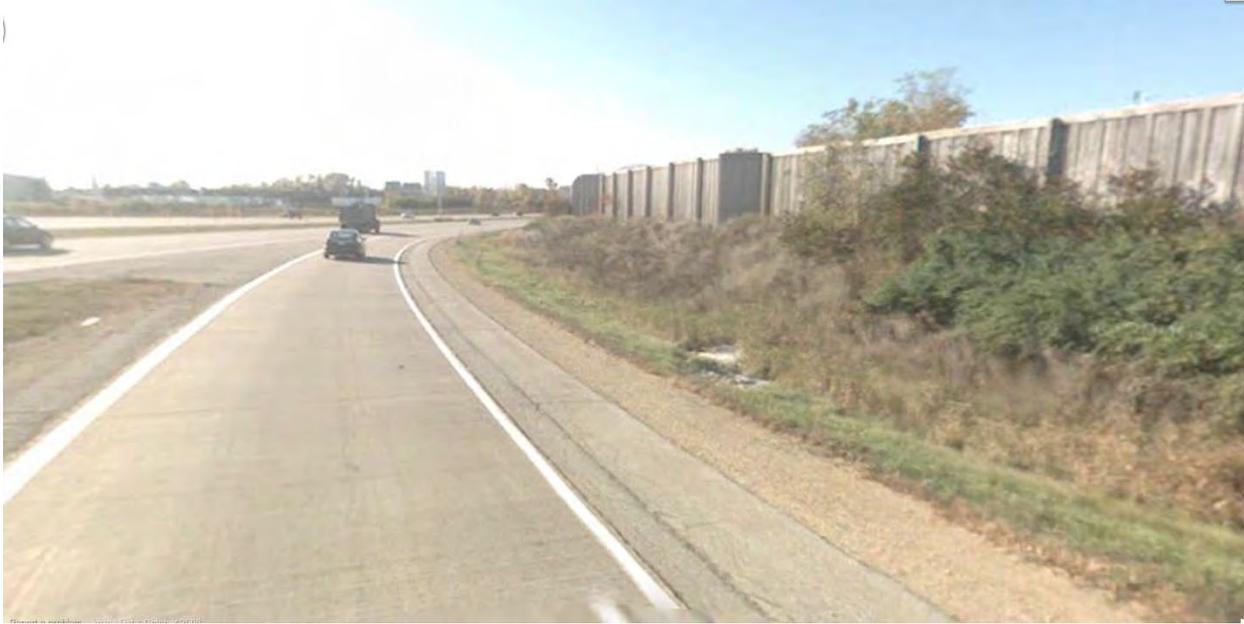
The Midway Road westbound on-ramp has a front slope of 40% and a back slope of 60% on the right side. These steeper slopes are not considered to be recoverable and are not shielded.

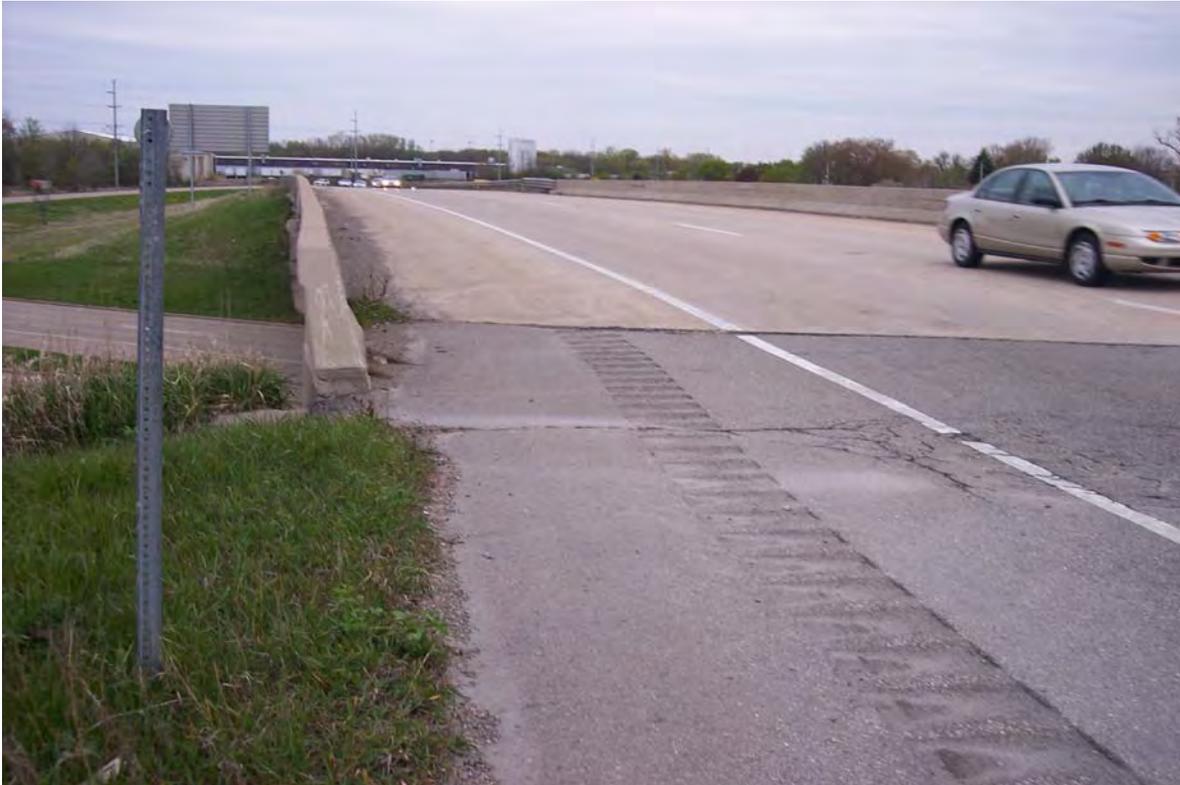
The front slope on the south side on the overpass at Midway Road is 42% and unshielded, and the front slope on the north side is greater than 50% and unshielded. The shoulder on both sides of the bridge is narrow.

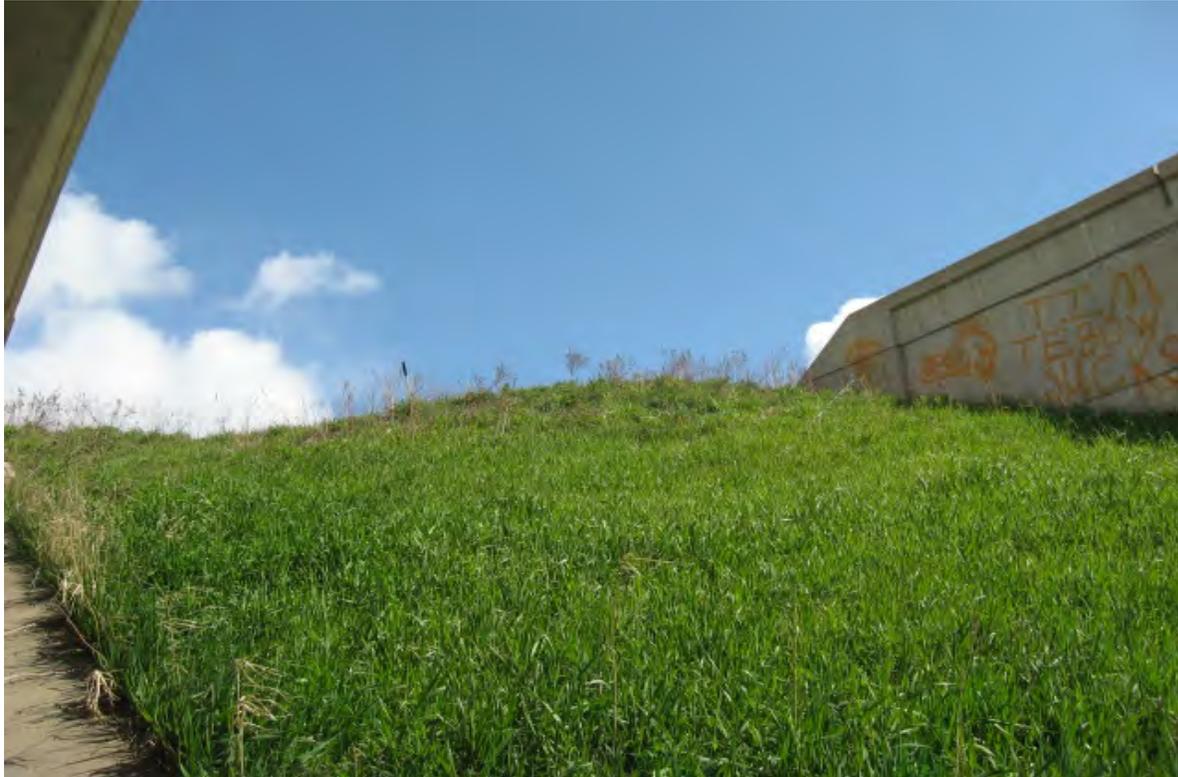
There is no guardrail or fencing at the top of bridge abutment slopes on the Midway Road overpass. A barrier would provide protection for maintenance working in the area and prevent pedestrians on Midway Road from accessing the WIS 441 median area.

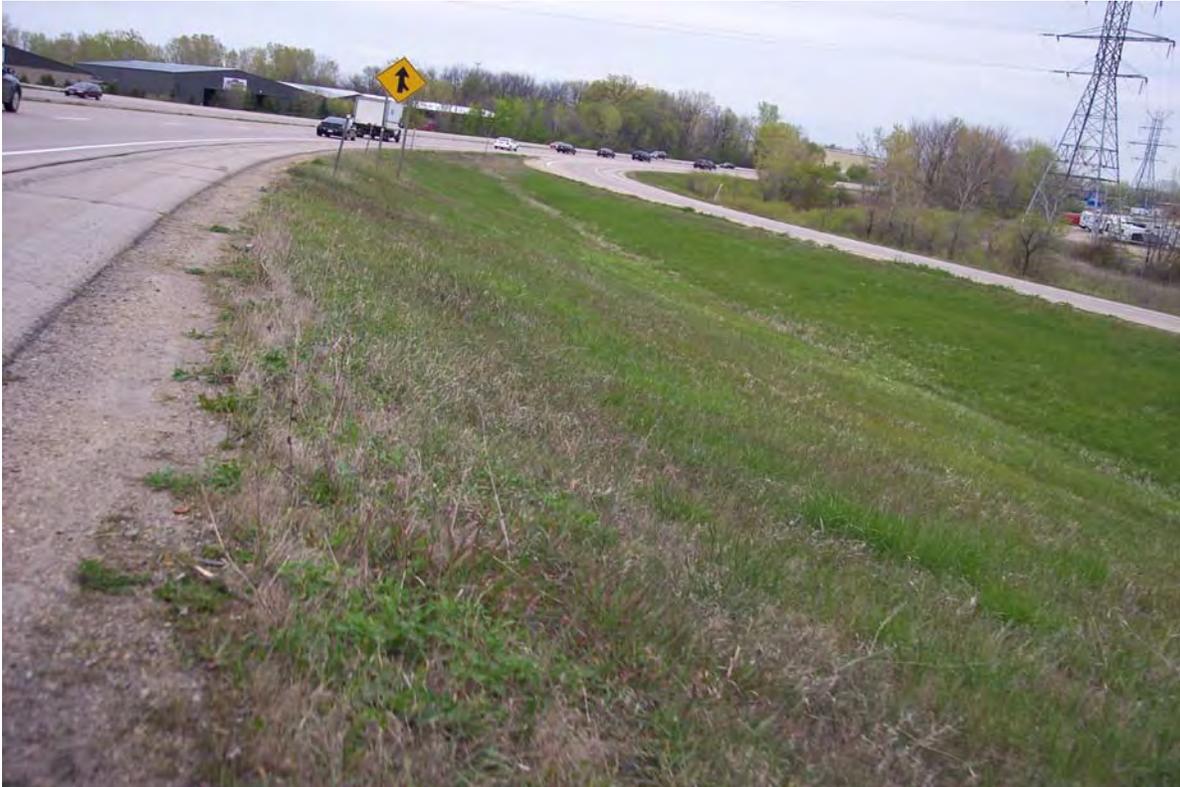
The slope on the shoulder on the south side just past the overpass for Midway Road is 38%. The area is not shielded. This slope is considered to be unrecoverable. This can be a safety issue if a vehicle runs off the road in this area.

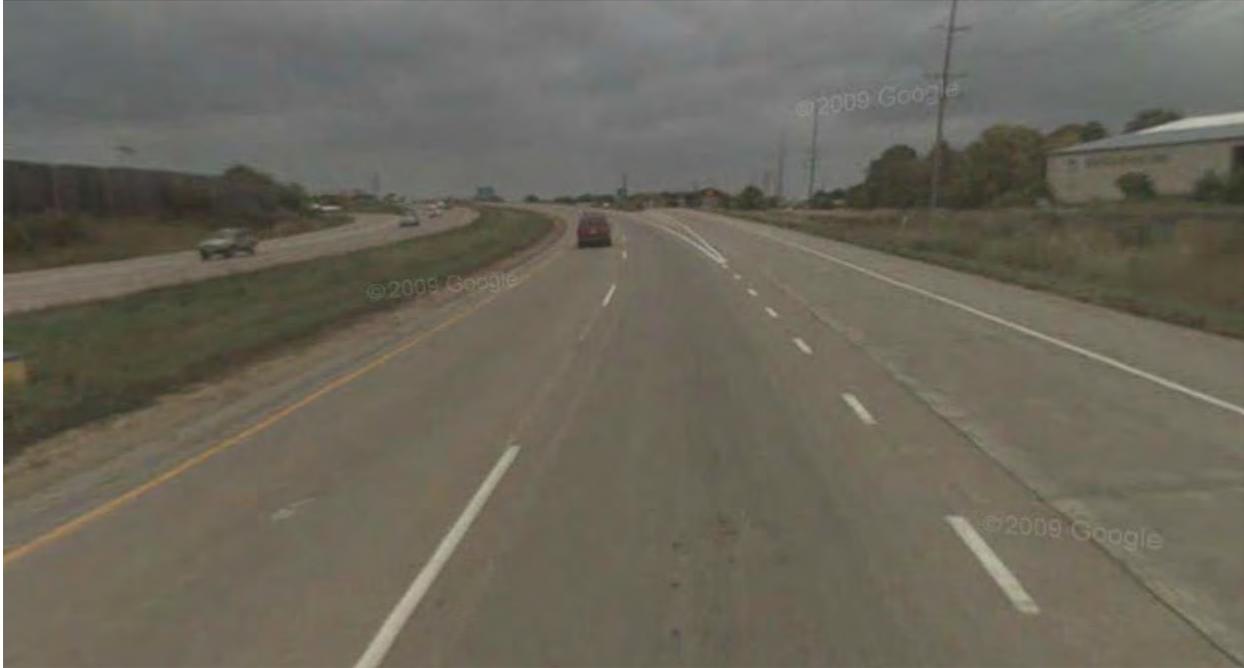
The eastbound WIS 441 Midway Road exit ramp alignment encourages a high speed exit because it aligns with the mainline.

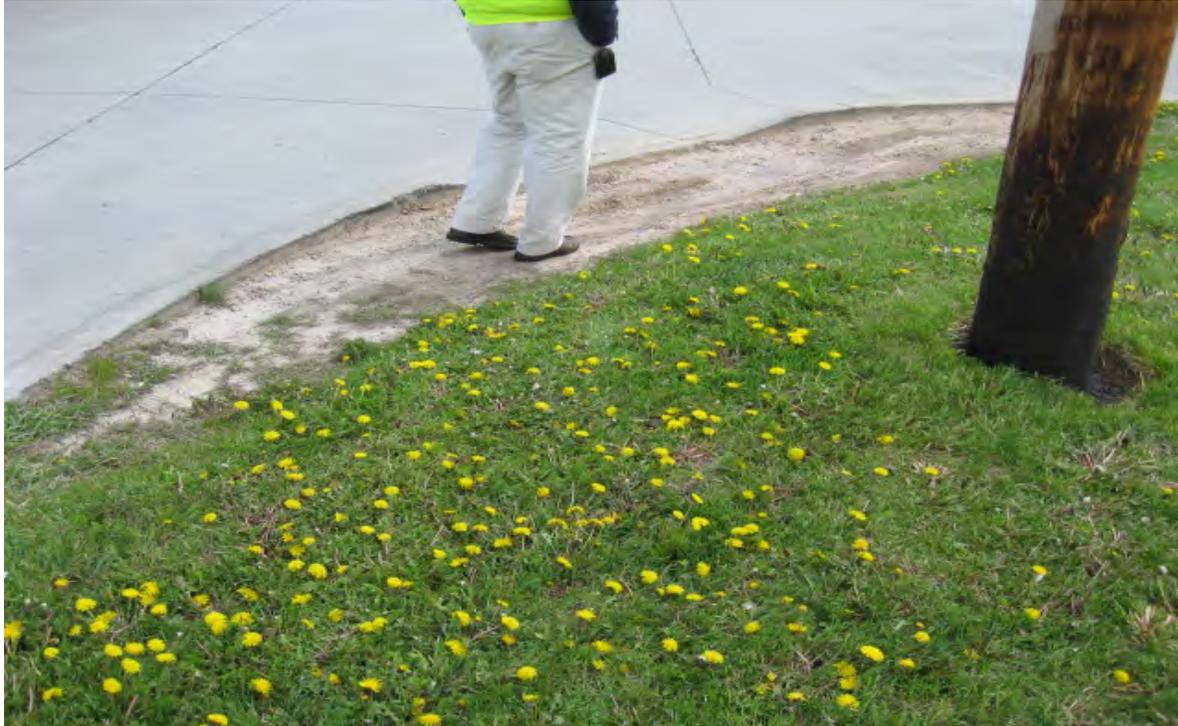
There is evidence of overtracking on the corner at the intersection of Midway Road and Earl Street. There is heavy truck traffic in this area and the radii are not sufficient to accommodate the vehicular movements.

Recommend increasing the radius for all corners at this interchange to accommodate the heavy vehicle traffic in this area.

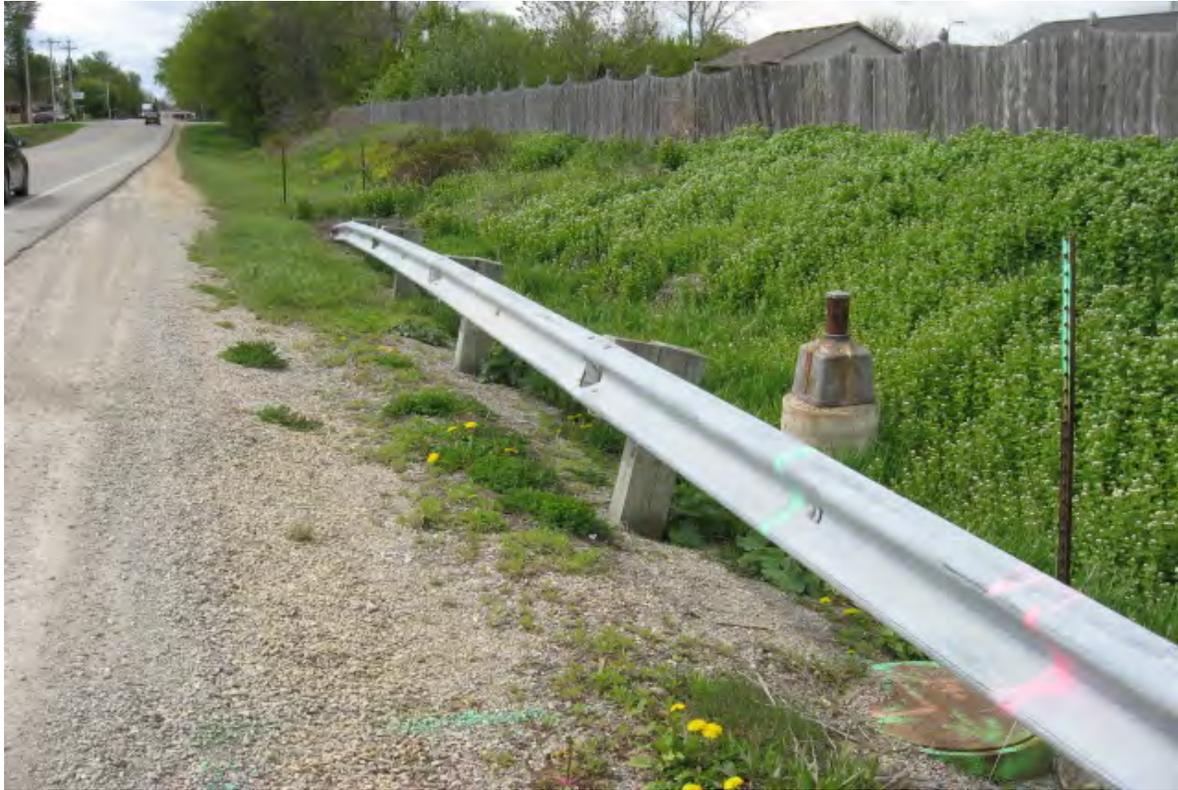
Issue 75: Guardrail and other hazards

On the west side of the T-intersection of Racine Road and Midway Road, there is guardrail shielding a slope and old signal equipment.

Regrade the west side of the intersection to remove the slope, remove the old signal equipment and any other hazards and remove the guardrail.

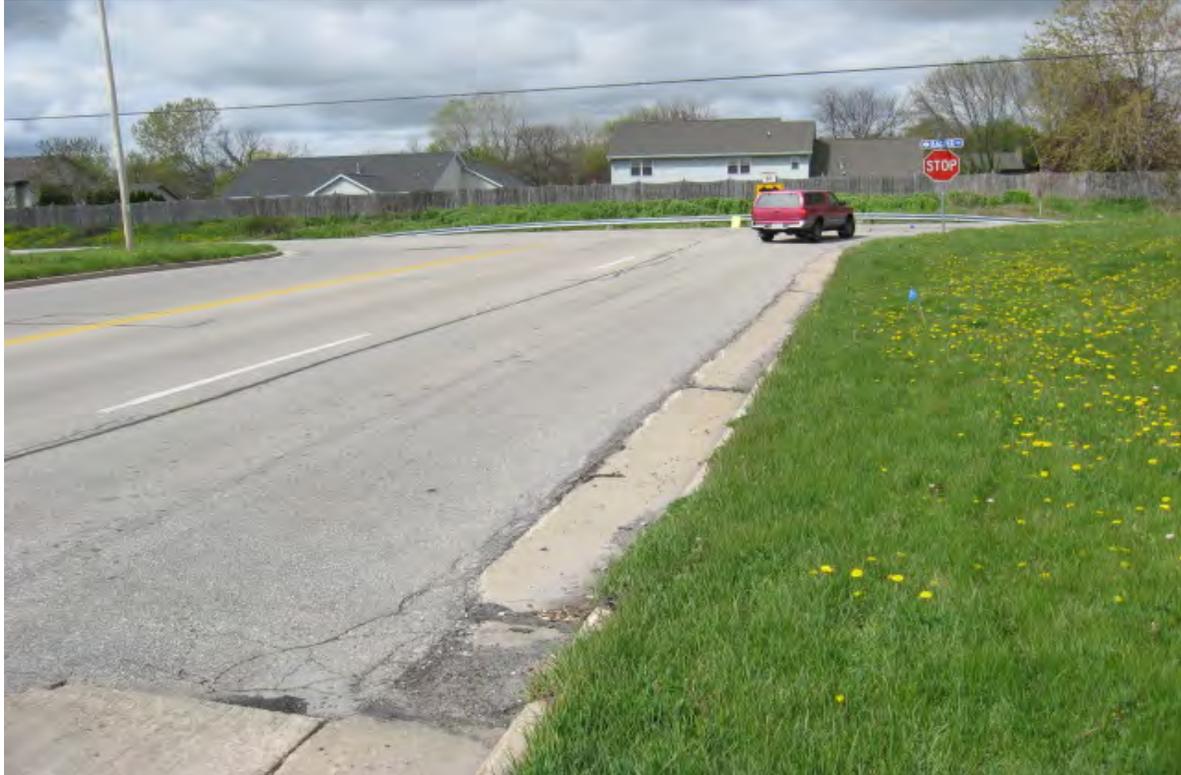
There are no bicycle lanes on Midway Road. Bicyclists in this area must travel in the roadway or on the shoulder in this area.

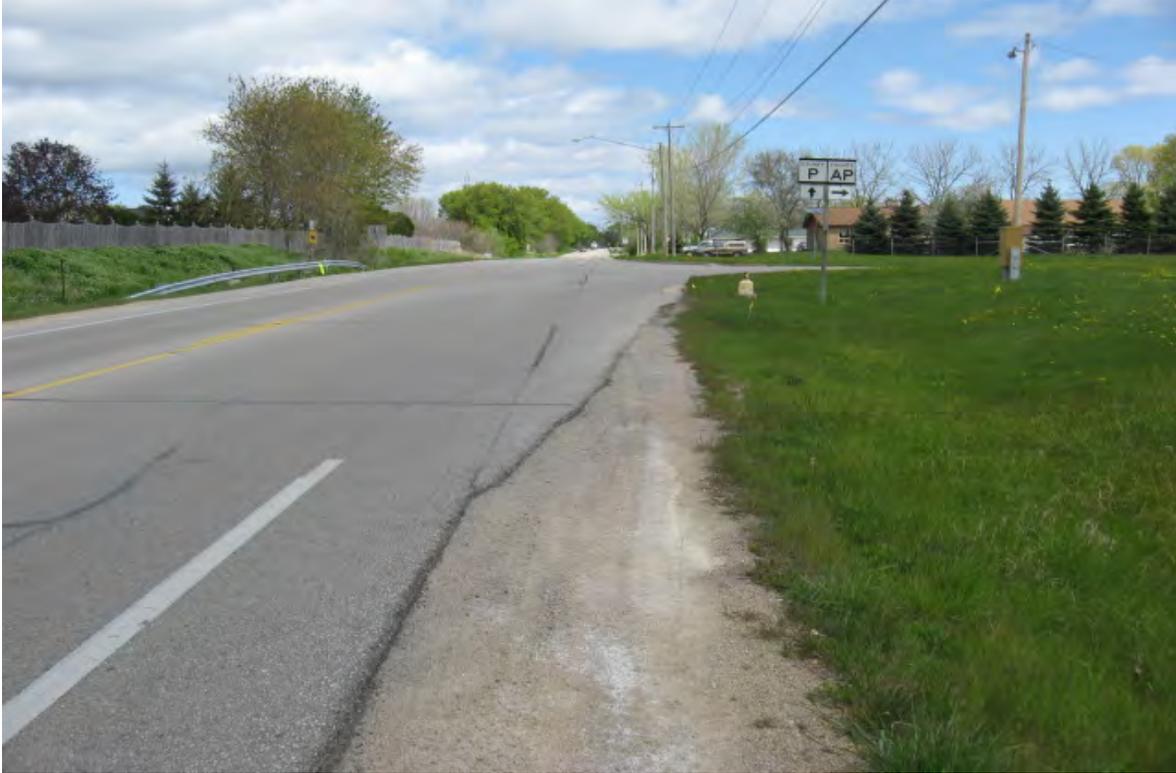
Trailblazer signs are located directly at the intersection. This does not provide advance notice to the motorist approaching the intersection and allow time to make a lane change prior to reaching the intersection.

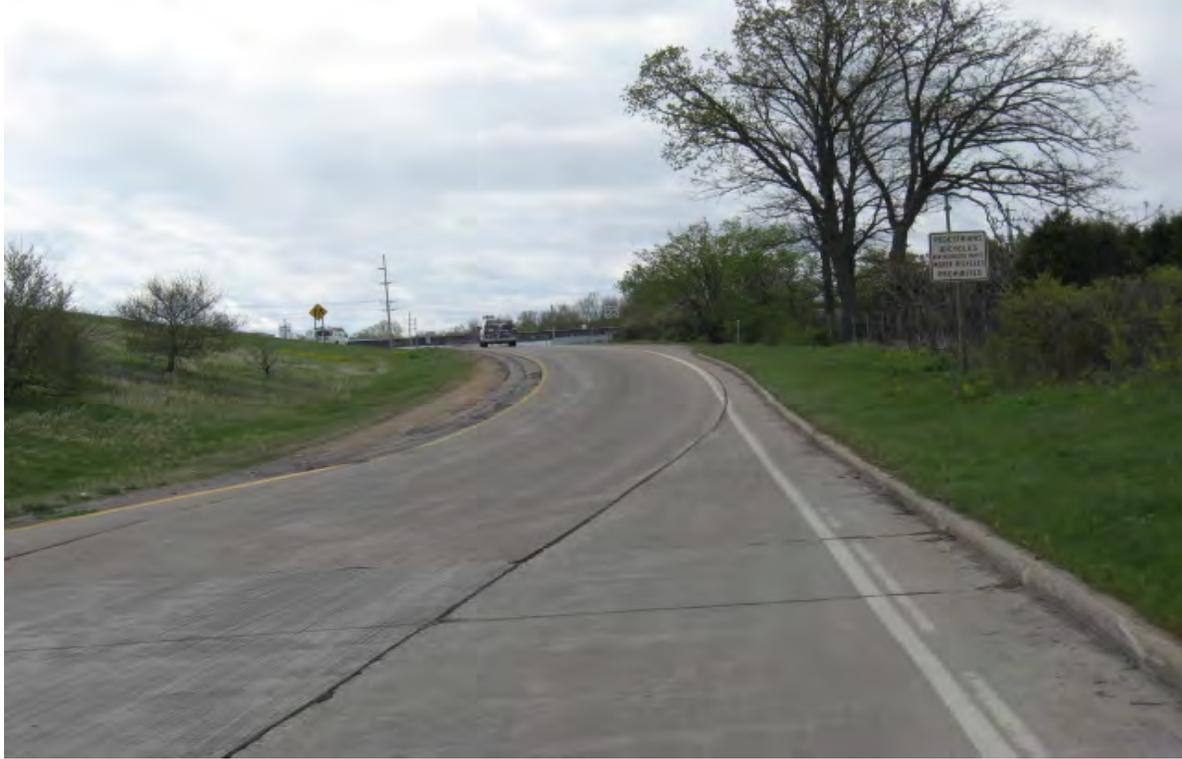
There is a 55 mph speed limit sign posted on the westbound WIS 441 on-ramp at Midway Road. This is the speed limit of the mainline WIS 441, not the ramp.

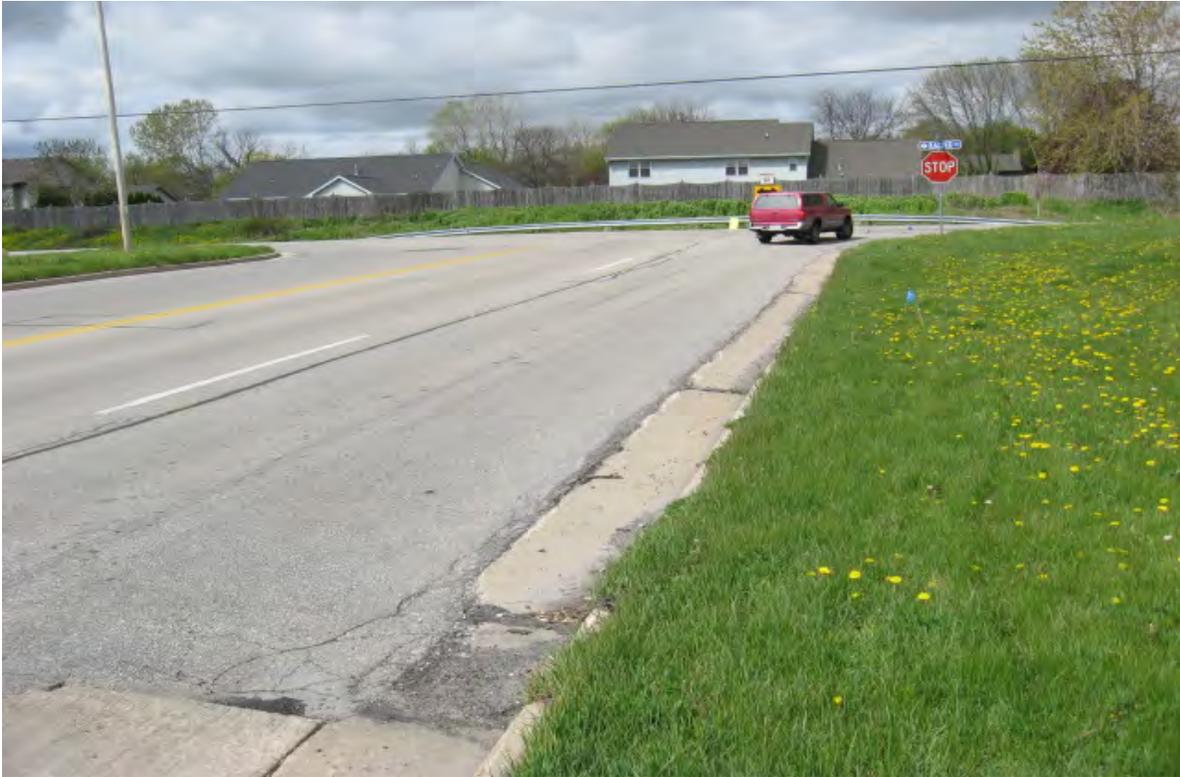
The arrow sign at the T-intersection of Midway Road with Racine Road does not have adjacent object markers.

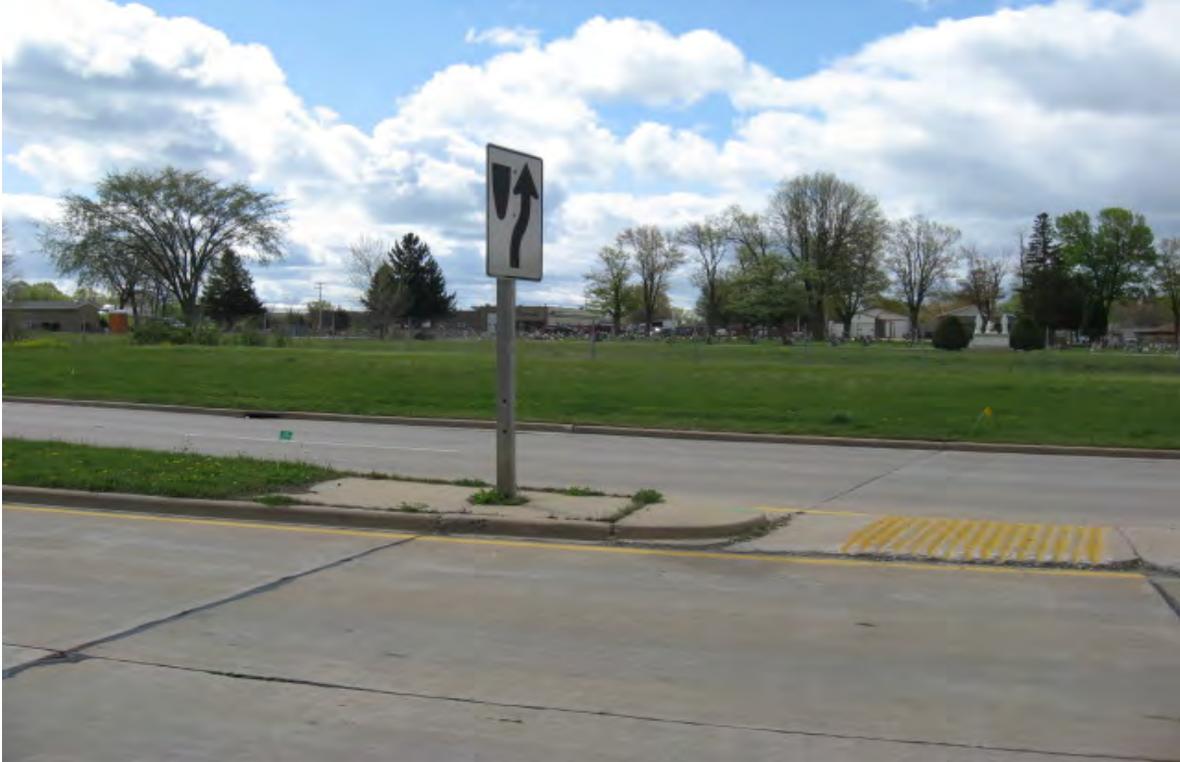
There are no delineators on the median noses.

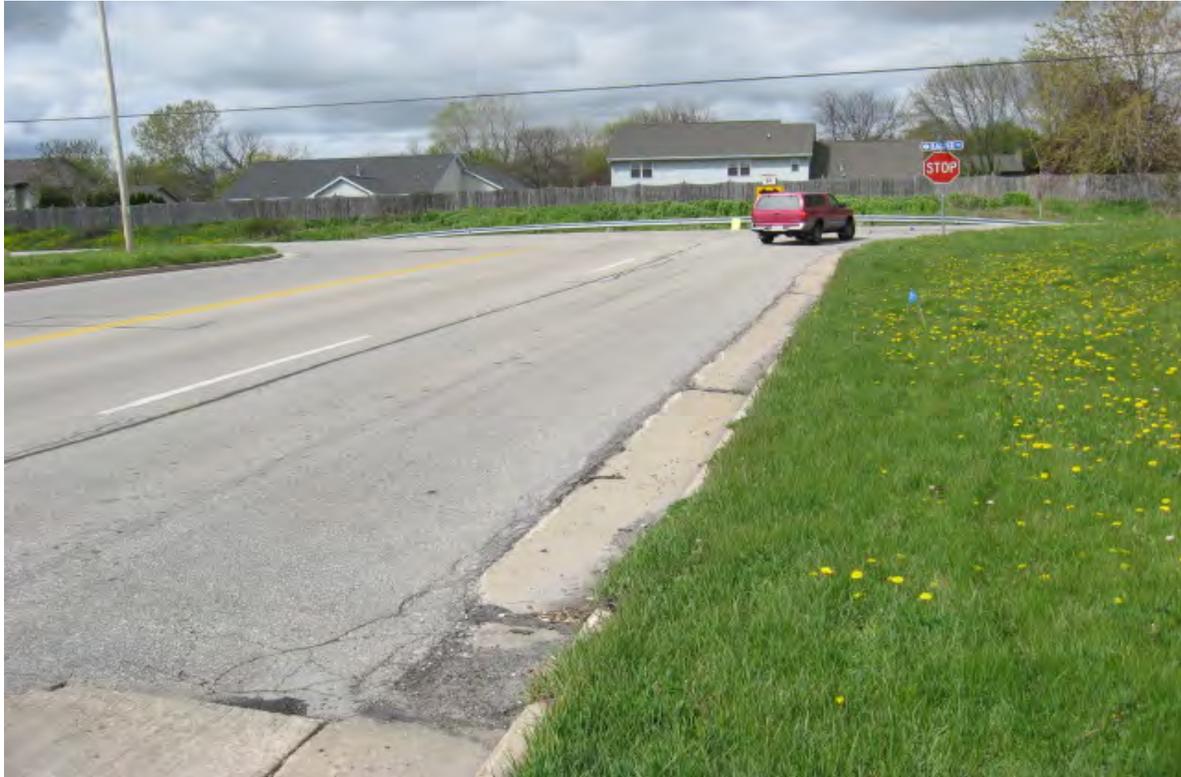
The lanes on Midway Road approaching the T-intersection with Racine Road do not have pavement arrows, messages, solid lane lines, or a stop bar. These pavement markings convey the message to the motorist that they are approaching an intersection and they are in a turn only lane.

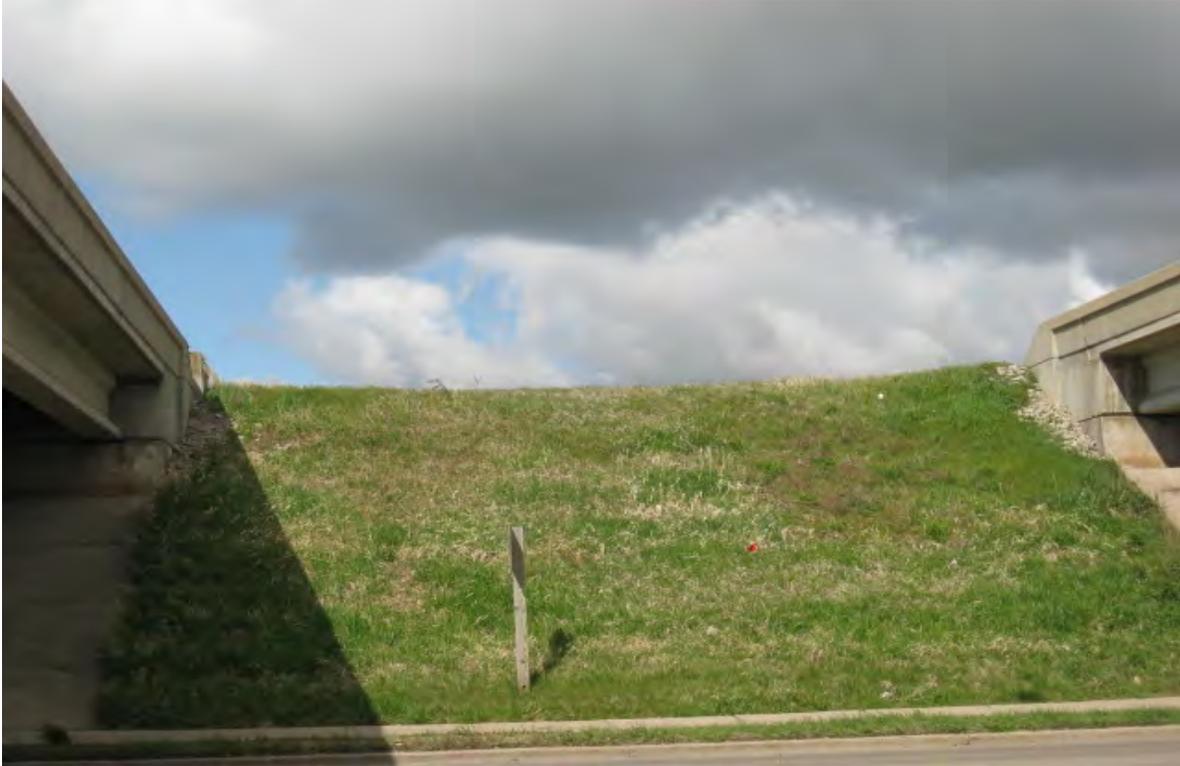
There is no guardrail or fencing at the top of bridge abutment slopes on the Appleton Road overpass. A barrier would provide protection for maintenance working in the area and prevent pedestrians on Appleton Road from accessing the WIS 441 median area.

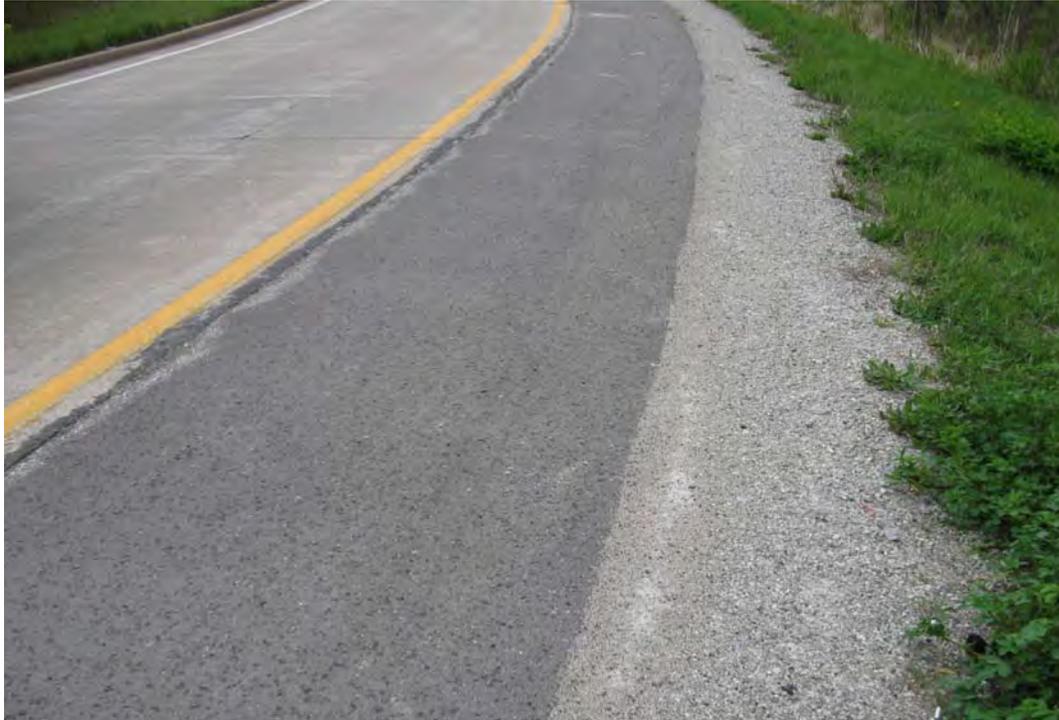
The loop ramp for southbound US 41 to eastbound WIS 441 does not have any rumble strips on the shoulder. These call attention to the driver that they have left the travel lanes.

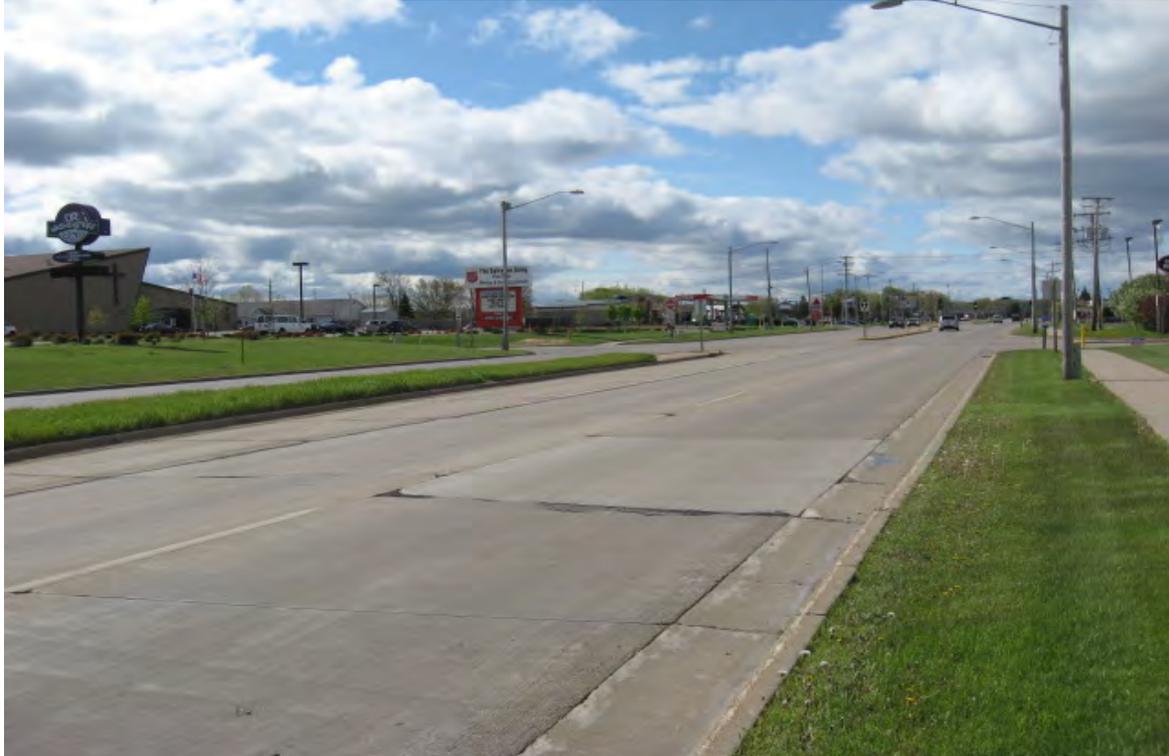
There is no southbound right turn lane into the strip mall at Drum Corps Drive. This strip mall appears to be a high traffic generator.
