Road Safety Audit REPORT

WIS 441 Tri-County Project

Date: Apr 25-26, 2012

Realignment of WIS 441 and reconstruction of five interchanges.

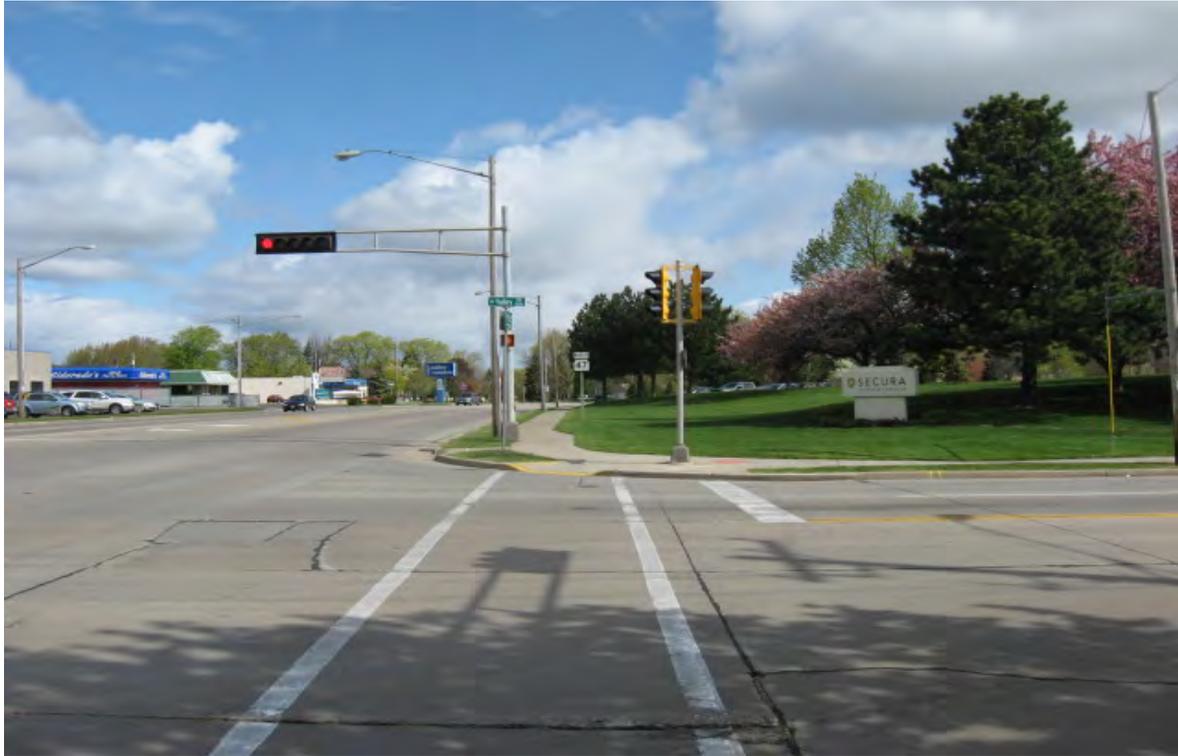
There is no traffic separator for the southbound left turn lane at the intersection of Appleton Road and Valley Road and the transition into the center two-way left turn lane is not in accordance with current standards. A separator serves as crossover protection for vehicles and can also provide refuge for pedestrians crossing the roadway.

Recommend providing a traffic separator for the southbound left turn lane and modifying the transition into the center two-way left turn lane to comply with current standards.

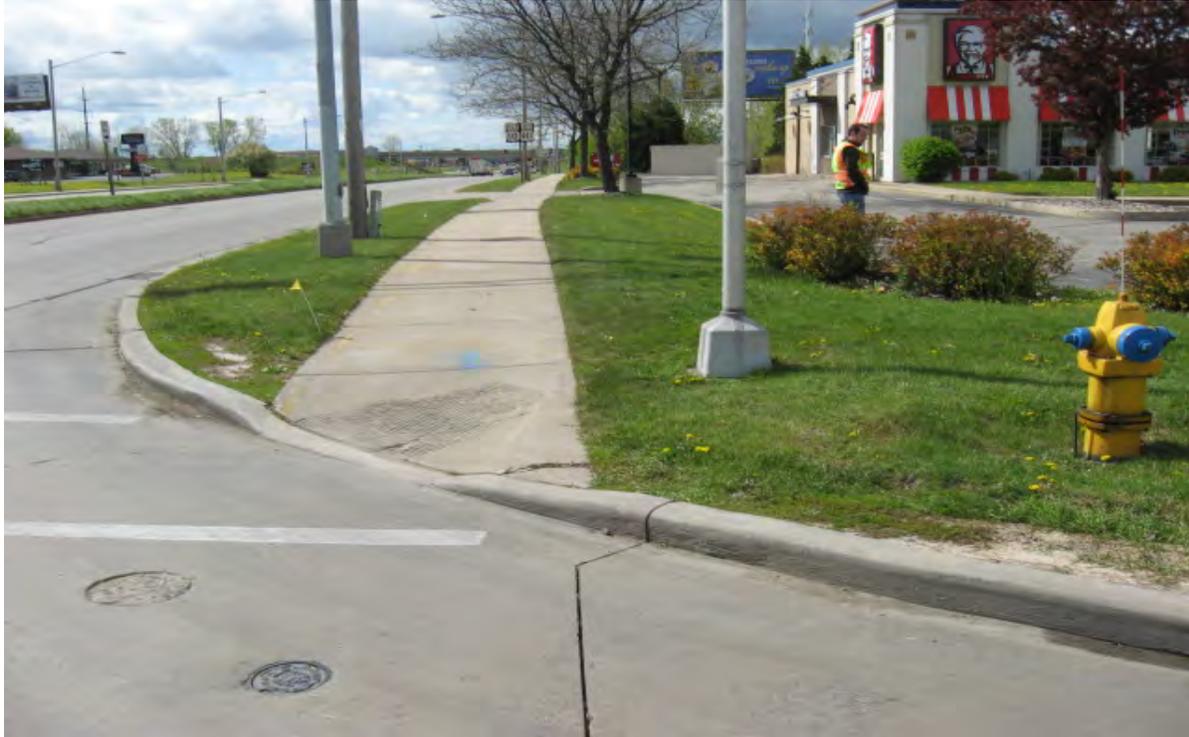
There are no detectable domes in the sidewalk ramps at the intersection of Appleton Road with Valley Road. These provide detection to the visually impaired that they are entering the roadway.

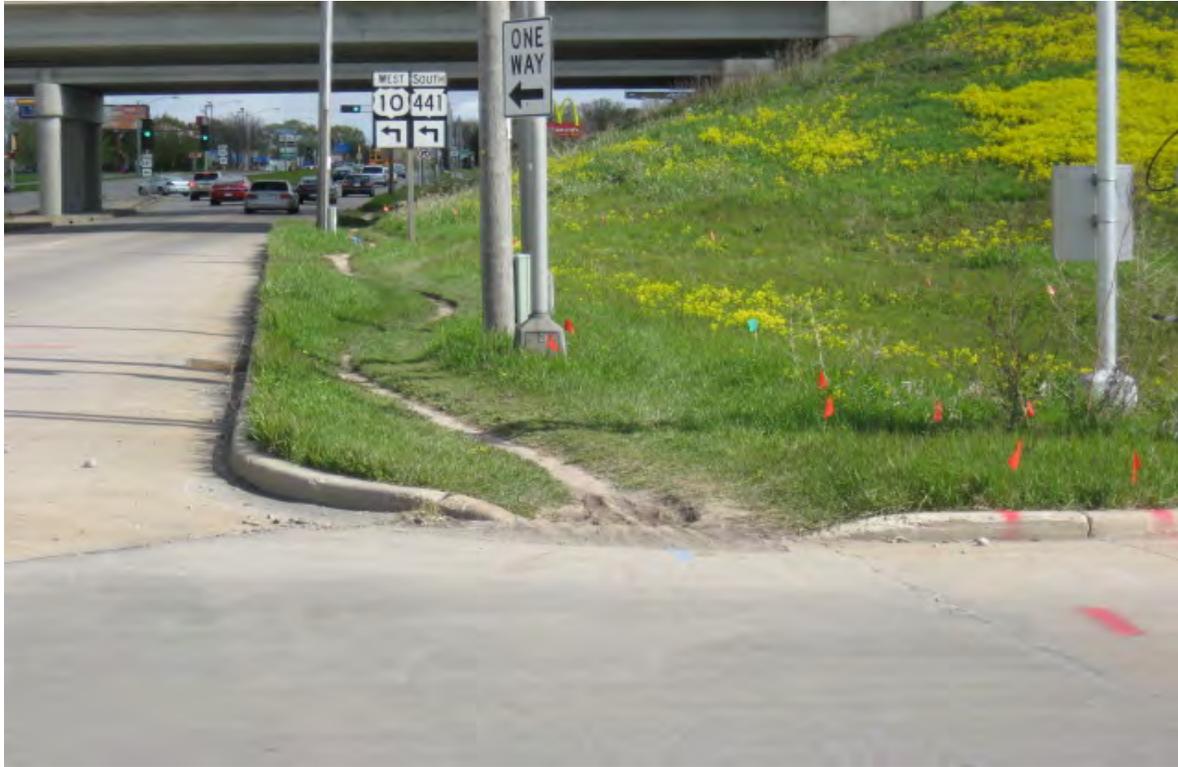
There are no pedestrian features at the intersection of Appleton Road with the WIS 441 eastbound ramps. There are no sidewalks or ramps on the east side.

Install ADA compliant crosswalks and ramps for pedestrians in this area. Provide pedestrian facilities in the proposed condition.

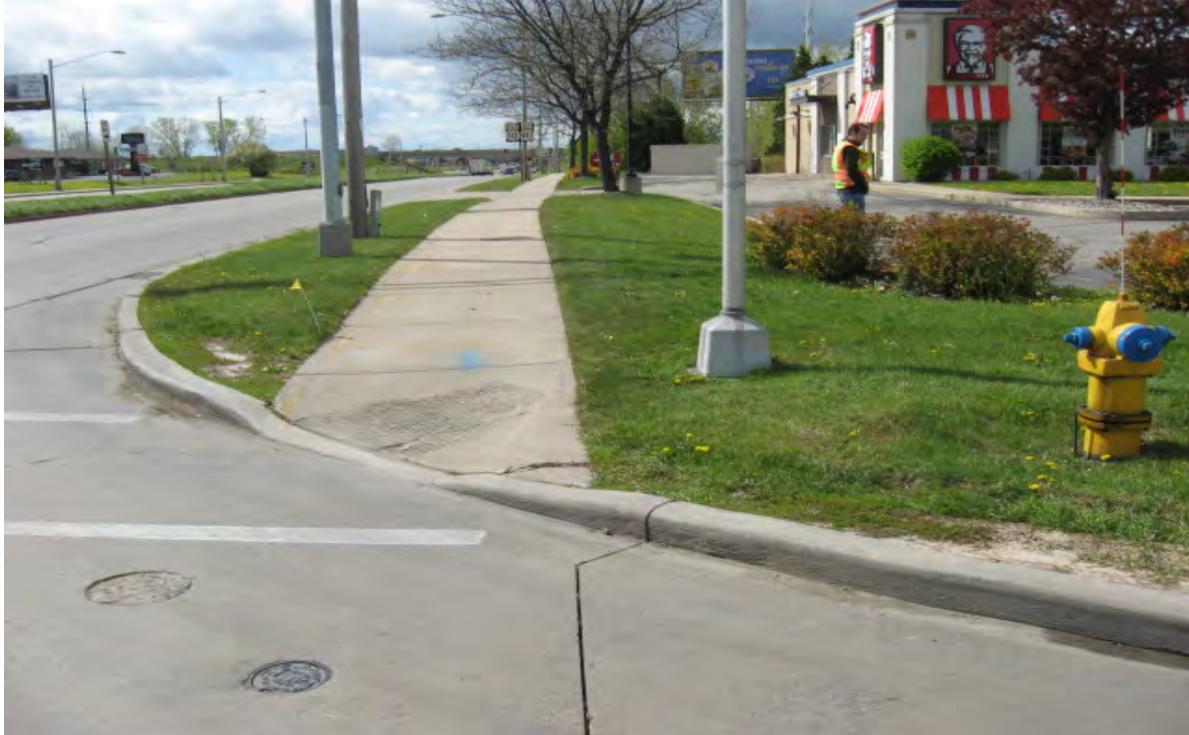
The pedestrian ramps on all of the corners of the intersection of Appleton Road with Valley Road are diagonal. This directs pedestrians using the ramps into the center of the intersection.

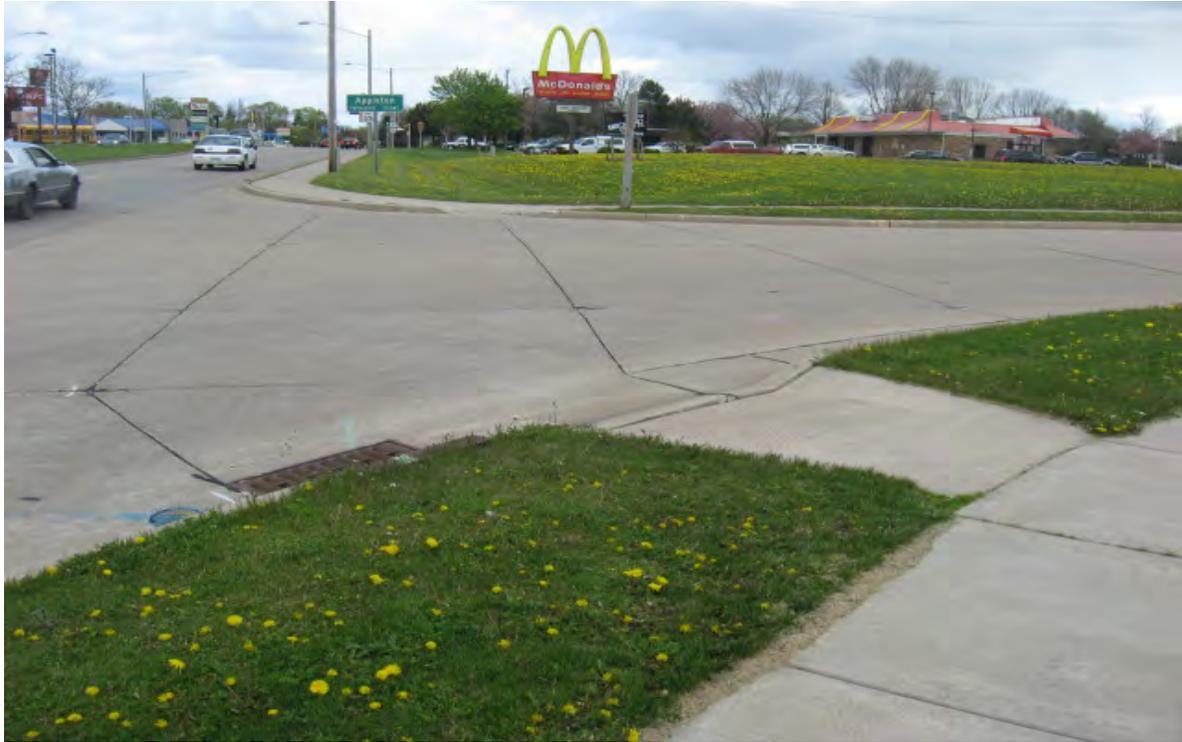
The pedestrian ramps are diagonal at Appleton Road and Tuckaway lane. Also, there is no crosswalk at this intersection.

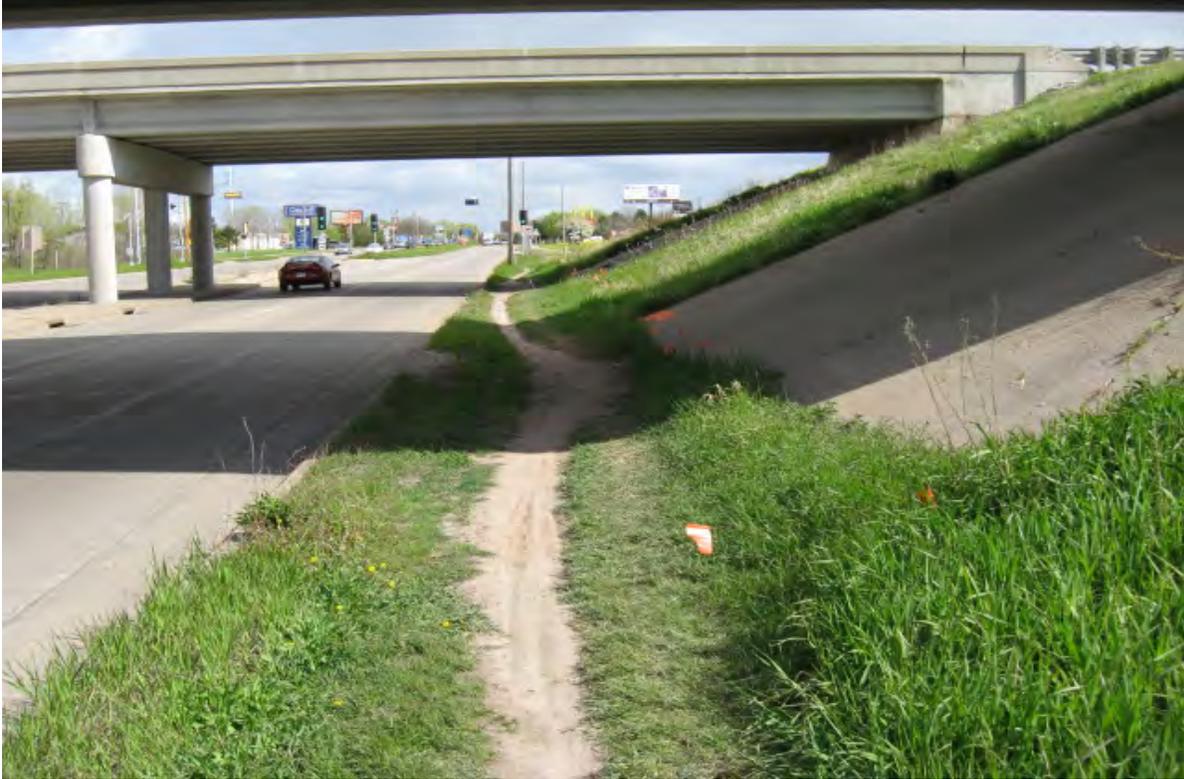
There is no sidewalk on the east side under the WIS 441 overpass.

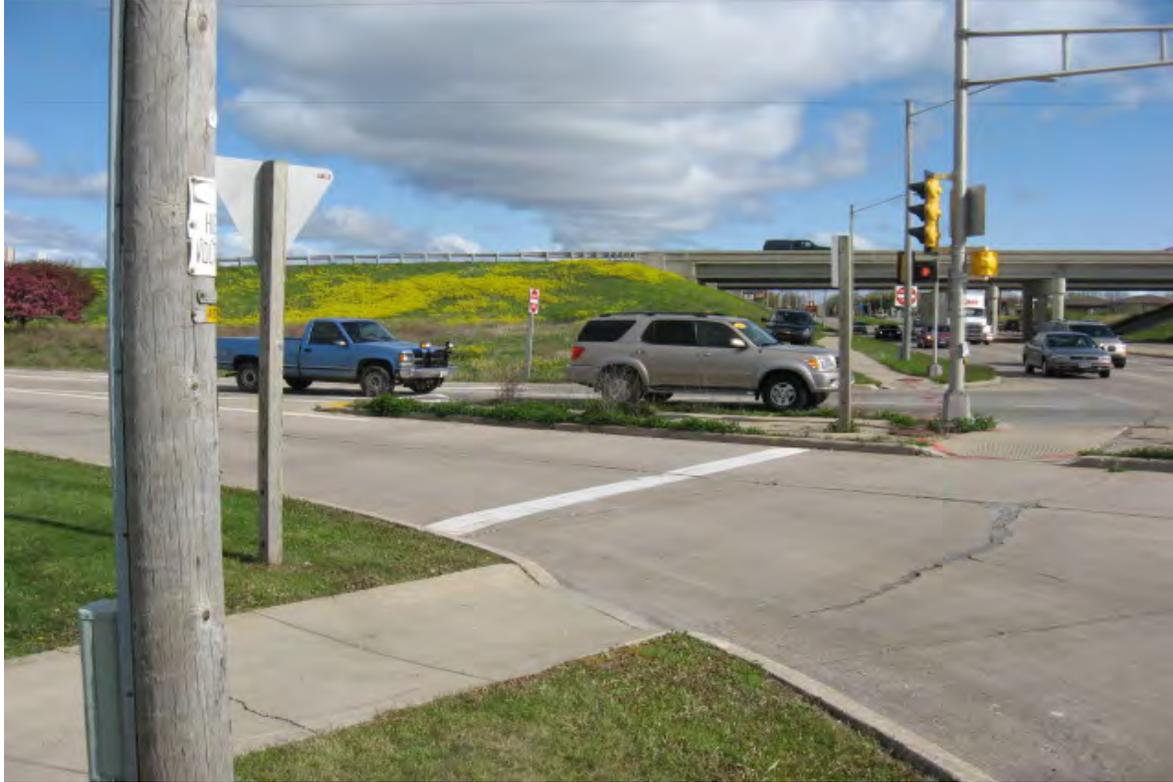
The sidewalk ramps at the intersection of Appleton Road with the WIS 441 westbound ramps are not ADA compliant.

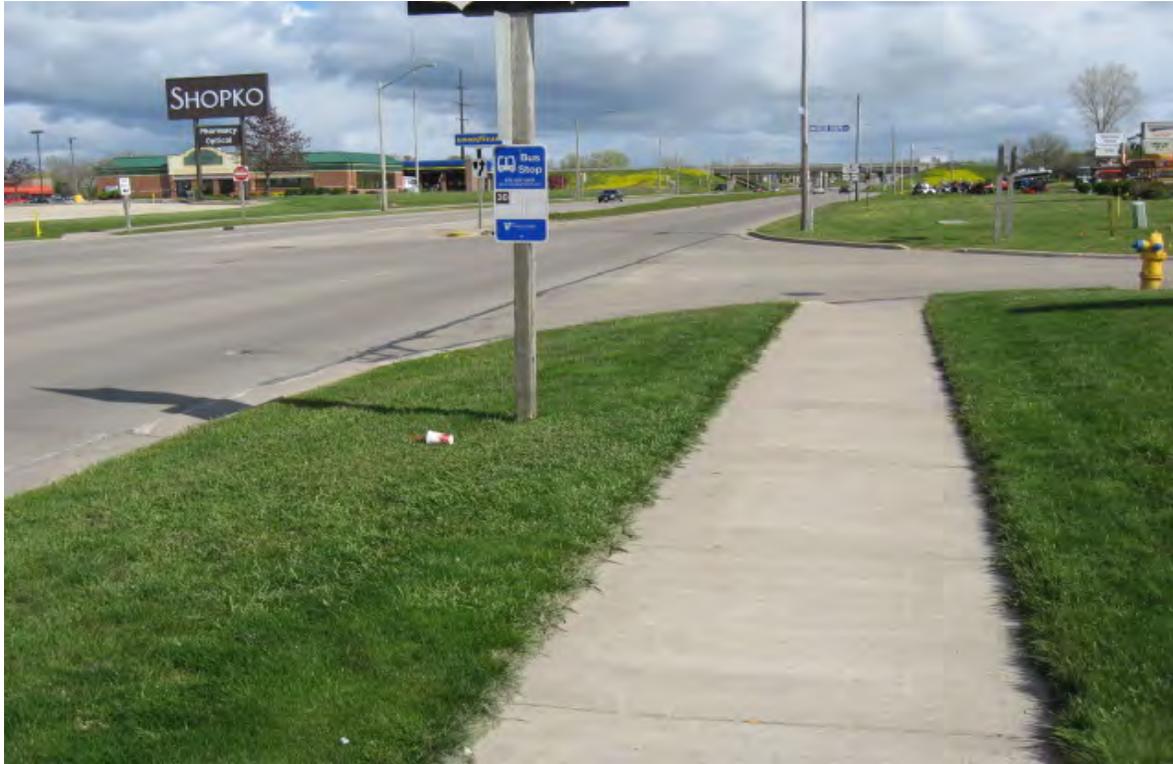
The sidewalk ramps at Drum Corps near the strip mall are diagonal and there are no crosswalks.

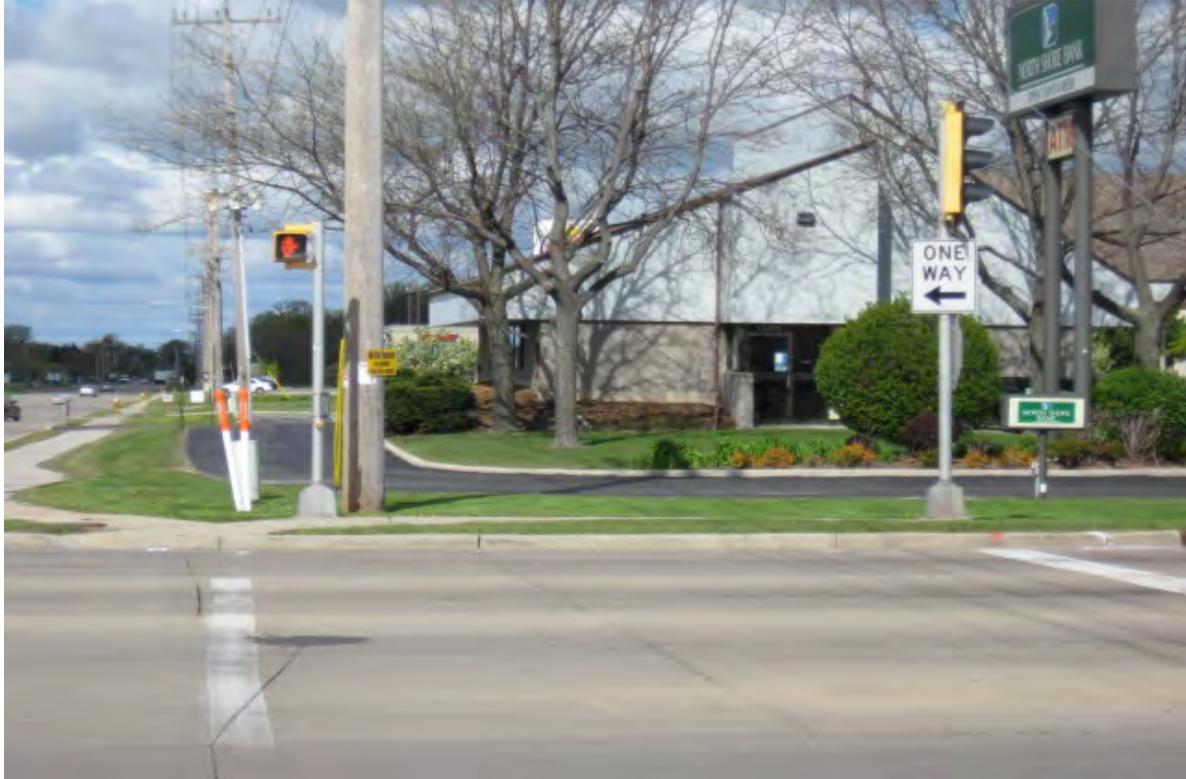
The sidewalk on the northwest corner of the intersection of Midway Road with Appleton Road is not ADA compliant and the ramp is diagonal. There is only one crosswalk at the intersection which is on the north side. The sidewalks and ramps are only on the northwest and northeast corners of the intersection.

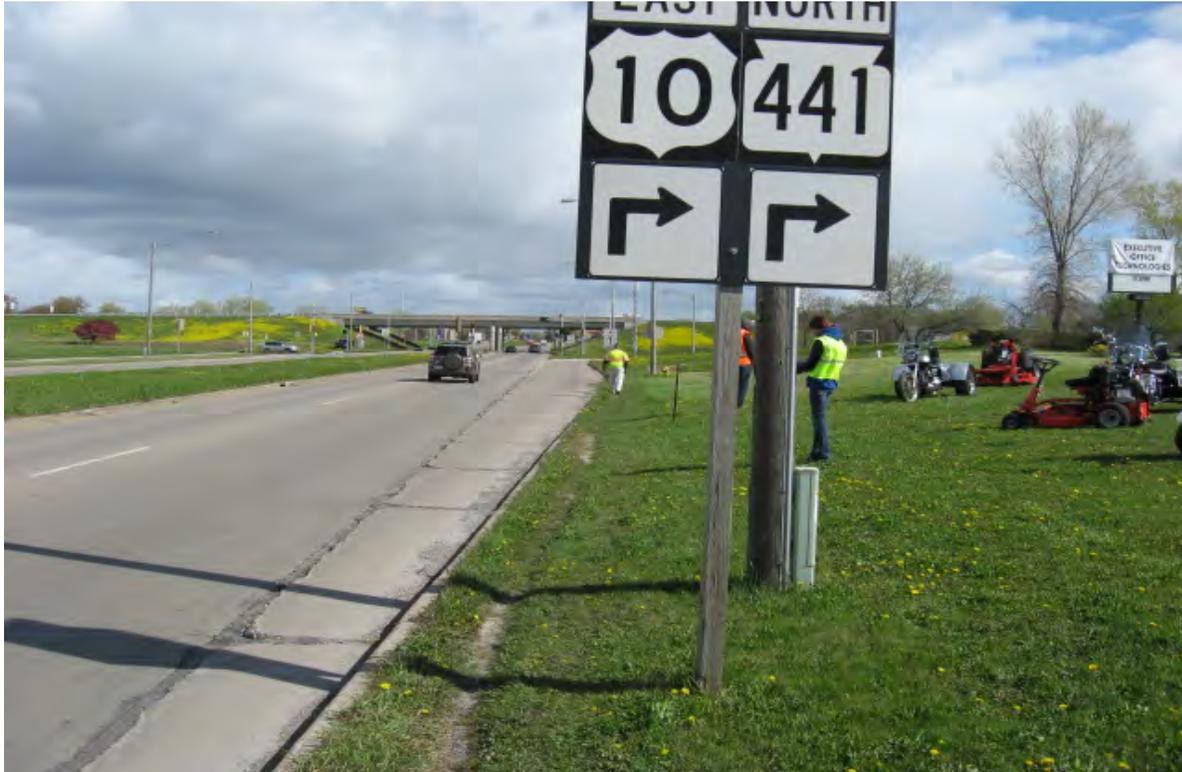
Issue 113: Bicycle path worn

There are no bicycle lanes on Appleton Road. There is a bicycle path in the grass on the east side with bicycle track marks.

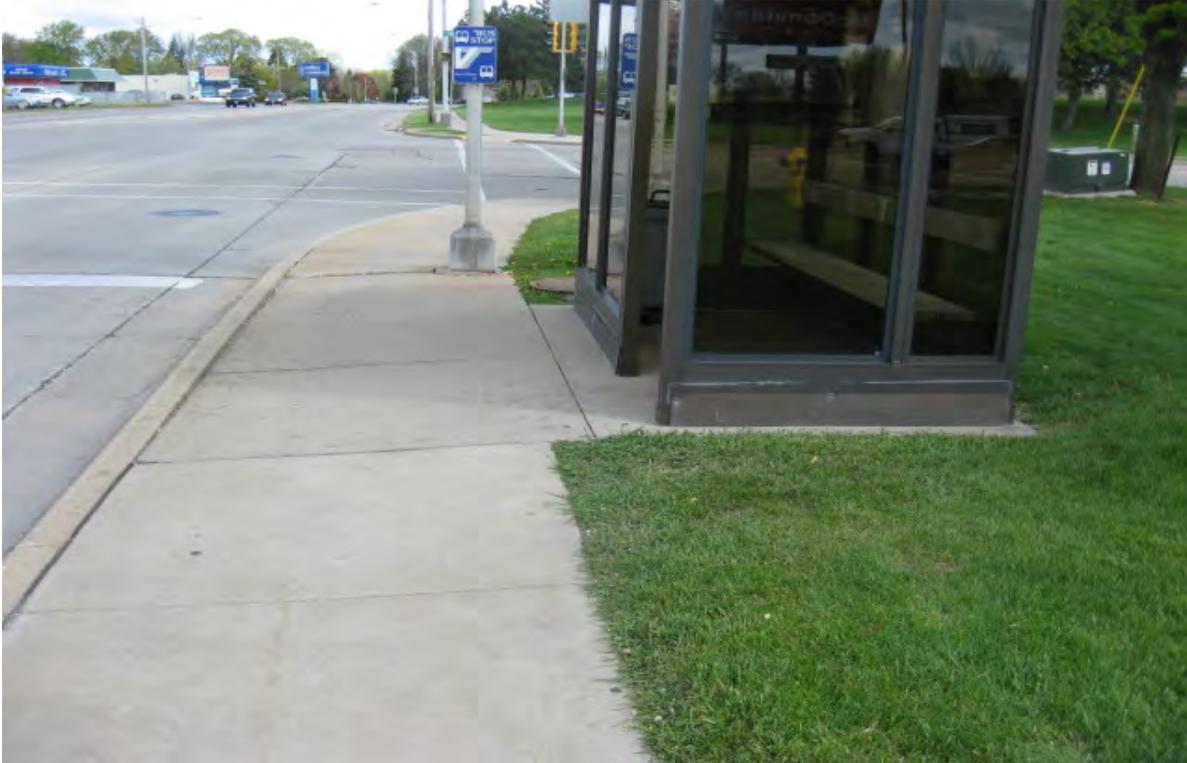
The bus shelter at Appleton Road and Tuckaway Lane is not ADA accessible.

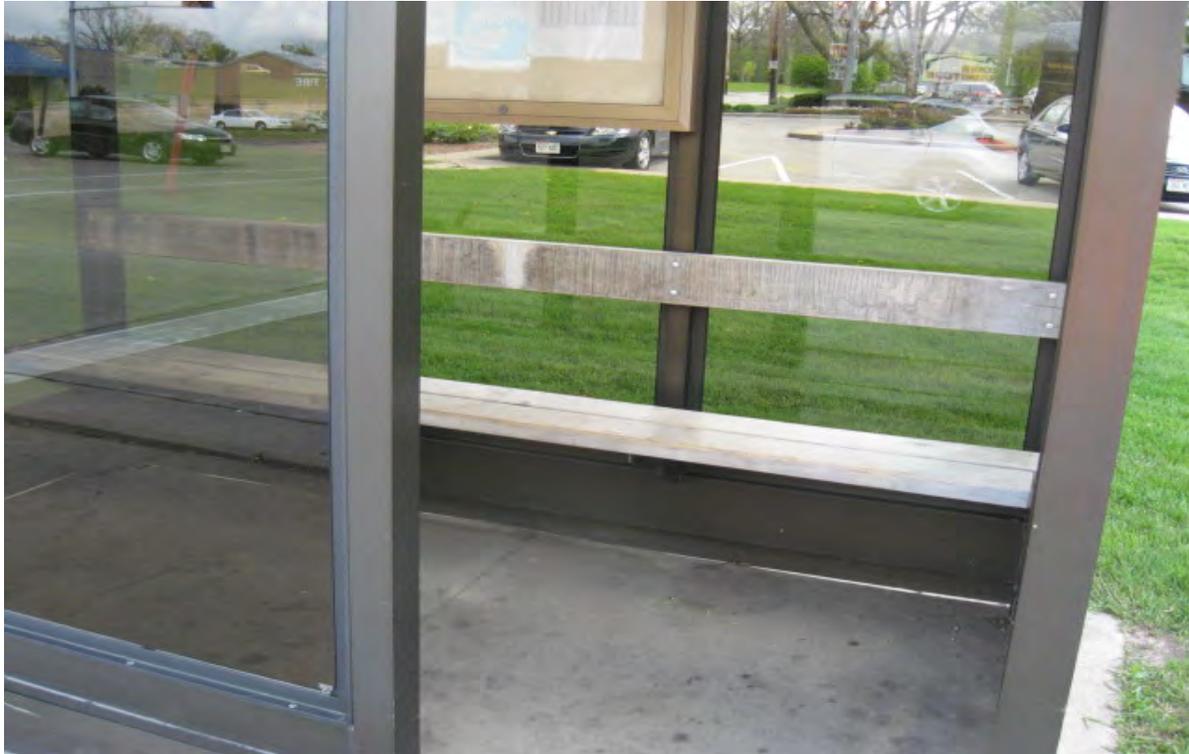
The bus shelter and bench at the SE corner of the intersection of Appleton Road with Valley Road are not ADA compliant.

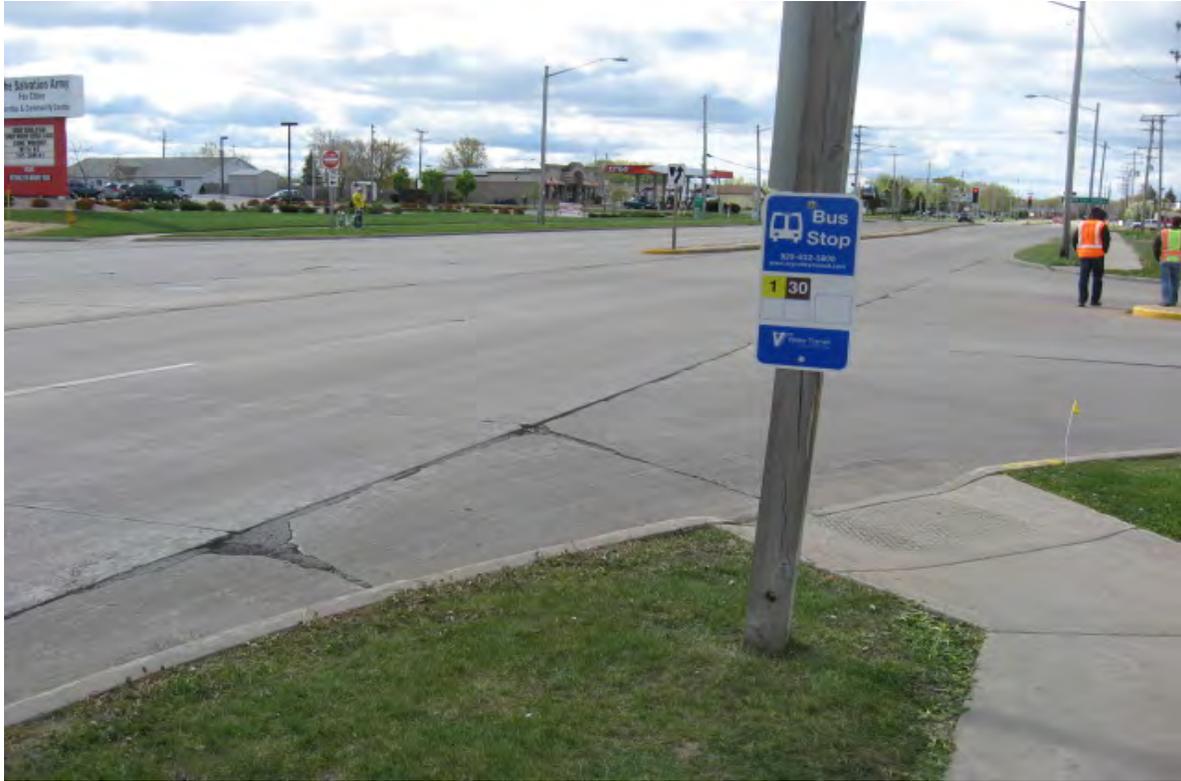
The bus stops on both sides of Appleton Road are not ADA compliant.

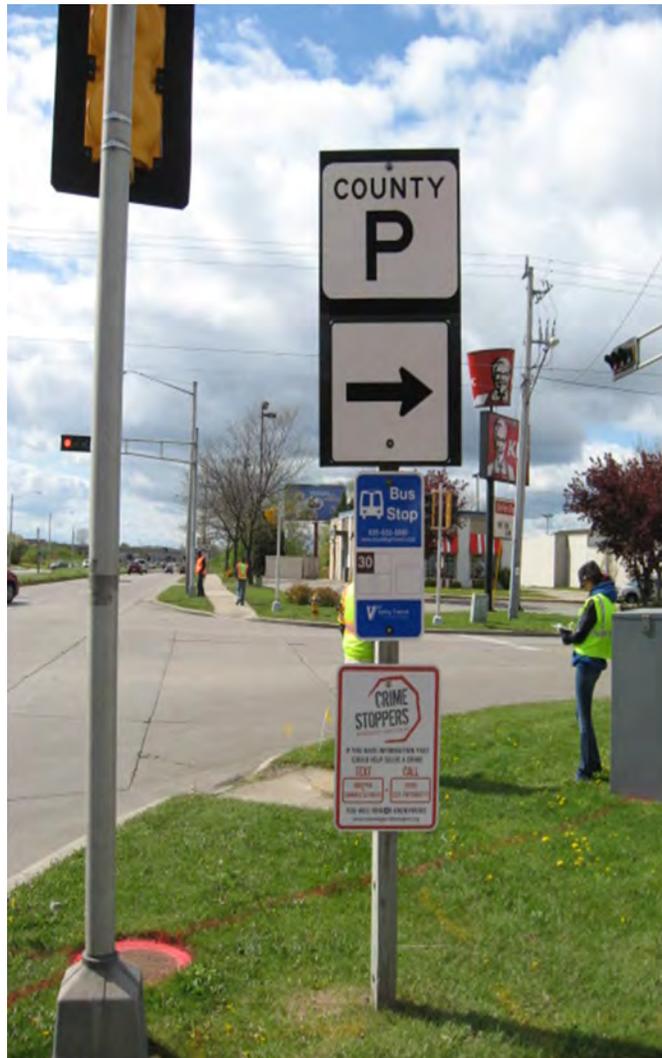
The trailblazers at Midway Road and Appleton Road are located right at the intersection. This does not provide advance notice to the motorist approaching the intersection and allow time to make a lane change prior to reaching the intersection.

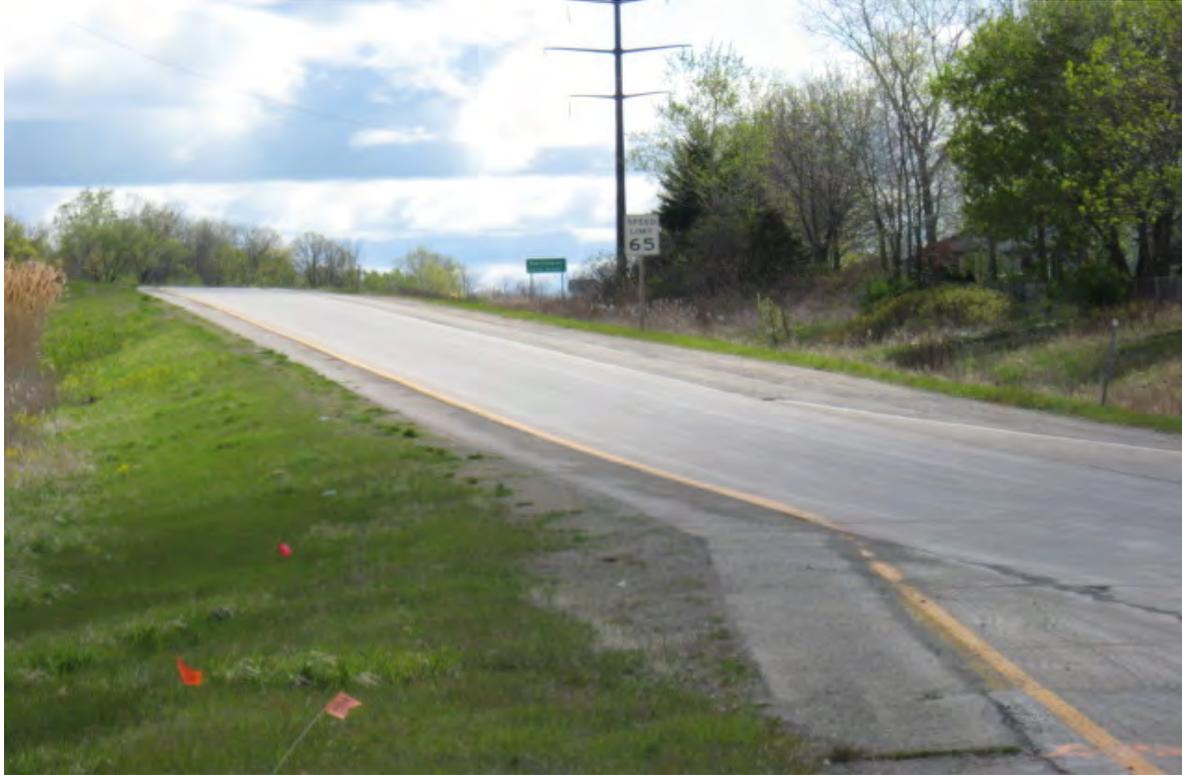
There is a 65 mph sign posted on the eastbound on-ramp. This is the speed limit of the mainline WIS 441, not the ramp.

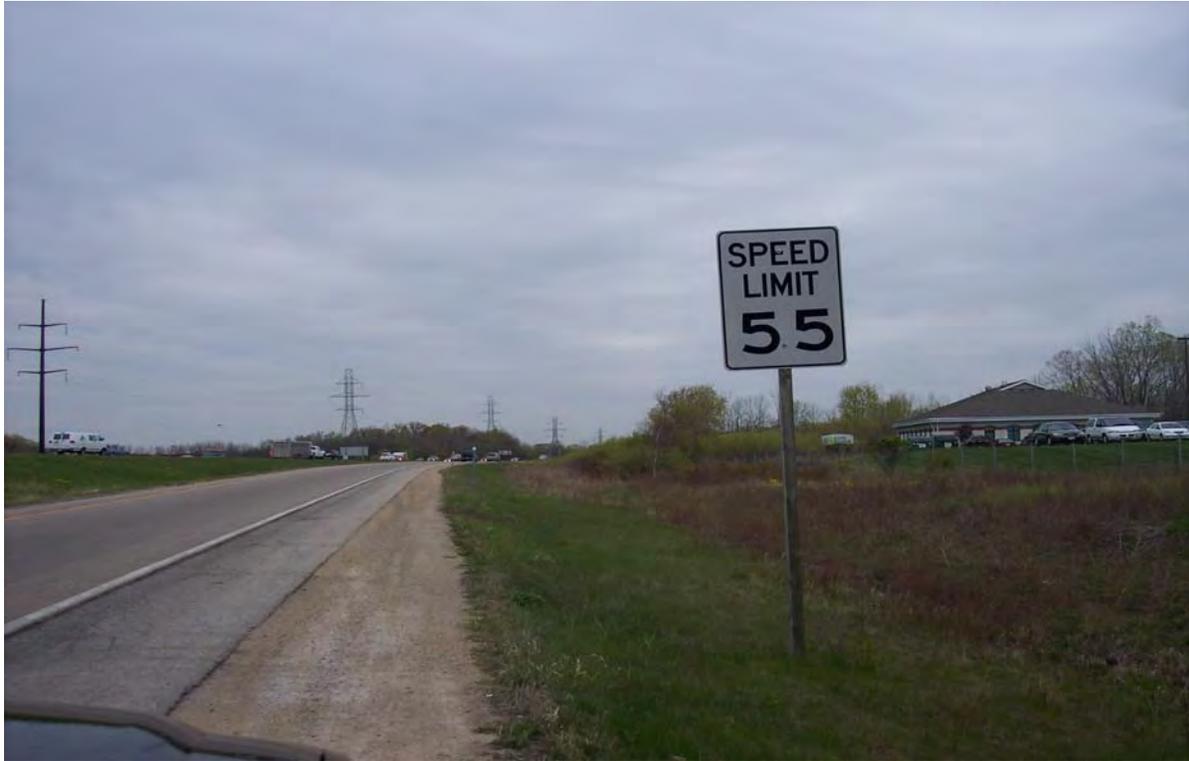
The westbound on-ramp has a 55 mph sign posted on the ramp. This is the speed limit of the mainline WIS 441, not the ramp.

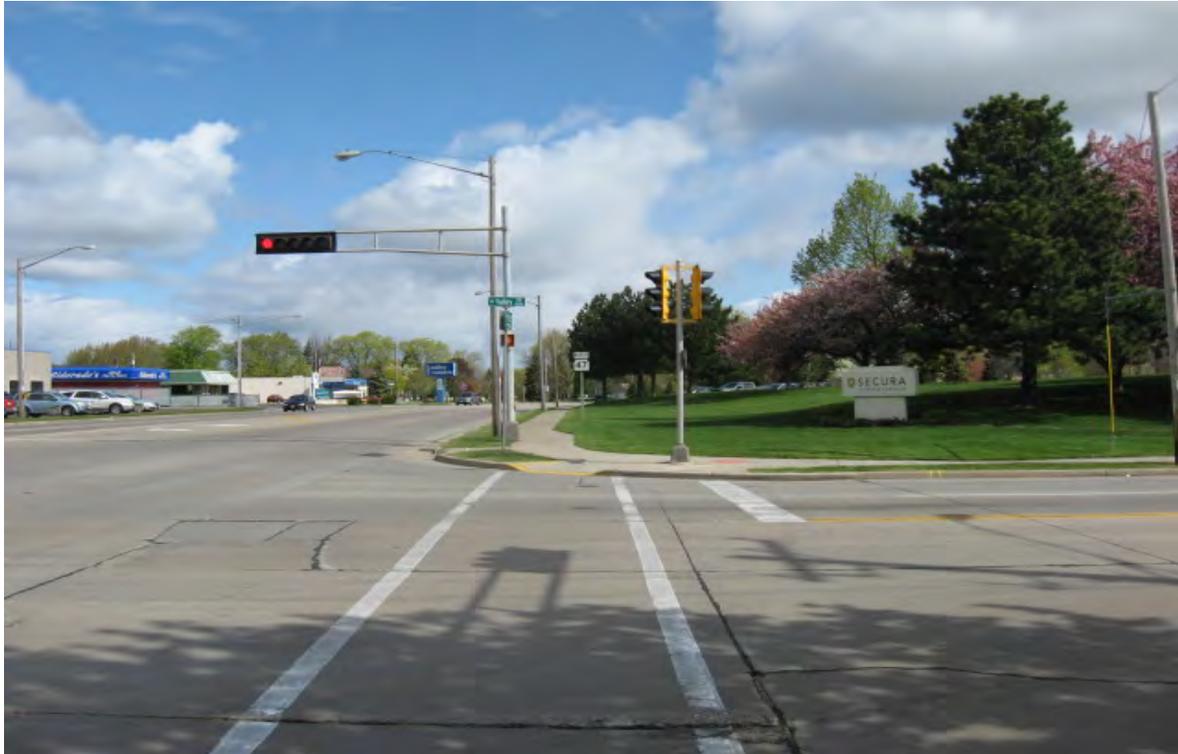
The street name signs at Midway Road and Appleton Road are not readily visible. Adequate visibility of the street name signs helps to guide motorists approaching the intersection and allow for advance lane change maneuvers.

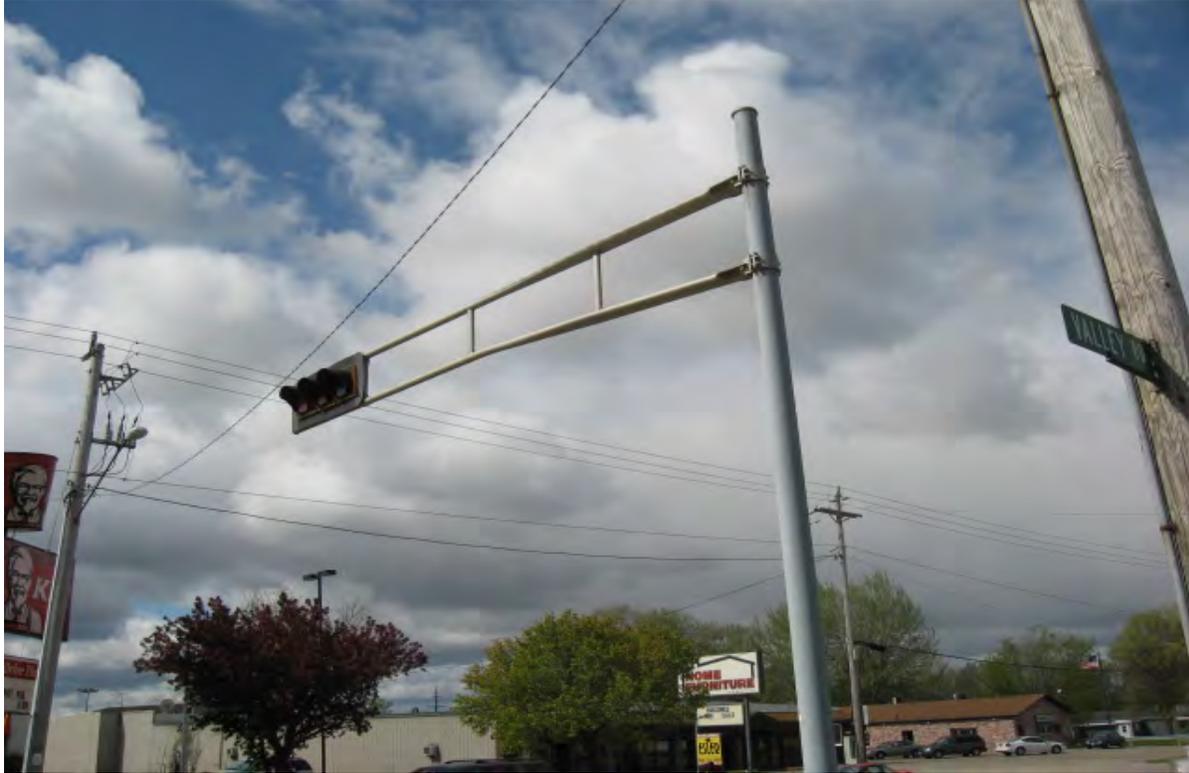
The street name signs at the intersection of Appleton Road and Valley Road are not readily visible. Adequate visibility of the street name signs helps to guide motorists approaching the intersection and allow for advance lane change maneuvers.

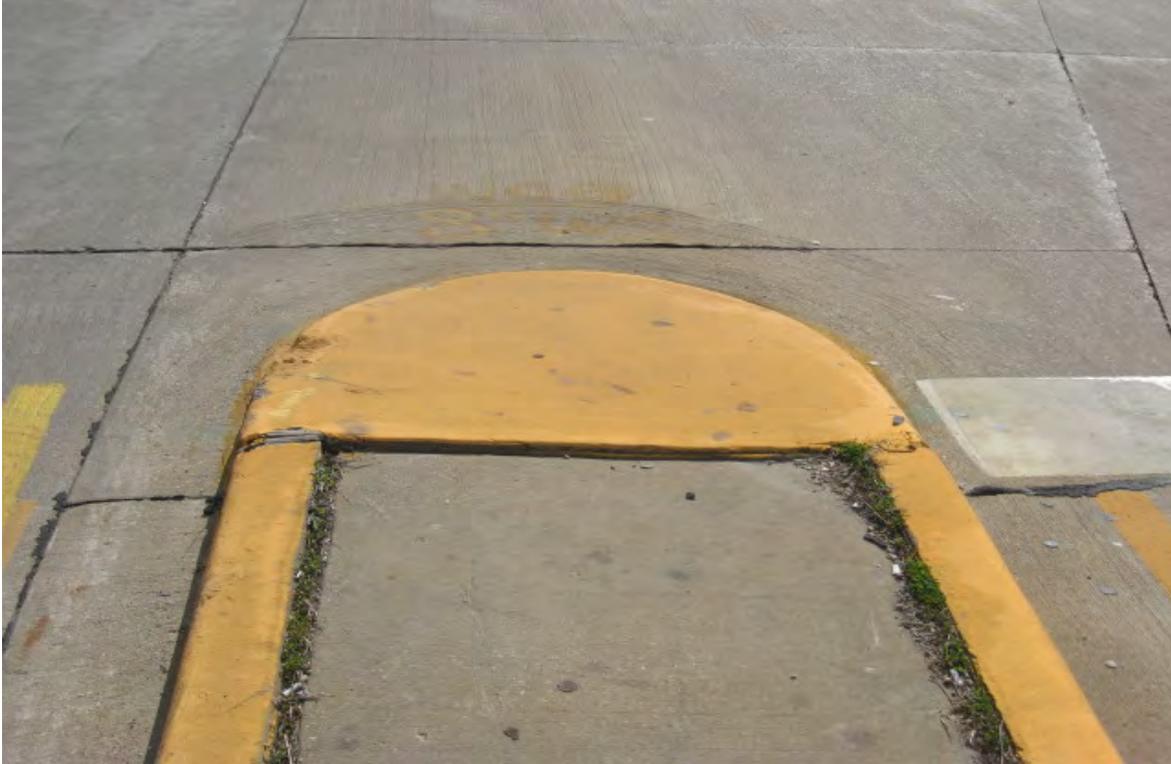
There is no delineation on the median island noses on Appleton Road, south of WIS 441.

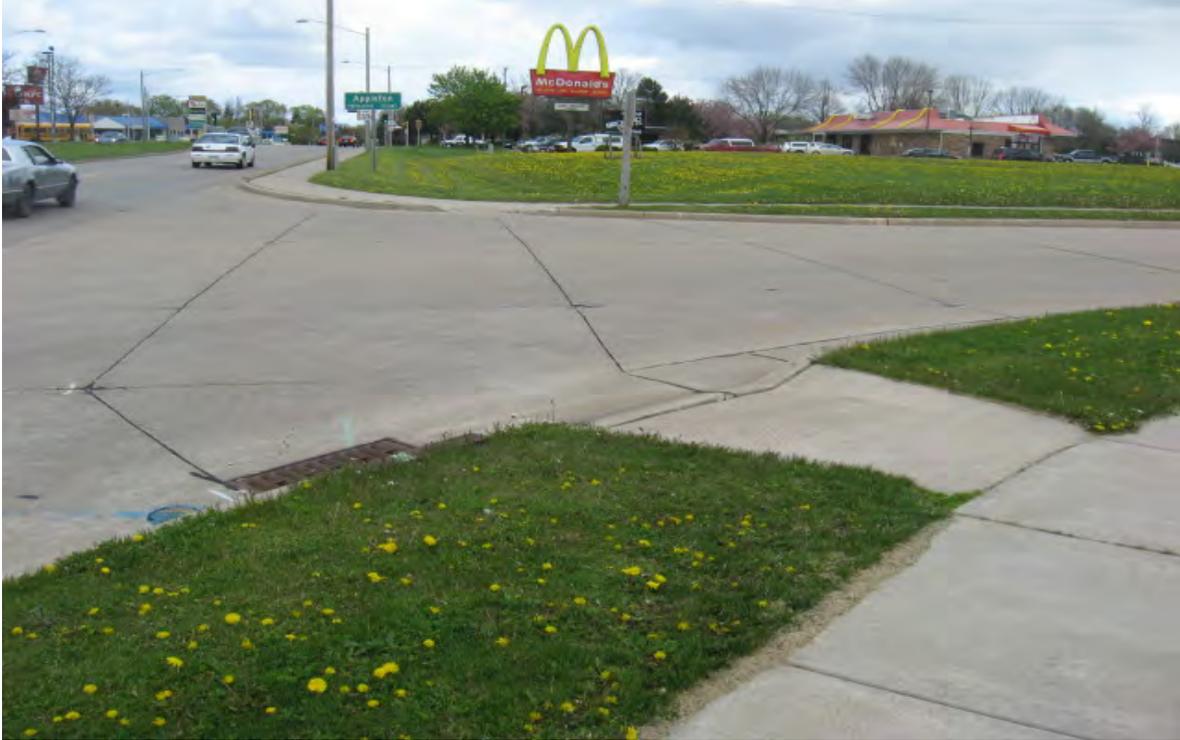
Issue 126: Missing stop bar

There is no stop bar on Tuckaway lane at Appleton Road. Stop bars designate where a vehicle on the side street should stop before entering into the intersection.

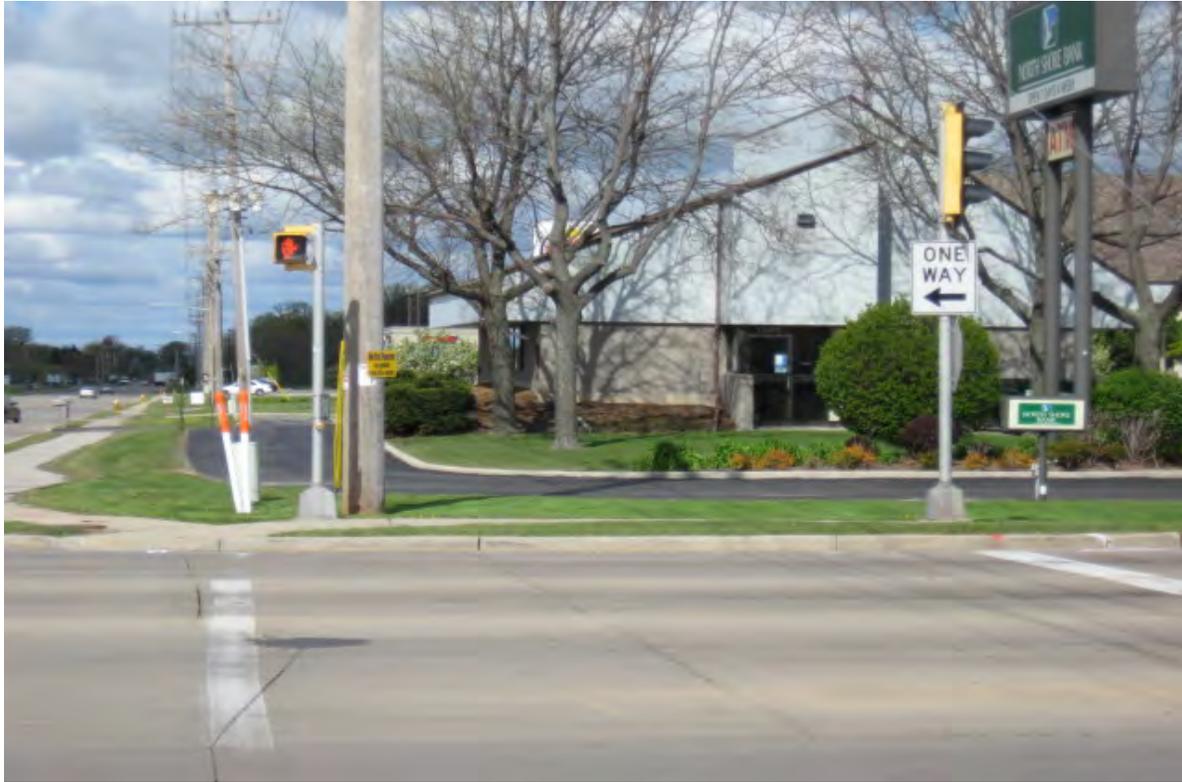
There is staggered stop bar on the eastbound approach at the intersection of Midway Road and Appleton Road.

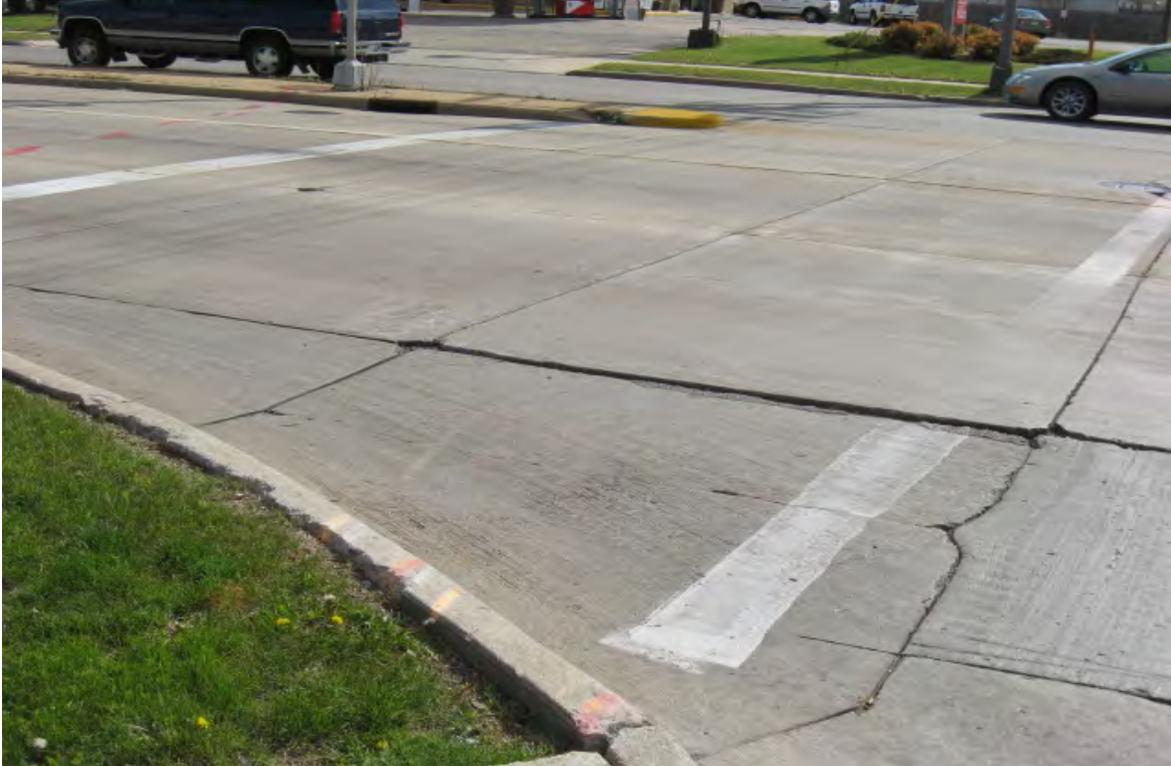
The stop bars and signal heads are set back from the intersection of Midway Road and Appleton Road.

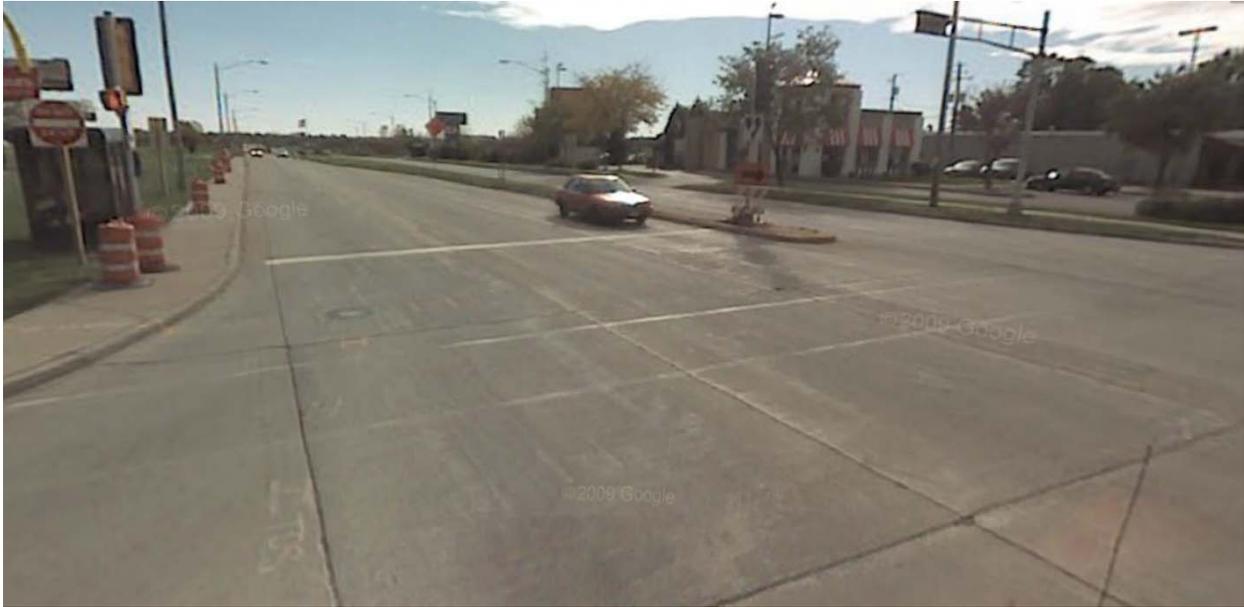
The stop bars and median noses at the intersection of Appleton Road and Valley Road are set back from the intersection. The median noses are not delineated

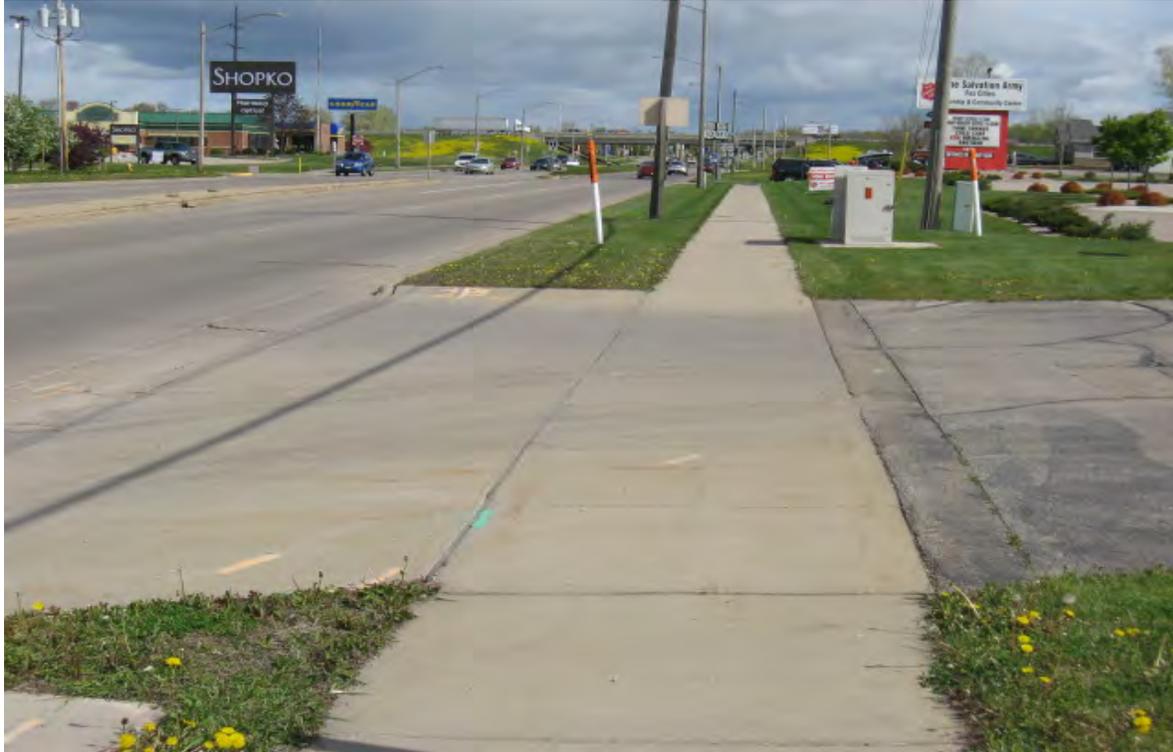
The cross slope of the sidewalk on the southern driveway to the Citgo gas station on Appleton Road is 4%. This is not in compliance with ADA guidelines which allows a maximum cross slope of 2%.
