Road Safety Audit REPORT

WIS 441 Tri-County Project

Date: Apr 25-26, 2012

Realignment of WIS 441 and reconstruction of five interchanges.

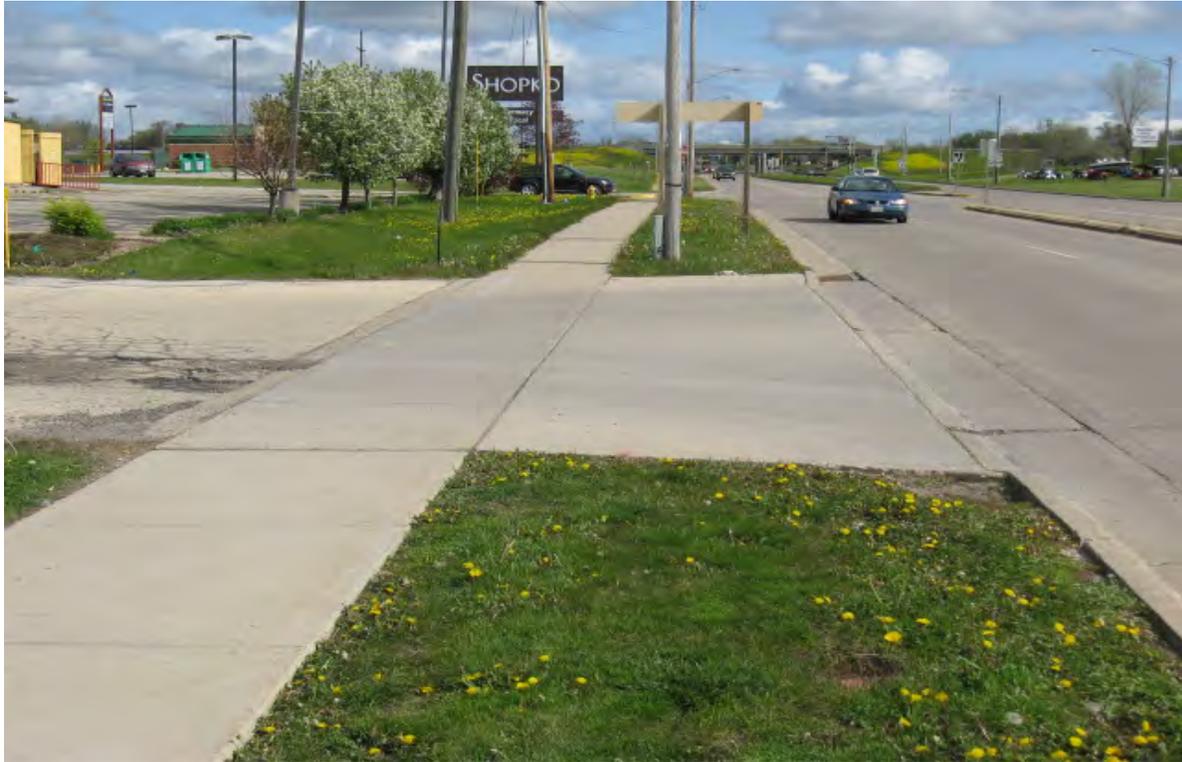
Several driveways closely spaced to a signalized intersection. Burger King has cross access at Drum Corps Drive and also has a driveway access to the south on Appleton Road. The Citgo gas station has two driveways onto Appleton Road; the south driveway is close to an intersection.

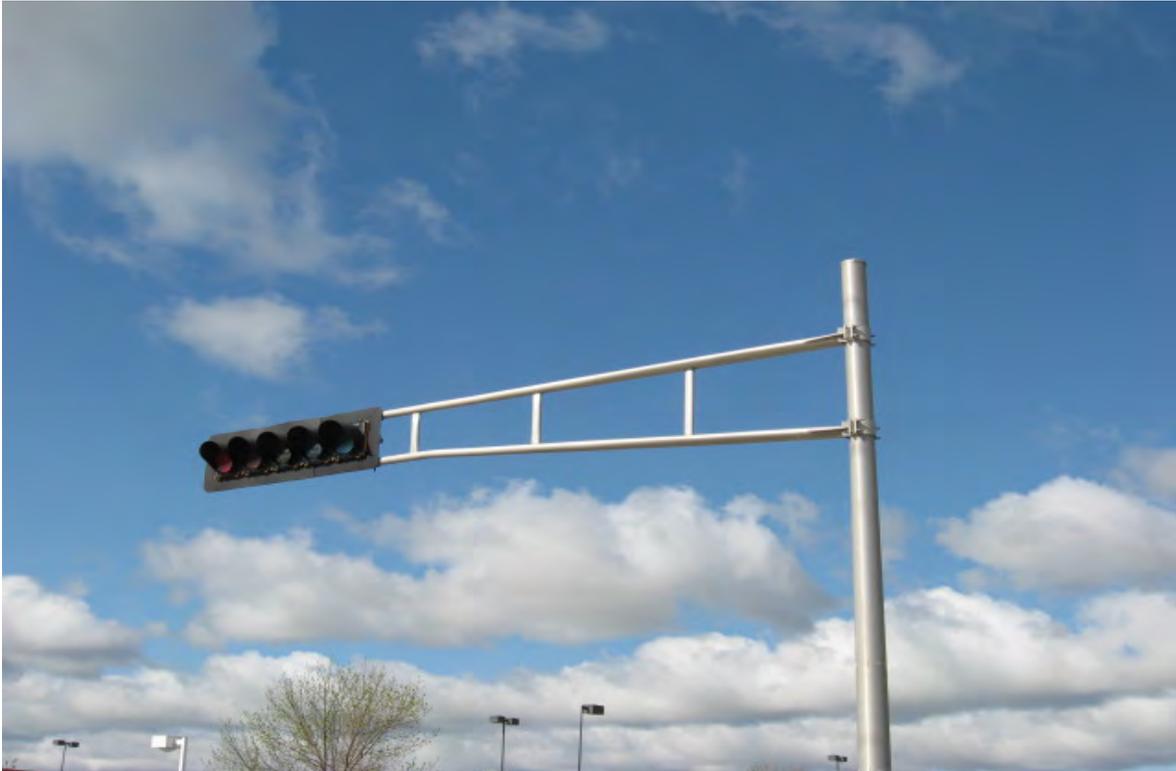
The signals at the intersection of Appleton Road and Midway Road have standard backplates.

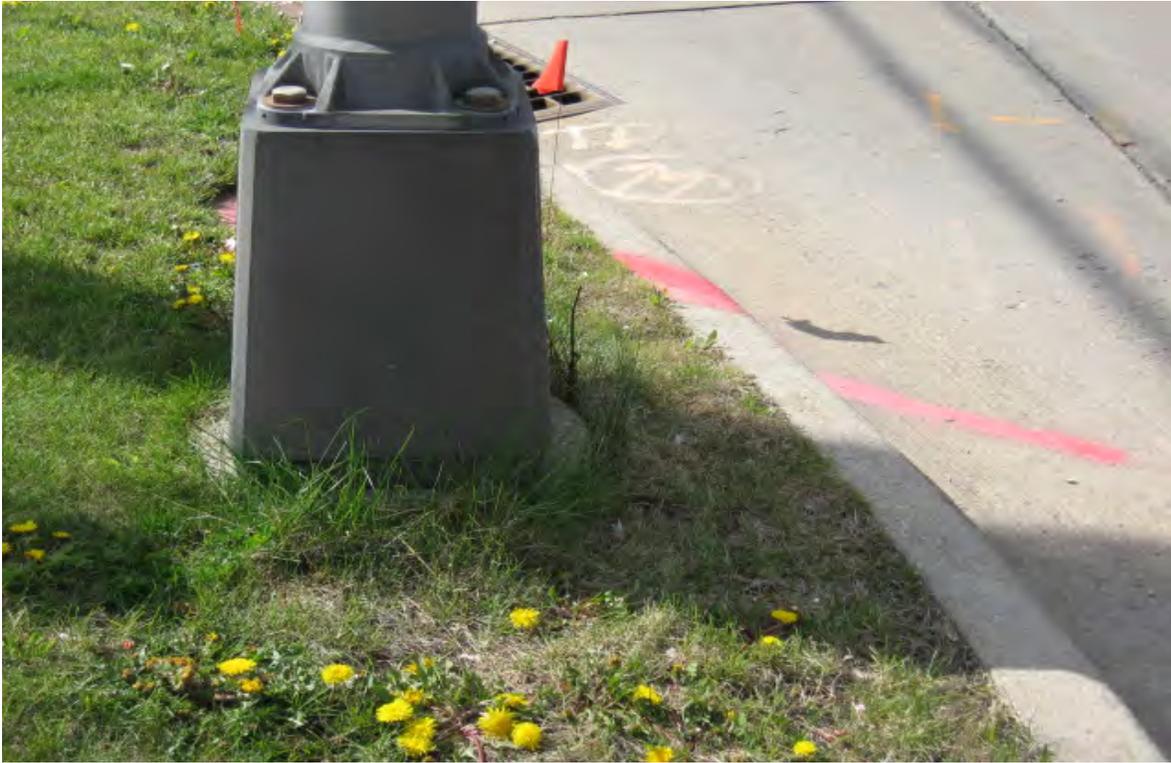
There is a signal pole near the back of the curb in the northeast corner of Appleton Road with Midway Road within the clear zone.

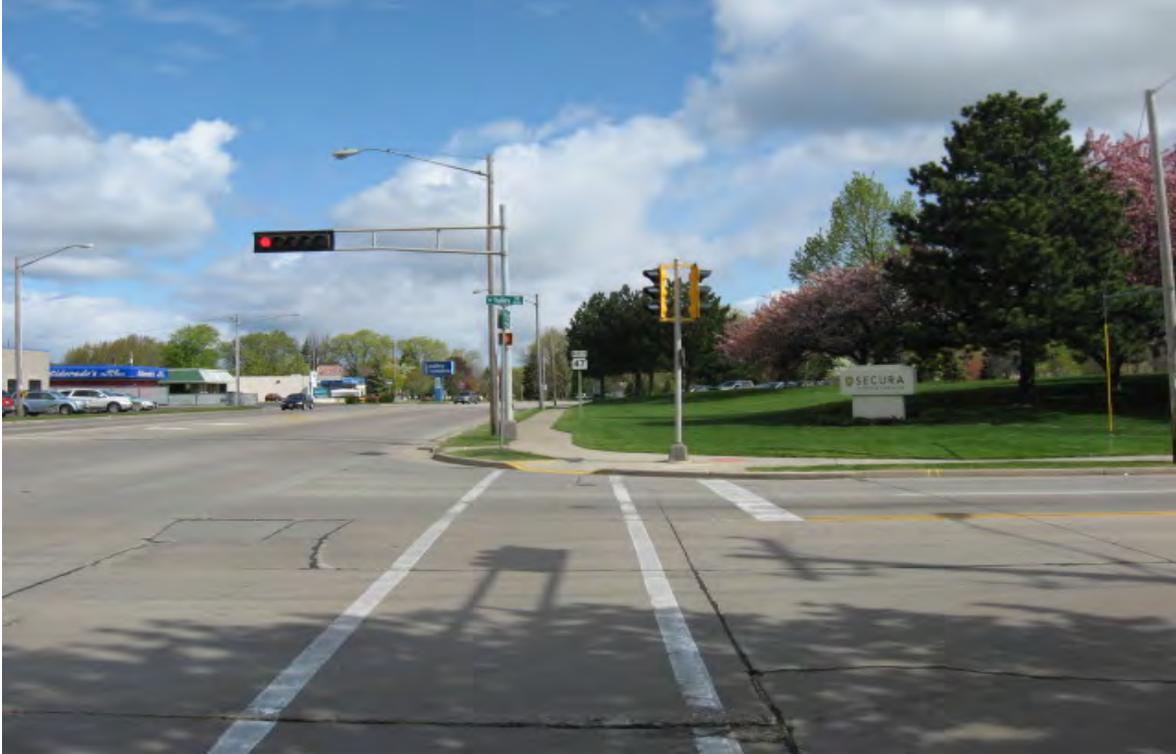
The pedestrian signal on the northeast corner of Appleton Road at Valley Road is poorly visible.

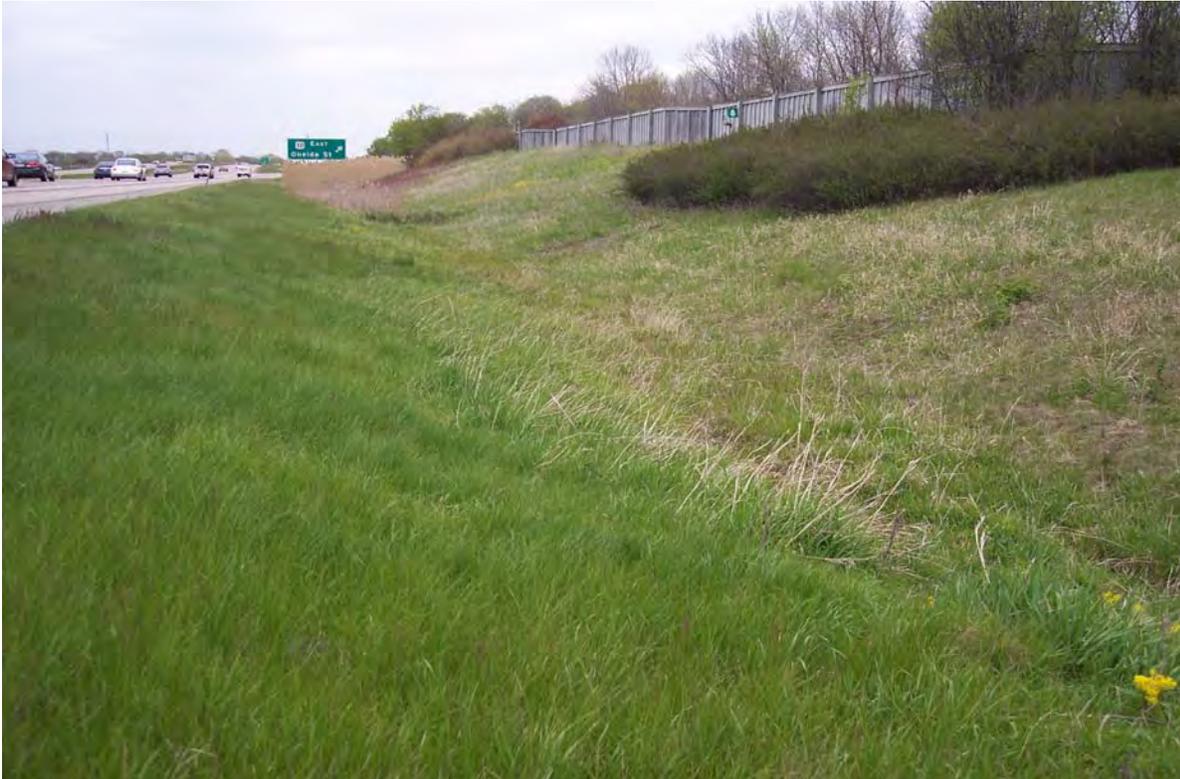
The front slope on the south side on the Oneida Street overpass before and after the bridge is 45% and unshielded. This is considered to be unrecoverable and may be a safety issue if an errant vehicle runs off the road in this area.

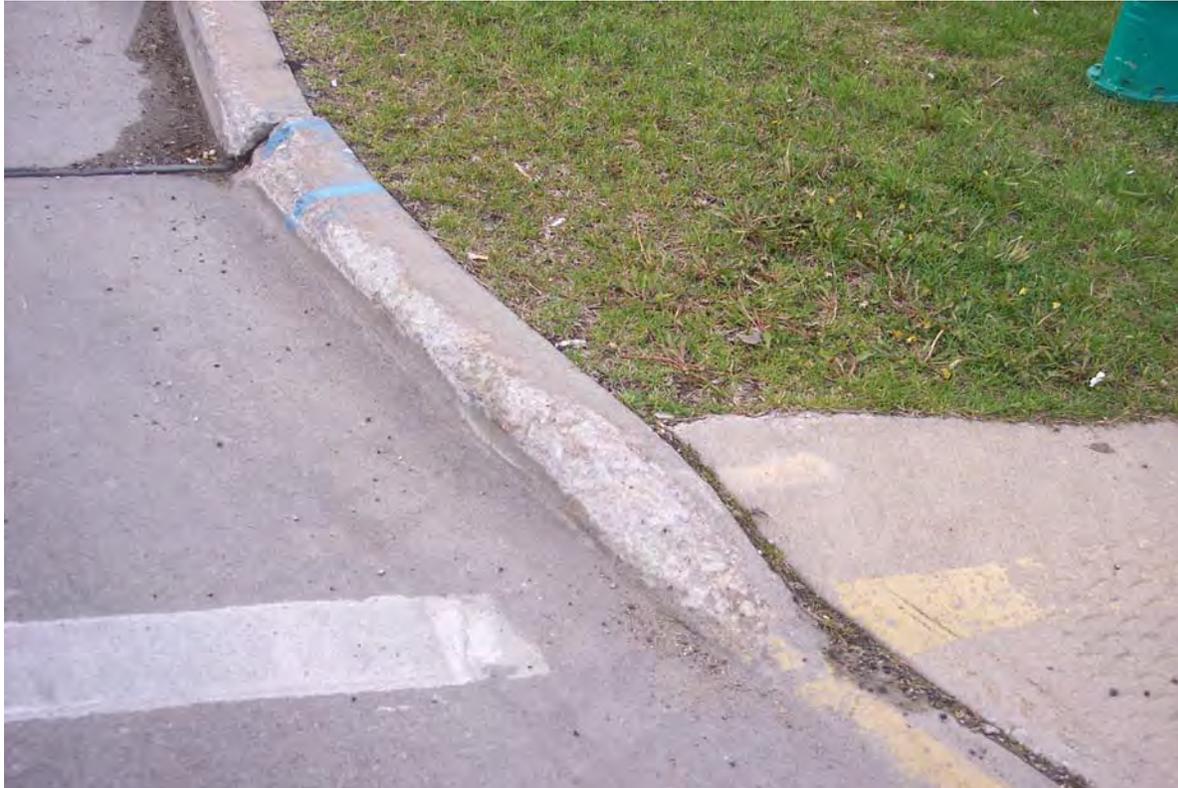
The curb is less than 6 inches in height. A shorter curb does not shield the roadside as well.

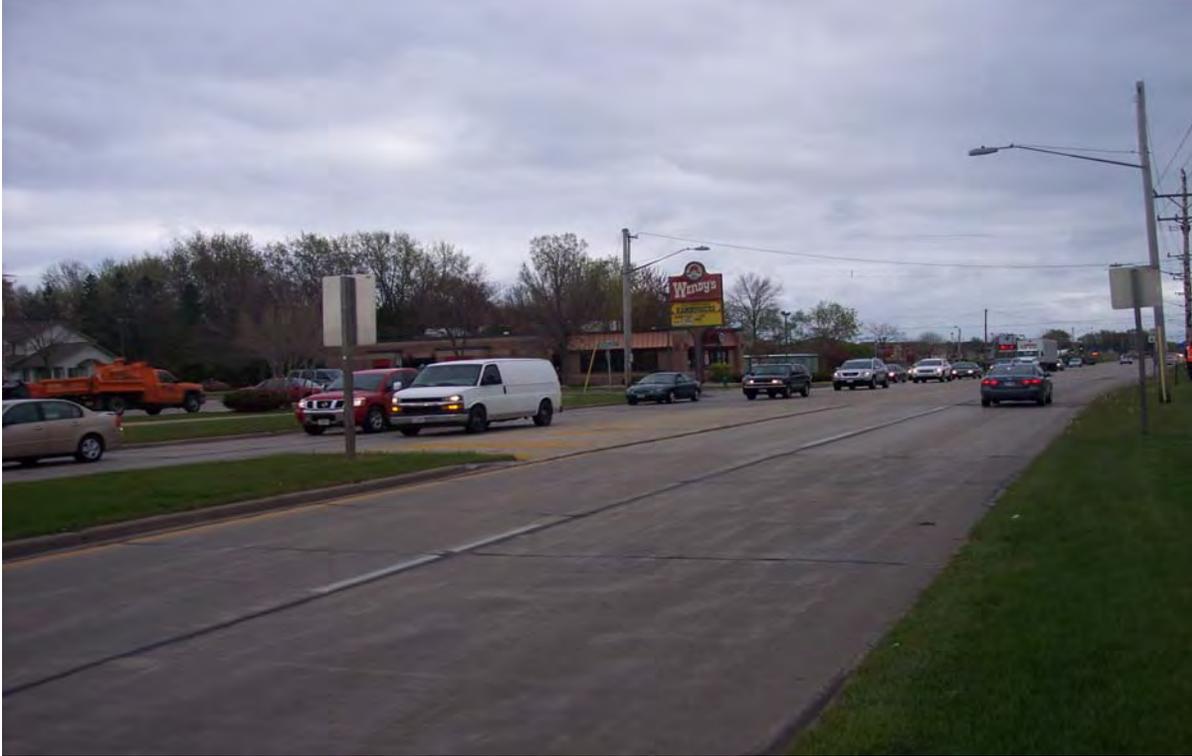
Vehicles are driving over the raised concrete gore area on Oneida Street while decelerating to turn left into Meadow Grove Blvd.

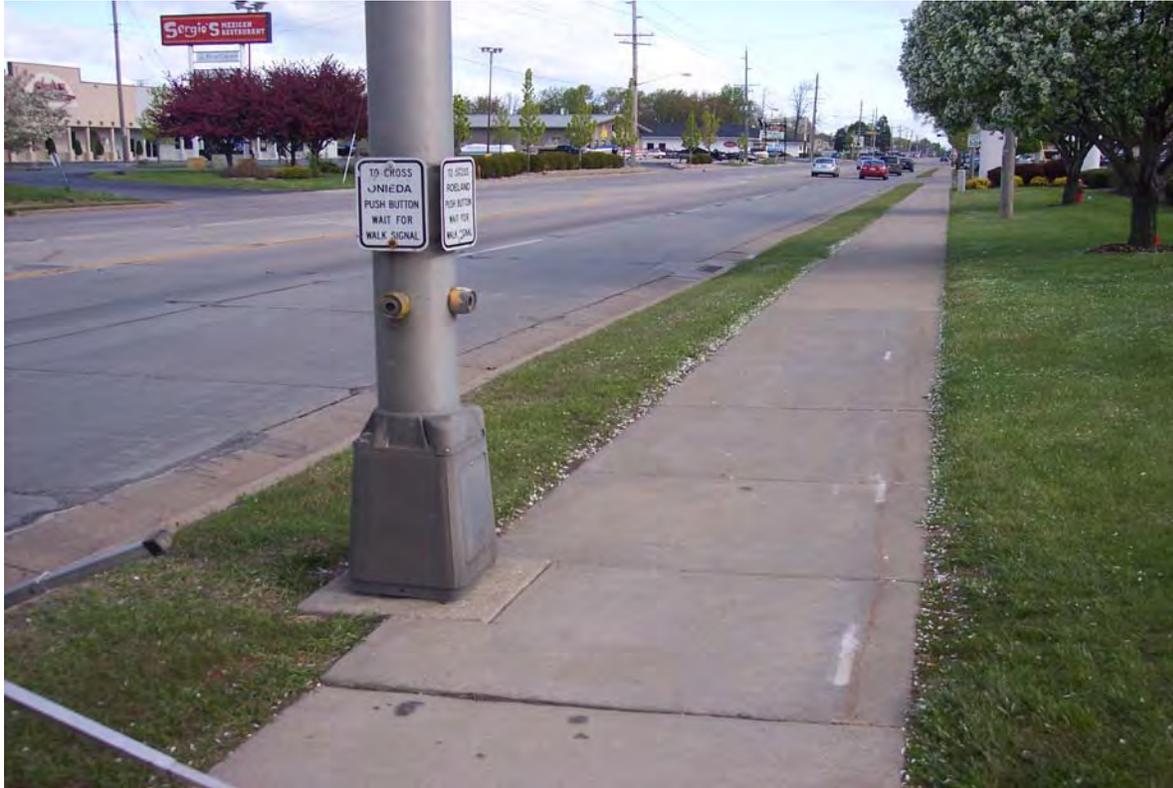
No bicycle facilities are provided on Oneida Street.

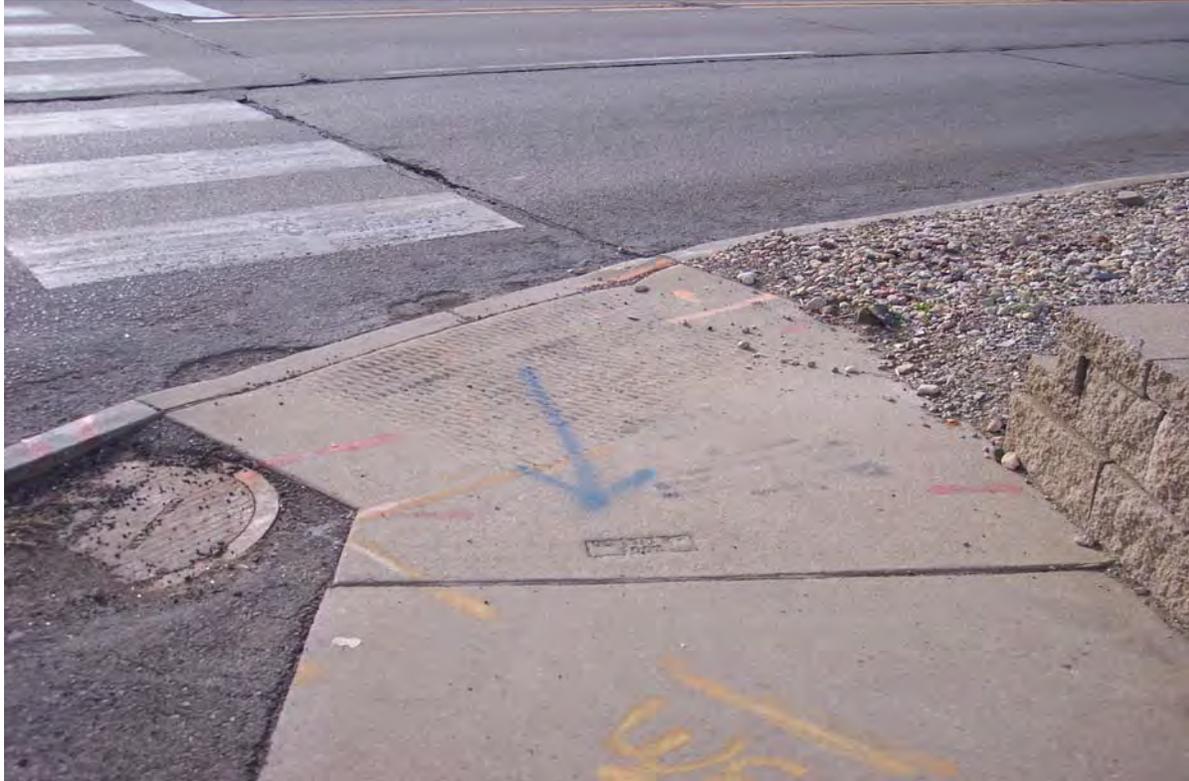
The existing cross slope on the sidewalk in the southwest corner of the intersection of Oneida Street at Midway Road is greater than 2%. This is not in compliance with ADA guidelines.

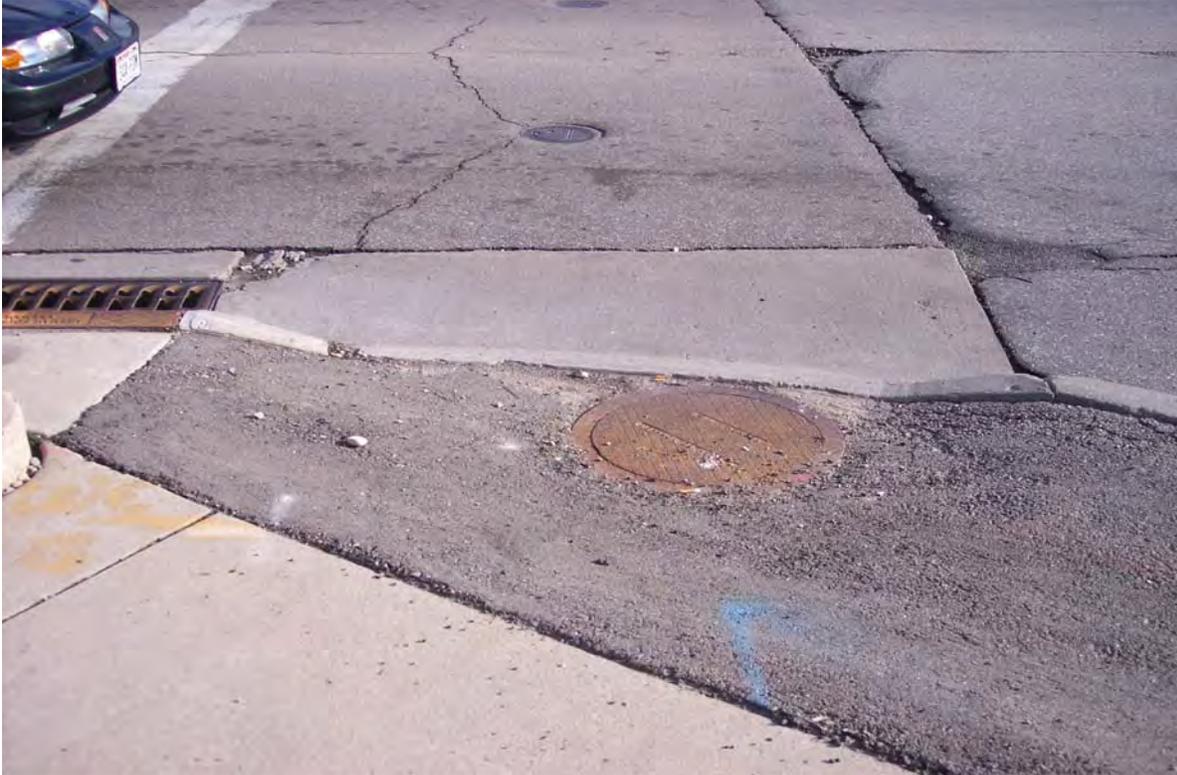
There are no detectable domes on the pedestrian ramps at the cross streets. These provide detection to the visually impaired that they are entering the roadway.

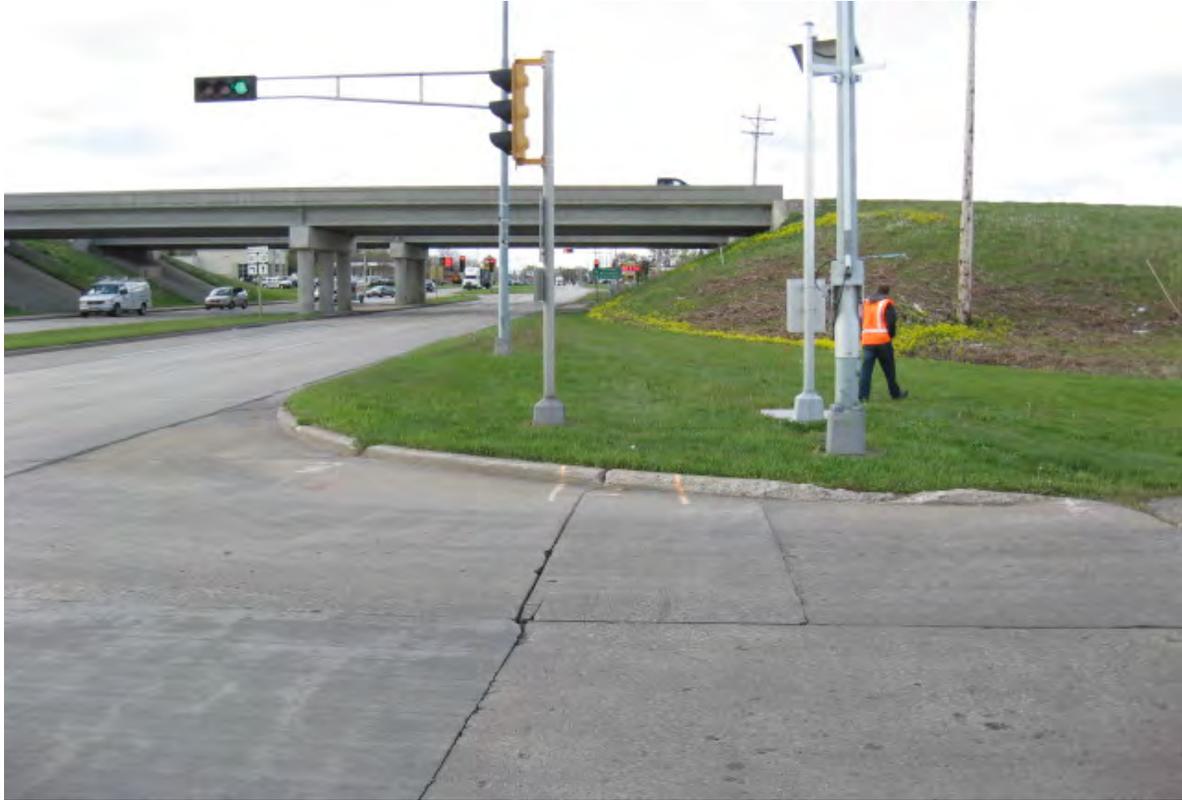
The pedestrian ramps and signals in the NE, SE, and SW corners of the intersection of Oneida Street with the WIS 441 ramps are not ADA compliant. The push buttons are located away from the ramps.

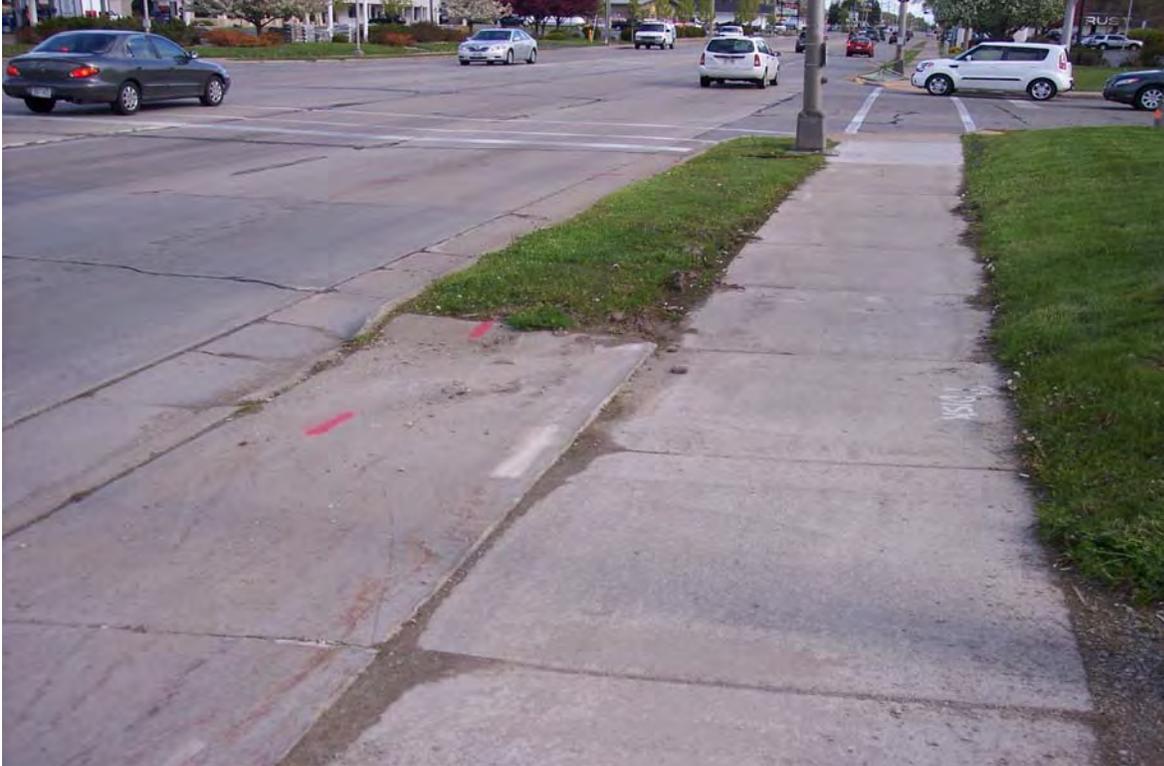
The intersection of Oneida Street with WIS 441 south of the overpass does not have pedestrian ramps.

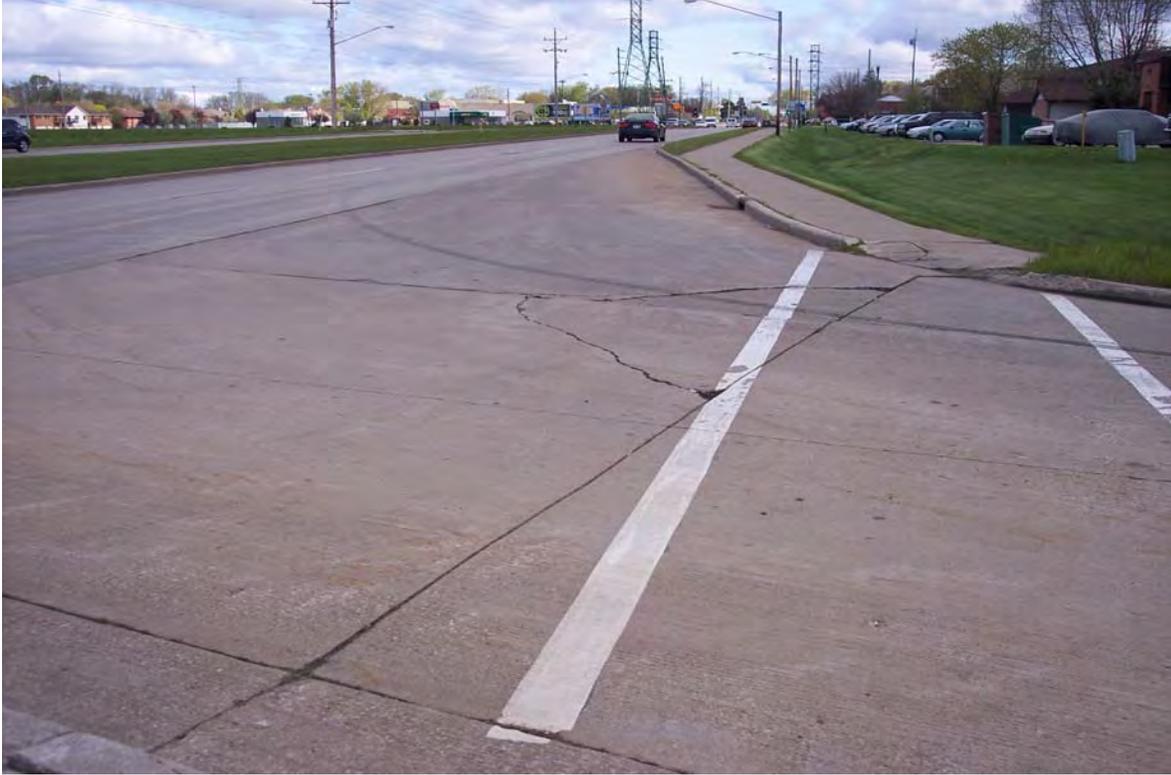
There is a 5 foot sidewalk at the back of curb on Oneida Street, north of WIS 441, which is not ADA compliant. Sidewalk located directly at the back of the curb should be a minimum of 6 feet wide.

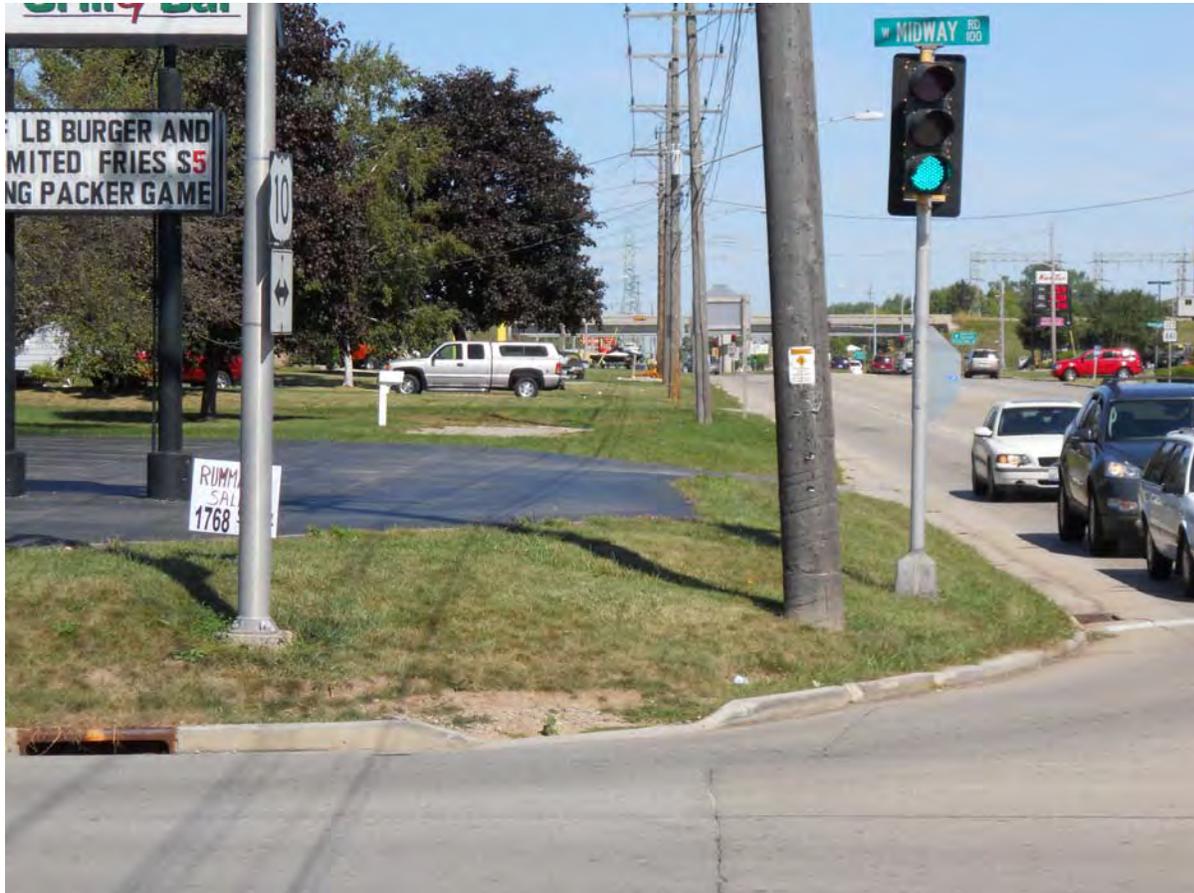
There are no sidewalks and pedestrian ramps in the northwest corner of the intersection of Oneida Street at Midway Road.

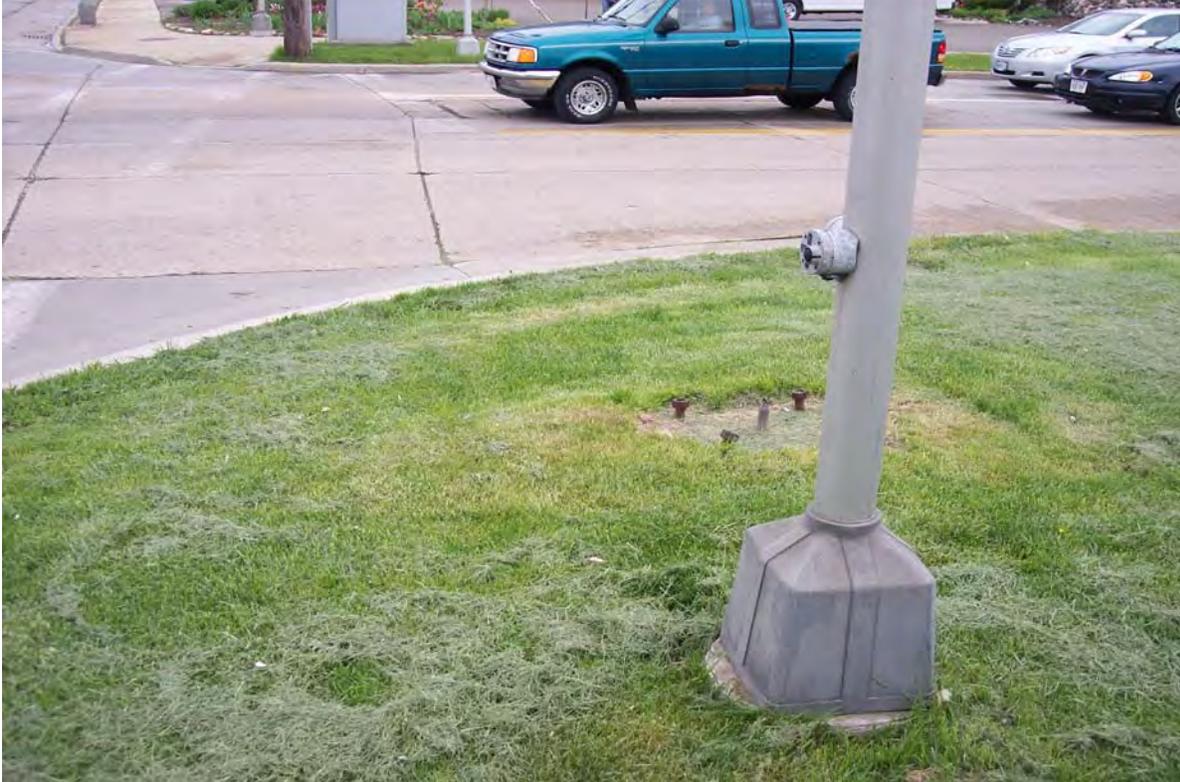
There are no pedestrian signals or crosswalks at the northwest corner of Oneida Street at Midway Road.

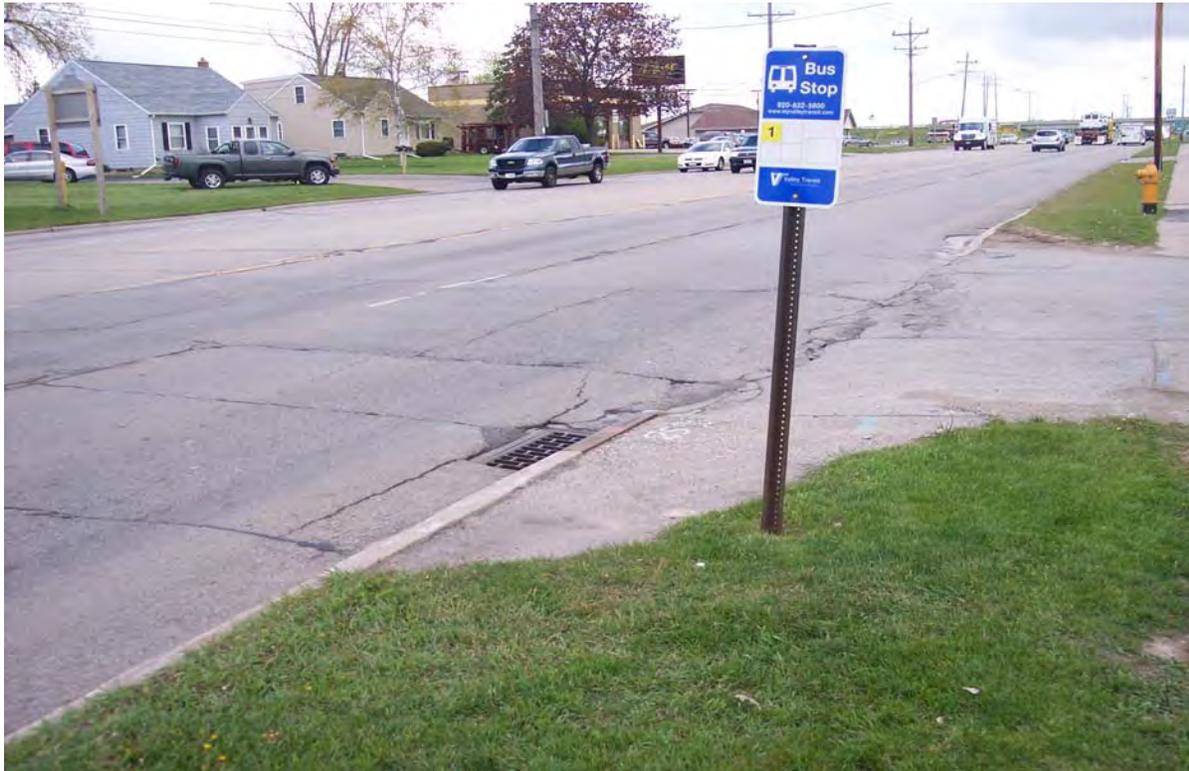
The bus stops on Oneida Street are not ADA compliant.

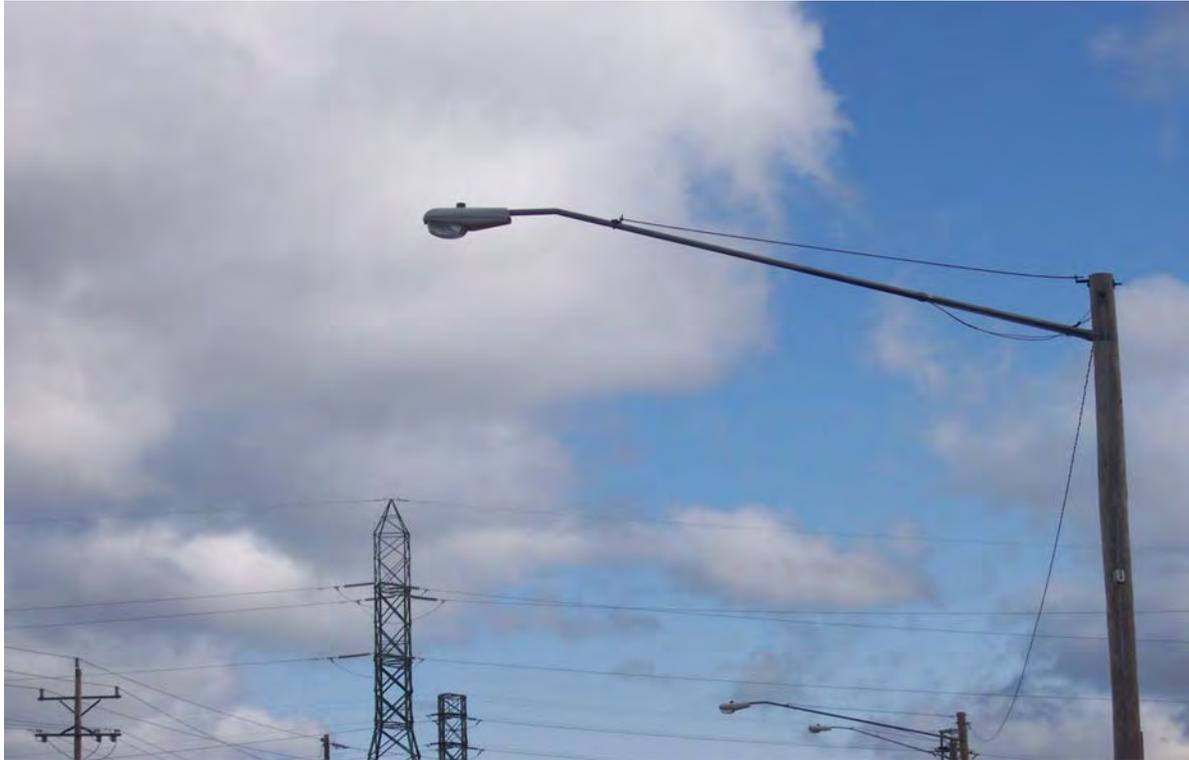
The current non-cutoff (drop-lens) luminaires on Oneida Street can produce glare.

Replace the existing luminaires with cutoff luminaires.

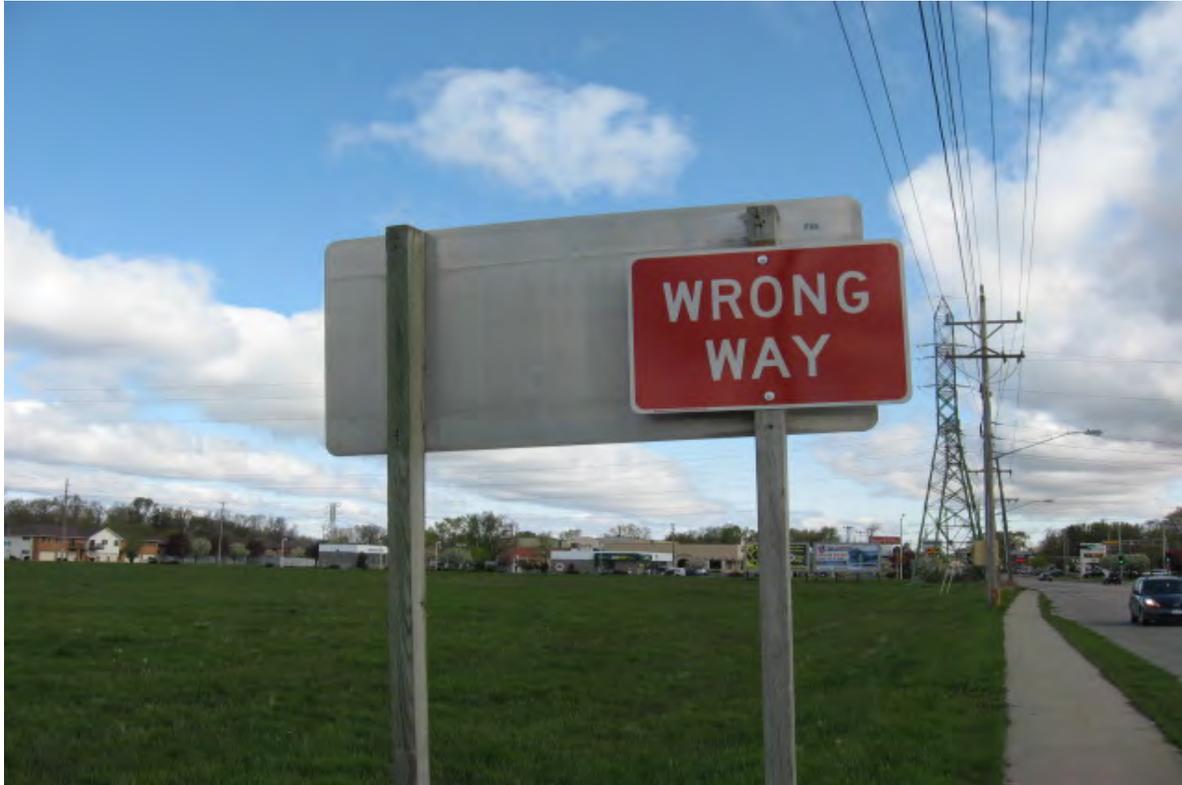
There are back to back sign panels of different sizes on the same post. Different types of signs are on the same post. This can obscure the shapes of the signs which are important to convey the message to motorists.

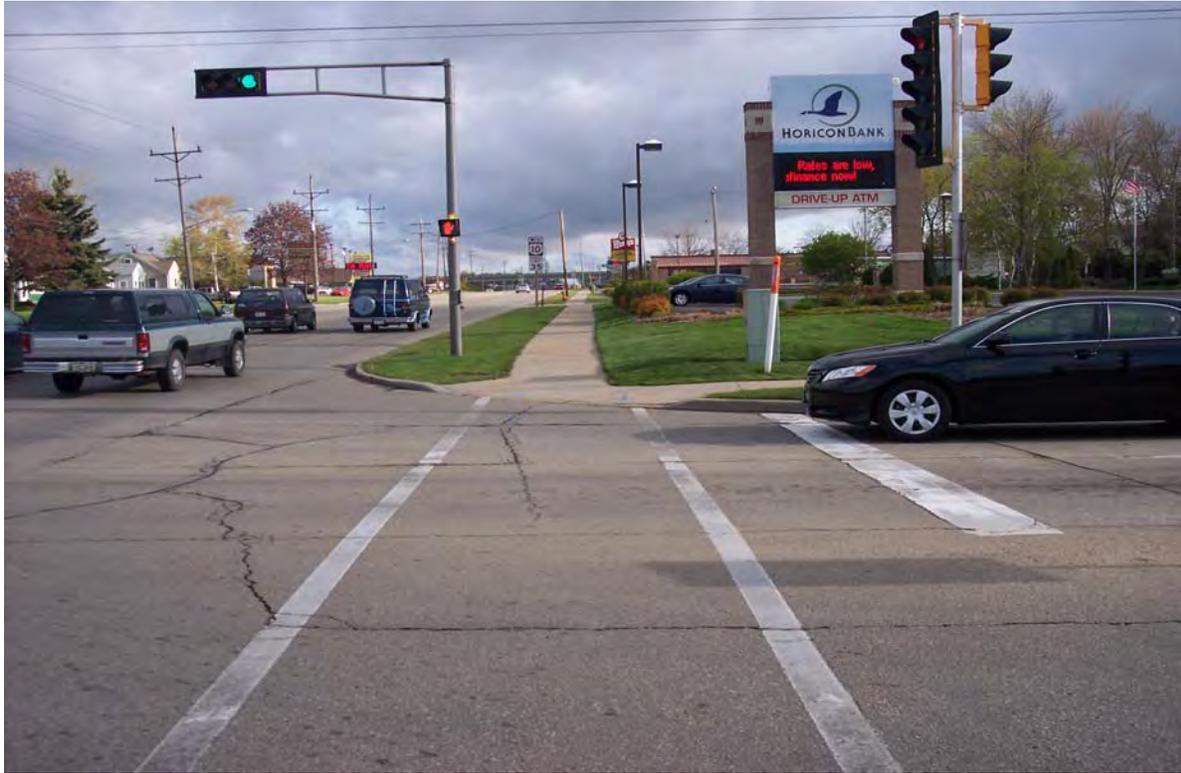
The street name signs are not readily visible at the major intersections. Adequate visibility of the street name signs helps to guide motorists approaching the intersection and allow for advance lane change maneuvers.

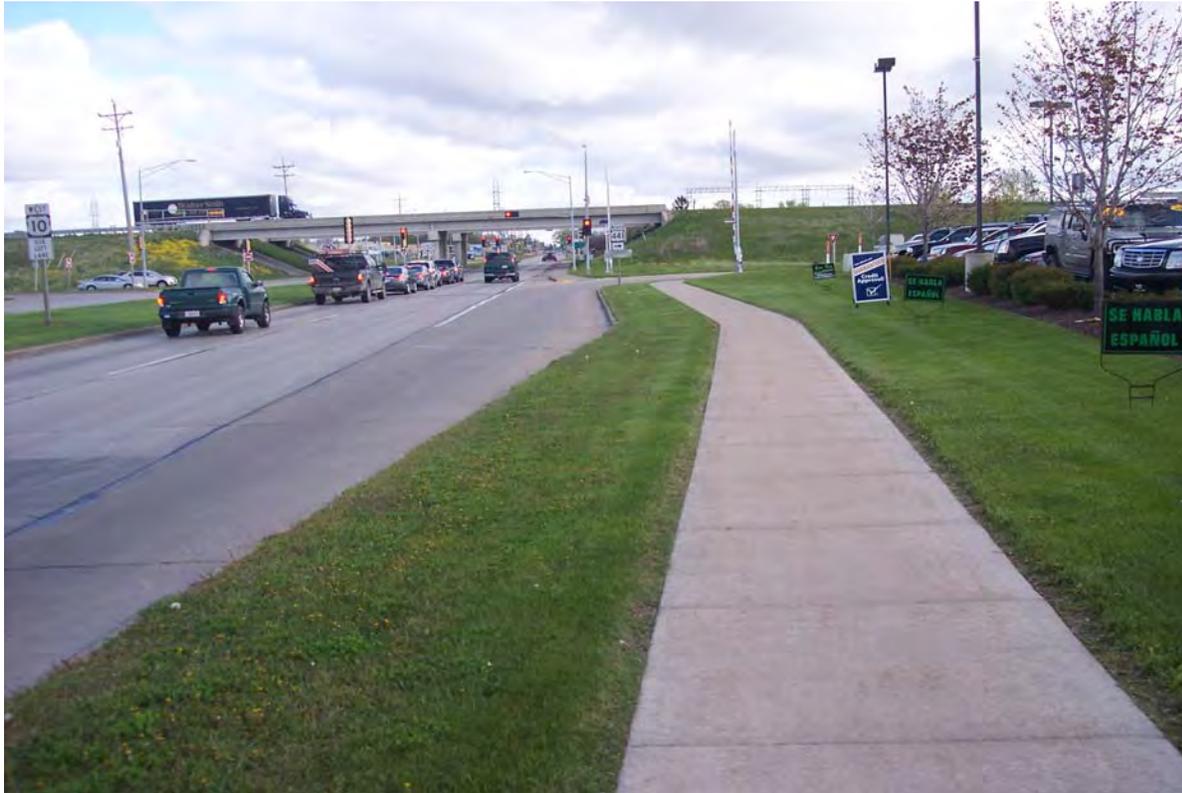
There are no right turn arrow pavement markings in the right turn lanes on Oneida Street. When the proposed roundabouts are constructed, motorists will require guidance on lanes uses.

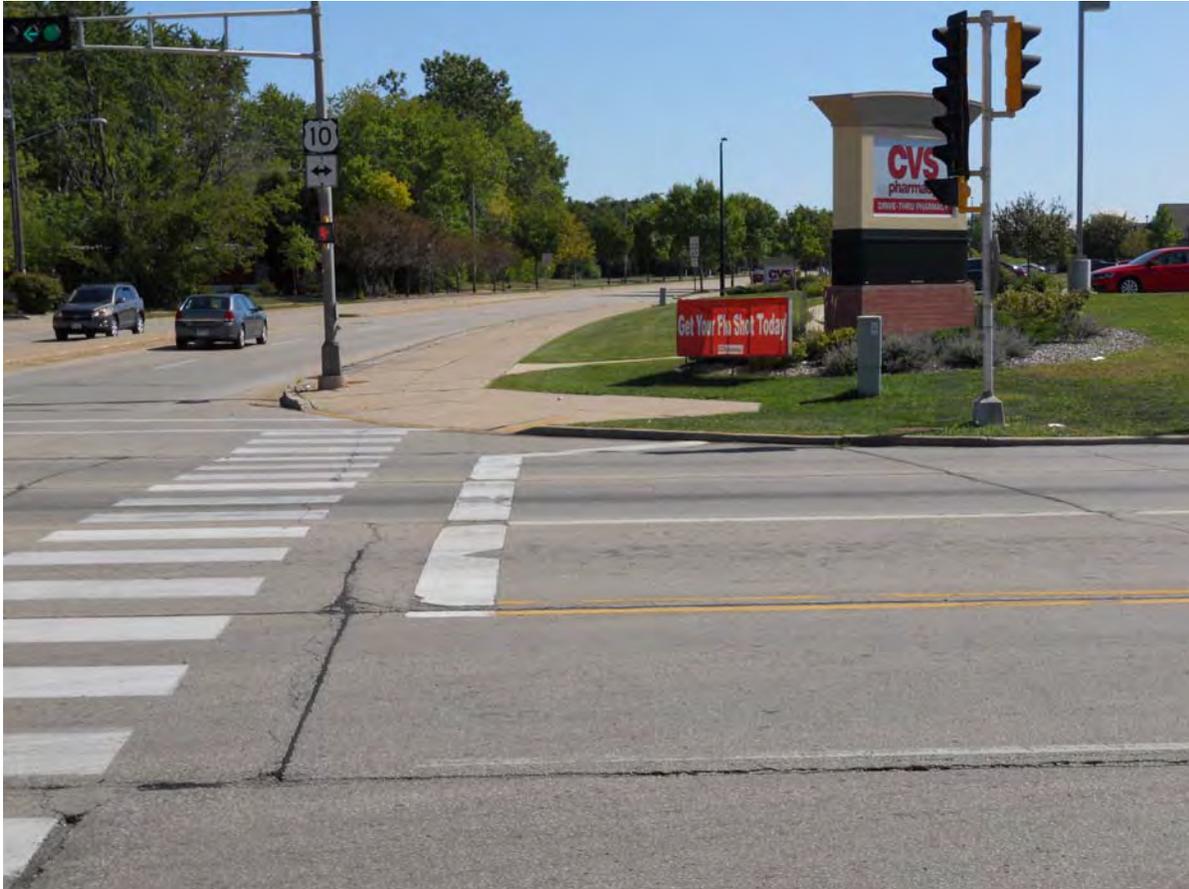
The stop bar on the northbound approach at the intersection of Oneida Street and Midway Road is not perpendicular to the approach.

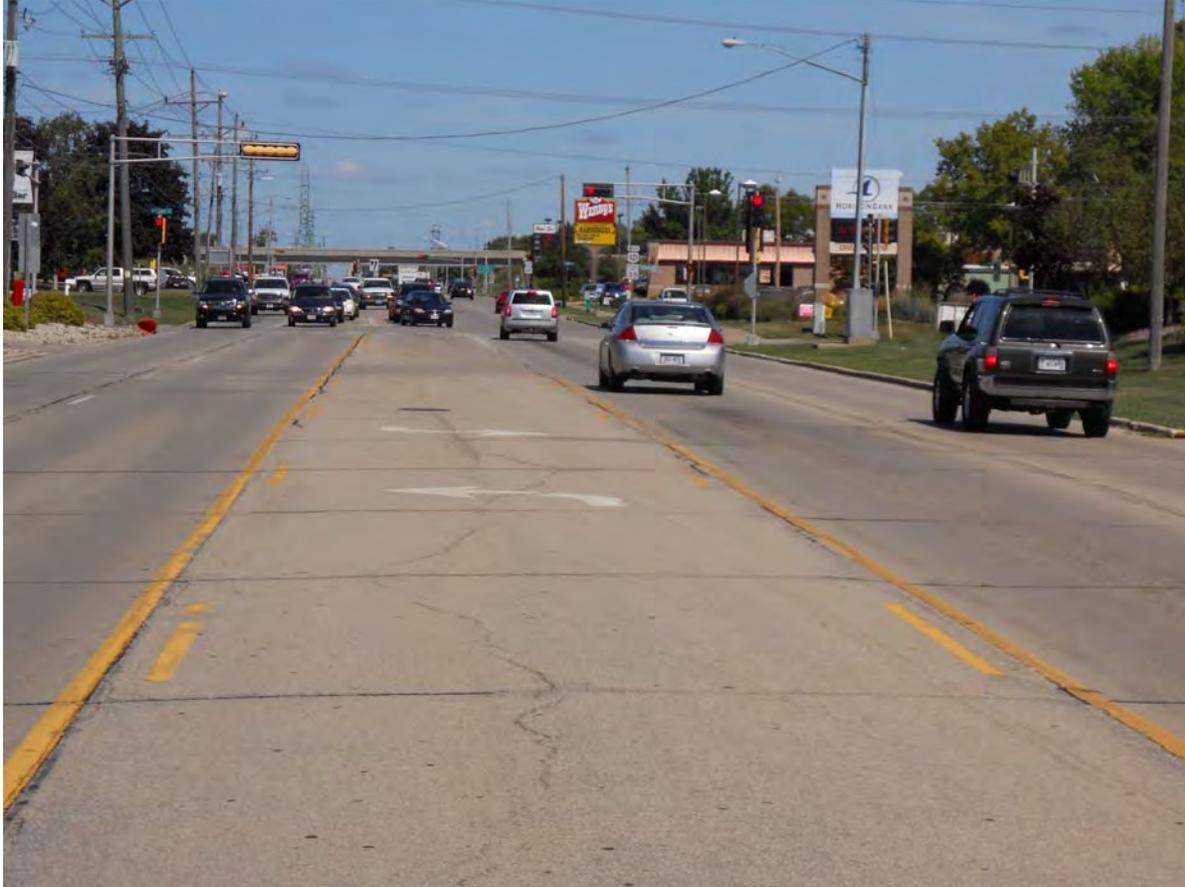
The current striping transition from the two-way left turn lane to the left turn lane on Oneida Street is not in accordance with current standards.

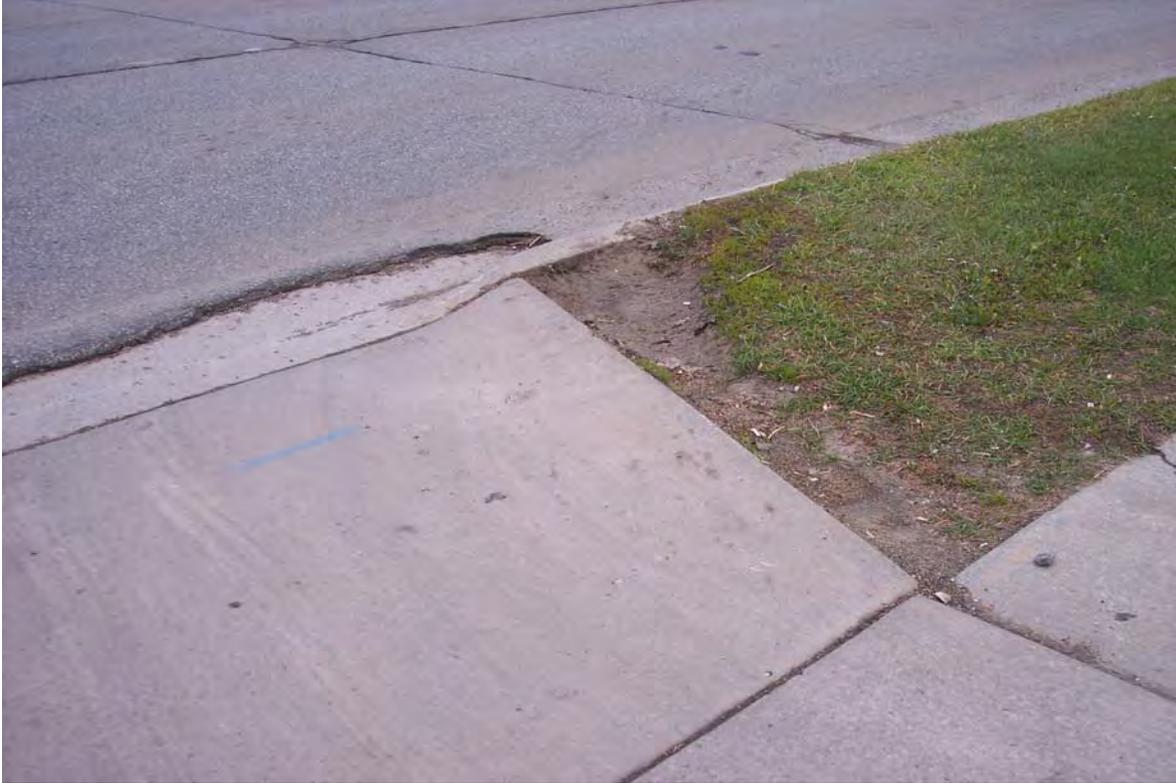
There is evidence of overtracking at the driveways and at Oneida Street and Meadow Grove Boulevard.

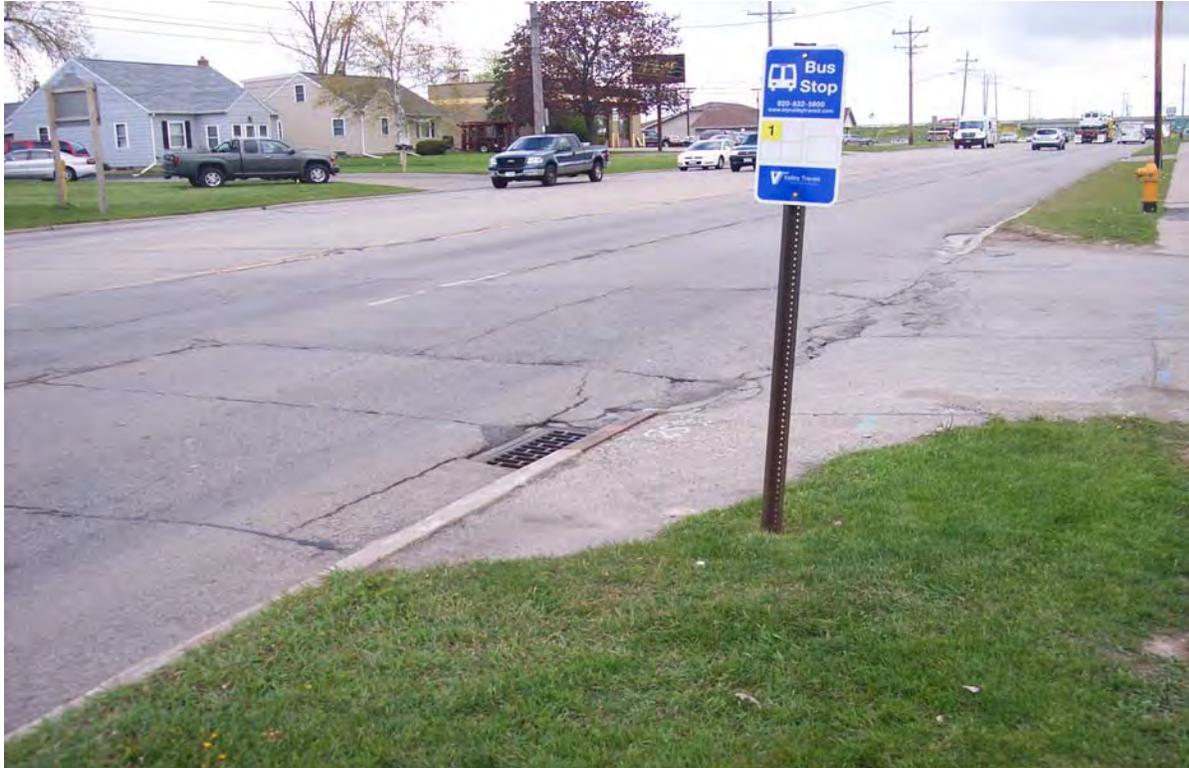
The intersection of Oneida Street at Primrose Lane has no returns.
