Road Safety Audit REPORT

WIS 441 Tri-County Project

Date: Apr 25-26, 2012

Realignment of WIS 441 and reconstruction of five interchanges.

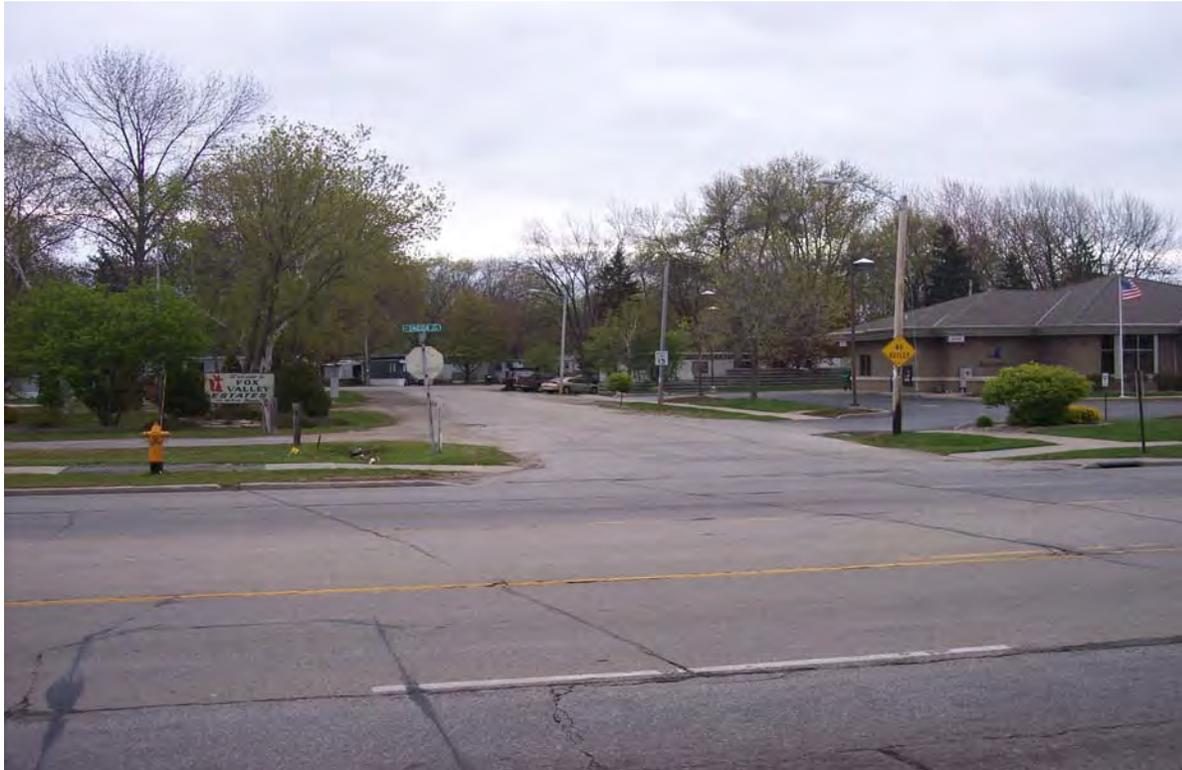
The roadway has unrestricted access with a center two-way left turn lane. There are many conflict points due to multiple driveways and side streets.

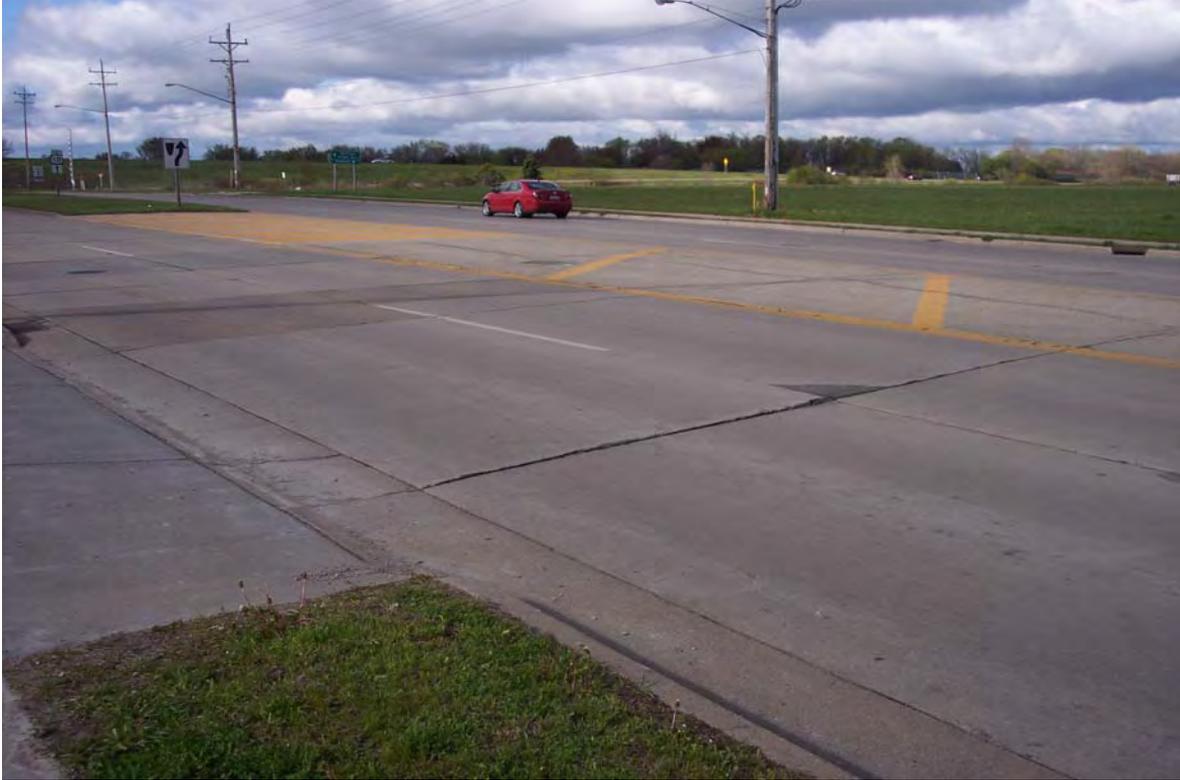
The roadway has unrestricted access with a center two-way left turn lane. There are many conflict points due to multiple driveways and side streets.

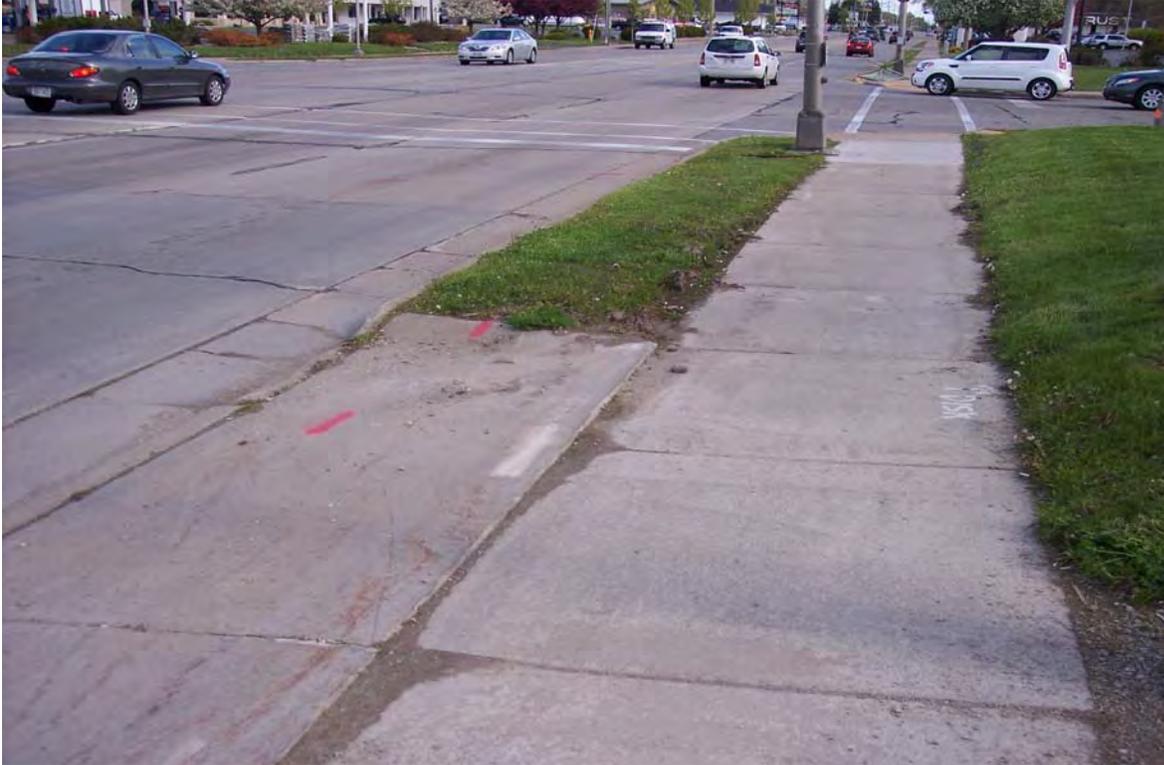
The north driveway to the substation near the intersection of Oneida Street with Valley Road/ Roeland Avenue is close to the intersection. The substation has two driveways onto Oneida Street.

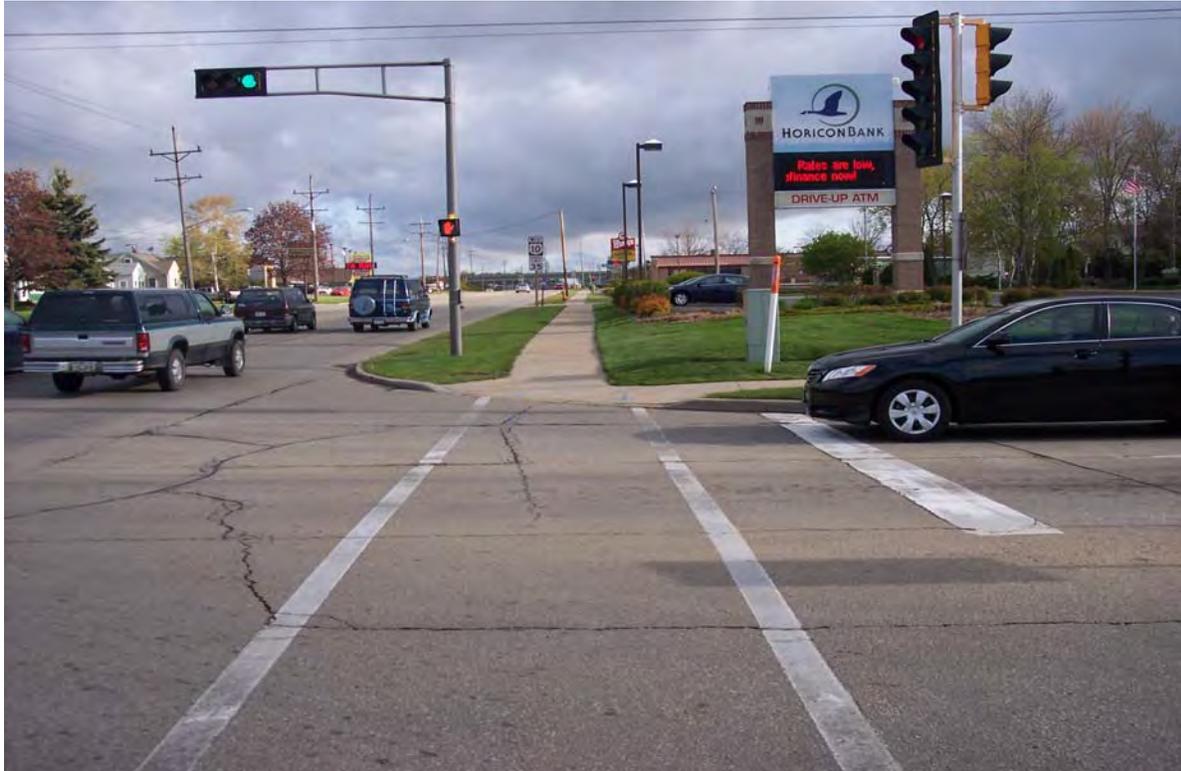
The signals at the intersection of Oneida Street and Midway Road have standard backplates.
