# I-43 Leo Frigo Memorial Bridge Investigation Report

## EXECUTIVE SUMMARY

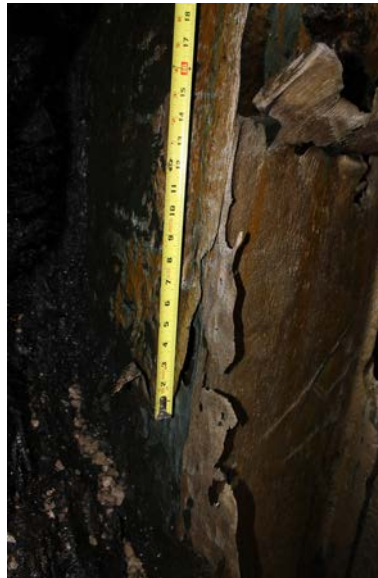
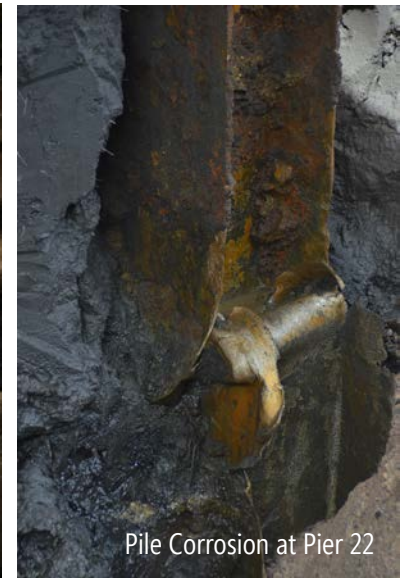
These site conditions led to rapid corrosion of sections of the steel piles. Once sufficient material and support were lost from enough piles, the remaining piling became unstable. Visual examination of selected Pier 22 piles indicated that the most common, perhaps only, mode of pile instability was crushing/buckling of the most heavily deteriorated sections of pile. Severe deterioration and crushing/buckling was observed on all piles that were exposed.
