# **Analysis of Concrete Pavement Joints to Predict the Onset of Distress**

WHRP 07-13

## ***FINAL REPORT***

Wisconsin Department of Transportation

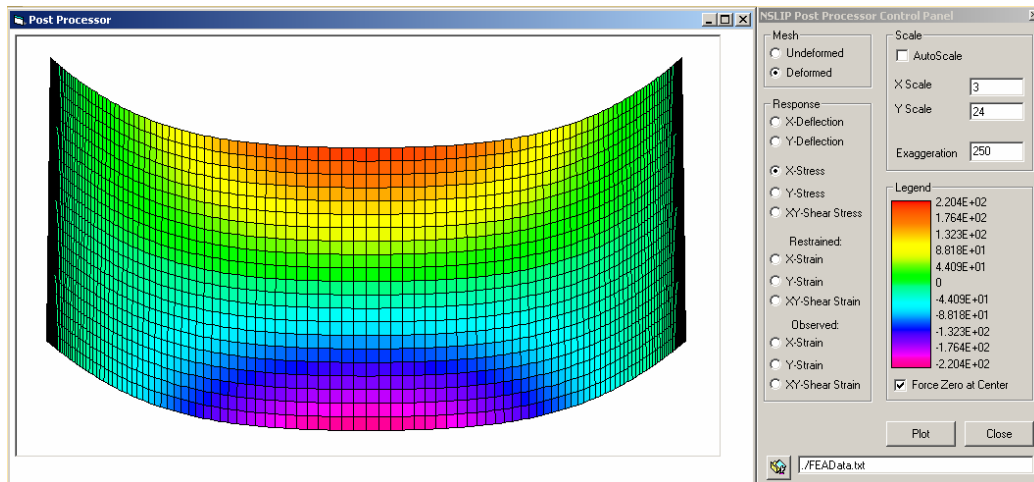
Figure 17. 18-ft. undoweled slab subjected to  $-1^{\circ}\text{F/in.}$  thermal gradient.

To illustrate how significant curling can be, note Figure 17 where an 18-ft. slab panel is subjected to a negative temperature gradient of 1°F per inch. The colors in the figure indicate the magnitude of stress, with red (positive numbers) representing tension. In Figure 17, it can be seen that a peak stress in the concrete of 220 psi has been induced. When the slab length is increased to 20 ft., as illustrated in Figure 18, the stresses increase by an additional 10%.

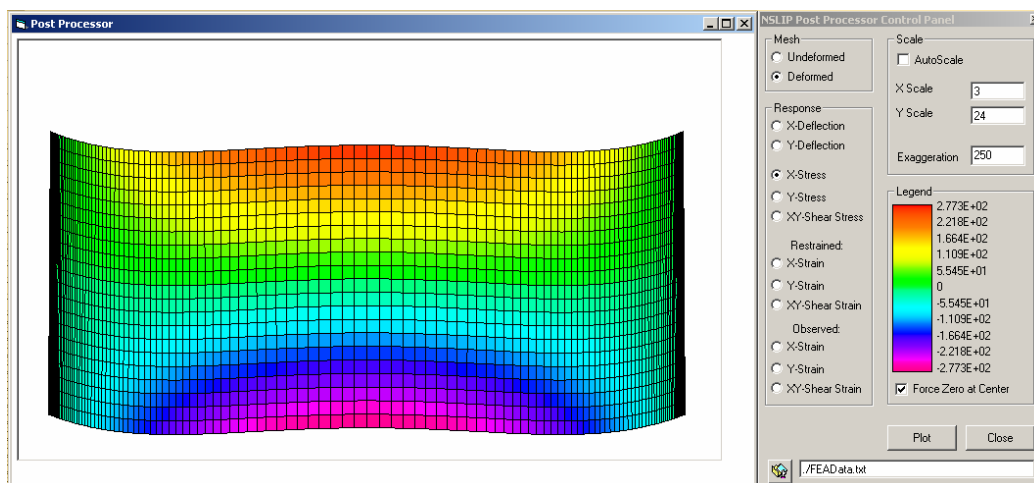
Figure 19. 18-ft. doweled slab subjected to  $-1^{\circ}\text{F/in.}$  thermal gradient.

A compounding effect that has largely been ignored by pavement engineers until recently is the restraining effect caused by the dowels. While their presence is critical in transferring wheel loads across joints, they also restrict free movement of the slab edges and corners due to curling and warping. To illustrate this effect, compare Figure 17 with an 18-ft. slab without dowels to Figure 19, showing the same slab restrained by the presence of dowels. Not only is the slab profile noticeably different, but the stresses induced mid-panel are increased by 25%.

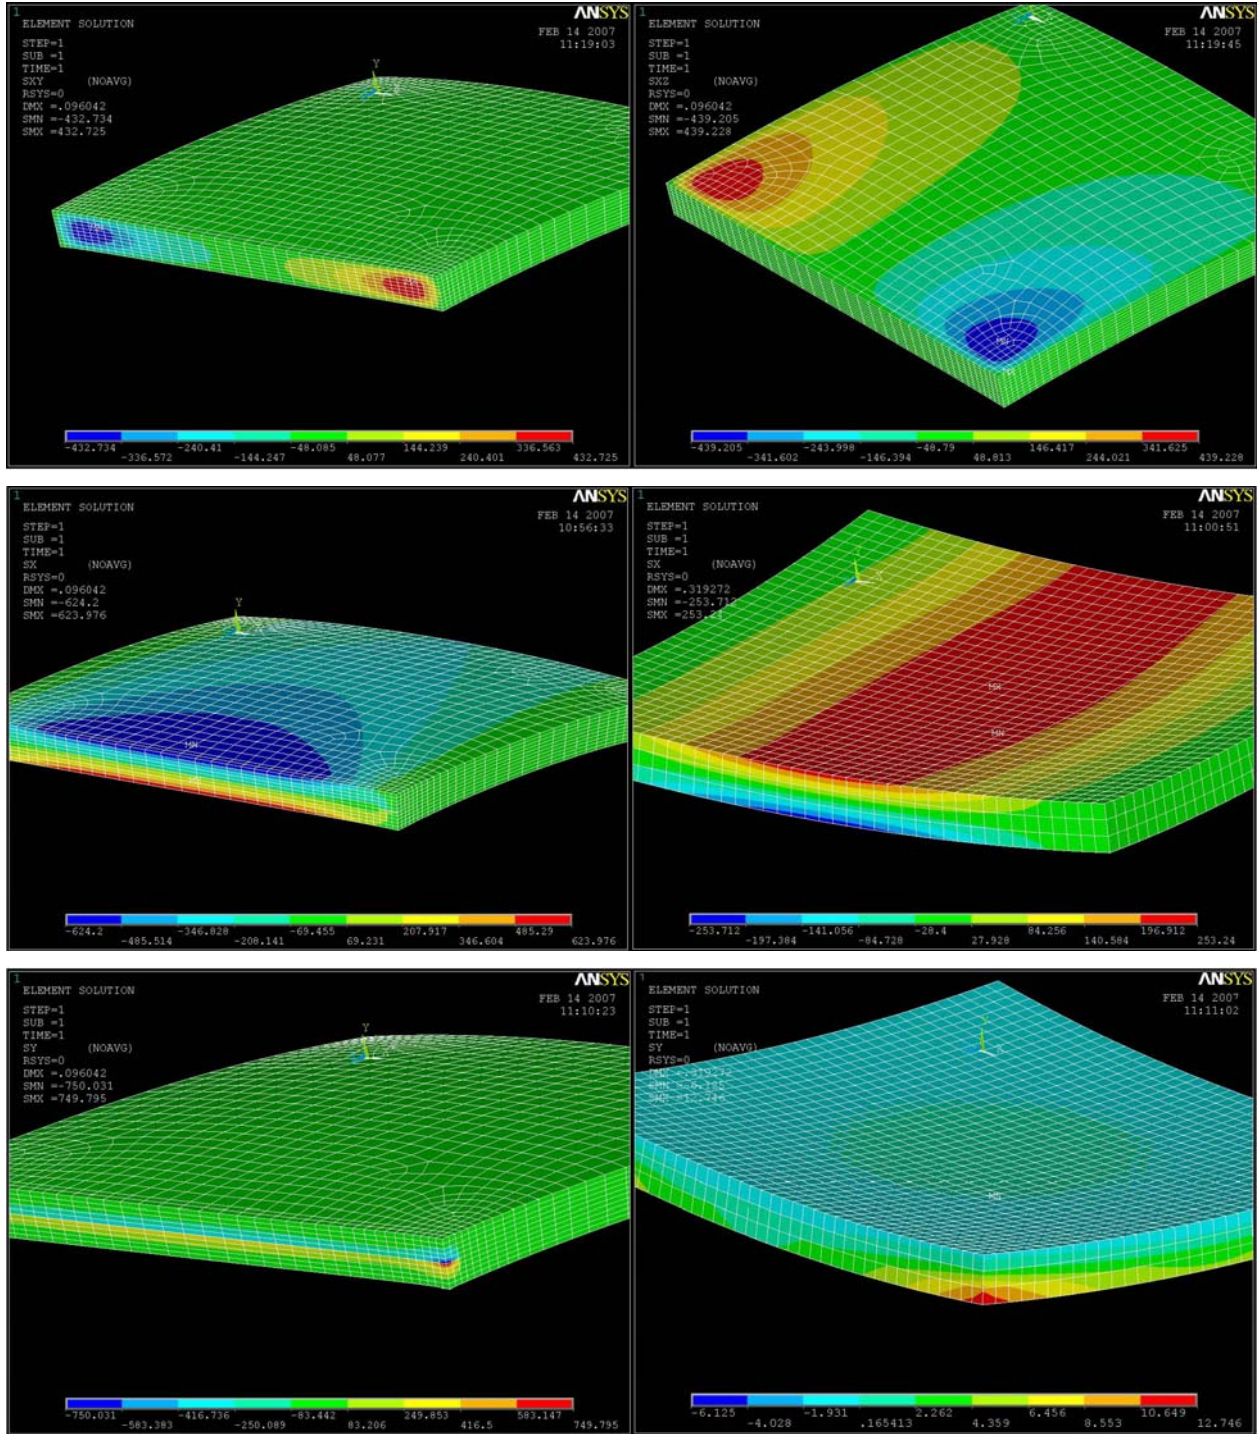
Figure 23. Illustrations of 3D FEM responses.

From these results, trends of slab behavior become evident that are both intuitive and support the hypotheses for failure. For example, increasing slab length increases mid-panel stresses. Increasing the temperature gradient significantly affects both slab shape and critical responses under load. One of the more important observations, however, is the effect of the skewed joint and the resulting acute angle. The responses on these corners are much more critical than those resulting from square joints.
