Impact of Railcar Weight Changes on Bridges of the State of Wisconsin- Owned Railroad System

Westbrook Associated Engineers, Inc., and E80 Plus Constructors, LLC

Final Report No. 0092-05-13

August 2006

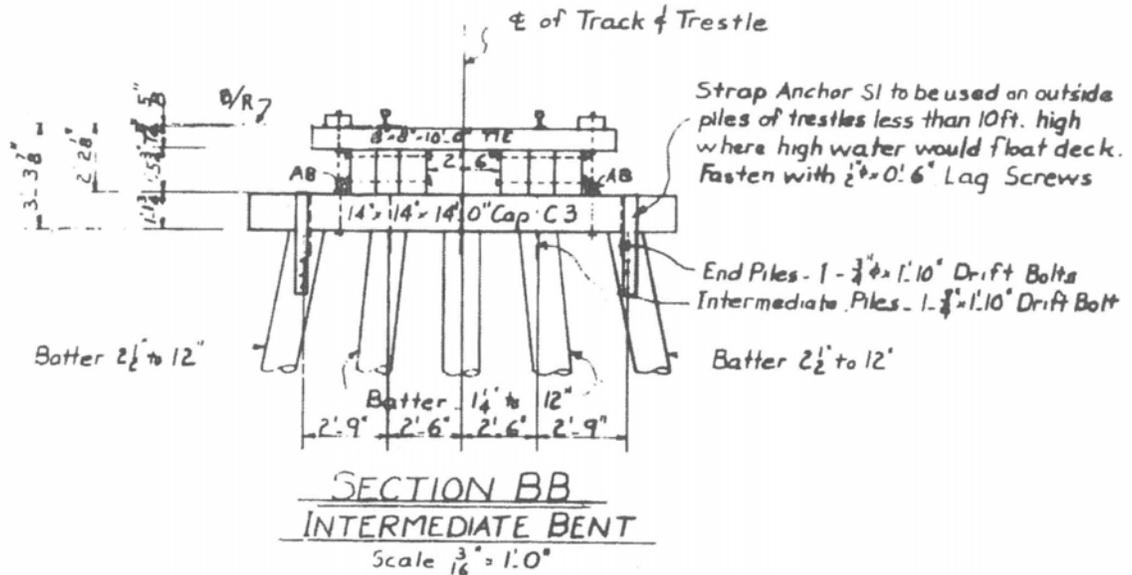
Typical Cross Section, Standard Drawings H-6140 & H-6160

Standard design H-6160 is an open-deck pile trestle bridge design with 16'-0" spans center-to-center of bents. Stringers consist of three 10"x18" timbers joined together under each line of rail. Bents consist of 14"x14" timber pile caps and five 14" diameter piles tapering to 9" minimum. Overall Cooper ratings are E 53 at normal level and E 63 at maximum level based on stringer Bending.

With an equivalent Cooper E load of E 55.5 for bending, the stringer stresses due to 286 kip railcar traffic will exceed AREMA normal rating stresses but are not high enough to cause significant damage. The stringers will be able to carry 286 kip railcar traffic at the cost of a reduction in the remaining useful service life.

Pile loads for the 286 kip railcar loading were 10.1 tons on the exterior piles, 24.4 tons on the intermediate piles, and 23.0 tons on the center pile. The standard plans specified that timber piles be driven to refusal or 25 ton capacity. As stated previously, actual pile capacities could be less than stated, and improper pile spacing will increase pile loads. Pile settlement is evident on many of the 16'-0" trestles inspected.

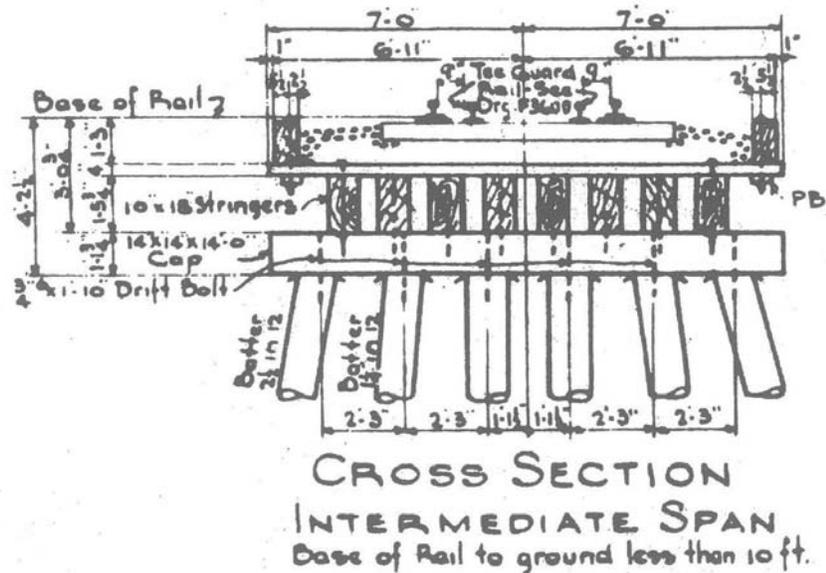
Typical Cross Section, Standard Drawing H-7040

Standard drawing H-7040 is a ballast deck pile trestle bridge design with 14'-0" spans center-to-center of bents. Stringers consist of eight 10"x18" timbers equally spaced underneath the ballast deck. Bents consist of 14"x14" timber pile caps and six 14" diameter pile tapering to 9" minimum. Overall Cooper ratings are E 86 at normal load level and E 104 at maximum level based on bending. These rating levels exceed 286 kip railcar traffic load criteria.

Pile loads for the 286 kip railcar loading were 8.7 tons on the exterior piles, 21.8 tons on the intermediate piles, and 17.9 tons on the center piles. The standard plans specified that timber piles be driven to refusal or 25 ton capacity. This design is adequate to carry 286 kip railcar traffic, and bridge D-78, the only ballasted deck trestle bridge inspected, did not exhibit any pile settlement.

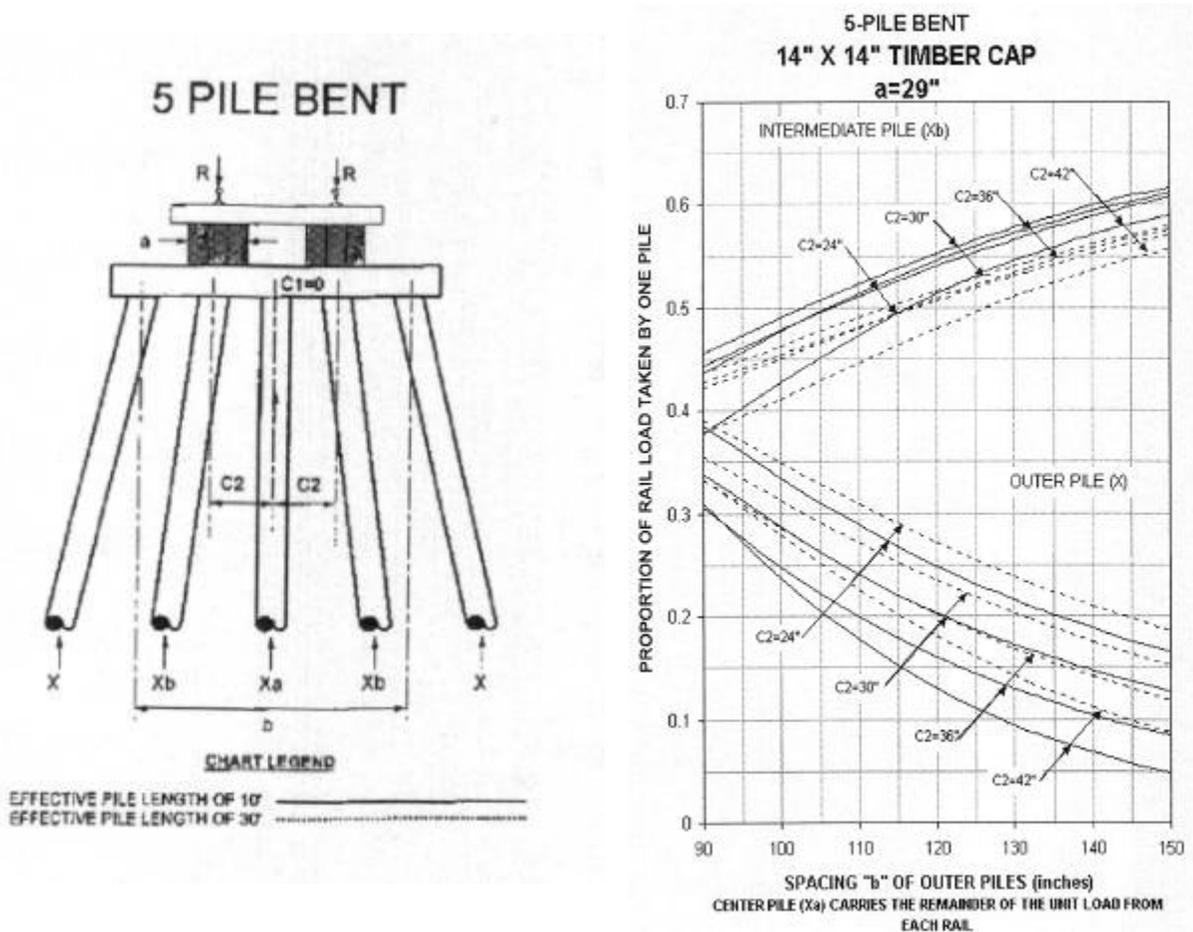
Pile settlement and/or poor pile spacing were noted on each of the five bridges. Pile settlement may be due to insufficient bearing capacity of the piles, increased rail loads, increased pile load due to poor pile spacing or any combination of the three. Pile spacing is particularly critical due to the fact that the interior piles in the bents were at or near the plan bearing capacity of 25 tons. The effects of the pile spacing noted in the field intensify the load distributed to the interior piles, aggravating an already critical issue.

AREMA Chart for Determining Pile Loads – Note how loads to intermediate piles increase with pile spacing.

Where gaps exist between pile caps and piles, the inspecting engineer recommended that the piles be cut down and double caps be installed. Double capping affects pile loads by creating a more even load distribution. The stiffer cap is able to “shed” more load to the exterior piles. The typical load distribution for the cap and pile spacing given in the standard plan is 11% of track load on exterior piles, 26.5% on intermediate piles, and 25% on the center pile. This distribution was determined using AREMA methods. Computer analysis shows that by doubling the stiffness of the cap the load distribution changes to 12.5% on exterior piles and 25% on intermediate and center piles. This distribution is used on bridge F-116 where double caps have been installed.

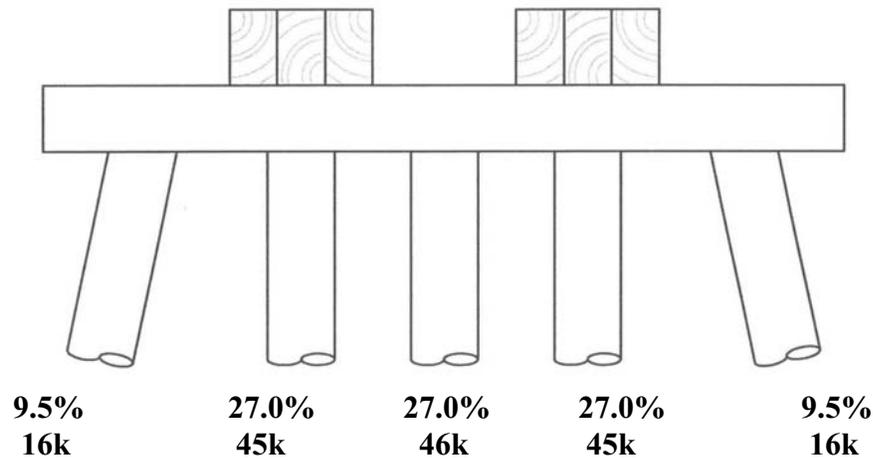
Single Cap - Pile Load Distribution for 286 kip Railcar Load, 16'-0" Span.

The effects of double capping timber pile bents can be estimated based on the increased stiffness of the caps. Estimated pile load distributions are shown below, given as a percentage of the total track reaction. A computer model was set up to match as closely as possible the AREMA distribution for a single cap bent. That same model was then changed to incorporate the stiffness of a double cap and a double cap with shear connectors (thus making a composite section). The results indicate that load on the interior piles may be reduced by four to five percent. The distributions shown in the following figures were determined for the design pile spacings shown on standard drawing H-6160: 2'-9" | 2'-6" | 2'-6" | 2'-9".

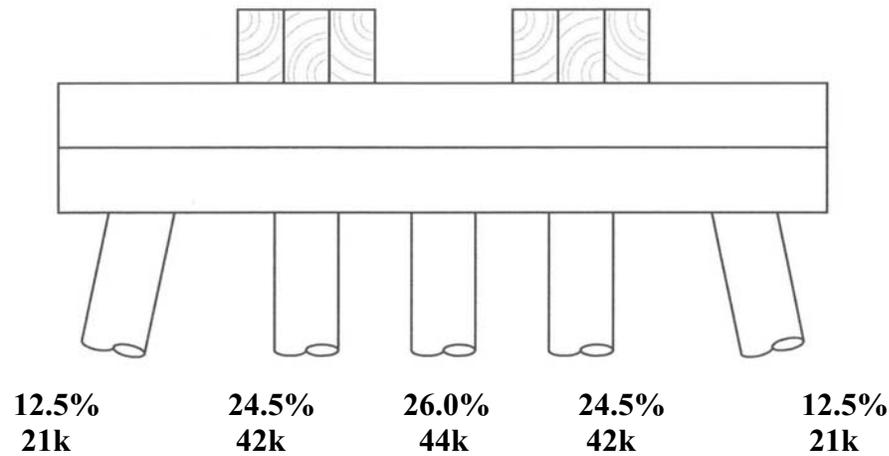
Double Cap - Pile Load Distribution for 286 kip Railcar Load, 16'-0" Span.

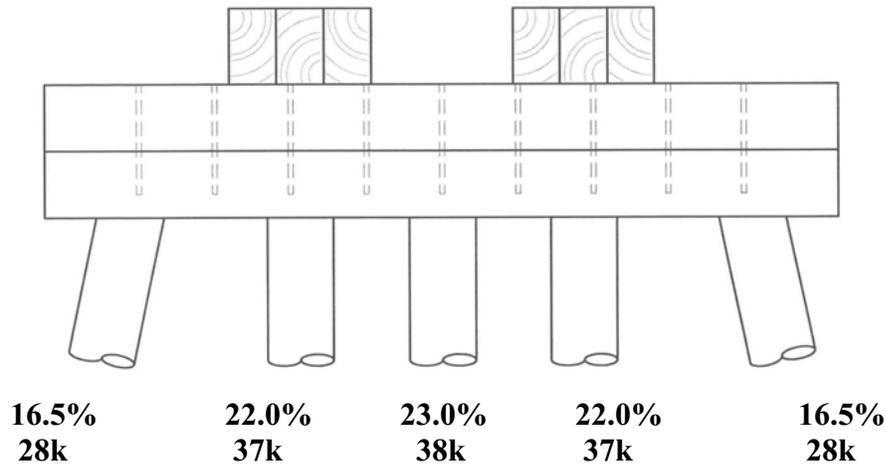
Double Cap Composite - Pile Load Distribution for 286 kip Railcar Load, 16'-0" Span.

Further analysis has shown that double capping may be more beneficial for bents with poor pile spacing, see Table 6. In this situation, a composite cap would reduce the load on the interior piles with greater effect – from five to seven percent of the total track reaction. Creating the composite double cap may be achieved using fiber reinforced polymer (FRP) shear spikes. Research has shown that FRP shear spikes bonded to the wood with an epoxy resin increased the effective stiffness of timber bridge members (Burgers, Gutkowski, Radford, and Balogh. *Composite Repair of Full-Scale Timber Bridge Chord Members Through the Process of Shear Spiking*).
