WHRP 08-06

# EVALUATION OF FIBERGLASS WRAPPED CONCRETE BRIDGE COLUMNS

**Final Report**

Submitted to the Wisconsin Department of Transportation

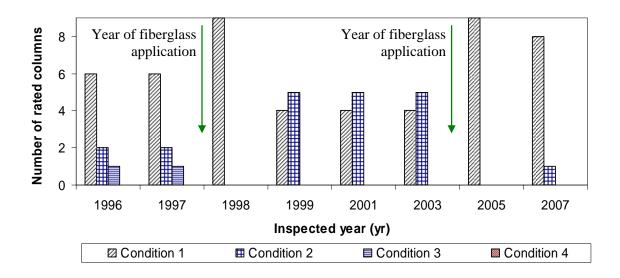
Year	Relevant inspection report comments
12/1996	Columns G, H, and I have been repaired and look good.
<b>~</b> 4/1999	Columns A, B, and C have spalls and delaminated areas with exposed rusty rebar.
7/2001	Columns G, H, and I have been repaired and look good.
	Columns A, B, and C have spalls and delaminated areas with exposed rusty rebar.
	Delamination/spall at columns G, H and I (pier 1) and at columns A, B, and C (pier
	3)
6/2003	Columns H and I have 2" by 2" spalls with exposed rebar.
	Column C has a 2" by 2" spalls with exposed rebar.
6/2005	Columns G and H have spalled areas repaired.
	Column C have spalled areas repaired
	Three columns are wrapped with fiber wrap.
6/2007	Vertical cracks in column G.
	Four columns are wrapped with fiber wrap.
	Note: New fiberglass wrapping was applied column G after this research team
	initial visual survey.

**Figure 3.3:** Timeline of inspected conditions of columns and maintenance operations in B-11-17 bridge (Condition rating definitions are summarized in Table 3.3).

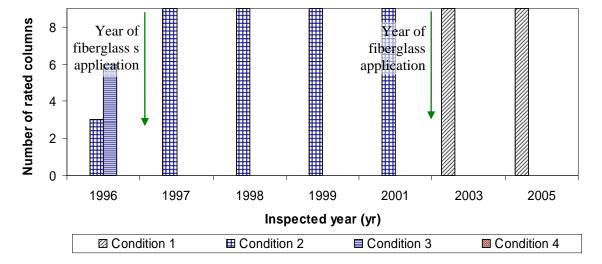
**Figure 3.5:** Timeline of inspected conditions of columns and maintenance operations in the B-13-113 bridge (Condition rating definitions are summarized in Table 3.3).

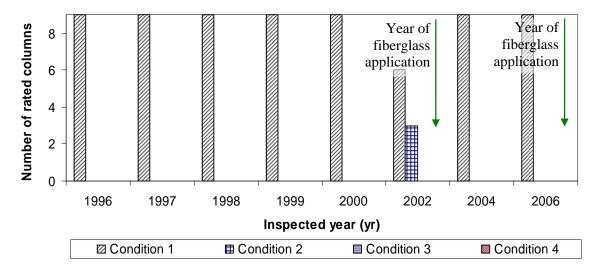
Year	Relevant inspection report comments
12/1996 ~	Columns A, B, and C have fiber wraps, all look good.
11/2000	Columns G, H, and I have fiber wraps, all look good.
2/2002	Columns A, B, and C have fiber wraps, all look good.
	Columns G, H, and I have fiber wraps, all look good. Fiber wrap at column
	G is starting to break open.
2/2004	Columns A, B, and C have fiber wraps, all look good.
	Columns G, H, and I have fiber wraps, all look good.
9/2004	Columns A, B, and C have fiber wraps.
	Columns G, H, and I have fiber wraps.
9/2006	Columns A, B, and C have fiber wraps, all look good.
	Columns G, H, and I have fiber wraps, all look good.

**Figure 3.7:** Timeline of inspected conditions of columns and maintenance operations in the B-13-144 bridge (Condition rating definitions are summarized in Table 3.3).

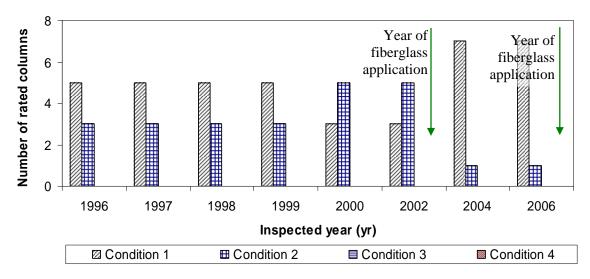
Year	<b>Relevant inspection report comments</b>
11/1996 ~	Columns E, F, G, and H have concrete patches. These patches have some
2/2002	cracks and sound hollow.
1/2004	Columns E, F, G, and H have concrete patches and patches have random
	cracks and sound hollow. All columns were wrapped and sealed.
9/2004	Columns E, F, G, and H have fiber wraps. Delamination/cracking in column
	F (or G?).
9/2006	Columns E, F, G, and H have fiber wraps. All columns look good.

**Figure 3.9:** Timeline of inspected conditions of columns and maintenance operations in the B-13-172 bridge (Condition rating definitions are summarized in Table 3.3).

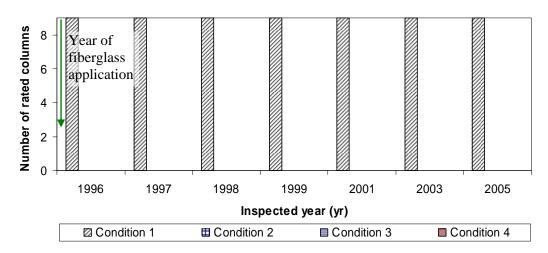
Year	<b>Relevant inspection report comments</b>
6/1996 ~	Columns A, B, and C have fiber wrap and look good.
6/2005	Other columns look good.

**Figure 3.11:** Timeline of inspected conditions of columns and maintenance operations in the B-28-35 bridge (Condition rating definitions are summarized in Table 3.3). Mid 1990s is the estimated wrapping year.

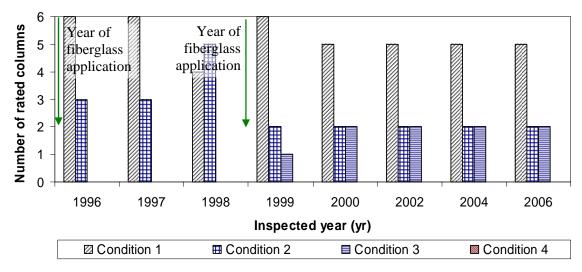
**Figure 3.13:** Timeline of inspected conditions of columns and maintenance operations in the B-28-40 bridge (Condition rating definitions are summarized in Table 3.3).

Year	<b>Relevant inspection report comments</b>
10/1996 ~	Columns A, B, and I are wrapped. There a few cracks in the three
11/1999	columns (A, B, I).
5/2000	Columns A, B, and I are wrapped
2/2002 ~	Columns A, B and I have fiberglass wraps.
2/2004	Column F has high rust steel, popout spalls.
	Column H has vertical cracks at bottom.
9/2004	Columns A, B and I have fiber wraps.
	Column F has high rust steel popout spalls.
	Column H has vertical cracks and delamination at bottom.
9/2006	Column A & B has fiber wraps and both columns look good. Column A
	has a couple rust stains.
	Column F has high rust steel popout spalls.
	Column H has vertical cracks and delamination at bottom.
	Column I has fiber wrap 1/3 up and it looks good.

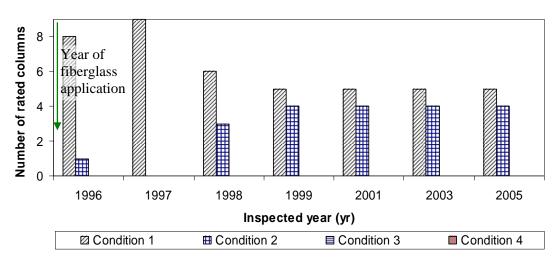
**Figure 3.15:** Timeline of inspected conditions of columns and maintenance operations in the B-28-43 bridge (Condition rating definitions are summarized in Table 3.3).

Year	Relevant inspection report comments
6/1996 ~ 6/2005	Columns A, B, and C have concrete collars one third up. Column G has a fiber wrap one third up. Column I has numerous cracks in concrete collars.

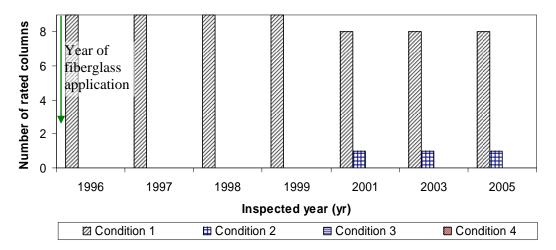
**Figure 3.17.** Timeline of inspected conditions of columns and maintenance operations in the B-28-45 bridge (Condition rating definitions are summarized in Table 3.3).

Year	Relevant inspection report comments
7/1997	Columns A and B are wrapped.
3/1998 ~ 3/1999	Columns A and B are wrapped.
6/2001 ~ 6/2005	Columns A and B have been wrapped halfway up. Column D has a small spalledout area half way up, no exposed rebar.

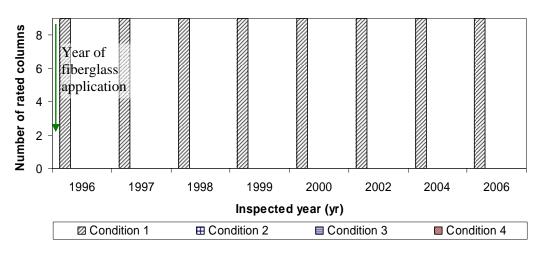
**Figure 3.19:** Timeline of inspected conditions of columns and maintenance operations in the B-28-50 bridge (Condition rating definitions are summarized in Table 3.3).

Year	Relevant inspection report comments
3/1996 ~	Fiberglass wrap on column A looks good.
3/1999	Fiberglass wrap on column G looks good.
5/2000 ~	Fiberglass wrap on column A looks good. Couple of vertical cracks remaining.
9/2006	Fiberglass wrap on column G looks good. Couple of vertical cracks remaining.

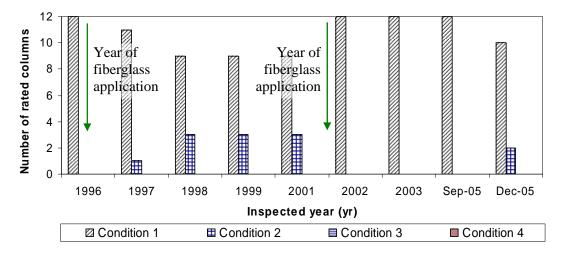
**Figure 3.21:** Timeline of inspected conditions of columns and maintenance operations in the B-53-65 bridge (Condition rating definitions are summarized in Table 3.3).

Year	Relevant inspection report comments
11/1996 ~	Columns I and K are wrapped with fiberglass.
9/2005	Columns A, C and D are wrapped with fiberglass. These columns have cracks and delaminations.
12/2005	Columns I & K are wrapped with fiberglass. The fiberglass wrap in column I is debonding and column is spalling. Columns A, C and D are wrapped with fiberglass. The fiberglass wrap in column A is debonding and column is spalling. The fiberglass wrap in column C is starting to debond. The fiberglass wrap in column D is in ok condition. Column B has hairline cracks & delaminations. There is no fiberglass wrap on it.

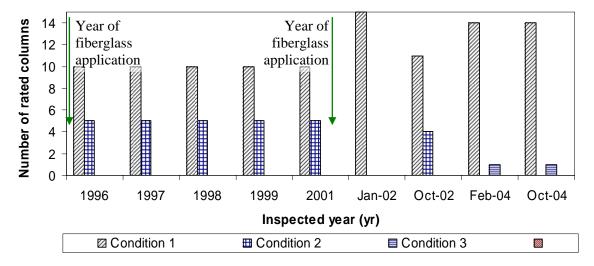
**Figure 3.23:** Timeline of inspected conditions of columns and maintenance operations in the B-53-66 bridge (Condition rating definitions are summarized in Table 3.3).

Year	Relevant inspection report comments			
11/1996 ~	Fiberglass wrapped columns K and M have some vertical cracks.			
11/1999	Column L has delaminated area.			
7/2001	Columns A, B and D were fiber wrapped in 2000 and painted gray.			
	They look good.			
10/2002 ~	Column K has old fiberglass wrap and the wrap is busting out.			
10/2004				
10/2006	Column K and M have old fiberglass wraps and are busting out at bottom.			
	Columns A, B & D were fiber wrapped in 2000 and painted gray. They look			
	good.

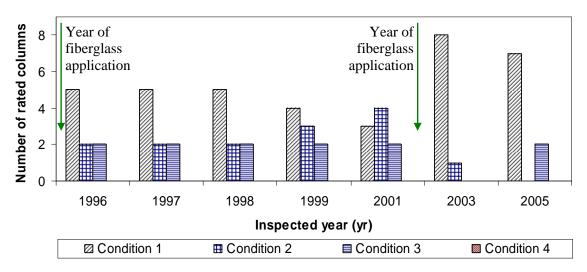
**Figure 3.25:** Timeline of inspected conditions of columns and maintenance operations in the B-53-71 bridge (Condition rating definitions are summarized in Table 3.3).

Year	Relevant inspection report comments					
10/1996	Columns A, B, and C are all fiberglass wrapped.					
	Column E has one concrete collar has several cracked rust stains					
10/1997	7 Columns A, B, and C are all fiberglass wrapped. Column C has several cracks with					
	rust stains.					
	Column E has a concrete collar has horizontal cracks, sounding was good.					
4/1998	Columns A and B have fiberglass wrap on the lower half.					
	Columns C has a complete fiberglass wrap.					
3/1999	Columns A and B have fiberglass wrap on the lower half.					
	Columns C has a complete fiberglass wrap.					
7/2003	Columns A, B, C, and D are wrapped.					
	The fiberglass wrapping in column C has failed near the ground line.					
	Column E has a collar.					
7/2005	Columns G and H both have bottom half spalling out.					
	Column E has a collar.					
	Column A is completely wrapped in fiberglass.					
	Columns B and C are wrapped half height in fiberglass. The wrap in column C is

coming off.

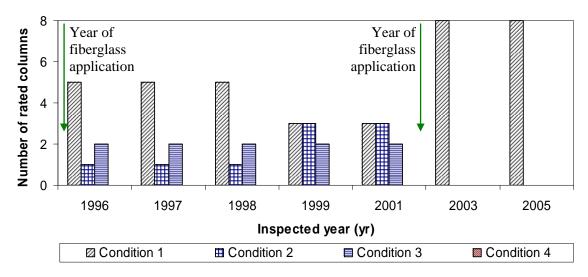
Year	Relevant inspection report comments		
10/1996 ~ 7/2001	Columns A, B, C, and D are cracked and delaminated in the bottom half. Column G is delaminated, exposed rusty rebar.		
7/2003 ~ 7/2005	Columns A, B, C, and D are wrapped.

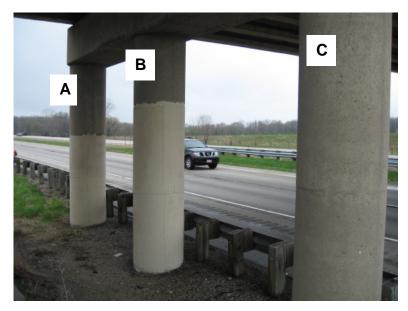
Figure 4.3: Tested columns in the Bridge B-28-45 (Eastbound).

P-wave velocity profiles and tomographic images were collected on three columns along of eastbound shoulder of Bridge B-28-45. Two of these columns (columns A and B) were coated with fiberglass wraps while the third column (Column C) was in its as-built condition, as shown in Figure 4.3. Columns A and B did not show external signs of distress while Column C showed cracks on the surface facing traffic.

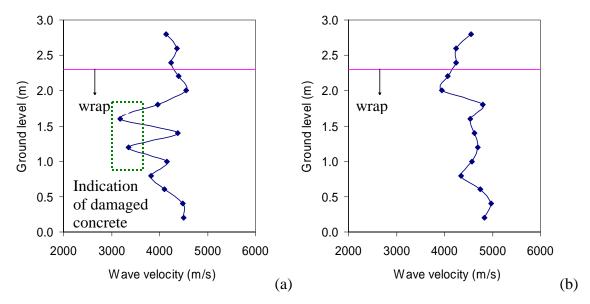
**Figure 4.4:** Horizontal P-wave velocity profiles on Bridge B-28-45 column A: (a) vertical parallel to traffic and (b) vertical plane perpendicular to traffic.

Average P-wave velocity profiles along vertical planes parallel and perpendicular to the traffic direction for column A are presented in Figure 4.4. The figure shows a significant reduction in the P-wave velocity and thus areas of weaker concrete at 1.2 m and 1.5 m high in the vertical plane parallel to the traffic direction. Because these measurements provide average P-wave velocities only and the local position of the weaker concrete material cannot be determined (e.g., how far from the concrete surface), P-wave data were also collected to obtain tomographic images of the vertical planes. These tomographic images are presented in Figure 4.5. The local distribution of P-wave velocity shown in Figure 4.5b indicates that the areas of degraded concrete facing the traffic direction.

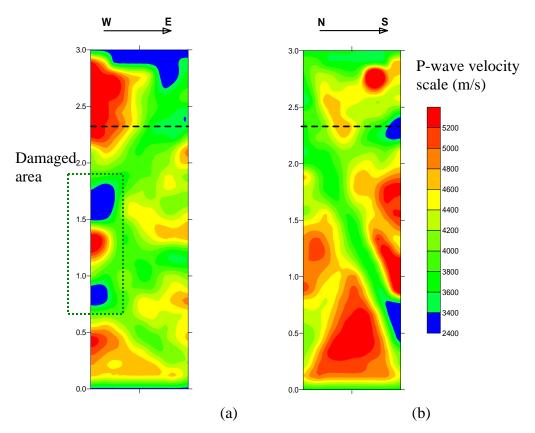
**Figure 4.5:** P-wave velocity tomographic images on Bridge B-28-45 column A: (a) vertical plane parallel to traffic and (b) vertical plane perpendicular to traffic.

does not seem to coincide with the damaged areas predicted in the same column using the Pwave velocity tomography (see Figure 4.5). Furthermore, the high volumetric water content (that is, low electromagnetic wave velocity) in the cross section tomographic image (Figure 4.23) appears in the center of the column. This observation seems puzzling. Traffic splashing should show higher water content on the concrete surface however the surface may also dry faster.

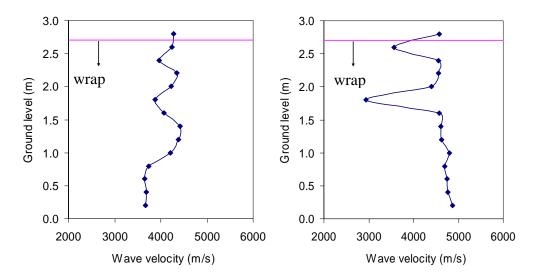
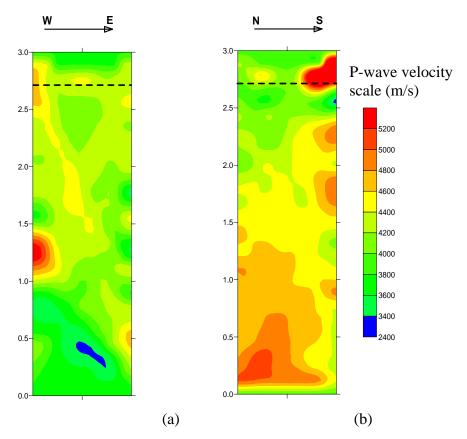
Similar P-wave velocity profiles and tomographic images along vertical planes were collected for Bridge B-28-45 column B, as shown in Figure 4.6. While the tomographic images presented in Figure 4.7 do not seem to indicate definite locations of the damaged concrete areas, the tomographic images along two horizontal cross-sections (Figure 4.8) clearly constrain the location of damaged area on the concrete facing the traffic direction.

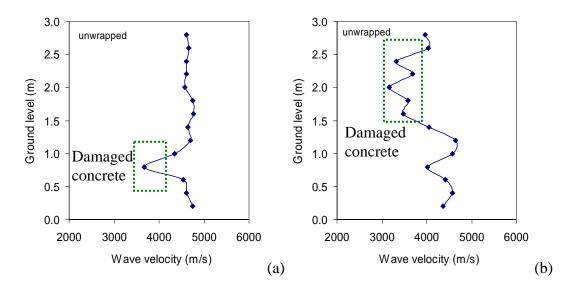
**Figure 4.9:** Horizontal P-wave velocity profiles on Bridge B-28-45 column C: (a) vertical parallel to traffic and (b) vertical plane perpendicular to traffic.

To provide a benchmark to the measurements conducted on the fiberglass wrapped columns A and B, P-wave velocity tests were also conducted on column C (unwrapped column) of Bridge B-28-45. Both horizontal P-wave velocity profiles (Figure 4.9) and tomographic images (Figure 4.10) along vertical planes parallel and perpendicular to traffic directions coincide in the locating areas of degrading concrete. These concrete areas face the traffic direction. Thus, it is likely that the damage observed in columns A and B using the wave propagation techniques reflect the degradation caused by the rebar corrosion even after the columns were treated with fiberglass wrap.

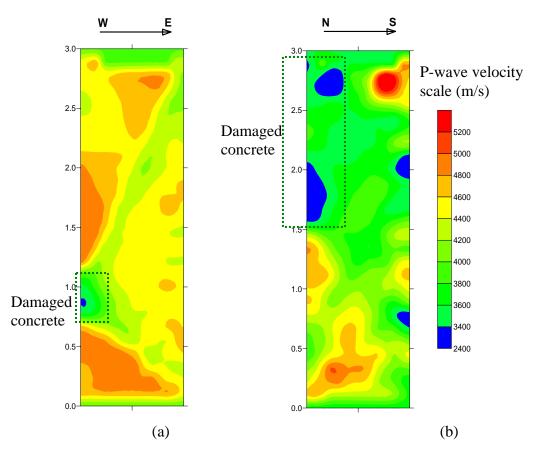
**Figure 4.10:** P-wave velocity tomographic images on Bridge B-28-45 column C: (a) vertical plane parallel to traffic and (b) vertical plane perpendicular to traffic.

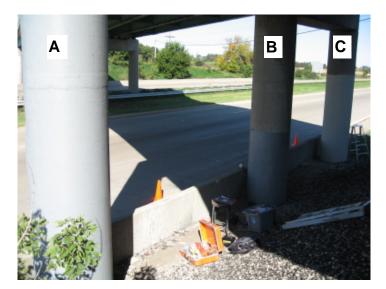
P-wave velocity profiles and tomographic images were collected on three columns along of eastbound shoulder of Bridge B-53-71. Two of these columns (columns A and C) were treated with fiberglass wrap along at least two third of the column high, while the third B was treated to less than half its height as shown in Figure 4.11. Column C was re-wrapped in 2007 due to corrosion damage at the bottom of the column (see Figure 3.1)

Figure 4.11: Tested columns in the Bridge B-53-71 (Northbound).

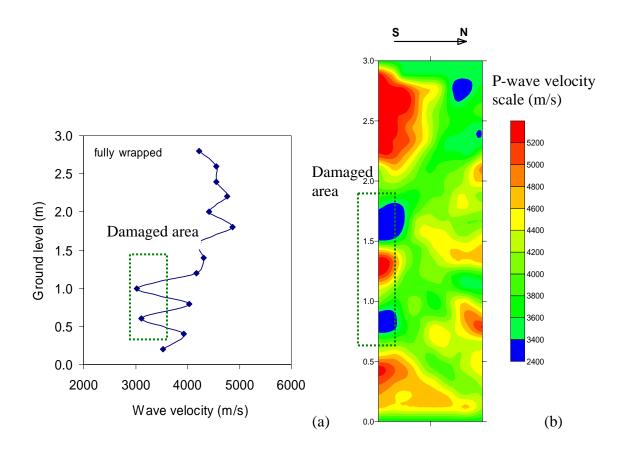
The average P-wave velocity profile and a tomographic image collected along a vertical plane parallel to traffic direction in column A are presented in Figure 4.12. These results show areas of weaker concrete at 0.6 to 1.2 m levels above ground. The results seem to show that despite of the repairs done with fiberglass wrapping (including replacing damage concrete with new mortar), areas of damaged concrete remains.

**Figure 4.12:** P-wave velocity results in Bridge B-53-71 column A along vertical plane parallel to traffic: (a) P-wave velocity profile and (b) tomographic imaging.

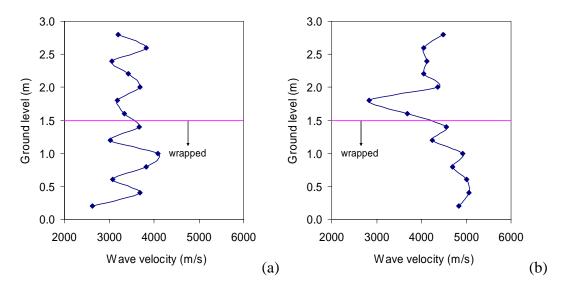
Figures 4.13 and 4.14 summarize the P-wave velocity profiles and tomographic images obtained in Bridge B-53-71 column B. This column shows relative low P-wave velocities along the vertical plane parallel to the traffic direction (Figures 4.13a and 4.14a) and higher P-wave velocities in the vertical plane perpendicular to the traffic direction. However even this plane shows pockets of low P-wave velocity both in areas above and below the fiberglass wrap level (see for example the drop on P-wave velocity at the 1.8 m level in Figures 4.13b and 4.14b).

**Figure 4.13:** Horizontal P-wave velocity profiles in Bridge B-53-71 column B: (a) vertical parallel to traffic and (b) vertical plane perpendicular to traffic.

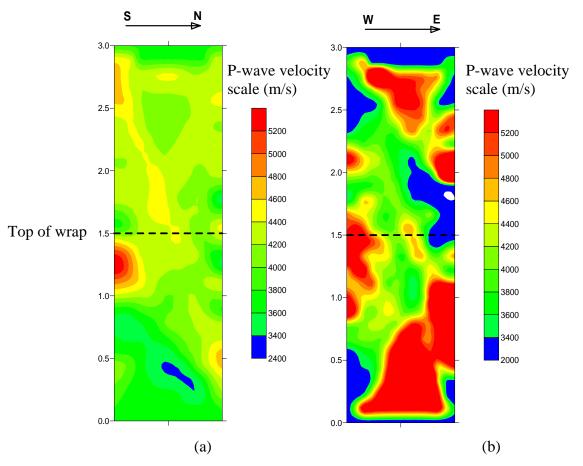
**Figure 4.14:** Horizontal P-wave velocity tomographic images of Bridge B-53-71 column B: (a) vertical parallel to traffic and (b) vertical plane perpendicular to traffic.

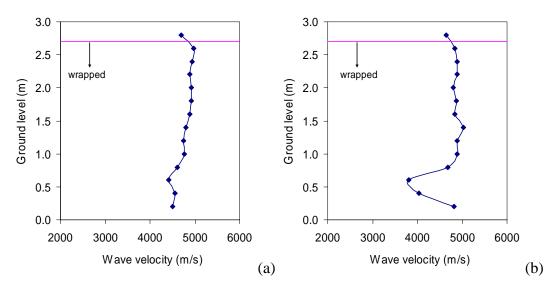
Finally, Figures 4.15 and 4.16 show the horizontal P-wave velocity profiles and tomographic images along vertical planes parallel and perpendicular to traffic directions coincide in the locating areas of degrading concrete for column C. This column was treated twice with fiberglass warp, most recently in 2007. Overall, the P-wave velocity profiles indicate good concrete quality

**Figure 4.15:** Horizontal P-wave velocity profiles in Bridge B-53-71 column C: (a) vertical parallel to traffic and (b) vertical plane perpendicular to traffic.

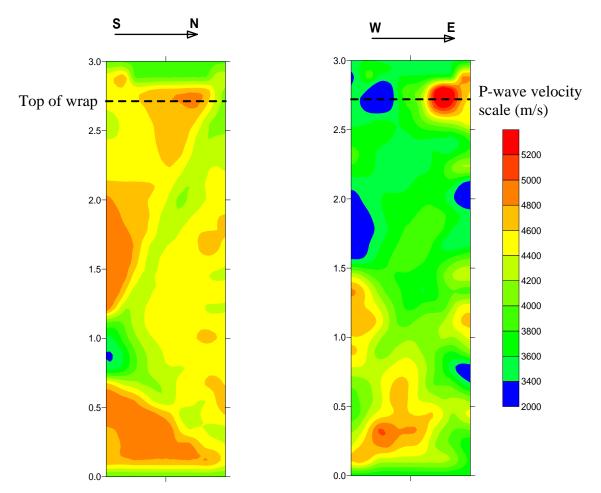
**Figure 4.16:** Horizontal P-wave velocity tomographic images of Bridge B-53-71 column C: (a) vertical parallel to traffic and (b) vertical plane perpendicular to traffic.

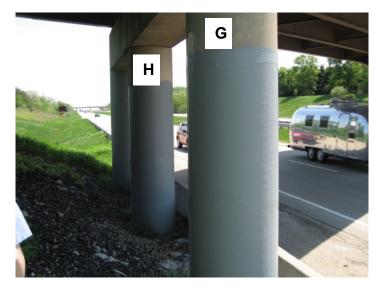
P-wave velocity profiles and tomographic images were collected on two columns along of eastbound shoulder of Bridge B-13-144. Two of these columns (columns G and H) were treated with fiberglass wrap (Figure 4.17). These wrapped columns seem to be in very good condition, however P-wave velocity profiles and tomographic images indicate that the concrete is damaged in the bottom 1.5 m of both columns (Figure 4.18 and 4.19). WisDOT regular inspection reports also indicate that column G had experience fiberglass wrapping failure and needed replacement.

Figure 4.17: Tested columns in the Bridge B-13-144 (Southbound).

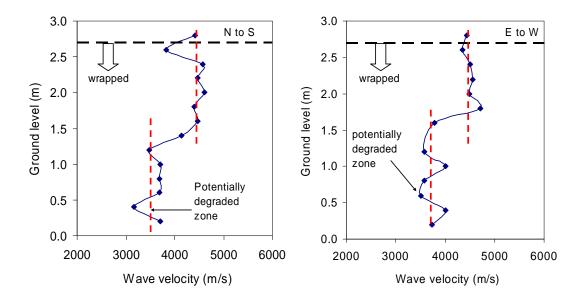
**Figure 4.18:** Horizontal P-wave velocity profiles in Bridge B-13-144 column H: (a) vertical parallel to traffic and (b) vertical plane perpendicular to traffic.

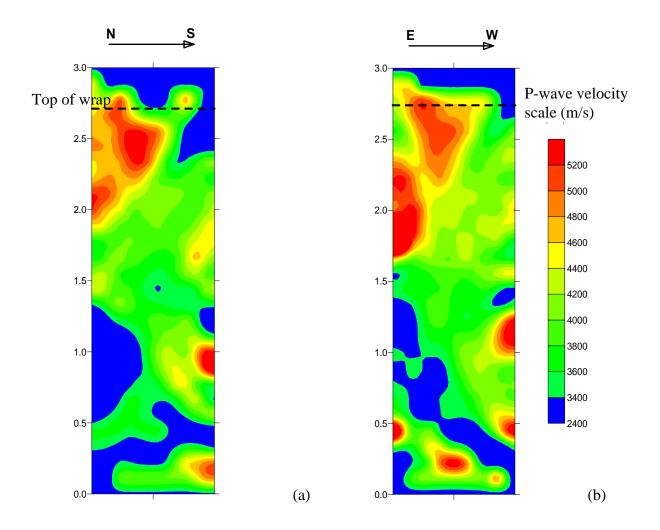
**Figure 4.19:** Horizontal P-wave velocity tomographic images of Bridge B-13-144 column H: (a) vertical parallel to traffic and (b) vertical plane perpendicular to traffic.

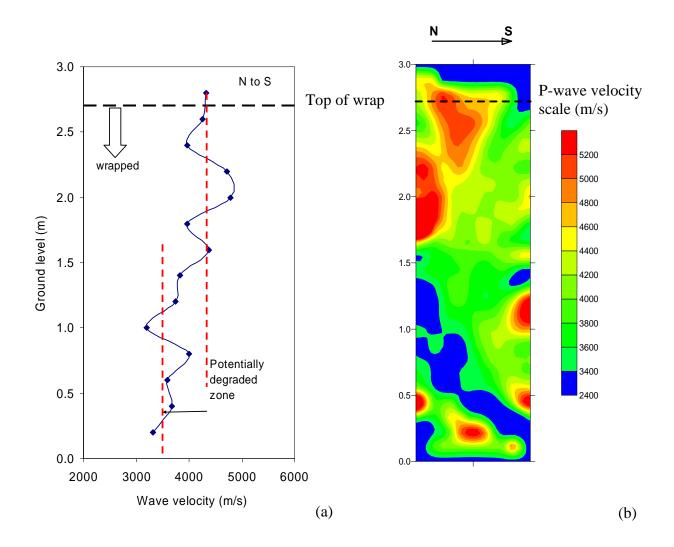
**Figure 4.20:** P-wave velocity results in Bridge B-13-144 column G along a vertical plane parallel to traffic: (a) P-wave velocity profile and (b) tomographic imaging.

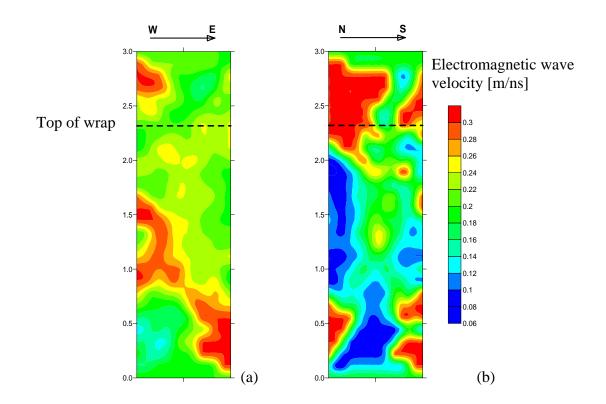
GPR data were collected in all three columns tested columns of Bridge B-28-45 (i.e., columns A, B and C). Figure 4.22 documents the GPR tomographic results along vertical planes: parallel and perpendicular to traffic directions. The lower electromagnetic wave velocity recorded along the midsection on north face of the column (Figure 4.22a) seems to indicate greater volumetric water content behind the fiberglass wrap. The location of this area of high volumetric water content

**Figure 4.22:** GPR tomographic images of Bridge B-28-45 Column A: (a) parallel to traffic and (b) perpendicular to traffic.

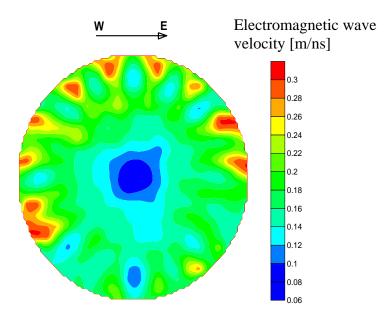
Figure 4.23: GPR tomographic images of Bridge B-28-45 Column A along 0.4 m high horizontal plane.

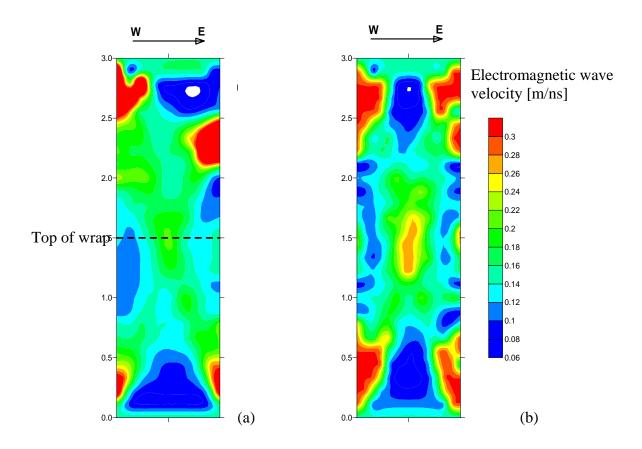
Finally, Figure 4.24 shows the tomographic images of Bridge B-28-45 columns B and C (Column C does not have fiberglass wrap). Once again the results show greater water content areas (that is low electromagnetic wave velocities) at the center of the column in the lower section of the column or the top of column where little splashing would be expected.

**Figure 4.24:** GPR tomographic images of Bridge B-28-45: (a) column B and (b) column C (parallel to traffic)

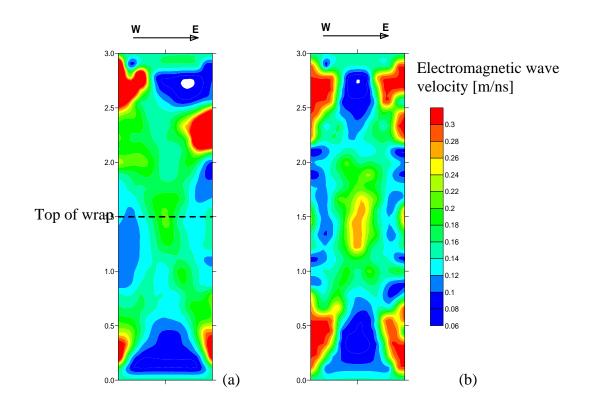
Figure 4.25shows tomographic images of Bridge B-13-144 columns H and G. Once again puzzling results are obtained. Areas with large water contents (that is, areas with low electromagnetic wave velocities) appear at the center of the column in the lower section of the column or the top of column where little splashing would be expected.

**Figure 4.25:** GPR tomographic images of Bridge B-13-144: (a) column H and (b) column G (plane parallel to traffic).

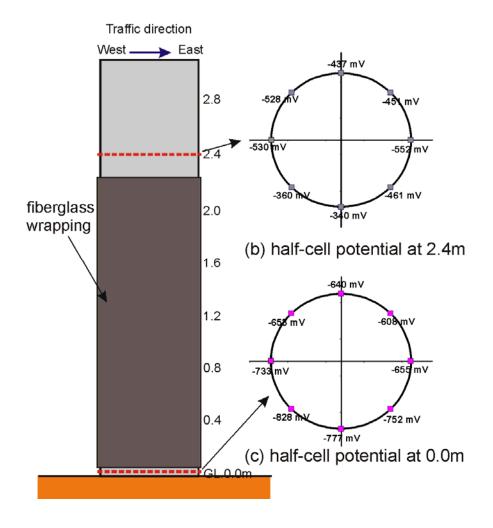
Figure 4.28: Half cell potential measurement in Bridge B-28-45 column A (fall 2007): (a) above wrap and (b) below wrap.

Figures 4.28 and 4.29 summarize half cell potential results for wrapped columns A and B collected in fall 2007. In both columns, the readings indicate strong corrosion activity (i.e., a 90% probability risk of corrosion - Table 2.4). The corrosion activity as indicated by the half cell potential measurements is particularly strong in column B. This activity is greater below the fiberglass wrap than above the wrap. This observation is expected as the salt solution splashing is

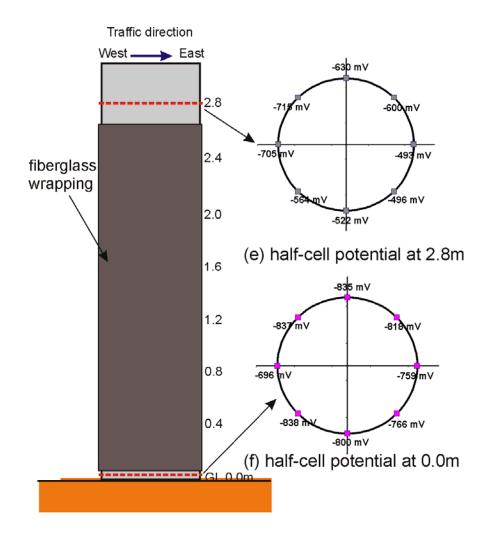
Figure 4.29: Half cell potential measurement in Bridge B-28-45 column B (fall 2007): (a) above wrap and (b) below wrap.

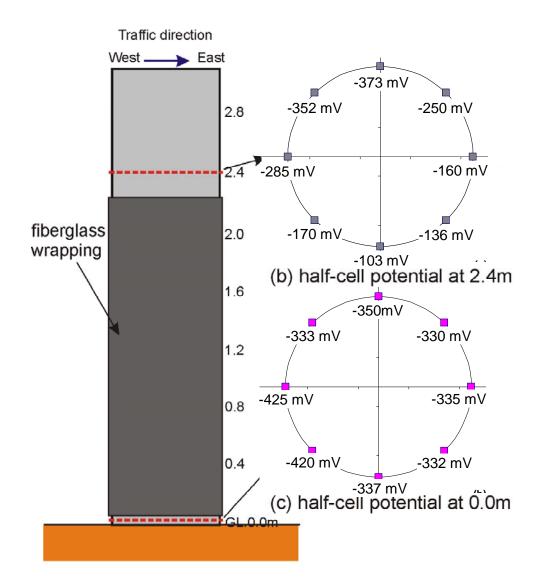
stronger at the bottom of the columns. Similar measurements were performed during the summer 2008. These results are summarized in Figures 4.30 and 4.31 and show a continuation of corrosion activity although the results are somehow smaller. The variation of the results may be caused by several environmental conditions such as changes in column moisture, temperature, etc.

Figure 4.30: Half cell potential measurement in Bridge B-28-45 column A (summer 2008): (a) above wrap and (b) below wrap.

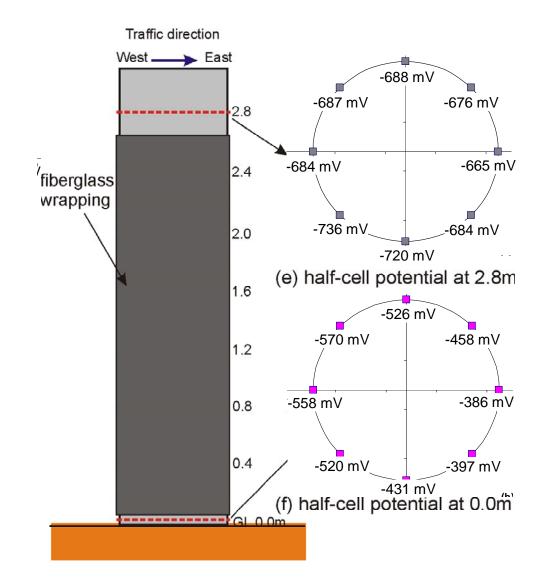
Figure 4.31: Half cell potential measurement in Bridge B-28-45 column B (summer 2008): (a) above wrap and (b) below wrap.

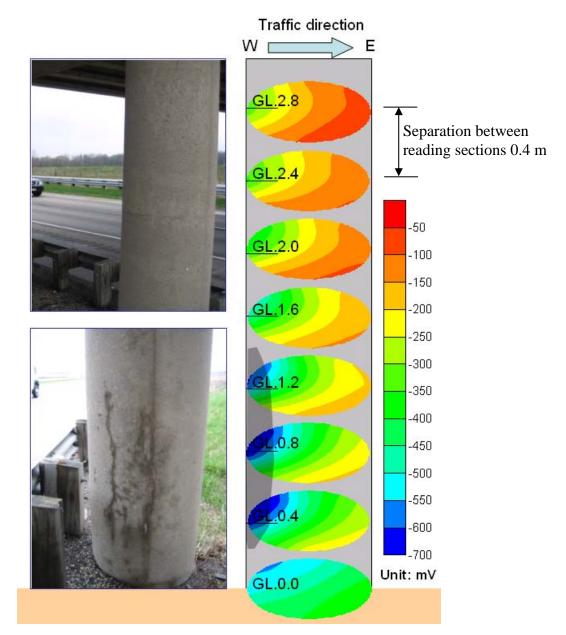
Half-cell potential readings were also taken on bridge B-28-45 unwrapped column C during fall 2007. These measurements shows greater negative values along the area with the corrosion distress (surface crack and discoloration – Figure 4.32). This area is also the surface of concrete that receives most of the deicing solution splashing (e.g., Figure 1.1). The half cell potential readings in the columns confirm the visual observations and show strong corrosion activity next and around the deteriorated concrete. It is also clear that the corrosion activity decreases at with height of the column as less saline solution splashing reaches at higher column elevations.

**Figure 4.32:** Half cell potential measurements in Bridge B-28-45 column C: View of the columns and half-cell potential measurement results (measurement at 0.2 m intervals above ground level - GL).

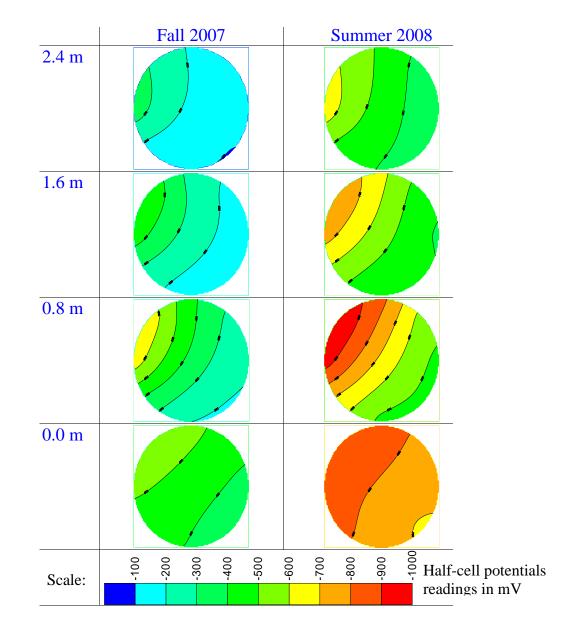
Half-cell potentials readings were also collected during summer 2008. Half-potential results collected in fall 2007 are compared to summer 2008 results in Figure 4.33. These data show a strong increase in the corrosion activity in one-year period. It is also important to note that half cell potential values collected in summer 2008 are clearly higher than the values obtained in the wrapped columns A and B.

Figure 4.33: Half cell potential measurements in Bridge B-28-45 column C: Comparison of measurements collected on fall 2007 and summer 2008.

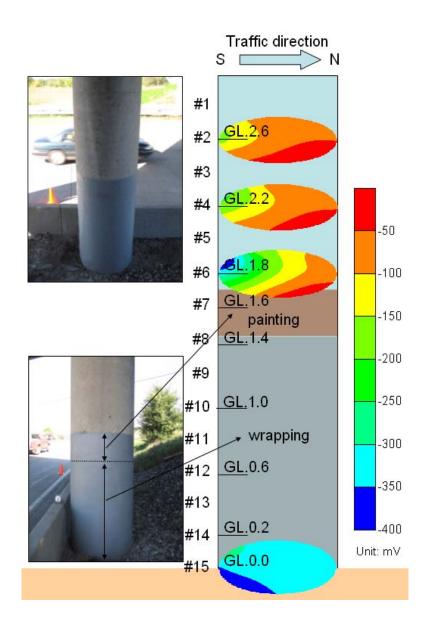
Half-cell potentials reading were collected in Bridge B-53-71 column B during fall 2007. This column was wrapped with fiberglass up to the 1.4 m mark and then painted with epoxy up to the 1.6 m mark. The data collected just below and above the fiber glass wrap are presented in Figure 4.34. These data show high probability of corrosion activity (< -350 mV) just above and just above the wrap and facing the traffic direction. The activity levels are stronger just below the

wrap than above the wrap. These data are evidence of the continuing corrosion in spite of the fiberglass wrapping application. These results were confirm using half cell potential data from bridge B-53-71 column C. Figure 4.35 show half-cell data obtained just above and just below the fiberglass wrap. The bottom collected just below the fiberglass wrap show strong evidence of corrosion activity. It seems from these data that moisture and  $Cl^-$  are still reaching the columns maintaining the conditions for corrections activity.

Figure 4.34: Half cell potential measurement in Bridge B-53-71 column B (fall 2007) at 0.2 m intervals above ground level (GL).

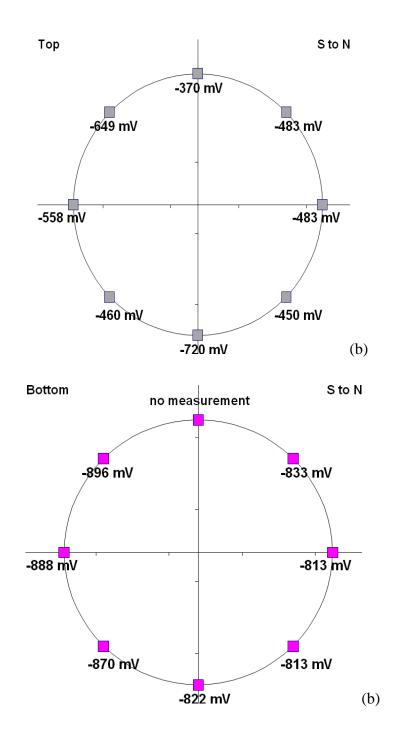
**Figure 4.35:** Half cell potential measurements in bridge B-53-71 column C: (a) just above the fiberglass wrap and (b) just below the fiberglass wrap.
