# Evaluation of Roadway Concrete Barriers and Materials

University of Wisconsin – Madison  
Department of Civil and Environmental Engineering

WisDOT ID no. 0092-19-03

July 2021

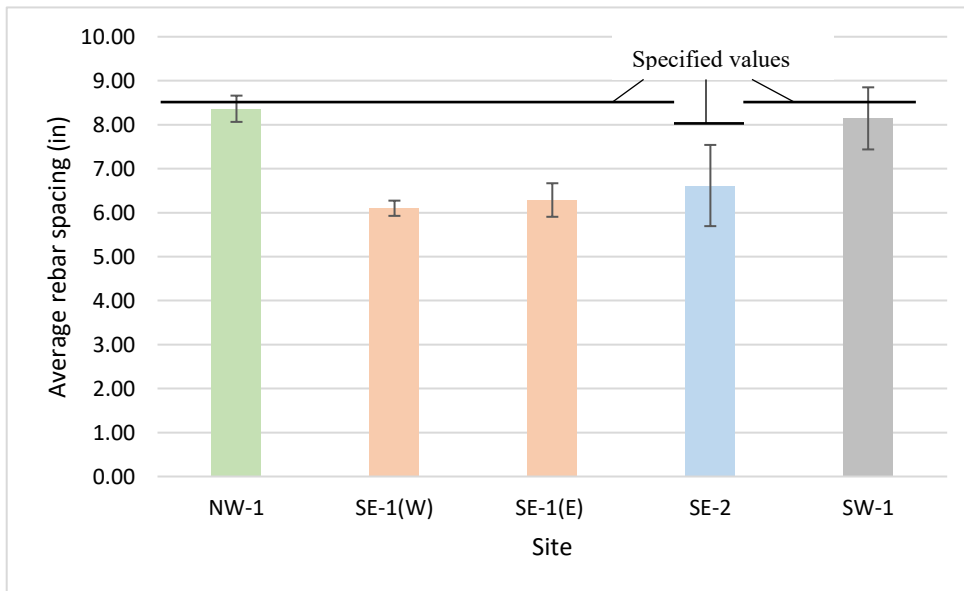
Figure 7.5: Average measured rebar spacing at different sites based on the GPR data

The average measured side cover at each site is shown in Figure 7.4. It can be seen that the actual bar cover is almost two times the specified value in most visited sites. This larger than specified concrete cover may be in part responsible for wider cracks on the barrier surface. The average measured rebar spacing at each site is shown in Figure 7.5. As shown in the figure, the average rebar spacing in all barriers was less than the specified value, particularly in sites SE-1 and SE-2.

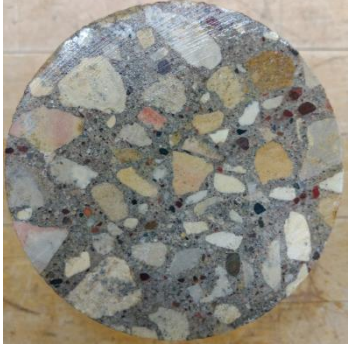
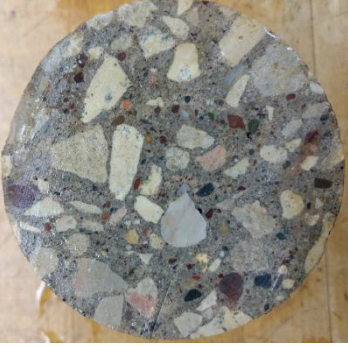
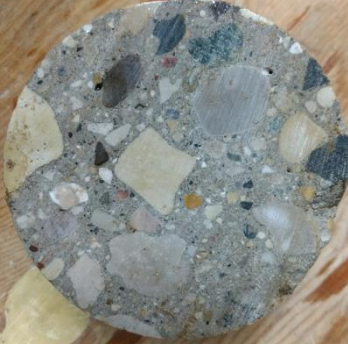
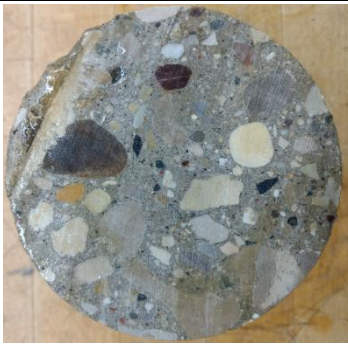
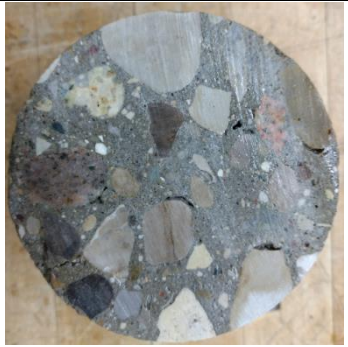
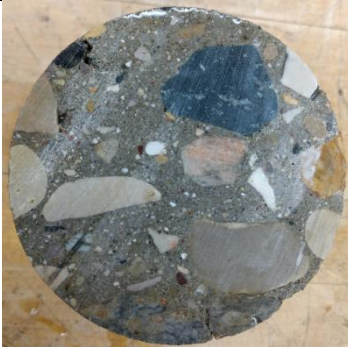
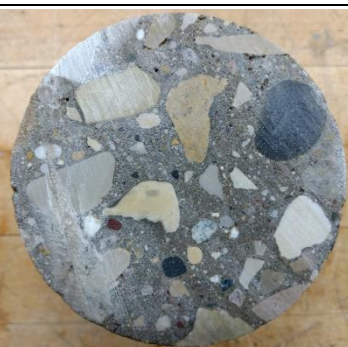
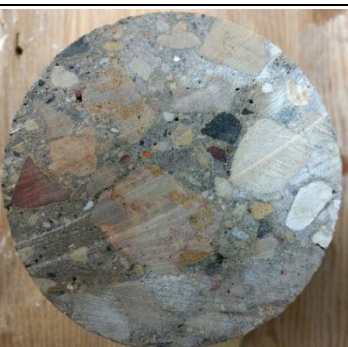
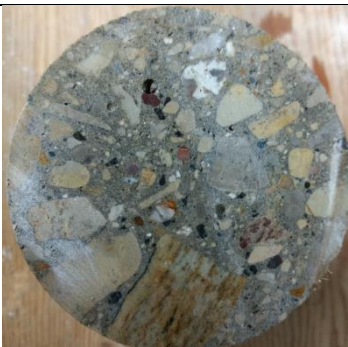
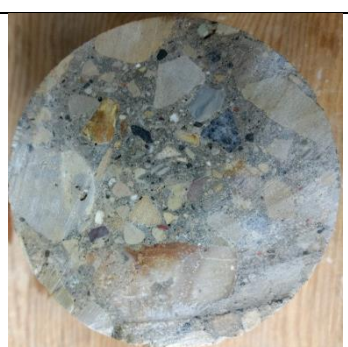
Table 8-1: Cross-section of the extracted cores

Visual observation and CT scan images of the extracted cores mainly show the difference in the aggregate type, size, and distribution among the visited sites. The barrier at site NW-1 which was least distressed has mostly crushed aggregates with the smallest aggregate size range, while barrier segments visited at sites SE and SW regions have round shape aggregates with a large aggregate size range (Table 8-1 and Figure 8.1). These observations are consistent among all the extracted cores.

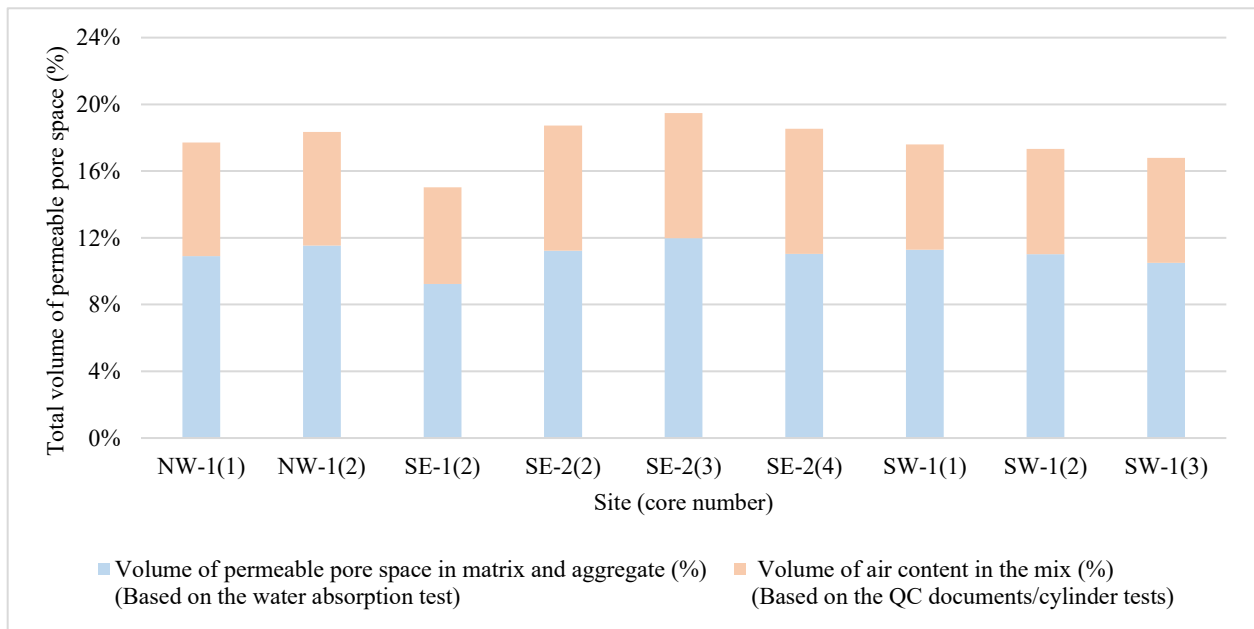
Figure 8.4: Total volume of permeable pore space (%)

The water absorption test performed in this study does not show a considerable difference (i.e. < 5%) of the volume of permeable pore space among the sites (Figure 8.4). Therefore, based on this test, it could not be concluded that the percentage of voids would influence the level and severity of distress of barriers. The data collected at each stage of this test are provided in section H.4 in Appendix H, in addition to the computed bulk and apparent density of the cores.

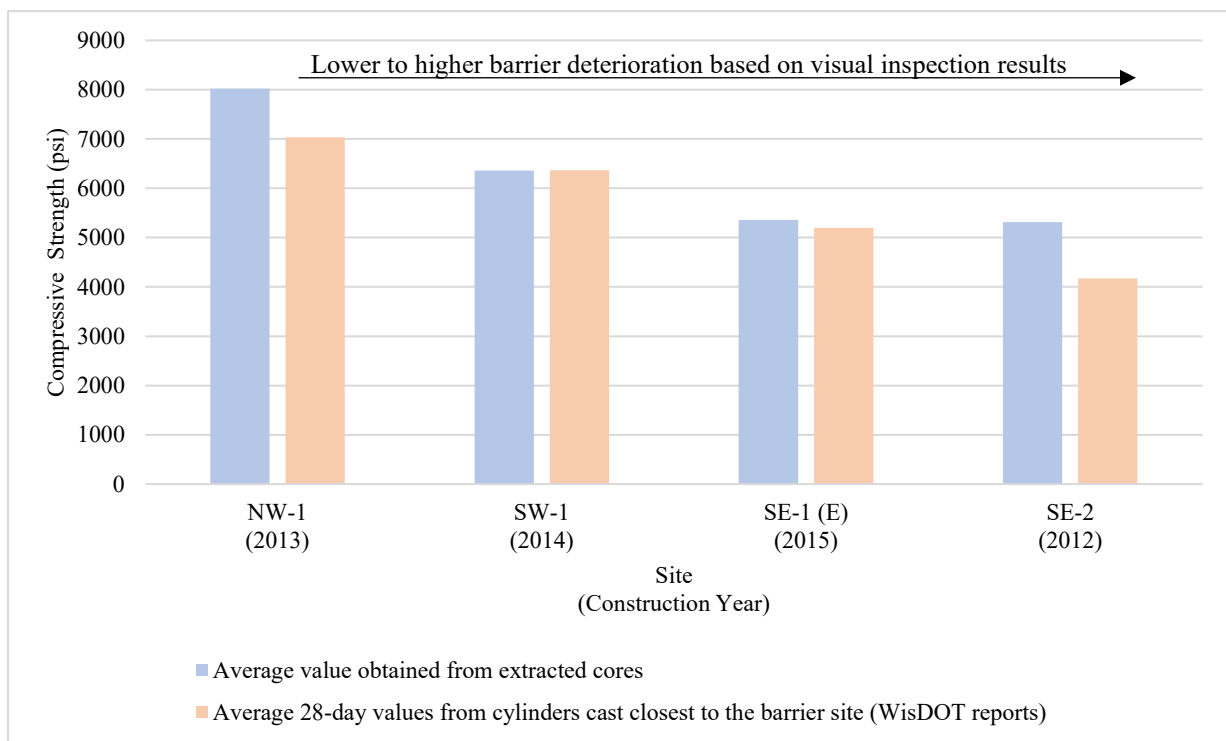
Figure 8.6: Measured compressive strength of the concrete

Results of the compressive strength tests performed in 2020 on the cores extracted in 2019 as part of this project are compared with the cylinder test data from reports by WisDOT (Figure 8.6). By comparing the results of this test with the visual inspection ranking, it can be seen that barriers that show less deterioration have concrete with higher compressive strength. In addition, the level of deterioration increases as the compressive strength decreases (Figure 8.6). More discussions about the results of this test are provided in section H.7 of Appendix H.
