**Investigation of  
Vertical Members  
to Resist Surficial  
Slope Instabilities**

SPR # 0092-05-09

WHRP 07-03

Final Report

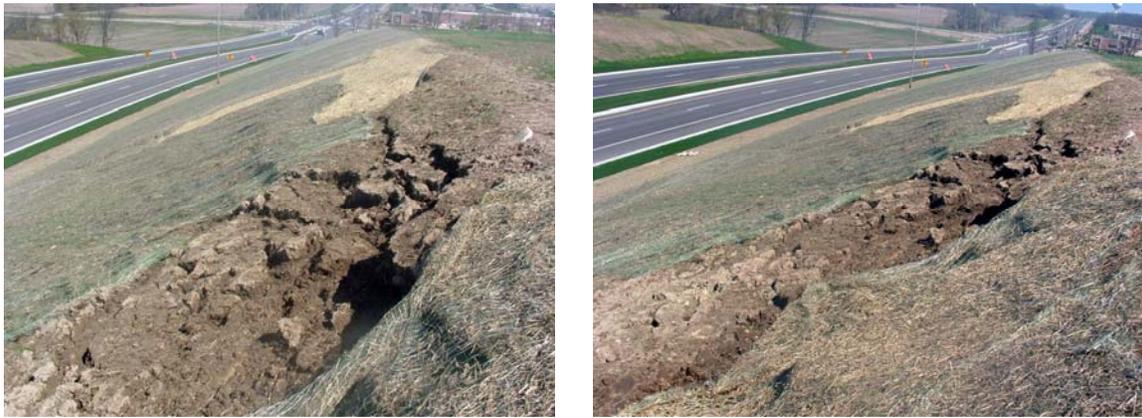
Figure 2.3: Pictures of surficial slope failure along STH-164 in Waukesha County, Wisconsin (cut slope).

of surficial failures. Evans (1972) defined the failure surface depth of shallow slope to be equal to or less than 4 ft. Loehr et al. (2000) characterized the depth of shallow slope failure as less than 10 ft. Field observations by WisDOT engineers at sites of shallow slope failures indicated that the failure surface depth ranges from approximately 2 to 4 ft. The research team performed field measurements of the depth of a shallow slope failure at STH-164 in Waukesha County (Figure 2.3) and found that the average depth of failure surface is about 2 ft.

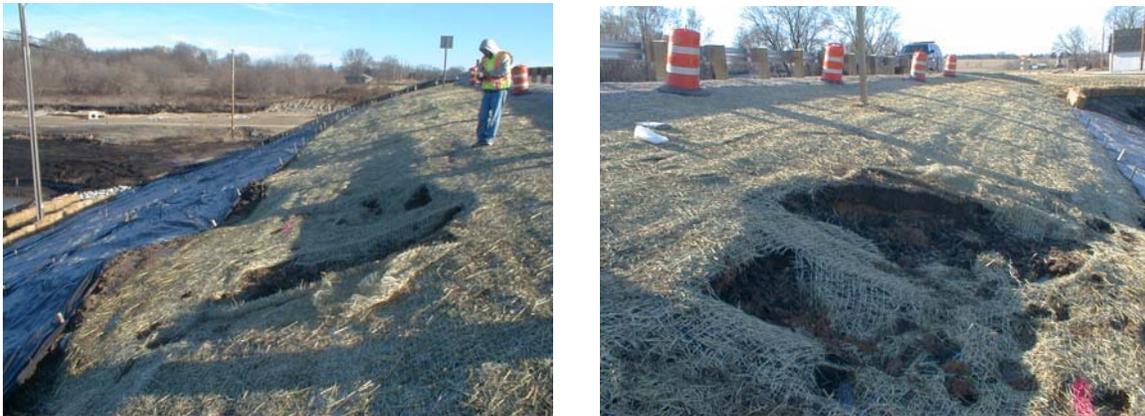
Figure 2.4: Pictures of surficial slope failure along CTH A near Burlington, Wisconsin (embankment slope).

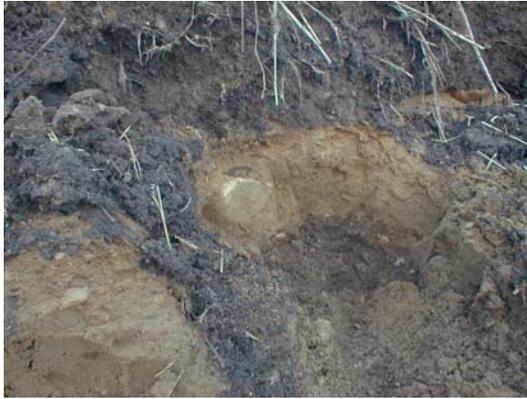
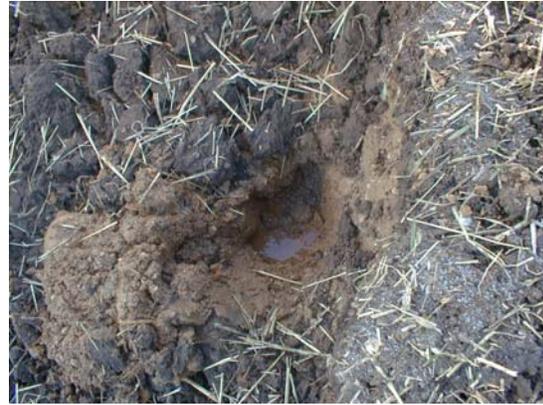
(a) Thin clay layer underlying cohesionless soil

(b) Water accumulated in the hole

Figure 2.9: Shallow slope failure at CTH A near Burlington (a) thin layer of clay underlying cohesionless soil; (b) water perched on clay layer seeping through the soil.

The surficial slope failure on the CTH A embankment near Burlington, Wisconsin is believed to have occurred as a result of saturated surficial soil due to prolonged rainfall and snowmelt. The principal investigator and a WisDOT engineer visited the site of the slope approximately two weeks after the failure. They noticed that the surficial soil of the slope was fully saturated with frozen water in some locations. As shown in Figure 2.9a, there is a cohesionless soil layer below the clay blanket, which comprises the top soil cover of the slope. Below the cohesionless soil is a thin clay layer with apparent lower permeability. This layer may act as a drainage barrier, allowing the water to perch on it and rise in the upper surficial soil. When the team excavated a small hole in front of the cohesionless soil layer, water filled the hole very quickly, indicating the abundant presence of water, as shown in Figure 2.9b. When the water rose in the upper surficial soil, the shear strength of the soil was reduced, causing the instability of the surficial soil.

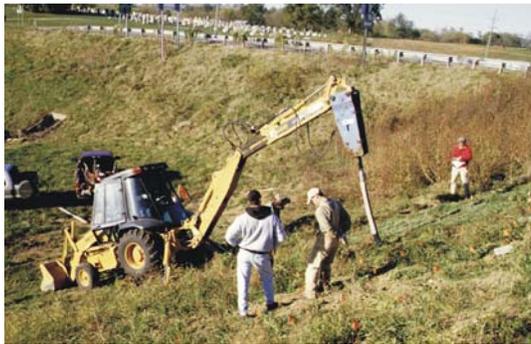
Figure 2.15: Installation of recycled plastic pins to stabilize surficial failures (after Loehr et al., 2000).

Installation of recycled plastic pins can be achieved by different methods. Sommers et al. (2000) used the modified pavement breaker and the pseudo vibratory driving system for vibratory installation of recycled plastic pins to stabilize shallow slope failures. Figure 2.15 depicts installing recycled plastic pins to stabilize shallow slope failures.

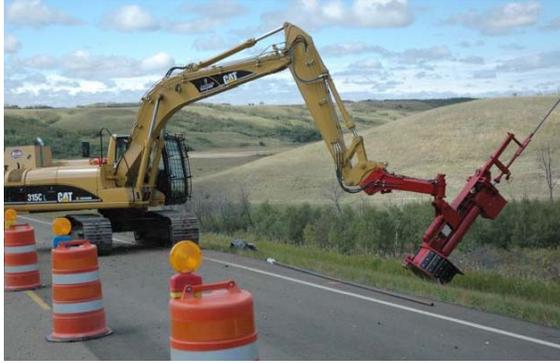
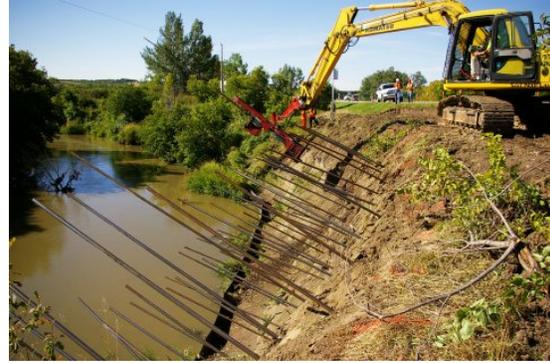
(a) Soil nail launcher

(b) Installation of launched soil nails

Figure 2.16: Soil nail launcher used to repair slope failures (SNL, 2007).

Launching soil nails is a proprietary method of Soil Nail Launcher, Inc., which was recently introduced. In this method, soil nails are inserted into the slope face at a high speed utilizing high pressure compressed air. The device that launches the nail is called the soil nail launcher (SNL), which can be attached to the end of an excavator, as shown in Figure 2.16a. Installing launched soil nails is depicted in Figure 2.16b. Typical soil nails can be solid or hollow steel bars. Galvanized soil nails also can be used in highly abrasive environments because they provide resistance to corrosion. Typical dimensions of hollow non-galvanized steel bars are an outer diameter of 1.5 in. (0.12 in wall thickness) and length of 20 ft., as shown in Figure 2.17. The minimum yield strength of the steel bars is 36 ksi. After installing launched soil nails, the slope surface can be treated with erosion mat, steel mesh, and shotcrete. Figure 2.18 shows a slope stabilized with launched soil nails.

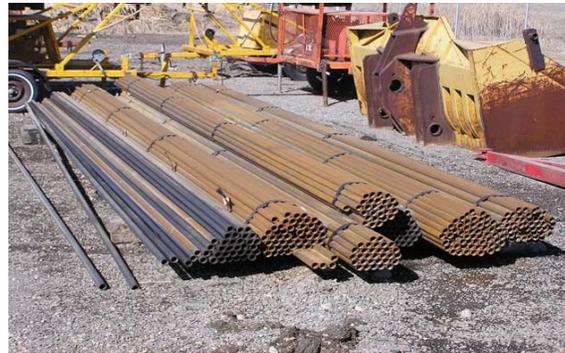
Figure 2.17: Launched soil nails of 1.5 in. diameter and 20 ft. in length (SNL, 2007).

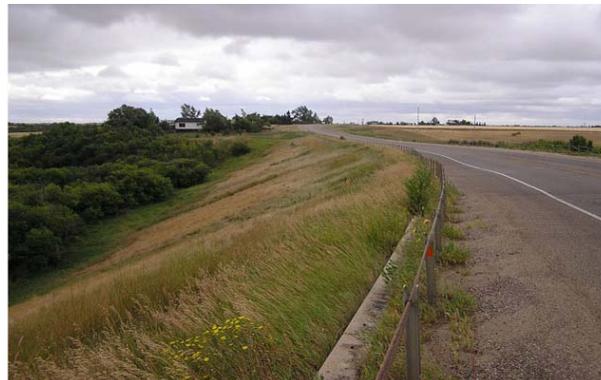
Figure 2.18: Highway 363 slope south of Moose Jaw, Saskatchewan, was stabilized with launched soil nails (SNL, 2007).

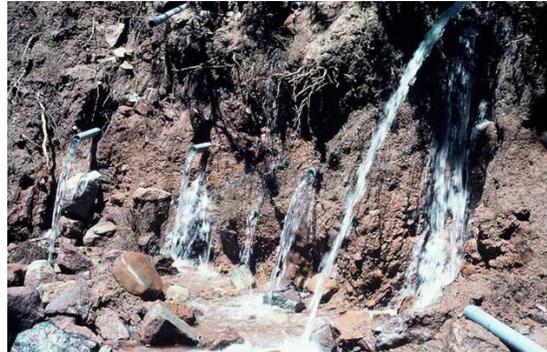
Figure 2.19: Horizontally launched hollow perforated nails act as drains (SNL, 2007).

Hollow perforated nails also can be used as horizontal drains to remove water from slopes and prevent development of pore water pressures that lead to reduced soil strength, as shown in Figure 2.19.

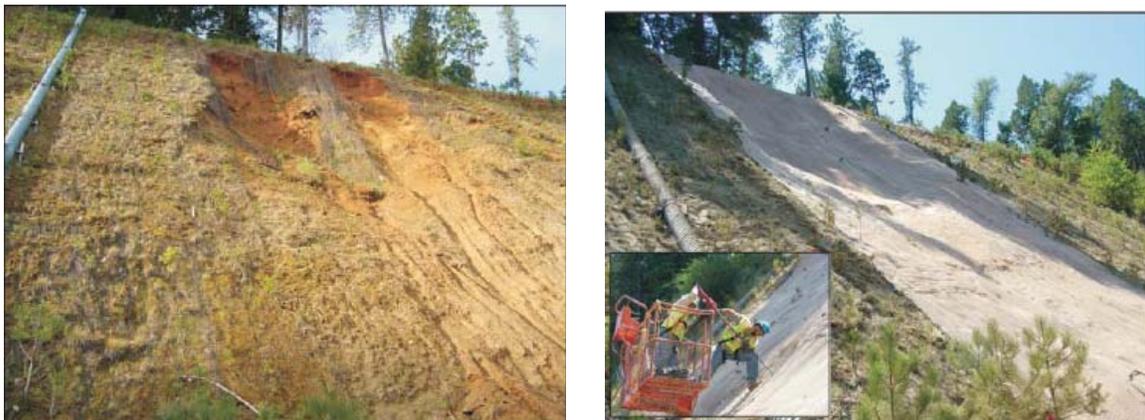
(a) Surficial slope failure

(b) Slope repair using earth anchors

Figure 2.24: Slope failure and repair along the Highway 26 cut slope in Calaveras County, CA, (Platipus, 2007).

Earth anchors are used to stabilize a surficial failure along the Highway 26 cut slope. The 1H:1V slope failed after a heavy rainy season. Figure 2.24a depicts the shallow slope failure. The Platipus S4 anchor was used to repair the shallow slope failure. The construction was fast and simple and at 5 ft. spacing. It was reported that Caltrans (California DOT) was satisfied by this repair method, particularly the speed and simplicity of construction (Platipus, 2007). Figure 2.24b depicts the repaired slope.

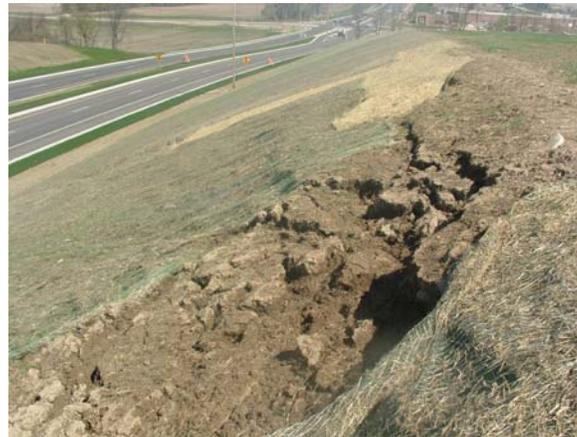
(c) Picture of the shallow slope failure

Figure 2.26: Shallow slope failure of the reconstructed STH 164 at Sta. 299+00.

A shallow slope failure was observed about four months after the slope was graded. An initial field survey showed that the failure occurred on the east side of the road with an approximate length of 300 ft. The failure consisted of a surficial topsoil layer sliding down the face of the slope, which was sparsely vegetated when the slide occurred. The slope failure occurred in an earth cut section and continued to worsen during the spring thaw until it covered two thirds of the slope length from the top. Figure 2.26b shows details of the slope failure and Figure 2.26c depicts the failure. A field investigation and survey were conducted to collect information and soil samples at the slope failure site. Field observations showed that the soil was wet, with moisture content variation between 28 and 32%. Water was allowed to sheet drain over the face of the slope.

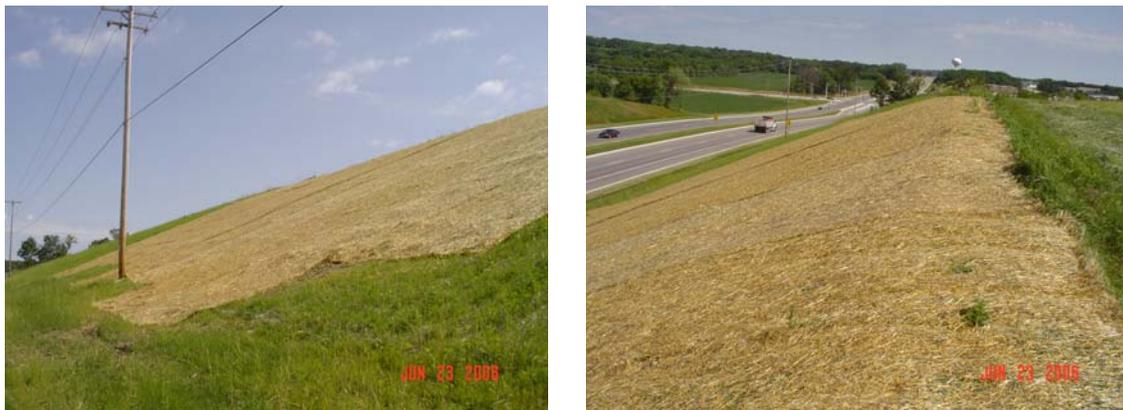
Figure 2.27: Pictures of the repaired shallow slope failure at STH-164.

Repair of the failed area was conducted about six months after the slope failure occurred. The failed material was left to dry and the slope was then re-graded to the pre-failure grades using a small bulldozer. After regrading, the slope was seeded and covered with an erosion control mat. Thereafter, measurement of the topsoil depth was performed by pushing a steel probe manually at 3-ft. intervals. Topsoil depth ranged from approximately 5 to 18 in. Within several weeks of repairs, vegetation was growing on the slope face. Currently, vegetation continues to grow and further failures have not been observed. Figure 2.27 depicts the repaired slope.

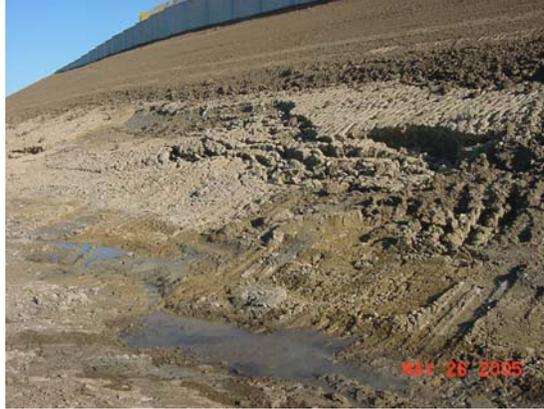
Figure 2.28: Shallow slope failure at STH-16 with water seeping out of the slope face.

The slope failure consisted of the surficial topsoil layer sliding down the face of the slope. The failure surface generally was parallel to the face of the slope and the underlying stable material and also resembled an infinite slope failure. During the original grading activities in the failure area, a significant amount of seepage was observed from the cut slopes onto the face of the slope. Figure 2.28 depicts the slope failure.

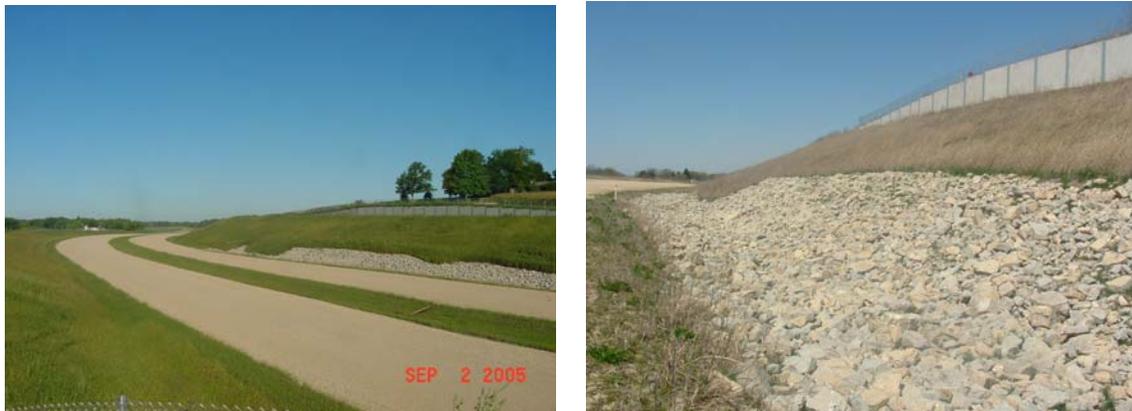
Figure 2.29: Riprap repair of shallow slope failure at STH-16.

The slope was repaired shortly after failure by removing the failed soil mass and replacing it with a layer of riprap or other large stone. Typically, a heavy riprap geotextile is placed on the slope prior to the riprap placement. A “keyway” typically is excavated at the toe of the slope prior to placement of the riprap. The “keyway” stabilizes the mass of riprap. The original slope configuration was not changed during repair and repeat slope failures have not occurred. Figure 2.29 shows a picture of the repaired slope. This repair method is generally effective, although it has the potential to cause additional failures if used incorrectly. One case of potential failure is when the underlying soil is weak and soft and it cannot resist the increased driving forces from the riprap. This method is not considered visually appealing.

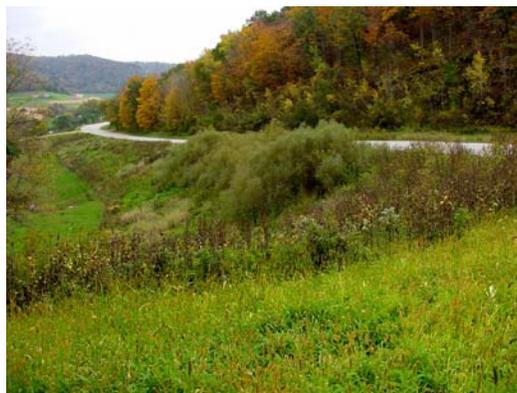
(b) Stabilized slope

Figure 2.30: Live staking application at County Trunk Highway K.

The live staking (shown in Figure 2.30) used on CTH K has worked well. The slopes remain stable and water seeping from the face of the slope no longer is observed. The live staking reinforced the soils and increased the factor of safety of the slope.

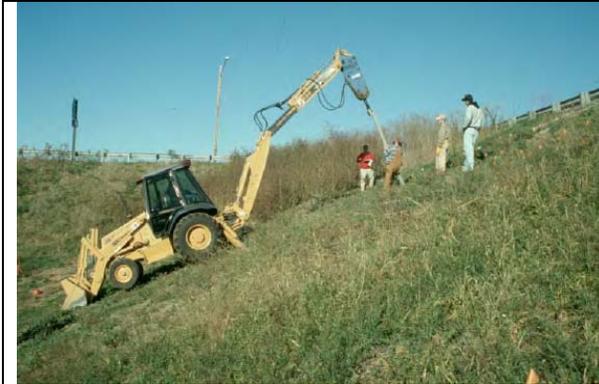
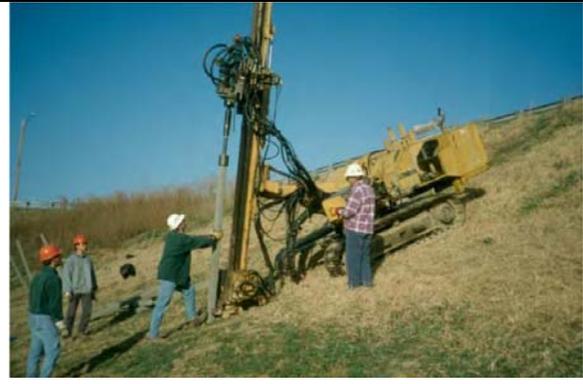
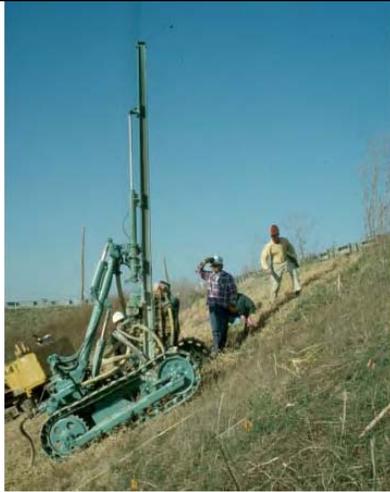
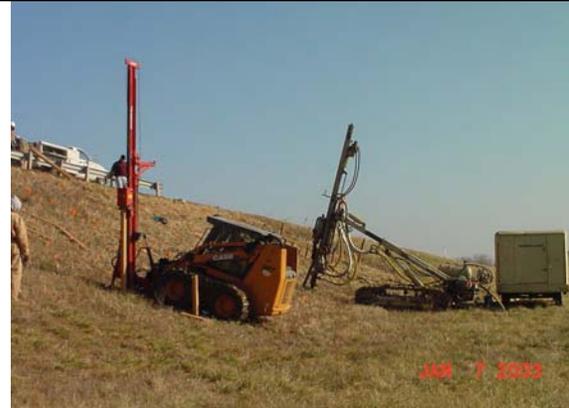
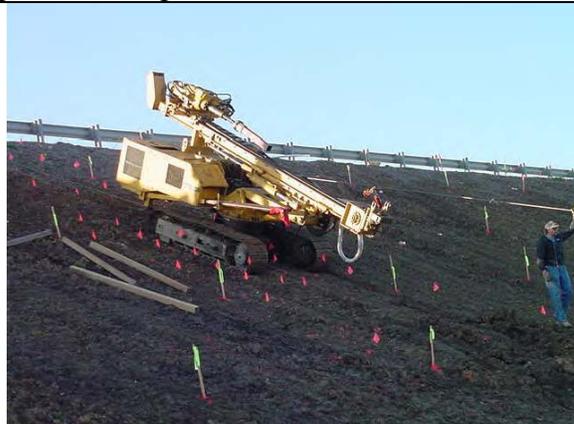
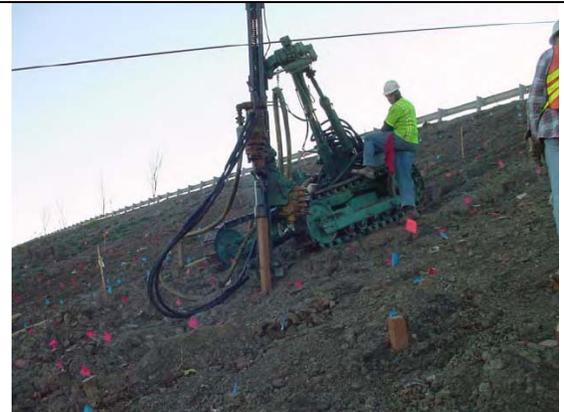
(a) Backhoe mounted hammer

(b) Davey-Kent DK100B track-mounted hydraulic rig

(c) Ingersoll Rand CM150 track-mounted pneumatic rig

(d) Ingersoll Rand ECM350 pneumatic hammer drill (background) and drop-weight hammer rig (foreground)

(e) Davey-Kent DK100B track-mounted hydraulic rig

(f) Ingersoll Rand CM150 track-mounted pneumatic rig

Figure 3.18: Equipment used to install plastic pins, steel pipes, and wooden posts at different sites of surficial slopes failures in Missouri (after Loehr and Bowders, 2007).

Loehr et al. (2000) and Loehr and Bowders (2007) presented a comprehensive analysis of the reliability and performance of construction methods and the equipment used for surficial slope stabilization using plastic, steel pipes, and wooden structural members. Table 3.12 summarizes their study, in which different equipment types were used to stabilize five surficial slope failures in Missouri. The equipment is depicted in Figure 3.18. Based on this study, Loehr and Bowders (2007) reached the following conclusion:
