IH-94 Willow Glen Rd - Zoo IC Corridor Needs Report

April 2025
ID: 1060-54-00

**I-94 Willow Glen to Zoo Interchange Needs Study
Corridor Needs Report**

I.D. 1060-54-00

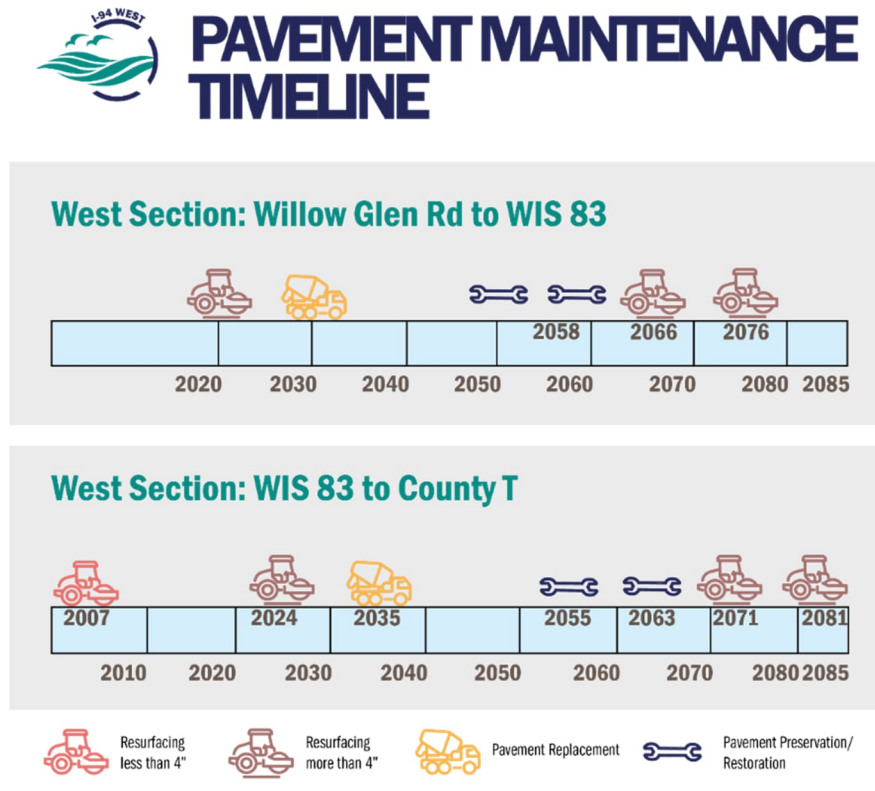
Figure 12. West Section Pavement Timelines

The West Section has planned pavement replacement throughout the next ten years. Willow Glen Road to WIS 83 is anticipated to need replacement around 2030, and WIS 83 to County T is anticipated to need replacement around 2035. Besides these two major pavement replacement projects, the West Section has ten additional pavement maintenance projects scheduled before 2080. Figure 12 shows the pavement maintenance timelines for the West Section.

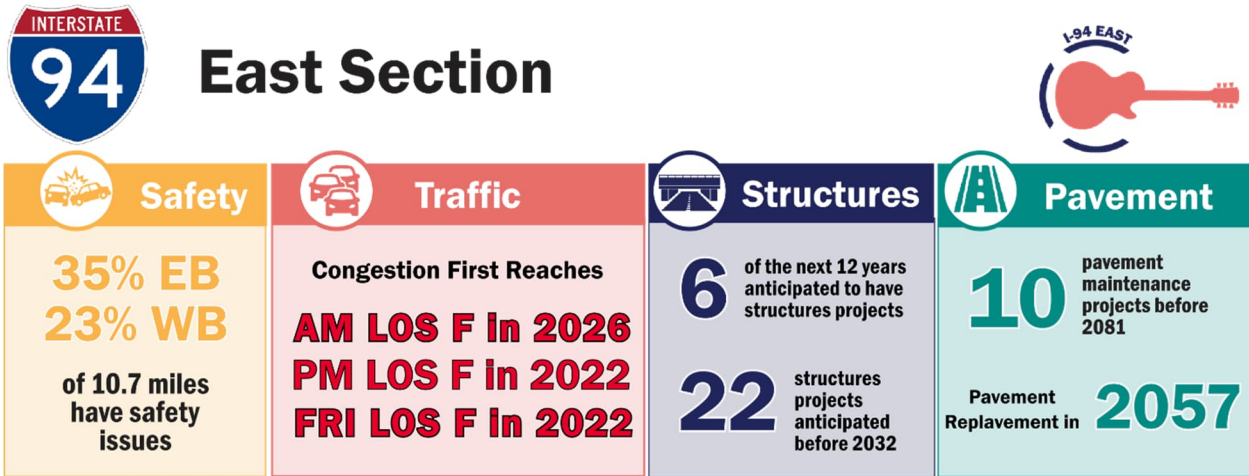
East Section

- Parts of the section are experiencing LOS F in the existing conditions. The mainline section between Goerke’s Corners and County O experiences LOS F in AM, PM and Friday peaks and both directions.
