**Table of Contents**

# WisDOT Structure Inspection Manual Part 4 – Ancillary Structures

## Chapter 4 – Retaining Walls

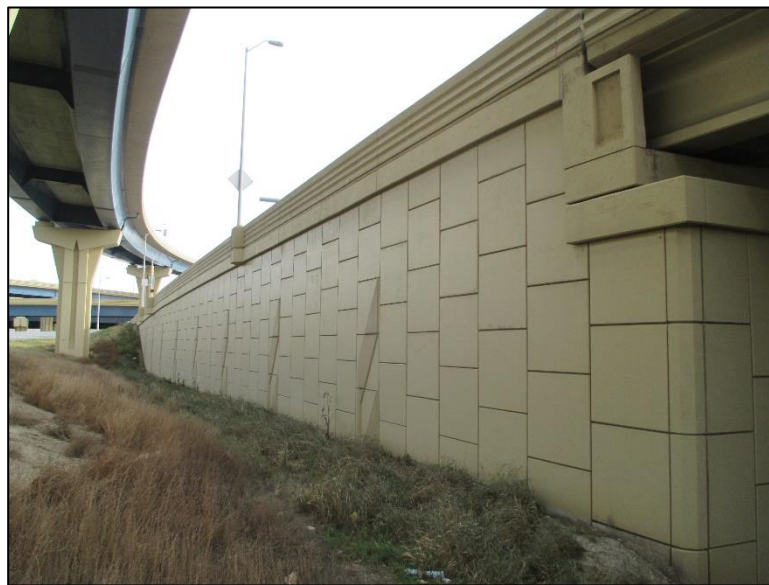
1. **Fill-Section Application:** The structure retains a roadway facility at a higher elevation than the adjacent earth. Specific areas of concern for inspection include heavier deterioration at the top and face of the wall from roadway salts washing over the wall, and geotechnical failure due to the added surcharge from traffic.

Figure 4.4.1-1: MSE “Fill” Wall

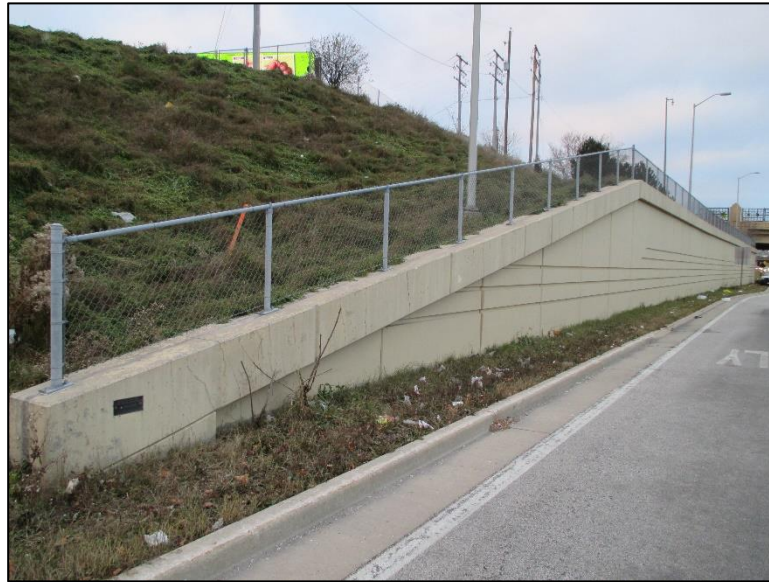
2. **Cut-Section Application:** The structure retains the adjacent earth at a higher elevation than the roadway facility. Specific areas of concern for inspection include heavier deterioration at the base of the wall from roadway salts washing against the wall, and vehicular impacts.

Figure 4.4.1-2: CIP “Cut” Wall

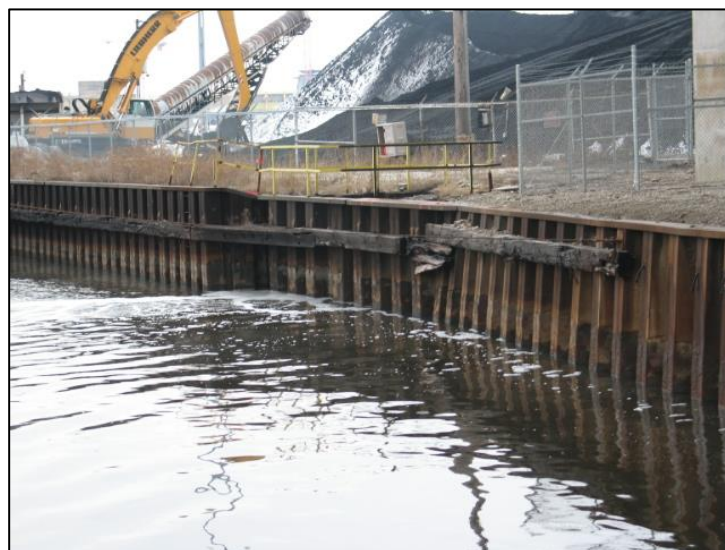
- Dockwall Application:** The structure retains the adjacent earth at a higher level than the waterway channel bottom. The deterioration mechanisms of a dockwall are the same as for a land-based earth retention structure; however, since a portion of the wall exists beneath the water the environment is more severe. This makes the wall more susceptible to scour and accelerated material deterioration. Also, dockwalls are typically associated with portions of the waterway where watercraft traffic and docking occurs, making the dockwall more susceptible to impact and ice flow damage. Underwater inspections are typically required to fully assess the condition of dockwalls. Refer to Part 1, Chapter 3, for a discussion of underwater inspection procedures.

Figure 4.4.1-3: Steel Sheetpile Dockwall

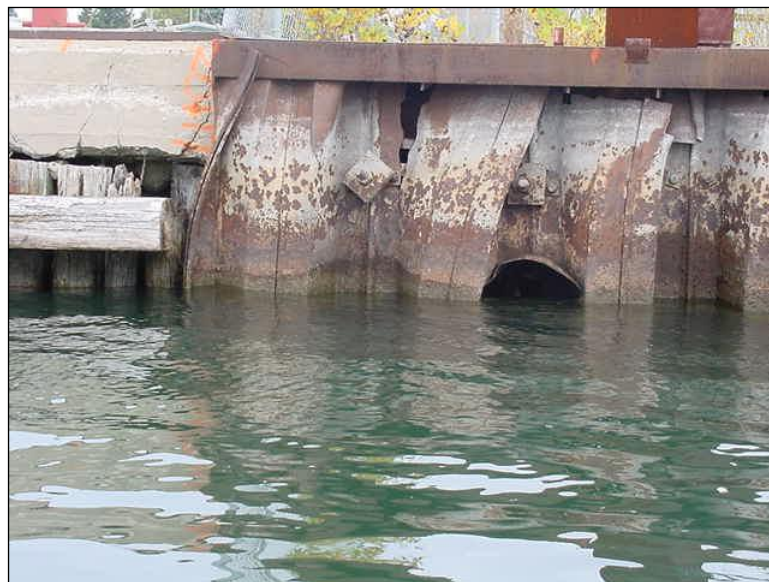
Figure 4.4.2-1: Impact Damage to a Steel Sheet Pile Dockwall.

Impact damage is typically confined to an area directly adjacent to the point of contact and is characterized by distortion or crushing of the construction material at the point of contact with cracking, splitting, or splintering radiating from this point. Refer to Figure for a view of an impacted dockwall.

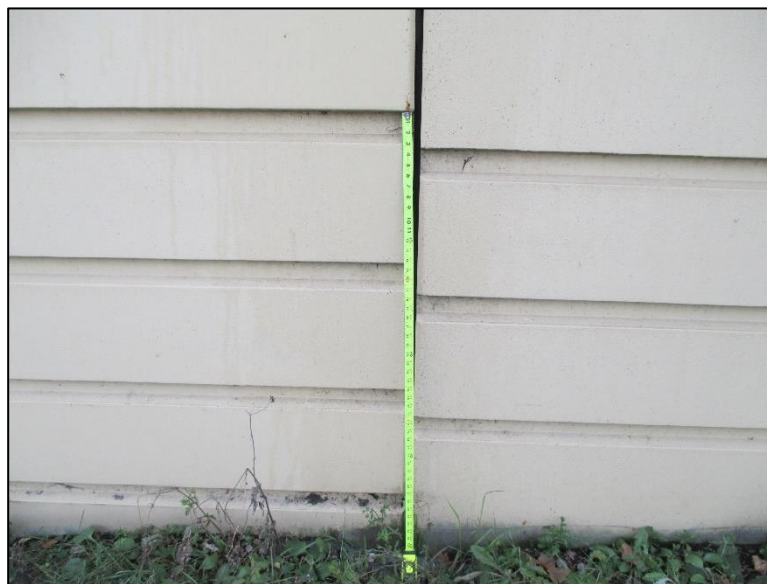
Figure 4.4.2-8: View of Differential Settlement between Precast Concrete Panels. Note Misalignment in Rustication.

opening of joints or cause wall cracking or transverse tipping. Refer to Figure 4.4.2-7, Figure 4.4.2-8 and Figure 4.4.2-9 for a diagram and view of differential settlement under a retaining wall.

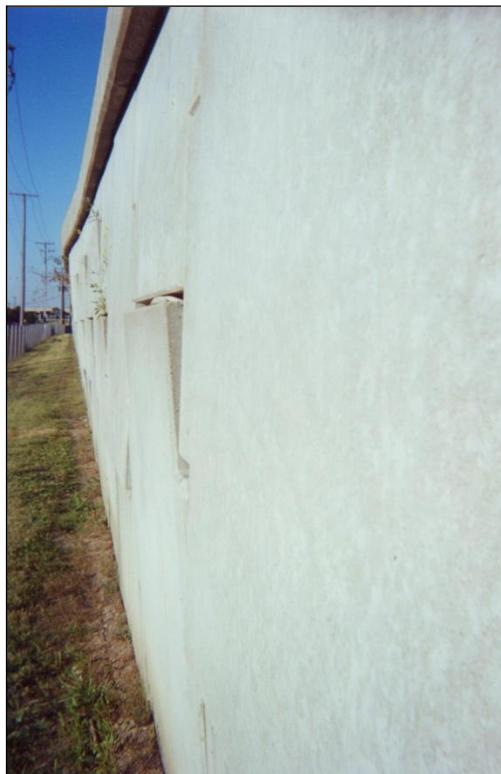
Figure 4.4.2-11: Lateral Movement of an Individual Panel of a MSE Wall.

The most common causes of lateral movement are slope failures (deep shear failures); seepage; changes in soil characteristics (e.g., frost action and ice); and consolidation of the original soil. Deep shear failures occur along a cylindrical surface when there is a weak layer of soil under the wall at a depth of approximately 1.5 times the width of the base of the wall. Refer to Figure 4.4.2-10 for a diagram depicting lateral movement of a wall due to deep shear failure. Refer to Figure 4.4.2-11 for a view of a mechanically stabilized earth (MSE) wall with extensive lateral movement.

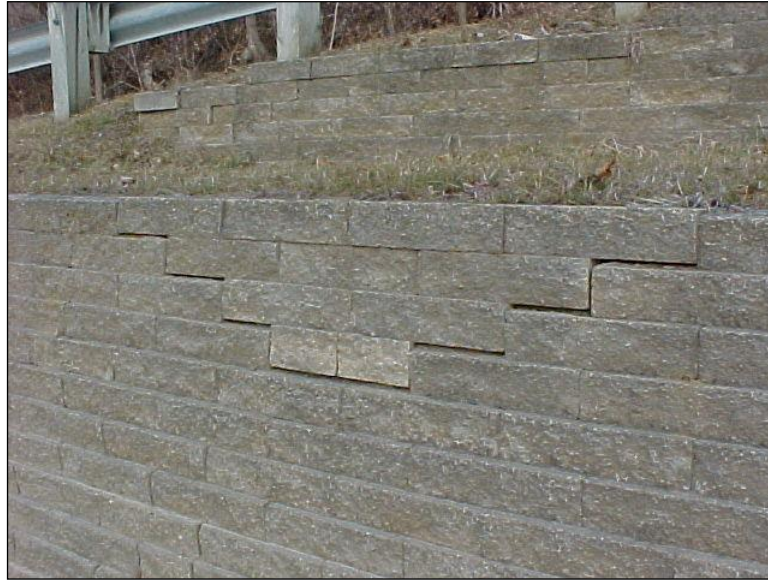
Figure 4.4.2-13: Poor Construction Methods Resulting in Block Separation.

- **Construction Defects:** Construction flaws are often characterized by damage to the blocks that appear to be due to poor construction technique or errors. Examples might include evidence of cracked units, open joints in locations other than a bend, or evidence of improper design or construction, such as improper block alignment. Refer to Figure 4.4.2-13 for a view of construction defects as shown by the open joint.

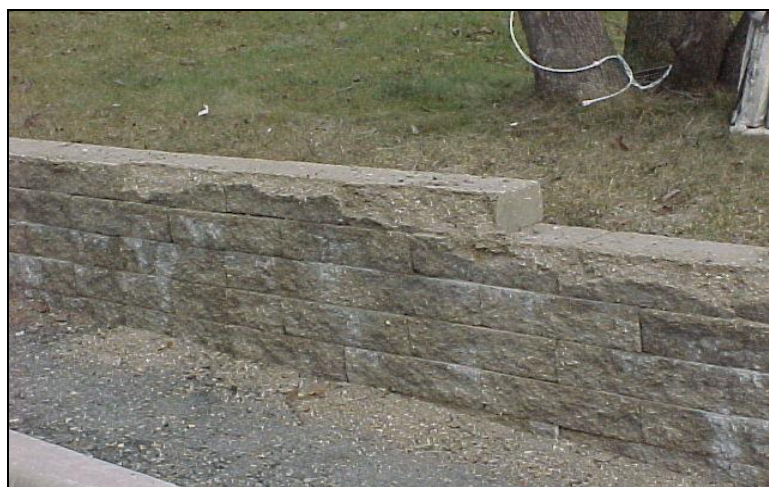
Figure 4.4.2-16: White Precipitate Formed due to Efflorescence.

- **Efflorescence:** Efflorescence, informally referred to as leaching, is a white deposit on the concrete surface caused by the crystallization of soluble salts (calcium chloride, calcium hydroxide) contained within the cement paste. Water traveling through the concrete dissolves these salts and usually deposits them along cracks where the water exits. Efflorescence indicates that water and dissolved chemicals are able to pass through and contaminate the concrete. This is primarily an aesthetic problem, but can serve as evidence of increased block porosity and weakness in extreme cases. Refer to Figure 4.4.2-16 for a view of efflorescence.

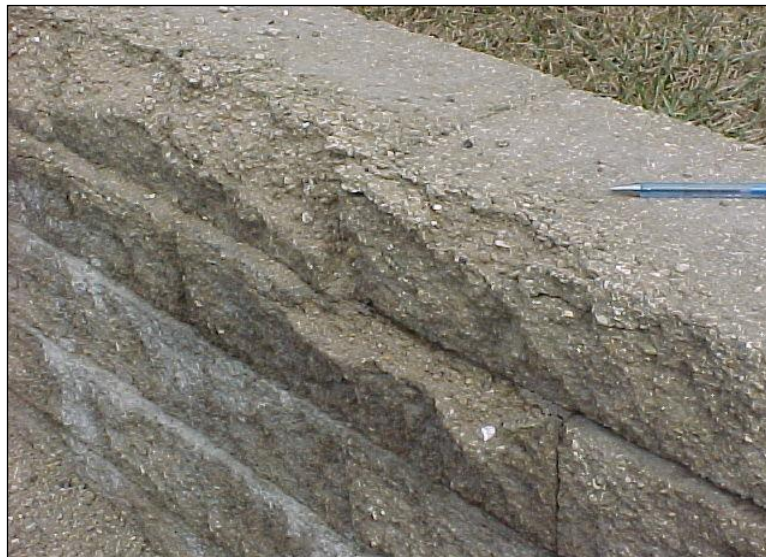
Figure 4.4.2-17: Spalling and Fraying on the Top Edge of the Block.

- **Fraying/Spalling (Block Edges):** Fraying or spalling is the presence of minor chipping along block edges and corners. Occasionally fraying or spalling will be the result of improper handling and placement during construction. Other causes include thermal expansion, or the placement of blocks on uneven surfaces. The presence of a large number of spalls in the same place on each block may indicate a problem in manufacturing. Refer to Figure 4.4.2-17 for a view of spalling and fraying along the block edges.

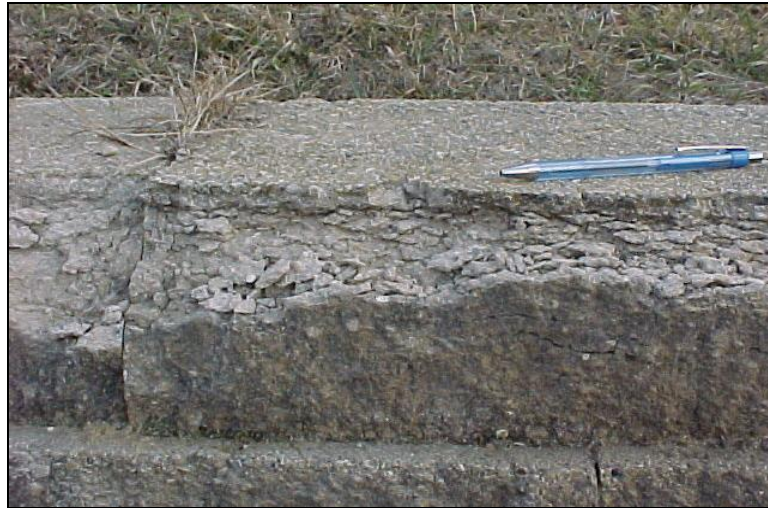
Figure 4.4.2-18: Freeze-Thaw Damage at a Corner.

- **Freeze-Thaw Damage:** This is the progressive internal deterioration of saturated block material in the presence of freezing and thawing temperatures. The expansion of water during freezing periods can produce significant internal damage. Resulting defects will appear as areas of crumbling or general deterioration. This type of damage is most often found in areas that are frequently saturated and exposed to freezing conditions. Note if this type of damage is occurring on a vertical or horizontal surface. Refer to Figure 4.4.2-18 for a view of typical freeze-thaw damage.

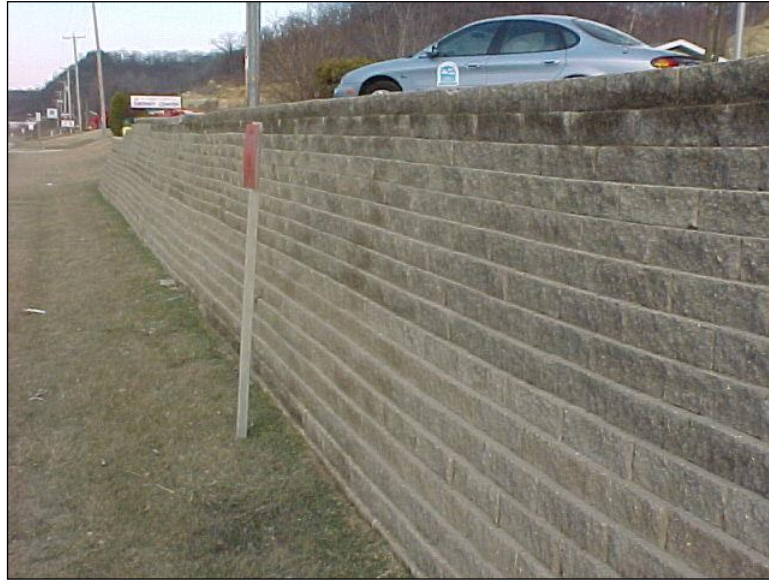
Figure 4.4.2-19: Typical Staining Evidenced by the Brown Discoloration of the Blocks.

- **Staining:** This is the discoloration of block units caused by exposure to elements such as surface runoff containing dark clays or organic material, deicing chemicals, mold growth, moss, and other sources. Refer to Figure 4.4.2-19 for a view of staining.

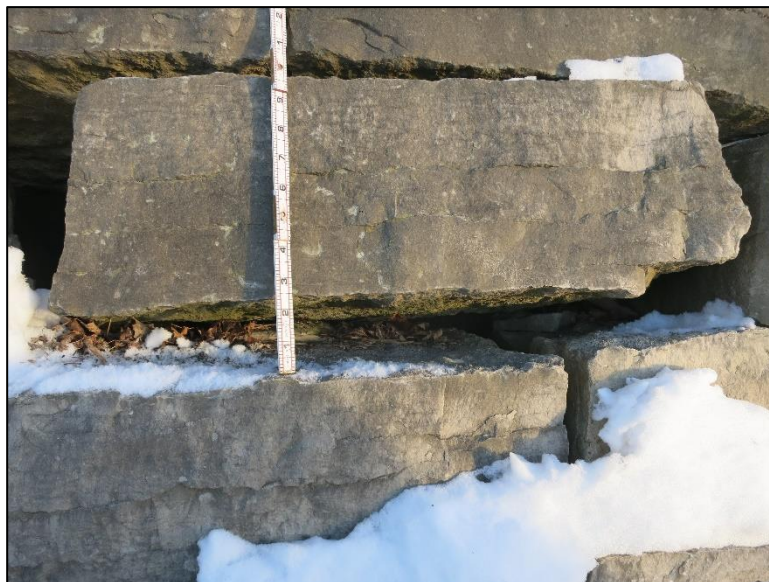
Figure 4.4.2-20: Excessive Gap Forming At Base of Stone Block.

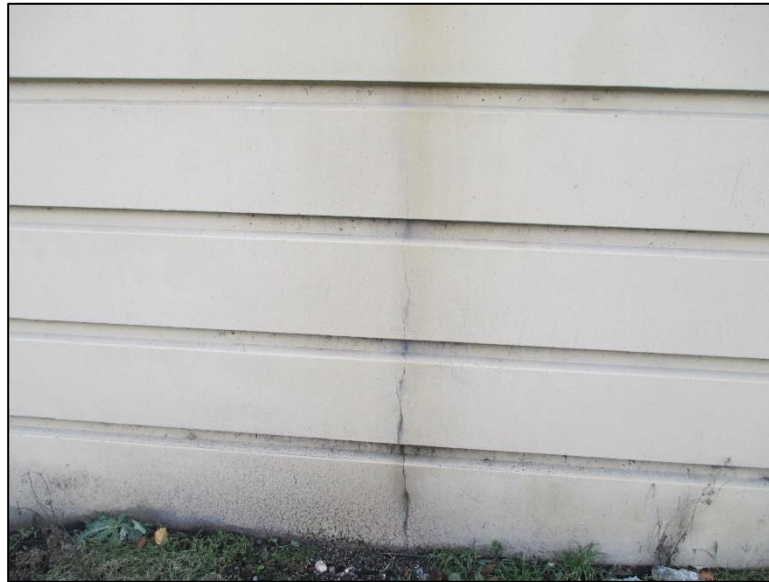
Figure 4.4.2-21: Vertical Crack Through Precast Concrete Panel.

- **Cracking:** Random cracks in the structure. The direct cause of the crack development is uncertain and may be attributed to movement, shrinkage or temperature. Examples might include diagonal, straight, or horizontal crack propagation. Refer to Figure 4.4.2-21 for a view of typical vertical cracking found in precast concrete panels.

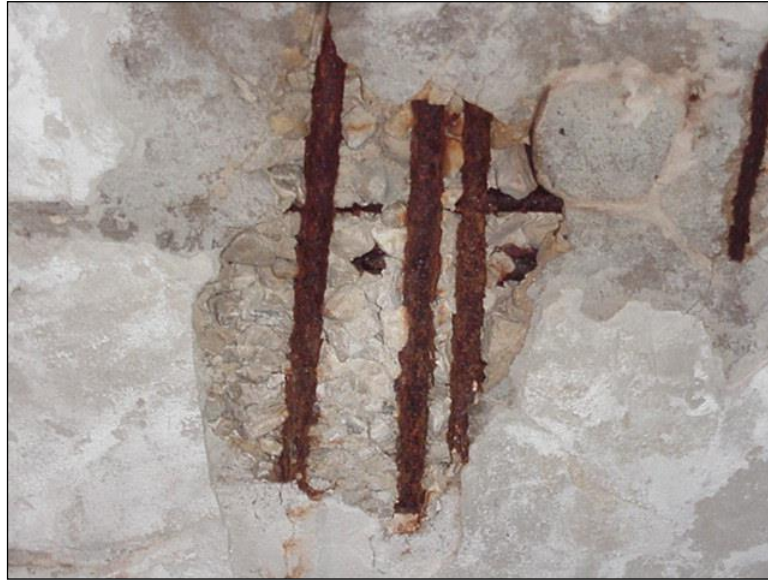
Figure 4.4.2-22: Concrete Spalling with Exposed Reinforcing Steel.

- **Spalling/Exposed Reinforcing Steel:** Spalling is the presence of minor chipping along concrete edges and corners. Occasionally spalling will be the result of improper handling and placement during construction but most cases it is caused by the increase in section of reinforcing steel due to corrosion, causing concrete to delaminate from the reinforcing steel and spall. Other causes include thermal expansion, or the placement of concrete panels on uneven surfaces. The presence of a large number of spalls in the same place on each panel may indicate a problem in manufacturing. Consistent spalling over time can result in exposed reinforcing steel. Refer to Figure 4.4.2-22 for a view of spalled concrete with exposed reinforcing steel.

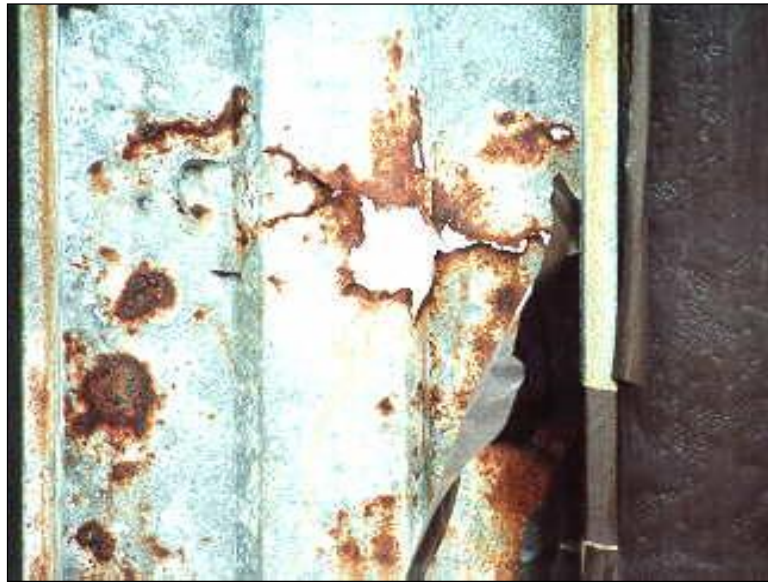
Figure 4.4.2-23: Severely Corroded Steel Sheeting Cantilever Wall.

- **Corrosion:** This type of deterioration is the slow, steady material deterioration due to chemical reactions between the material and outside elements. Refer to Figure 4.4.2-23 for a view of steel corrosion.
- **Cracking:** Cracks can occur due to fatigue and or brittle fracture. Cracks are arrested by drilling mouse holes at the tips, or sometimes with bolted splices.

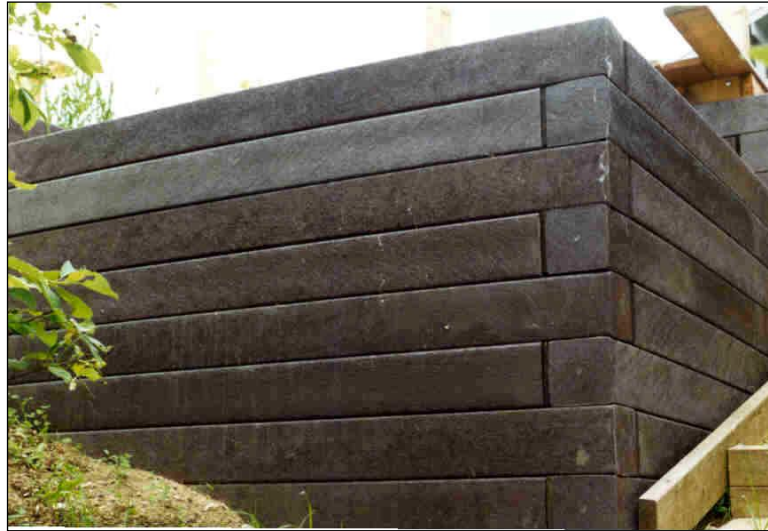
Figure 4.4.2-24: Plastic Lumber Retaining Wall.

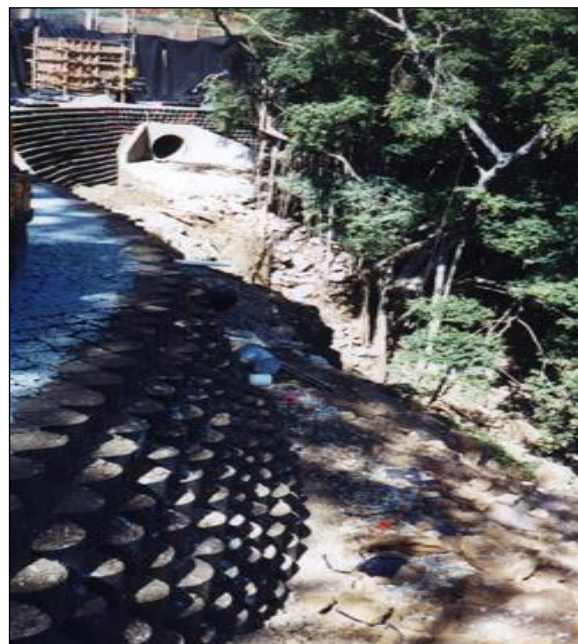
Figure 4.4.2-25: Geotextile Grid Cell Retaining Wall.

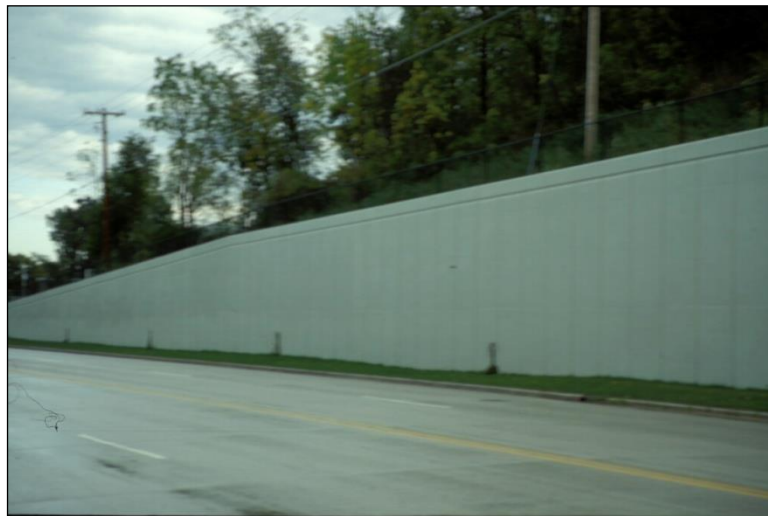
Figure 4.4.4-1: Cast-in-Place Concrete Cantilever Wall.

Cast-in-place (CIP) concrete walls are made by placing ready-mix concrete into removable forms that are built around reinforcing steel at the final intended position of the wall. A CIP wall can incorporate tie-backs or prestressed soil anchors for stabilization depending on the height of the wall and characteristics of the soil that is being restrained. Footings with piles may also be used. The weight of the soil on the inner half of the footing slab (heel) provides additional vertical weight for stability. The wall is fully reinforced and relatively thin, allowing for an economical use of materials.

The exposed concrete stem may be plain, textured and/or colored. The height on these types of walls is typically less than 28 feet. Walls higher than 28 feet typically require counterforts or tie-backs for additional strength and deflection control. Refer to Figure 4.4.4-1 and **Error! Reference source not found.** for a typical cast-in-place concrete gravity cantilever wall.

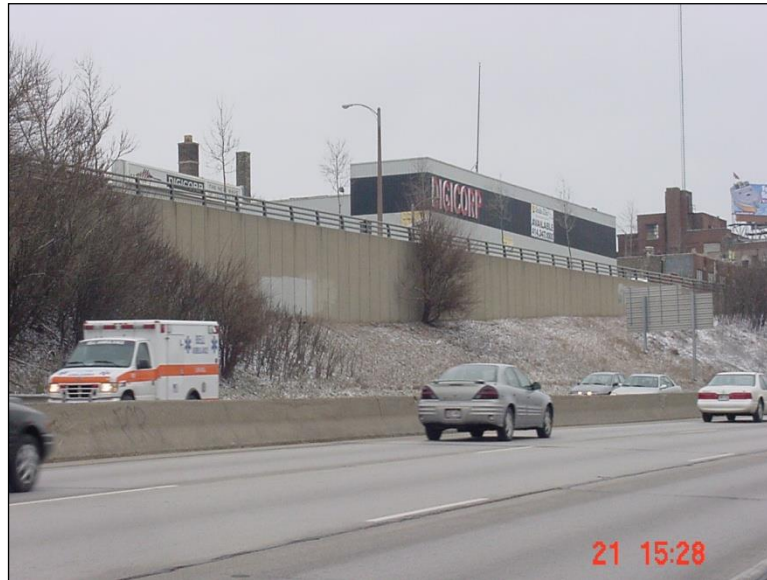
Figure 4.4.4-2: Cast-in-Place Concrete Cantilever Wall.

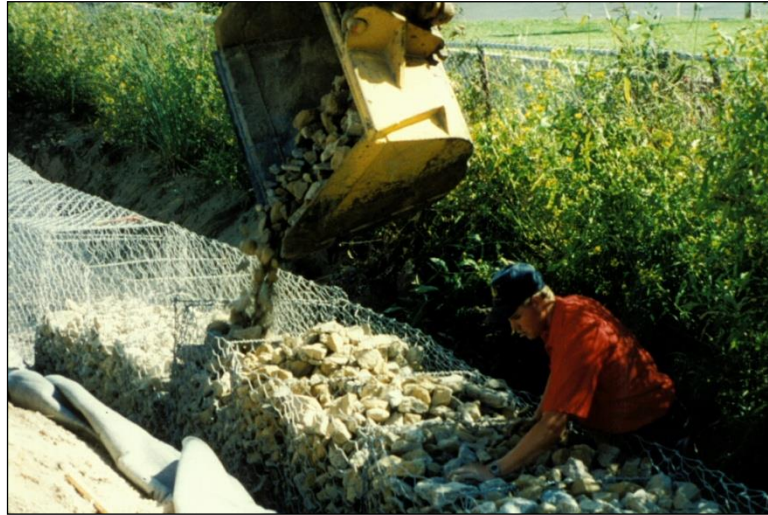
Figure 4.4.4-3: Gabion Gravity Crib Wall Under Construction.

Gabion gravity crib walls are constructed from rock-filled wire mesh baskets. The gabions typically have a heavy wire mesh with a nominal 3-inch opening and are formed into rectangular baskets, normally 1.5 to 3 feet in height. Individual baskets are placed on the prepared earthen surface, reinforced with internal tie wires, and filled with a select stone ranging from 4-inch to 10-inch diameter. After the baskets are filled, the wire lids are closed and wired shut to form a relatively rigid block. Succeeding rows of gabions are laced onto the filled underlying gabions and filled in the same manner. Manufacturers typically provide details for the wires, lacing, and lid closure. As wall heights increase, more baskets are wired together to increase the wall depth into the slope. Gabion walls are typically less than 18 feet tall. Geotextile fabric is placed behind the baskets to keep the backfill soils from entering the rock filled gabions. Gabion gravity crib walls are often used in fill sections of a roadway and/or adjacent to waterways. For water installations, the wall typically needs additional protection from scour by the use of riprap or other suitable material.

There are a variety of different types of gabion gravity crib walls on the market. They can be easily constructed without the use of skilled labor or specialized equipment, and they are often built rapidly. Unfortunately, it is difficult to make height adjustments to the wall once in place. Refer to Figure 4.4.4-3 and Figure 4.4.4-4 for views of gabion gravity crib walls.

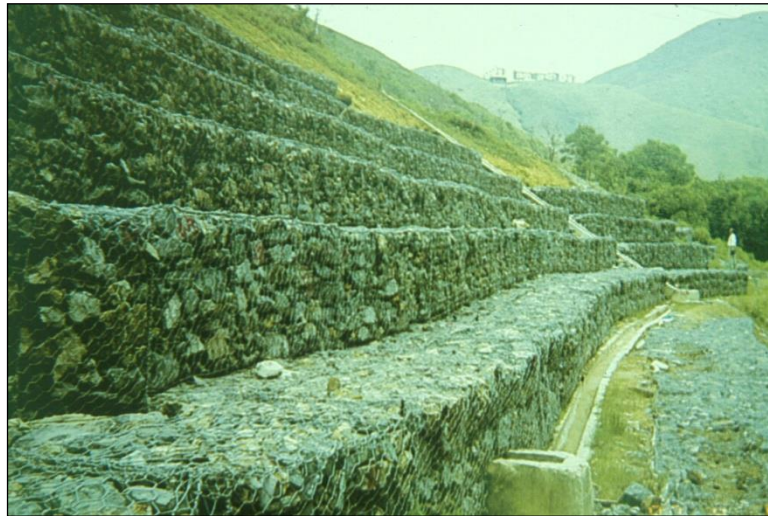
Figure 4.4.4-4: Tiered Gabion Gravity Crib Wall.

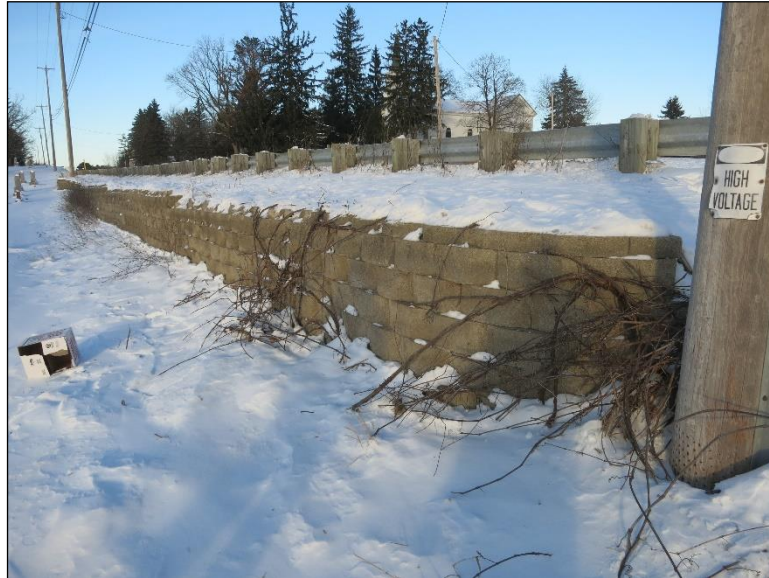
Figure 4.4.4-5: Segmented Modular Block Gravity Wall.

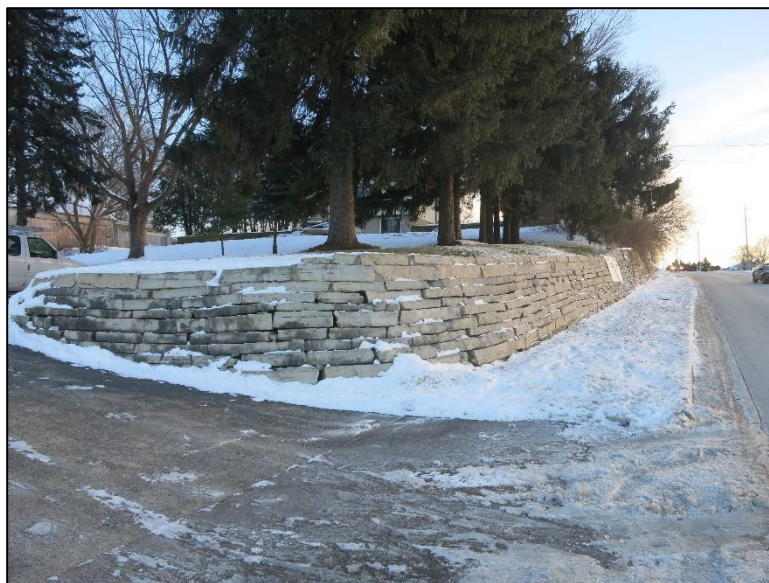
Figure 4.4.4-6: Lannon Stone (Limestone) Block Gravity Wall.

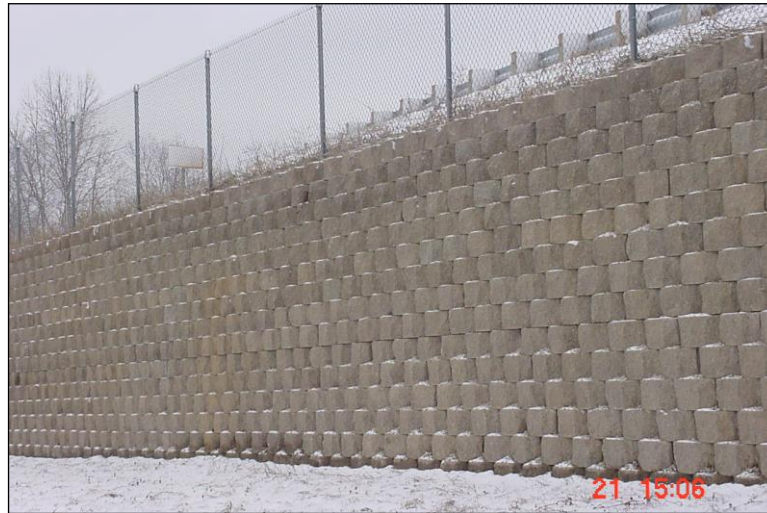
Figure 4.4.4-7: Segmented Modular Block MSE Wall.

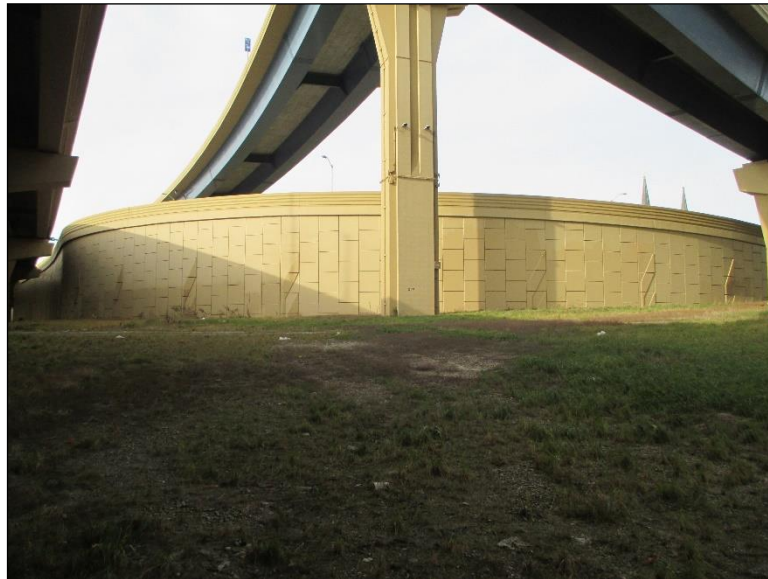
Figure 4.4.4-8: MSE Precast Concrete Panel Facing Wall.

For the Precast Concrete Panel Facing MSE wall, metallic strips, or wire grids are used to reinforce the soil mass and act as a gravity retaining structure. This type of MSE Wall is best used in fill sections. Refer to Figure 4.4.4-8 for a View of a Precast Concrete Panel MSE Wall. These walls cannot be built over existing utilities, and new utilities cannot be located within the reinforced soil. All reinforcement must lie within the permanent right of way. Foundation materials must have adequate bearing capacity to support the loads. Differential settlement limitations vary based on height and construction. Refer to the WisDOT Bridge Manual Chapter 14 for the maximum differential settlements.

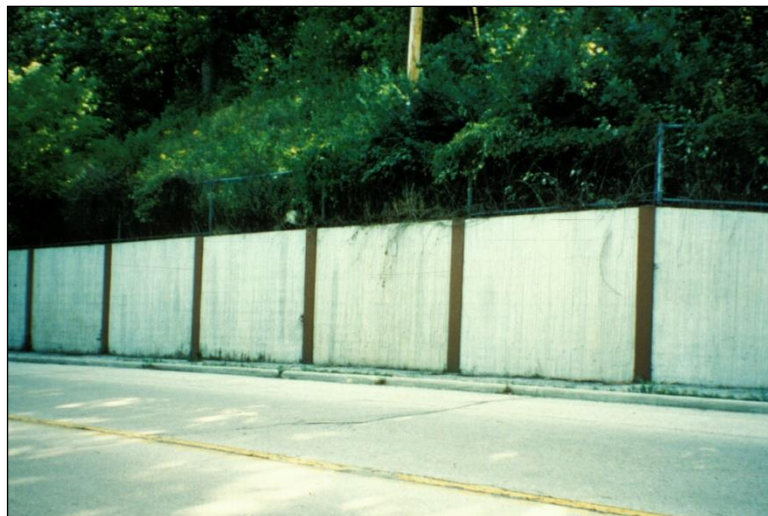
Figure 4.4.4-9: Post and Panel Cantilever Wall with Precast Panels and Steel "H" Piles.

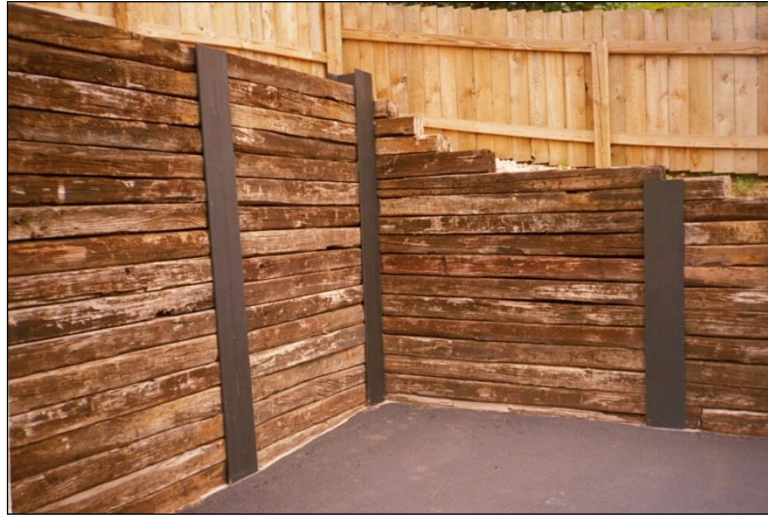
Figure 4.4.4-10: Post and Panel Cantilever Wall with Timber Planks and Steel "H" Piles.

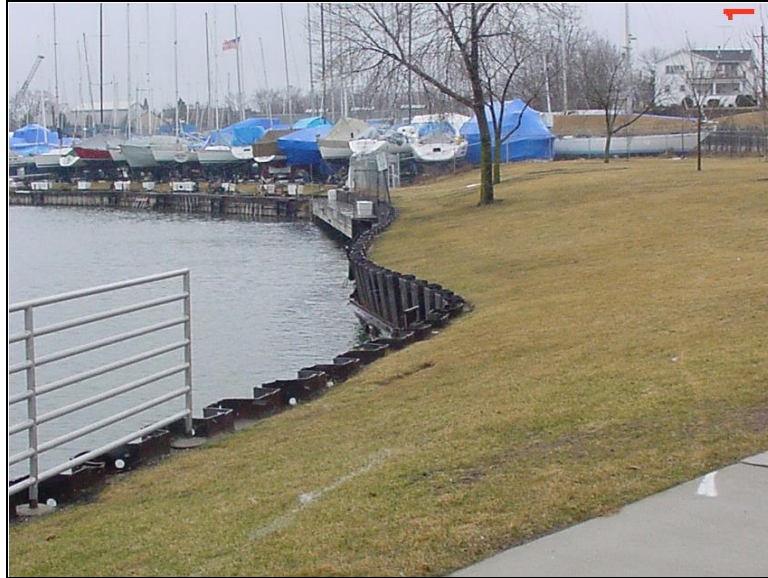
Figure 4.4.4-11: Tilted and Deformed Sheet pile Dockwall.

A common type retention structure found in Wisconsin is the Steel Sheet Pile Wall. These walls can either be temporary or permanent walls and they may or may not be anchored (often depends on exposed height of wall). Temporary walls can be used in construction to retain fill materials while construction adjacent to the wall is performed. Permanent sheet pile walls will typically be found along rivers and shorelines to protect the shoreline from erosion. Another permanent use for sheet pile walls is around boat docks to allow for proper water depths for boat to draft. The corrosion potential for these walls is high, and site conditions should be taken into account. These walls should not be used in areas where there is shallow bedrock. A steel sheet pile wall can be a maximum of approximately 15 feet high without tiebacks being required. Only the connections at the face of the wall for tiebacks are accessible for inspection. Therefore the inspector should carefully note any distress in fasteners. Refer to Figure 4.4.4-11 and Figure 4.4.4-12 for a view of an anchored sheet pile dockwall and a failed tie-rod, respectively.

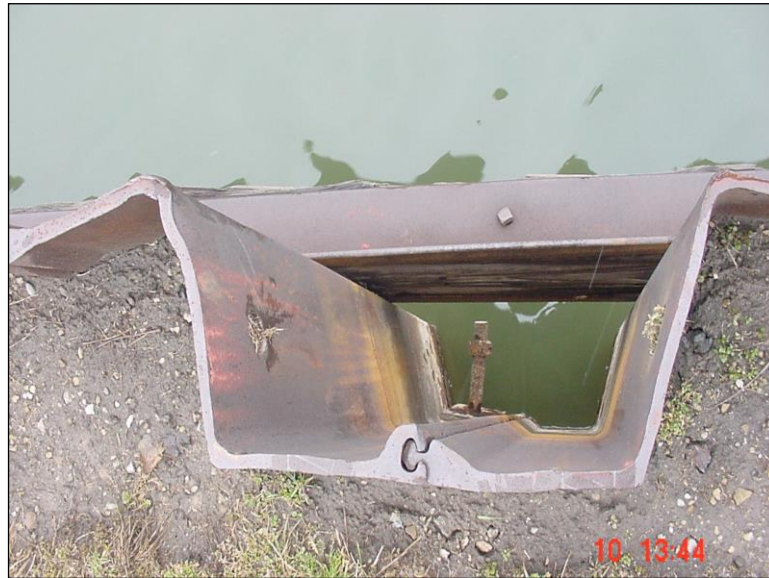
Figure 4.4.4-12: Failed Tie-rod Along a Sheet Pile Dockwall.

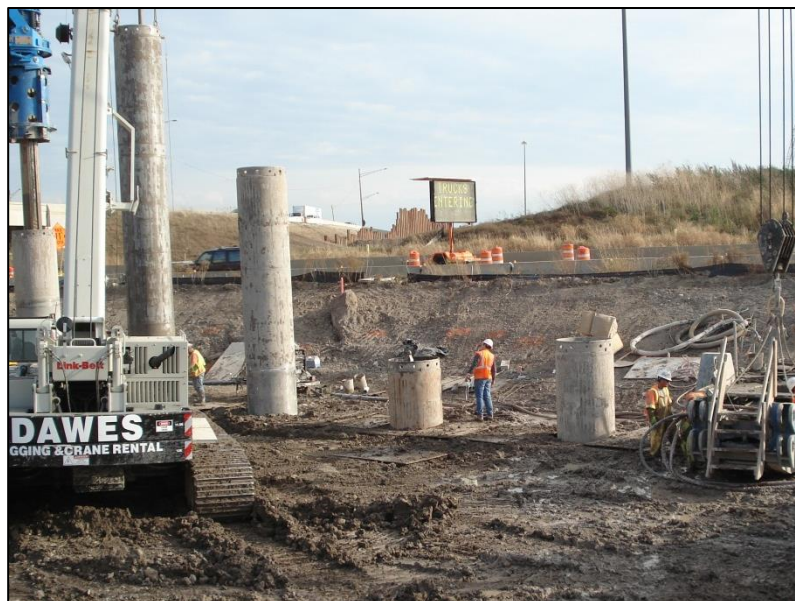
Figure 4.4.4-14: Secant Wall Construction.

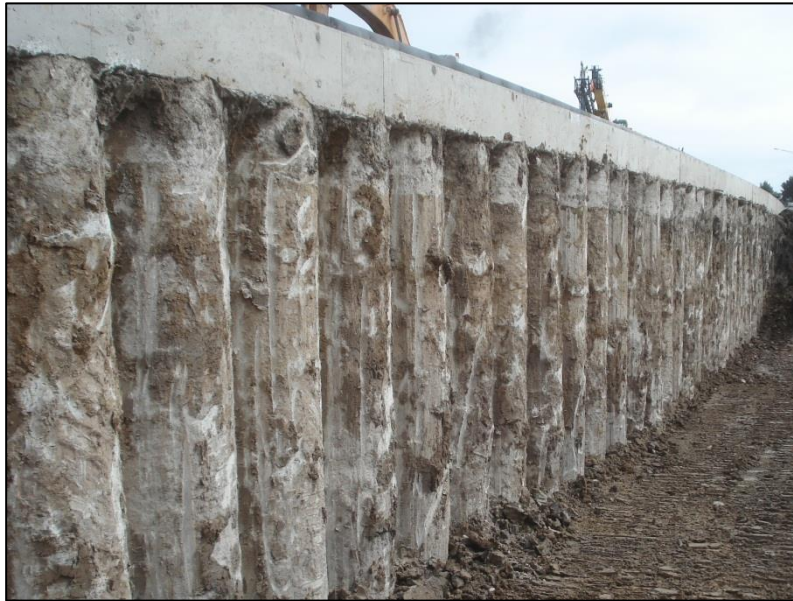
Figure 4.4.4-15: Secant Wall Constructed as Tunnel Wall.

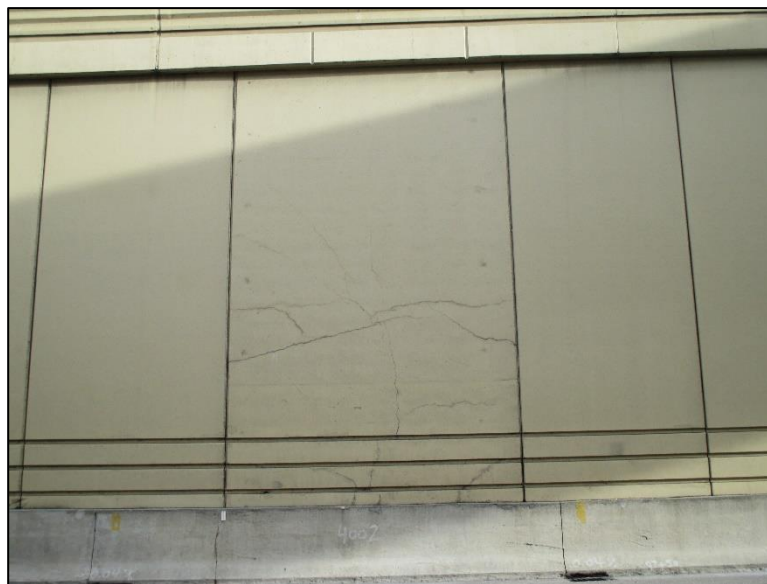
Figure 4.4.4-16: Excessive Cracking within Secant Wall Facade Concrete Panel.

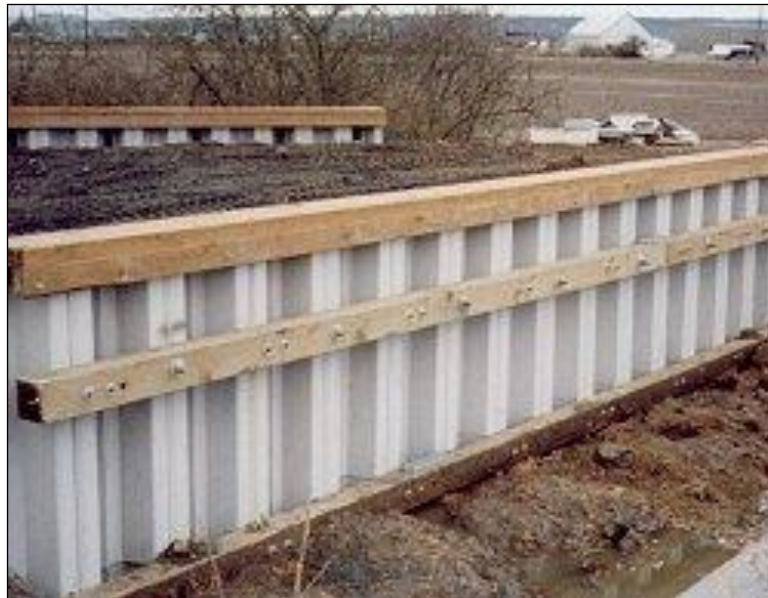
Figure 4.4.4-17: Vinyl Sheet Piling Retaining Wall.

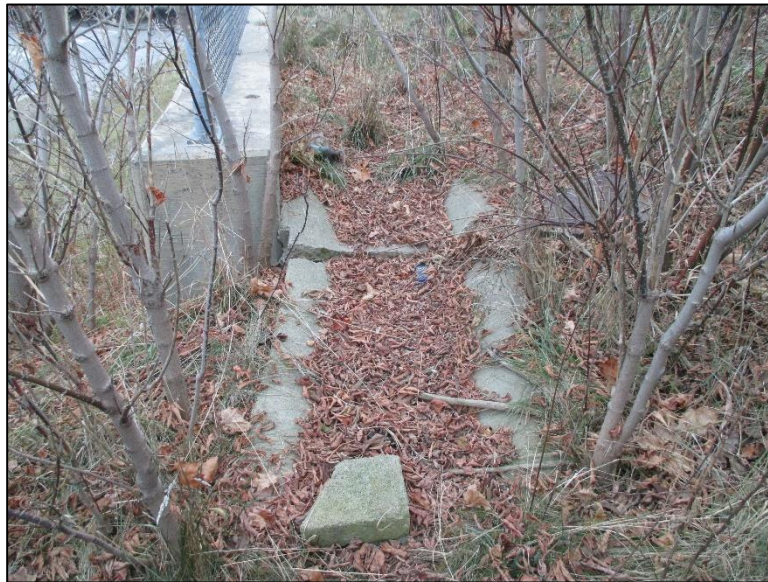
Figure 4.4.5-1: Concrete Flume at End of Wall. Condition State 2 (Fair) – No Erosion Evident, with wide crack.

This assessment captures the condition of the soil and slopes at the ends of the retaining structure. The inspector shall note any erosion or loss of fill due to drainage at the ends of the walls. The inspector shall note any remediation recommendations under the maintenance items on the inspection report as well as noting the assessment state of the Drainage Approach. This assessment is quantified as 1 EA for each end of the wall. For unit walls, the inspector shall note this fact, and evaluate the condition of the sidewalk/soils at the walls' interface.

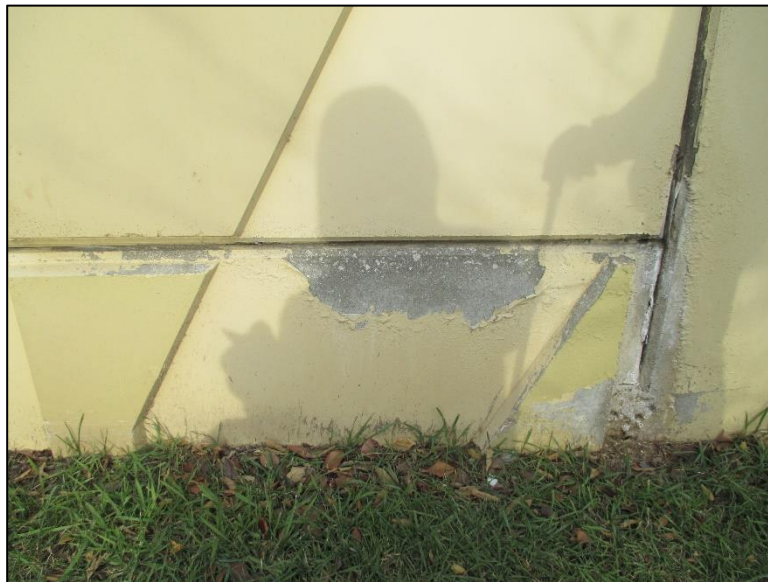
Figure 4.4.5-2: Failed Concrete Stain.

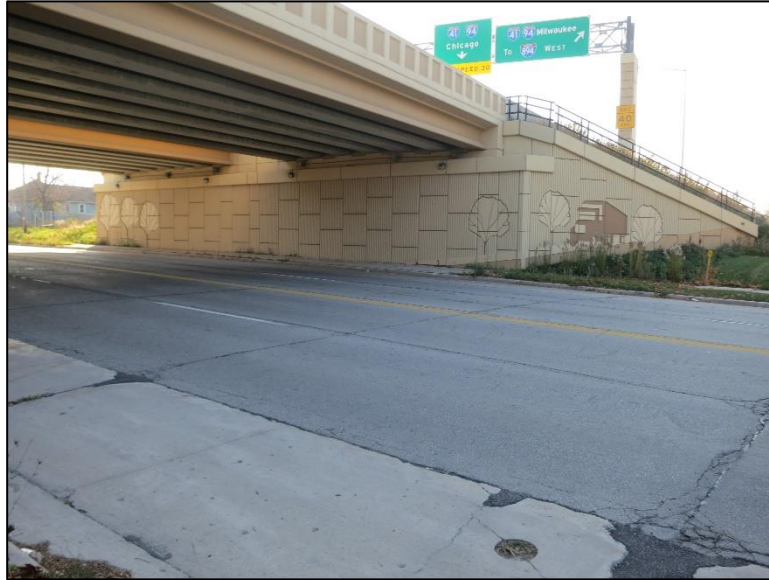
Figure 4.4.5-3: Aesthetic Treatment Form-Lined Precast Concrete Panels.

Similar to the bridge inspection assessment, this item is used to evaluate the condition of all the aesthetic treatments located on the retention structure. In certain settings, a structure may contain several aesthetic components, from concrete staining, stamped concrete façade, obelisks, etc. It is necessary for an inspector to review the plan set to determine the type of structure being inspected to determine whether the façade is an aesthetic feature or integral structural component. For instance, secant walls are comprised of main load retaining secant piles typically installed behind precast concrete paneling. During an inspection only the precast paneling can be inspected. The inspector shall use visible distress in the precast panels to determine the condition of the secant piling behind. A similar inspection would be performed with an MSE wall. In this case, any distress noted in the paneling would be noted in the secant pile defects. Any stained concrete or form-lined features would be accounted for under the Aesthetic Treatments assessment.

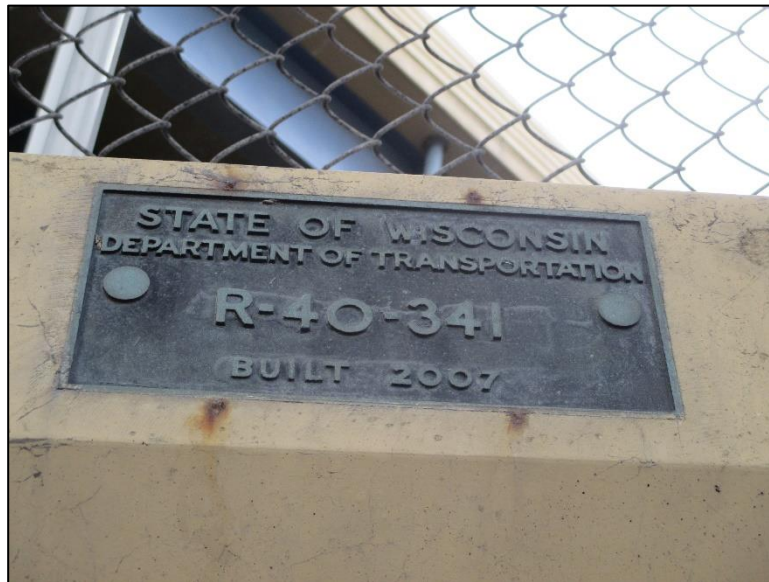
Figure 4.4.5-4: Retaining Wall Name ID Plaque.

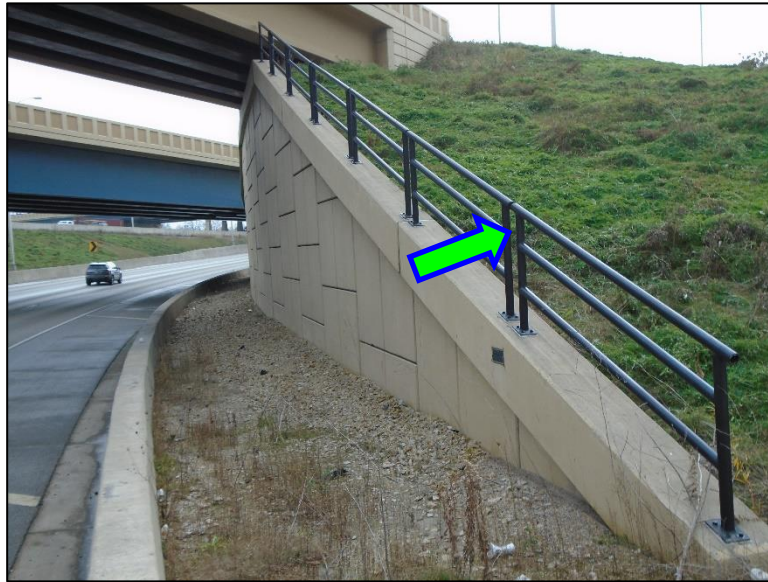
Figure 4.4.5-5: Decorative Rail atop a Horizontal Coping.

All extensions fastened to a bridge railing element or horizontal coping on a retaining earth structure and not considered comprised of chain-link fencing shall be quantified and evaluated under the Decorative Rail assessment.

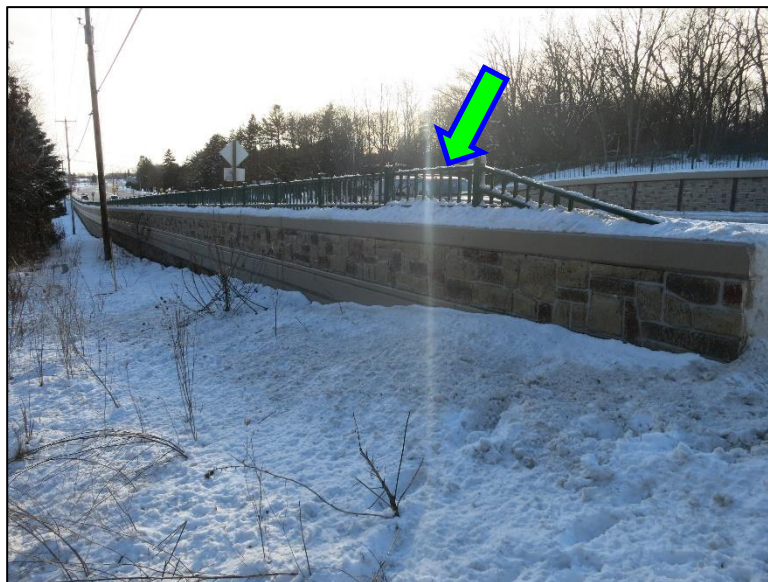
Figure 4.4.5-6: Decorative Rail atop a Bridge Rail Element.

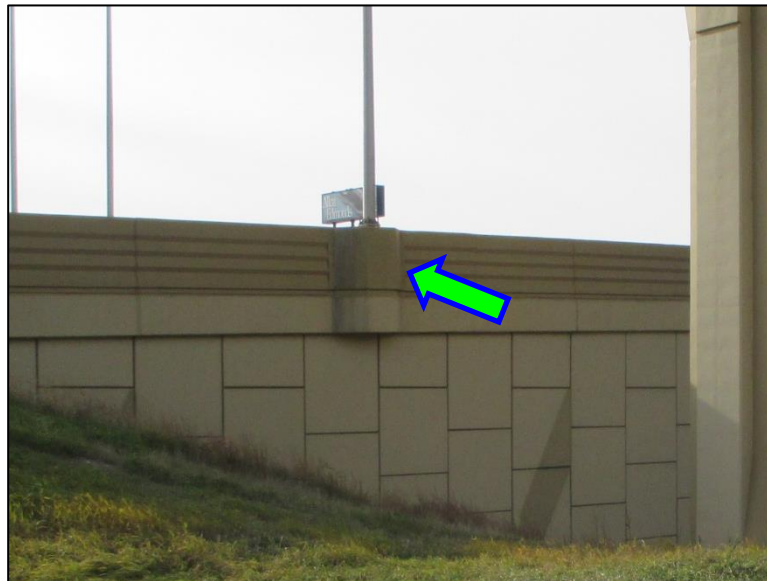
Figure 4.4.5-7: Luminaire Base Placed in Coping and Barrier Wall.

Luminaire bases are the bump-outs located along a retaining earth structure that support vertical light posts. These will typically poured monolithic with the bridge railing element atop the horizontal copings. Note that these bases do not include sign structure foundation bump outs. Sign structure bump outs are inspected under a separate inspection for the sign structure itself.

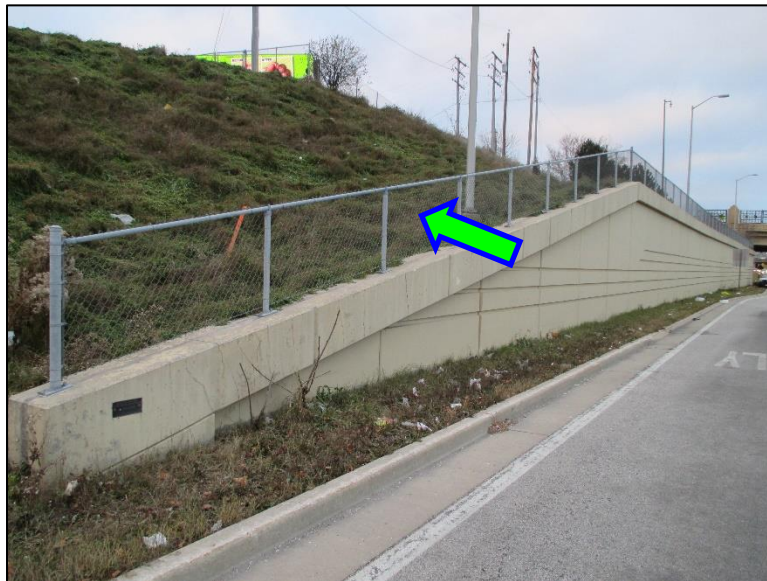
Figure 4.4.5-8: Protective Screening Fastened to a Horizontal Coping. Note the Screening is Not Adjacent to a Sidewalk.

In contrast to the Decorative Rail assessment, the Protective Screening assessment shall be utilized for any extension above a bridge railing element or coping that is comprised of chain-link fencing. This is regardless if the screening is the active barrier between the leading edge of a sidewalk or simply on top of the coping/railing.

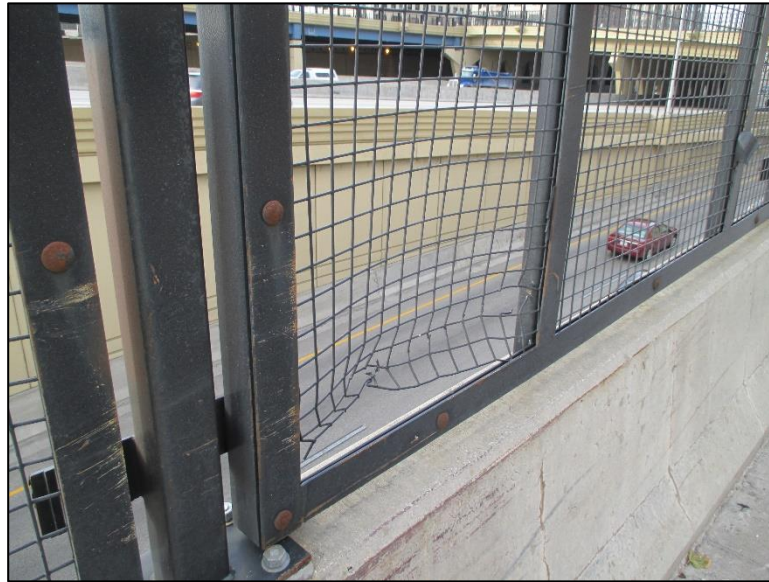
Figure 4.4.5-9: Assessment State 3 Protective Screening atop Bridge Rail. Note Chain-link Fence Deformation but Function Remains.

- **Condition State 3 (Poor):** Chain-link fence has moderate deterioration. Coating may have moderate failure – surface rust may be prevalent. Components may be slightly bent or misaligned – connections may be slightly loos. Fabric may have snags or holes (areas may be slightly stretched or deformed).
