**Table of Contents**

# WisDOT Structure Inspection Manual Part 4 – Ancillary Structures

## Chapter 4 – Retaining Walls

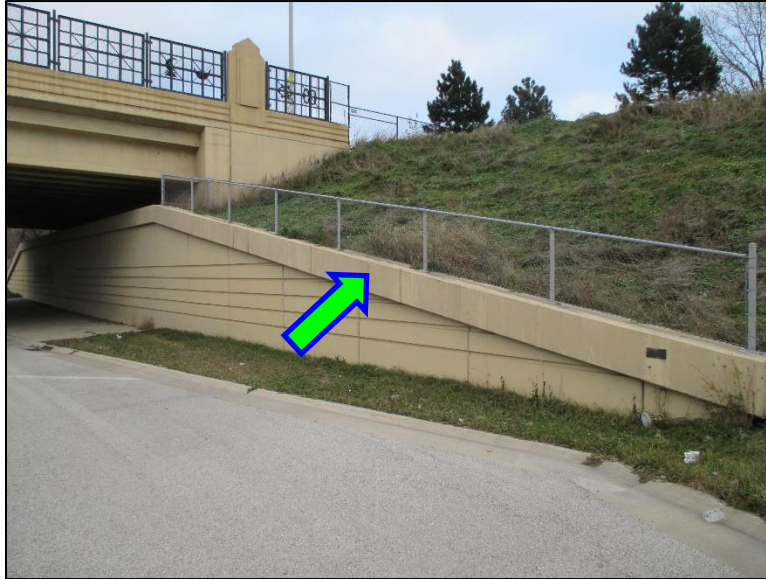
Figure 4.4.5-10: Cast-In-Place Horizontal Coping

at the top of the wall and providing a sound base for placing bridge railing elements. The coping provides protection from deterioration caused by water runoff, snow, freeze/thaw and ice by diverting water away from vertical seams, the top of the wall, and the wall facing. These assessments will typically be comprised of cast-in-place concrete or in some instances precast concrete.

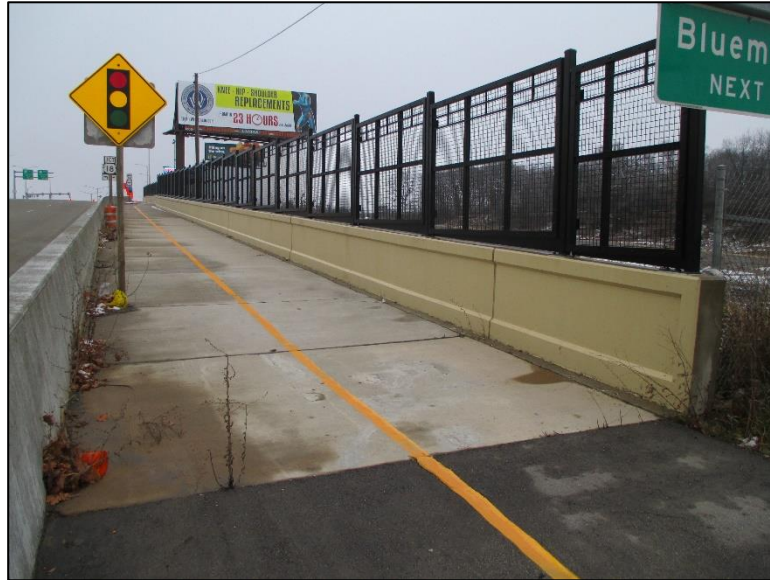
Figure 4.4.5-11: Concrete Sidewalk Along Top of Retaining Wall.

Typically, fill and cut section walls will have roadways, sidewalks, driveways or other facilities adjacent or carried by the wall. Regardless if these features are along the face or along the top of the wall, the inspector shall perform a visual inspection of the features paying particular attention to any settlement, joint separation or excessive cracking. These deficiencies may indicate wall movement or wall distress in the adjacent wall. The slope behind the wall should be stable and adequately supported by the wall. Any backfill losses, indication of water retention, or other defects may indicate performance issues with the wall and should be noted.

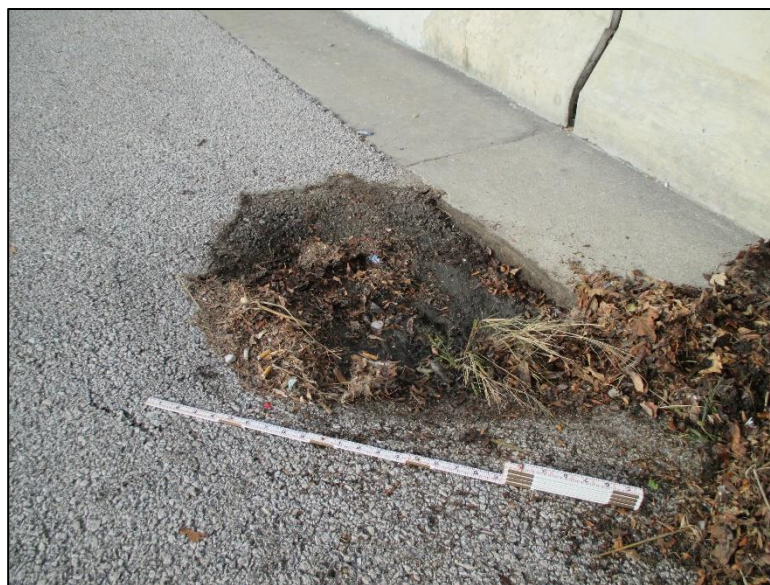
Figure 4.4.5-12: Pothole Due to Loss of Fill Within Shoulder Gutter Pan Along Top of Retaining Wall.

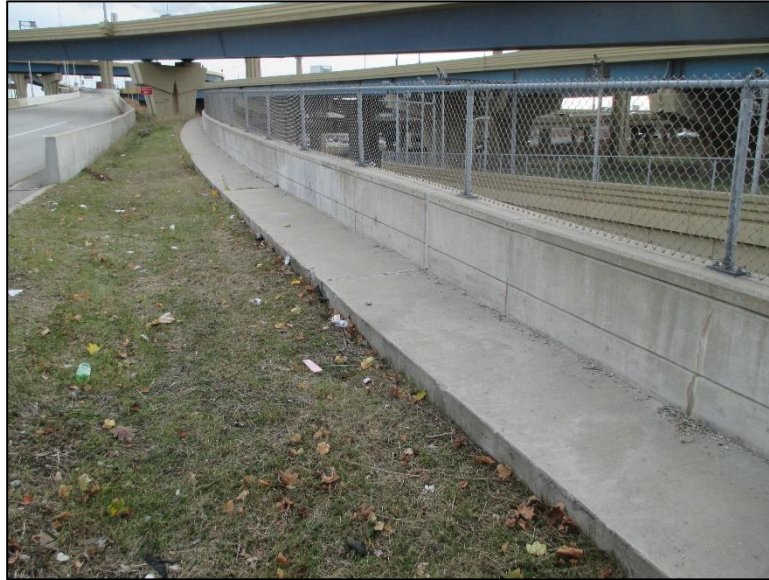
Figure 4.4.5-13: Drainage System Along Top of Retaining Wall. Note Vegetation Exhibits No Signs of Erosion or Settlement.

This assessment defines the drainage along the retaining wall, both on top and along the face. Typically systems to note during inspection include vegetation or lack thereof along the wall and whether run off is able to properly drain away or through the wall. Storm sewer pipes including inlets or field inlets along the wall should be inspected and noted if clogged. Debris preventing adequate drainage should be noted or removed by the inspector. The inspector should note any settlement of fill along or above the wall. Settlement localized in the vicinity of storm sewer inlets and outlets may be an indication that the drainage system is not functioning properly or may be broken and eroding fill material away from behind the wall.

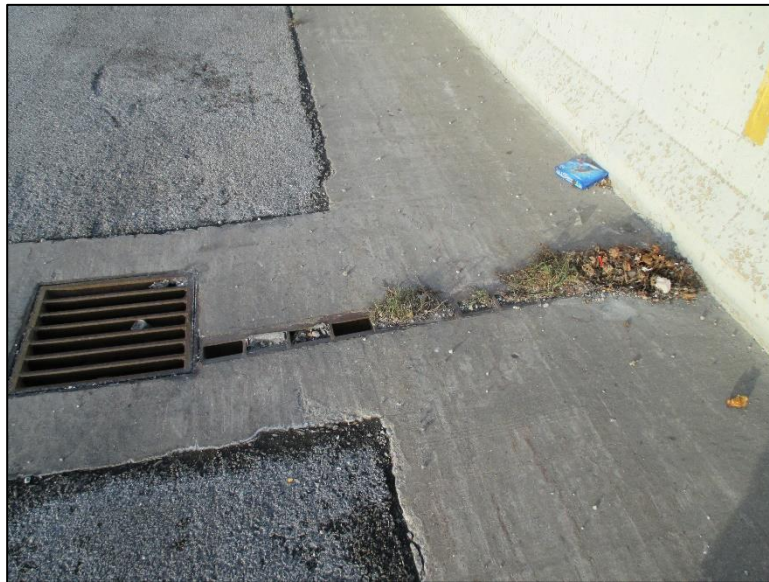
Figure 4.4.5-14: Drainage System Located along Top of Retaining Wall.
