Preventing Settlement—and Bumps—at Bridge Approaches

This brief summarizes project 0092-00-13, “Evaluation of Bridge Approach Settlement Mitigation Methods,” produced through the Wisconsin Highway Research Program for the Wisconsin Department of Transportation Research Program, 4802 Sheboygan Ave., Madison, WI 53707.

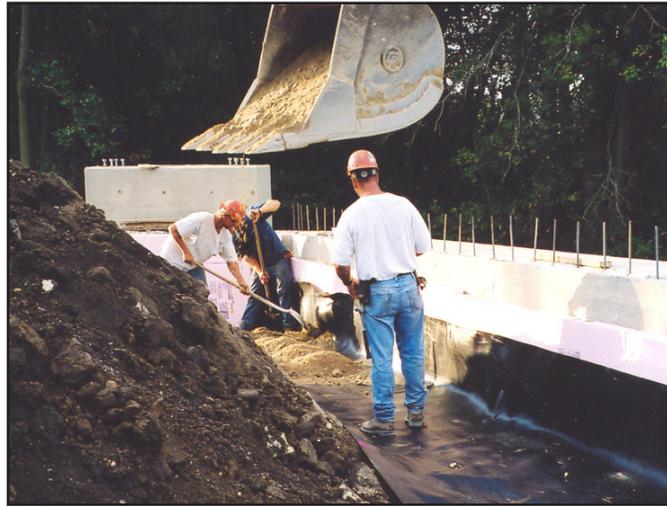
Roadway crews placed geosynthetic-reinforced fill behind the east abutment of the Western Avenue bridge over Cedar Creek in Washington County, which was built on cohesive soil.
