## Stabilizing Surficial Slope Failures with Vertical Members

*This brief summarizes Project 0092-05-09, “Investigation of Vertical Members to Resist Surficial Slope Instabilities,” produced through the Wisconsin Highway Research Program for the Wisconsin Department of Transportation Research Program, 4802 Sheboygan Ave., Madison, WI 53707.*

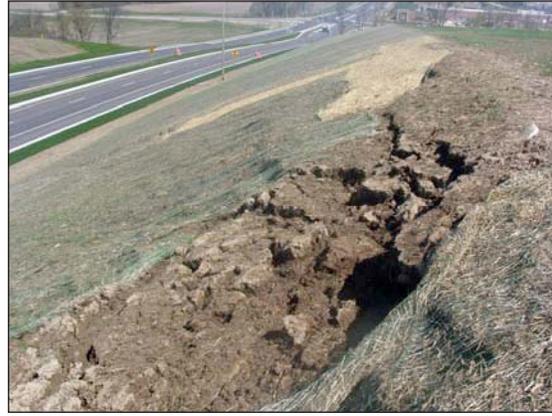
Researchers determined that wood lumber and earth anchors are cost-effective choices for stabilizing surficial slope failures such as this one along WIS 164 in Waukesha County (Fig. 2.3 of the final report).

To further analyze the effectiveness of these methods in Wisconsin, a comprehensive slope-stability analysis was conducted using various Wisconsin soil and slope parameters for both dry and saturated conditions. A surficial slope failure along WIS 164 in Waukesha County was selected for the analysis. The results demonstrated that all three methods were effective in stabilizing the failure. Noted improvements were increased factors of safety and the elimination of the surficial nature of the slope failure.
