## Monitoring Loading and Environmental Effects on Bridge Performance

*This brief summarizes Project 0092-07-09, “Monitoring and Load Distribution Study for the Land Bridge,” produced through the Wisconsin Highway Research Program for the Wisconsin Department of Transportation Research Program, P.O. Box 7915, Madison, WI 53707.*

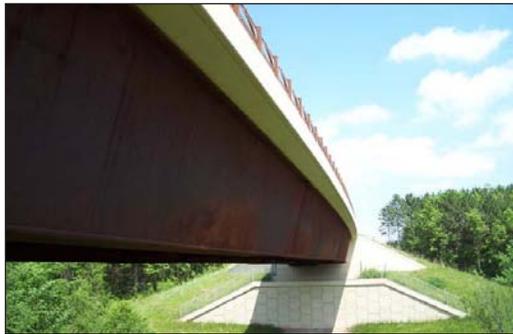
East side of bridge, looking north

Wisconsin's first bridge using high-performance steel was completed in 2002 on WIS 131, between Ontario and Lafarge. Called the Land Bridge, it spans about 275 feet and is supported by two side-by-side box girders—hollow beams with box-shaped trapezoidal cross sections.
