BRIEF

Reliability-Based Inspection Intervals for Sign Supports

This brief summarizes Project 0092-08-14, “Fatigue Risks in the Connections of Sign Support Structures: Phase I,” produced through the Wisconsin Highway Research Program for the Wisconsin Department of Transportation Research Program, 4802 Sheboygan Ave., Madison, WI 53707.

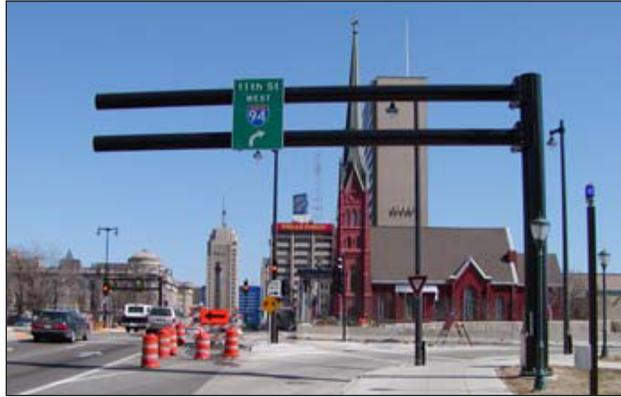
This double-arm sign support structure over Wisconsin Avenue at Interstate 43 in Milwaukee is an example of the type of sign support being evaluated.
