# **ANALYSIS OF LOAD-INDUCED STRAINS IN A HOT MIX ASPHALT PERPETUAL PAVEMENT**

WisDOT Report FEP 01-09

Wisconsin Research Study # FEP-02-02  
“EVALUATION OF AN ASPHALTIC CONCRETE PERPETUAL  
PAVEMENT”  
(Kenosha Safety & Weigh Station Facility)

James A. Croveti  
Marquette University  
Transportation Research Center  
Department of Civil and Environmental Engineering

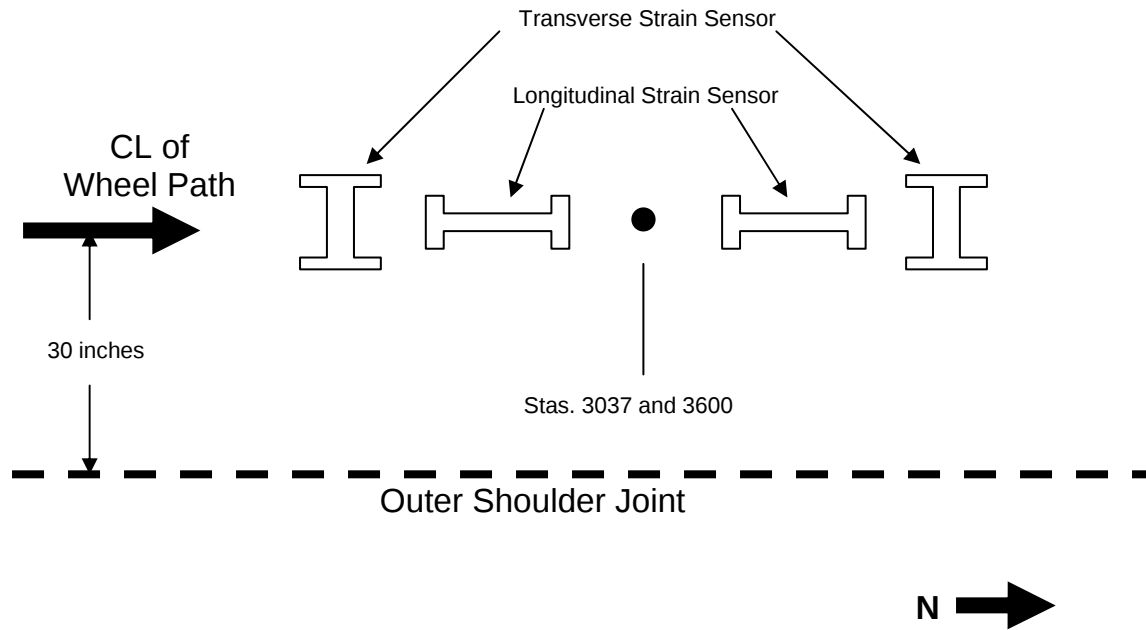
**Figure 1: Schematic Illustration of Strain Sensor Configurations**

Marquette University was contracted to design, build and install asphalt strain sensors to record load-induced strains within the HMA perpetual pavement system. A total of 16 H-Type strain sensors were fabricated and installed in the outer wheel path at stations 3037 and 3600. Eight sensors were installed at the bottom of the lower HMA layer and the remaining eight sensors were installed at the interface of the lower and middle HMA layers. Figure 1 provides a schematic illustration of the sensor arrangement used at each placement/depth location. As shown, there is a redundant set of longitudinal and transverse oriented strain sensors at each instrumented location.

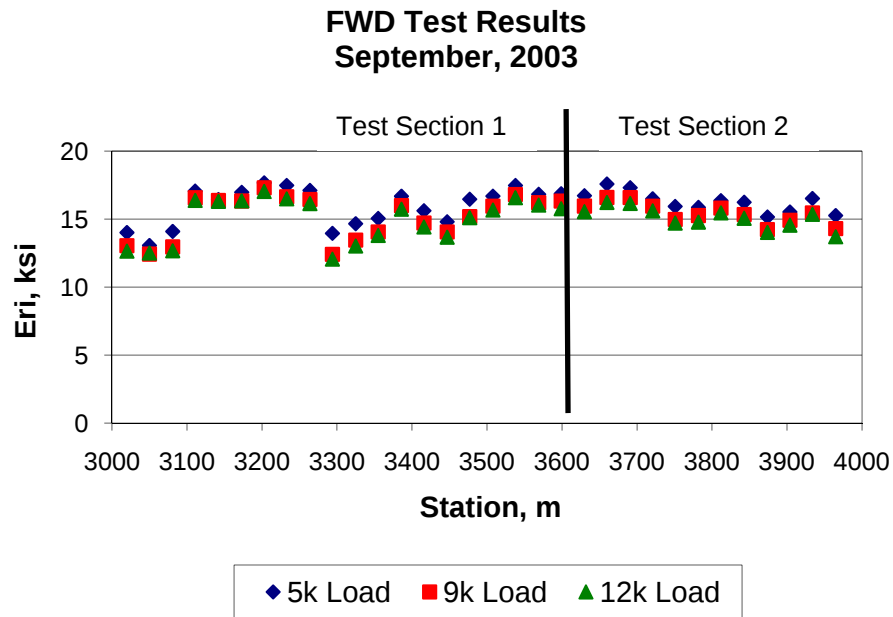
**Figure 2: Backcalculated Subgrade Eri Profile, Sept. 2003**

As shown in Figure 2, the backcalculated subgrade Eri values are relatively consistent within Test Section 2 and more variable in Test Section 1. Furthermore, the deflection results indicate a slight stress sensitivity in the lean clay soils, whereby there is a minor reduction in the backcalculated Eri values with increasing FWD load levels. This trend of stress-softening is typical for fine grained, cohesive soil materials. Summary statistics for the backcalculated subgrade Eri values are provided in Table 1.

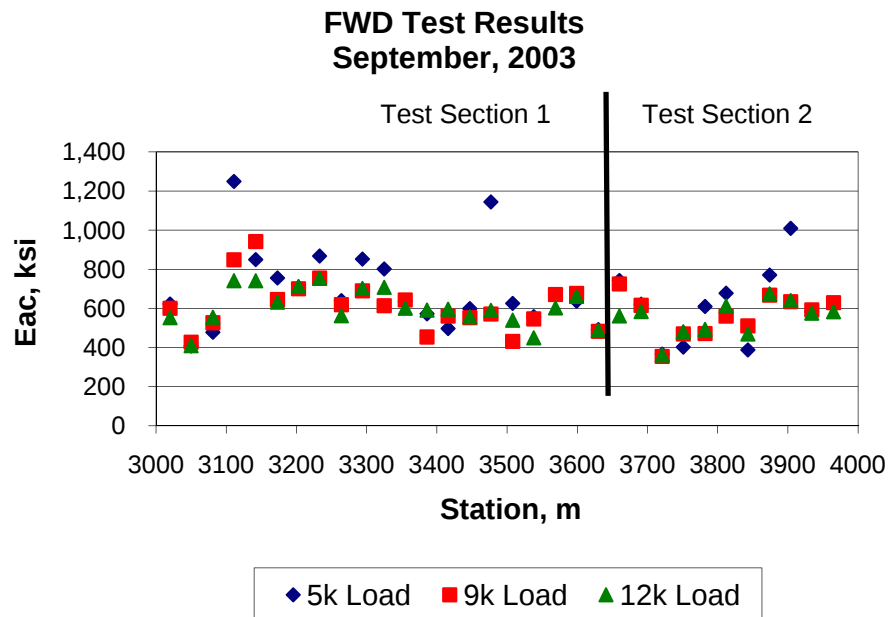
**Figure 3: Backcalculated HMA Modulus Profile, Sept. 2003**

The backcalculated  $E_{AC}$  values illustrated in Figure 3 and provided in Table 2 indicate relative consistency within each test section; however, there is more variability compared to the backcalculated Eri values (i.e., higher COV values). Also, the overall average  $E_{AC}$  values are increased within Test Section 1 as would be expected due to the reduced air voids in the lower HMA layer.

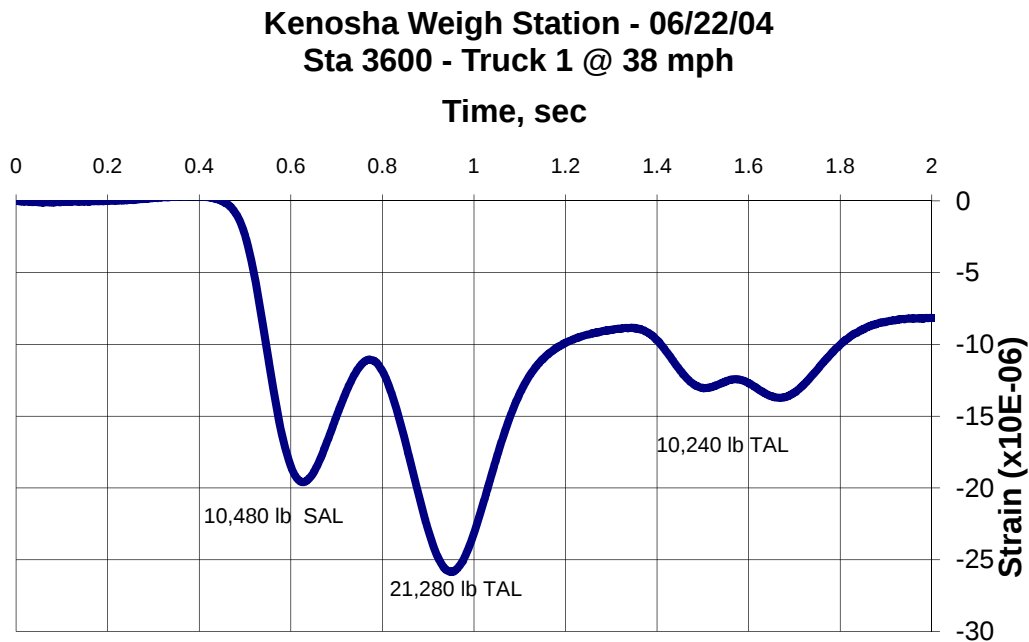
**Figure 4: Strain Measurement from Truck 1 – June 2004**

Strain measurements were made in conjunction with moving truck loadings to establish trends of strain data as a function of speed, load magnitude and position. On June 24, 2004 a series of strain measurements were obtained in Test Section 2 (Station 3600) under the action of FHWA Class 9 trucks (WisDOT Designation 3S-2). Strain measurements were captured at the bottom of the HMA layer for four separate trucks traveling between 37 – 42 mph. Axle loadings were obtained from the weigh station records and ranged from 10,480 – 12,740 lb on the steering axle and from 10,240 – 34,680 lb on the dual-tandem axle. Figures 4 – 7 illustrate the maximum strain readings obtained under each axle of the four truck loadings. As shown, the peak strain values (tension is negative) produced by the single axle loads (SAL) and tandem axle loads (TAL) are well correlated to the magnitude of the axle loadings and all strain reading are below 50 microstrain.

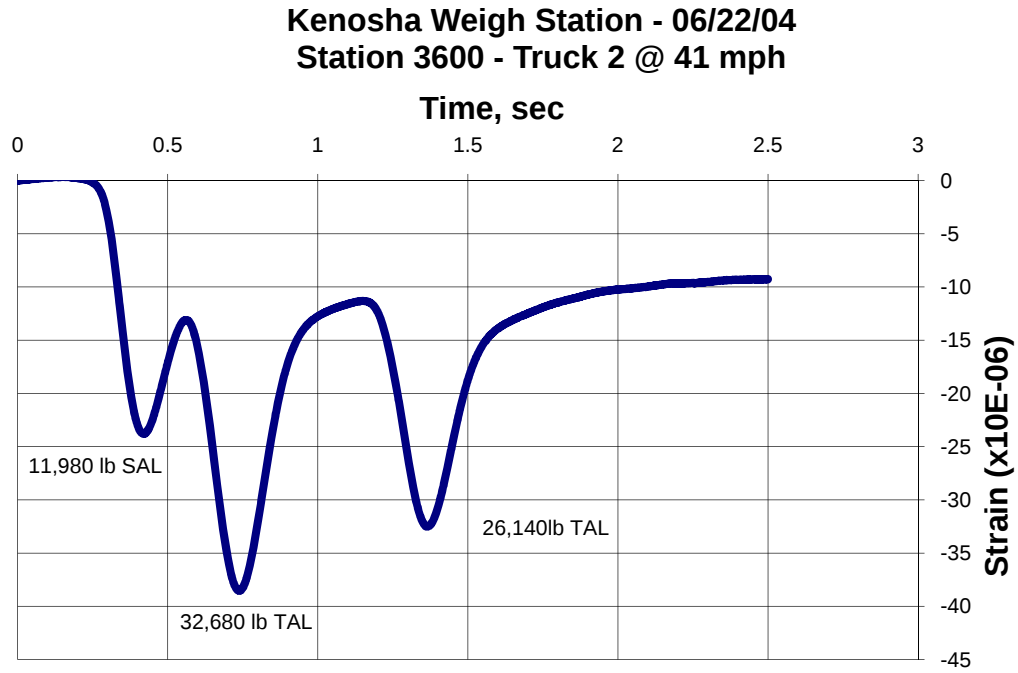
**Figure 5: Strain Measurement from Truck 2 – June 2004**

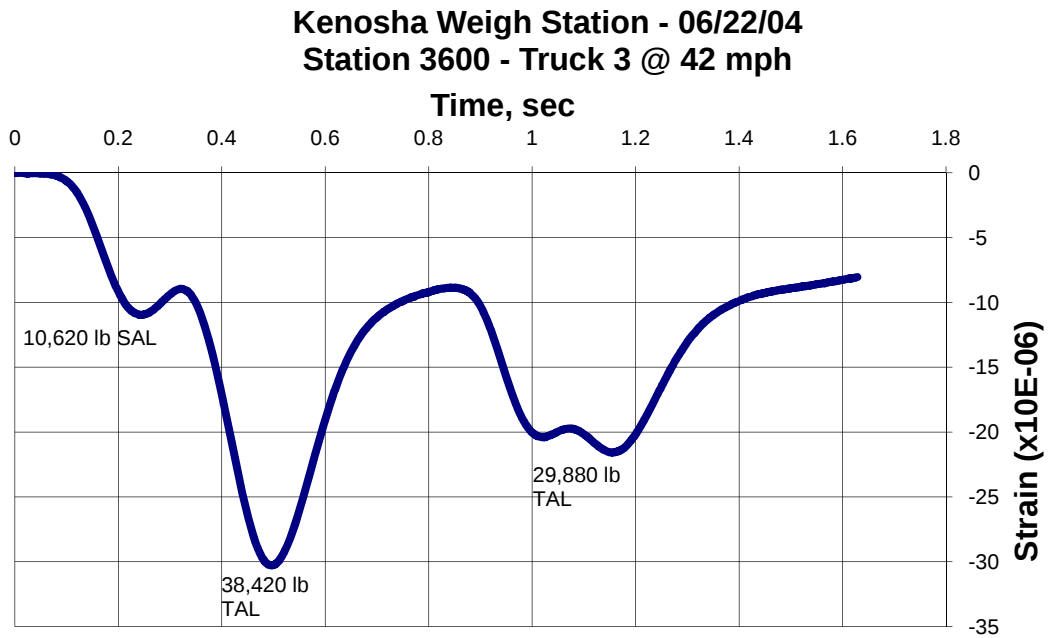
**Figure 6: Strain Measurement from Truck 3 – June 2004**

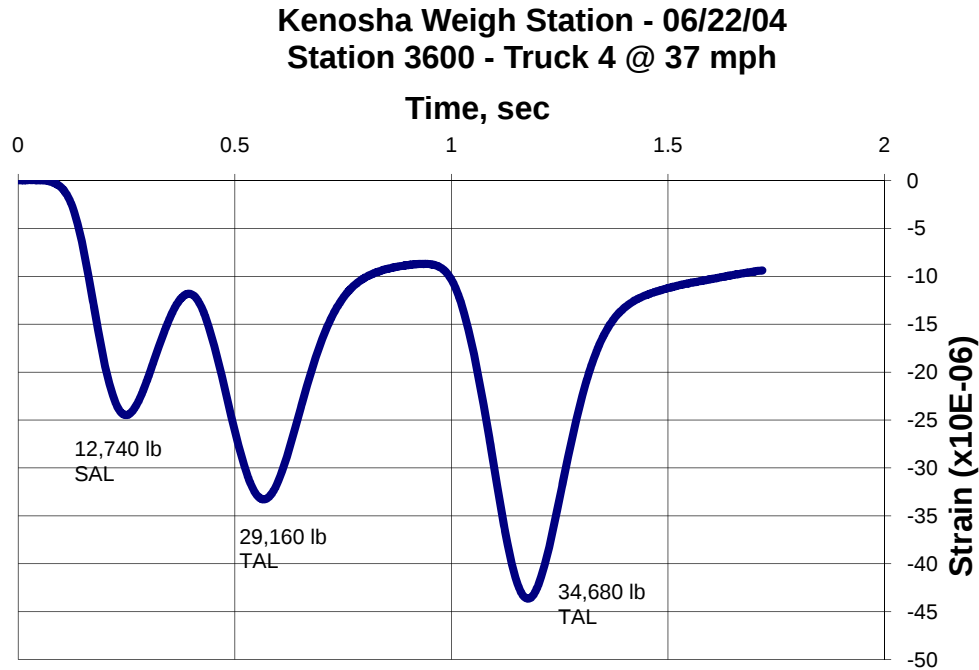
**Figure 7: Strain Measurement from Truck 4 – June 2004**

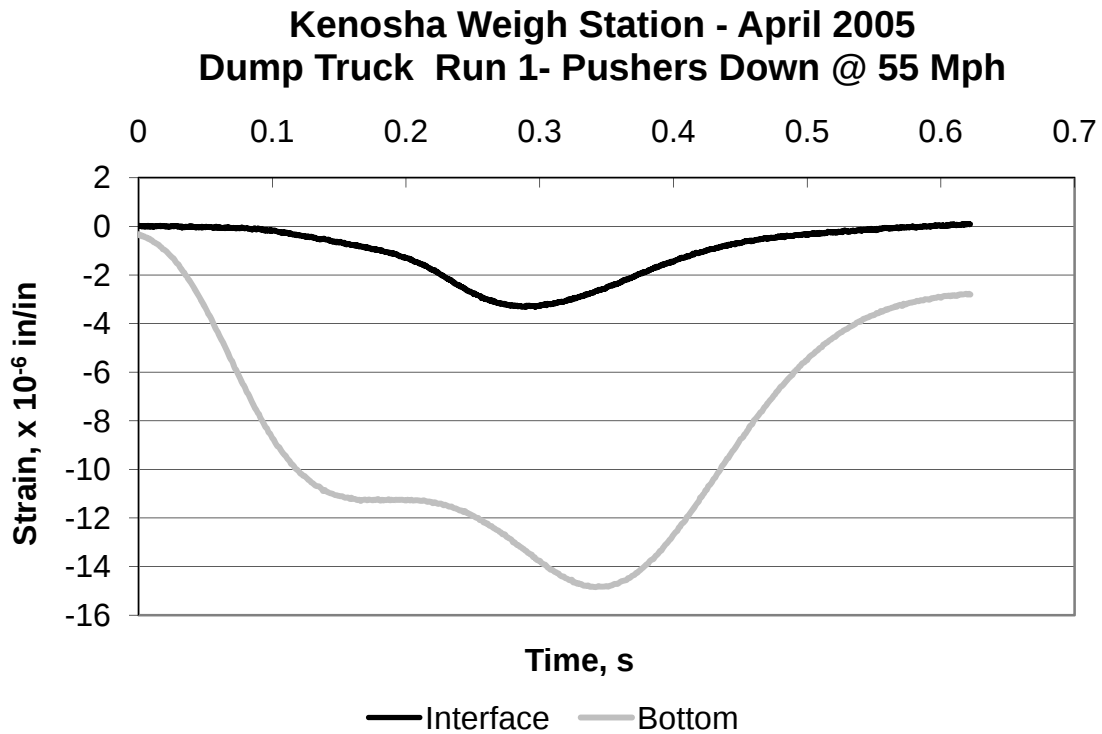
**Figure 8: Strain Measurement from Truck Run 1 – April 2005**

A second series of truck measurements were made on April 18, 2005 using a loaded quad-axle dump truck with a total gross vehicle weight of approximately 72,700 lb. Strain measurements were obtained from the bottom and interface sensors at Station 3600. Pavement surface temperatures ranged from 80.2 to 90.8 °F during testing. Two truck runs were recorded with the pusher wheels up, which results in a steering axle loading of approximately 25,400 lb and a rear dual-tandem axle loading of approximately 47,300 lb. An additional truck run was recorded with the pusher axles down, resulting in a steering axle loading of approximately 19,000 lb, a rear dual-tandem axle loading of approximately 38,600 lb and a pusher axle loading of approximately 15,000 lb. Figures 8 - 10 illustrate the results of these truck tests. As shown, the bottom strain readings are significantly higher than the interface values, as expected. Furthermore, all strain readings are below 25 microstrain.

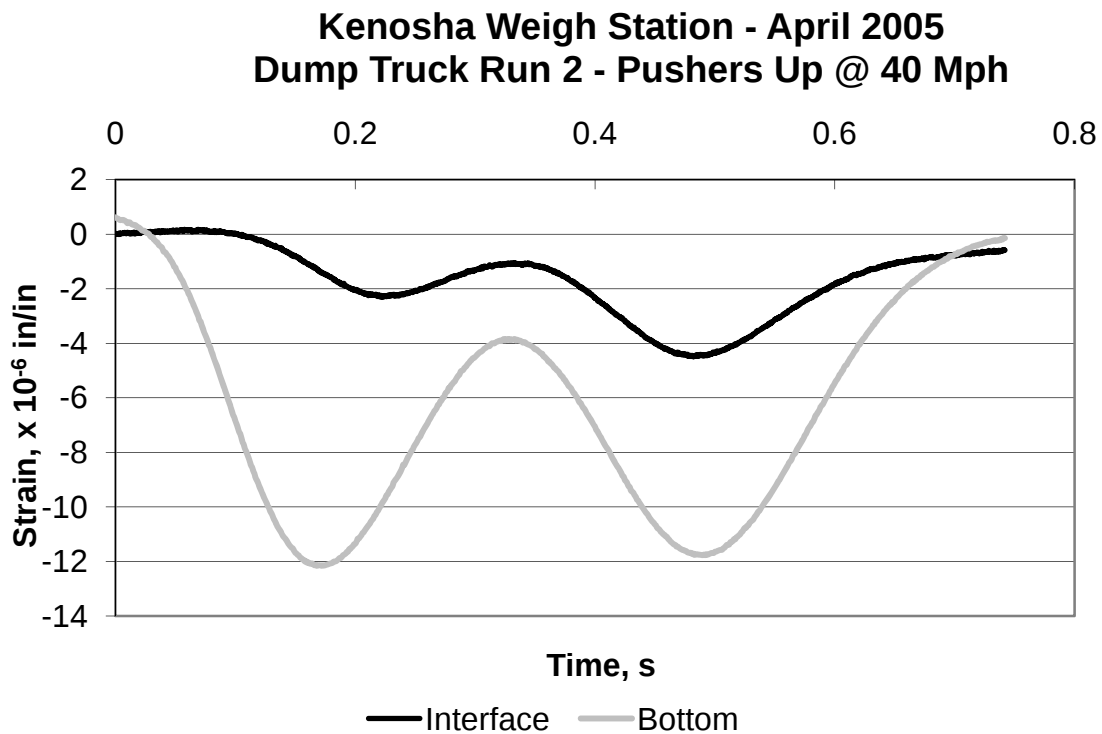
**Figure 9: Strain Measurement from Truck Run 2 – April 2005**

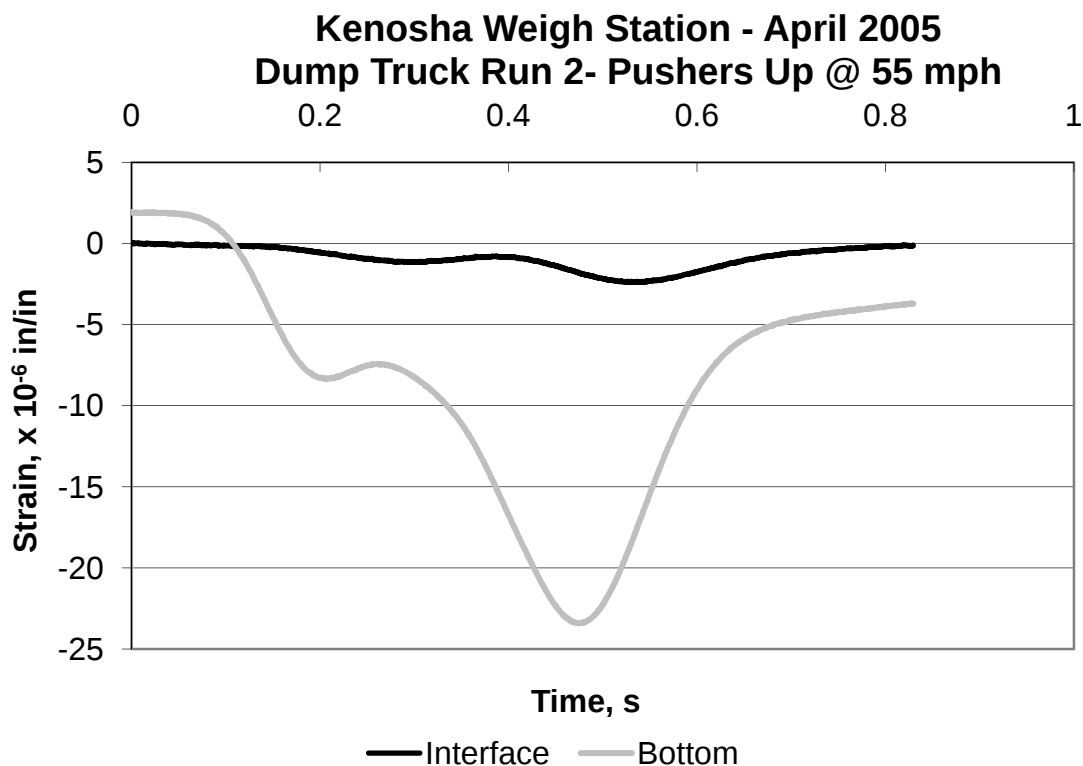
**Figure 10: Strain Measurement from Truck Run 3 – April 2005**

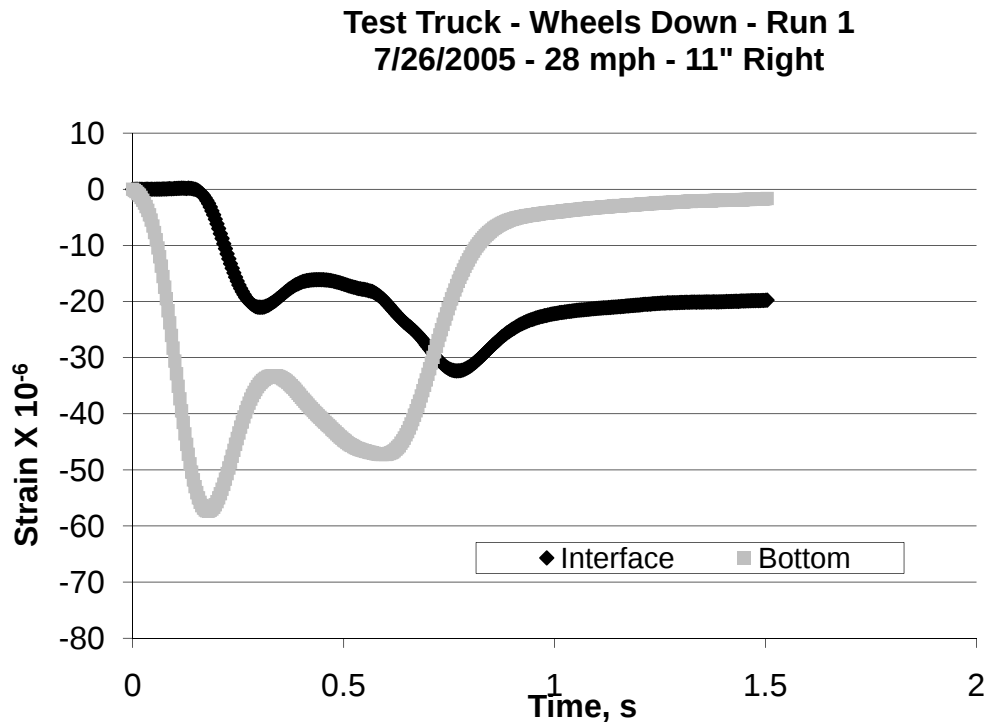
**Figure 11: Strain Measurement from Truck Run 1 – July 2005**

A final series of truck measurements were conducted on July 26, 2005. Strain measurements were obtained from the bottom and interface sensors at Station 3600. These measurements were again made under the action of the loaded quad-axle dump truck with a total gross vehicle weight of approximately 72,700 lb. Pavement surface temperatures ranged from 90 to 103 °F during testing. Four truck runs were recorded with the pusher wheels down (19,000 lb SAL, 38,600 lb TAL, 15,000 lb PAL). Four additional truck runs were recorded with the pusher axles up (25,400 lb SAL and 47,300 lb TAL). During each run, the position of the right front steering wheel was recorded in reference to the centerline of the right wheel path. Figures 11 - 18 illustrate the results of these truck tests. As shown, the strains recorded during this testing are substantially higher than during the previous test series in April 2005, likely due to the higher pavement temperatures and slower truck speeds. In particular, the effects of speed on strain development can be seen by comparing Figures 12 and 13, which clearly demonstrate the increase in strains resulting from reduced truck speeds (equal offset values). When the pusher axles were lowered (legal loadings) all strain readings were below 70 microstrain. With the pusher axles raised, slower truck speeds produced bottom layer strains in excess of 100 microstrain under the heavily loaded single axle (steering axle).

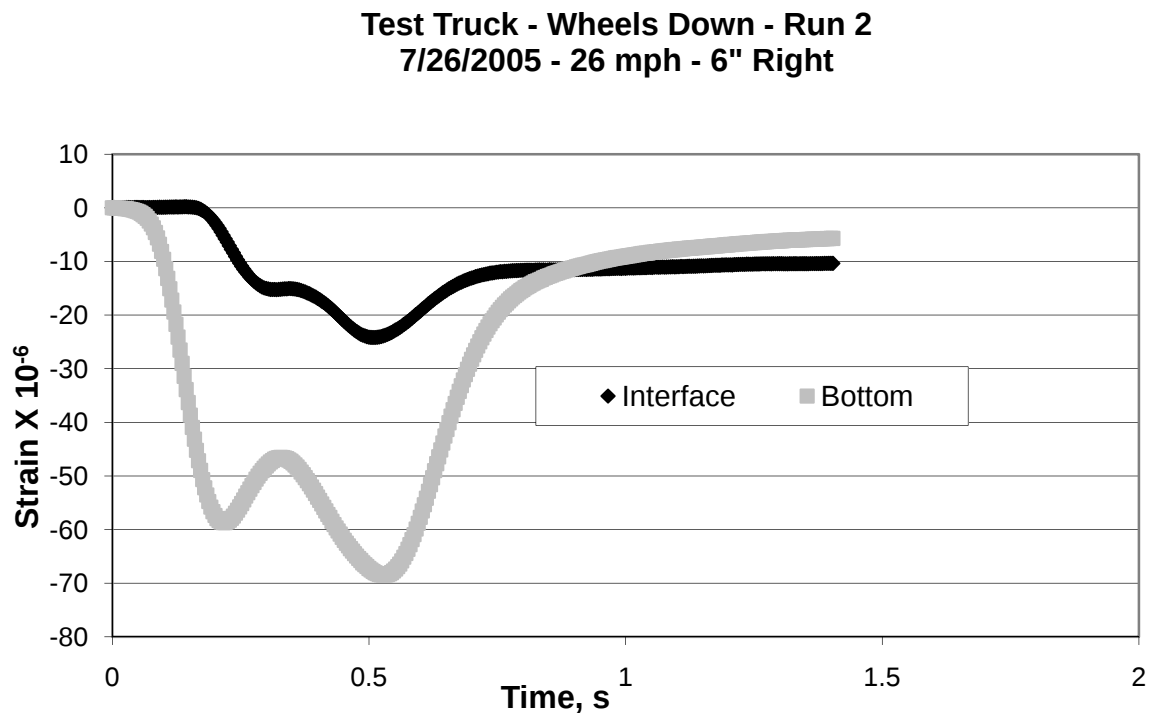
**Figure 12: Strain Measurement from Truck Run 2 – July 2005**

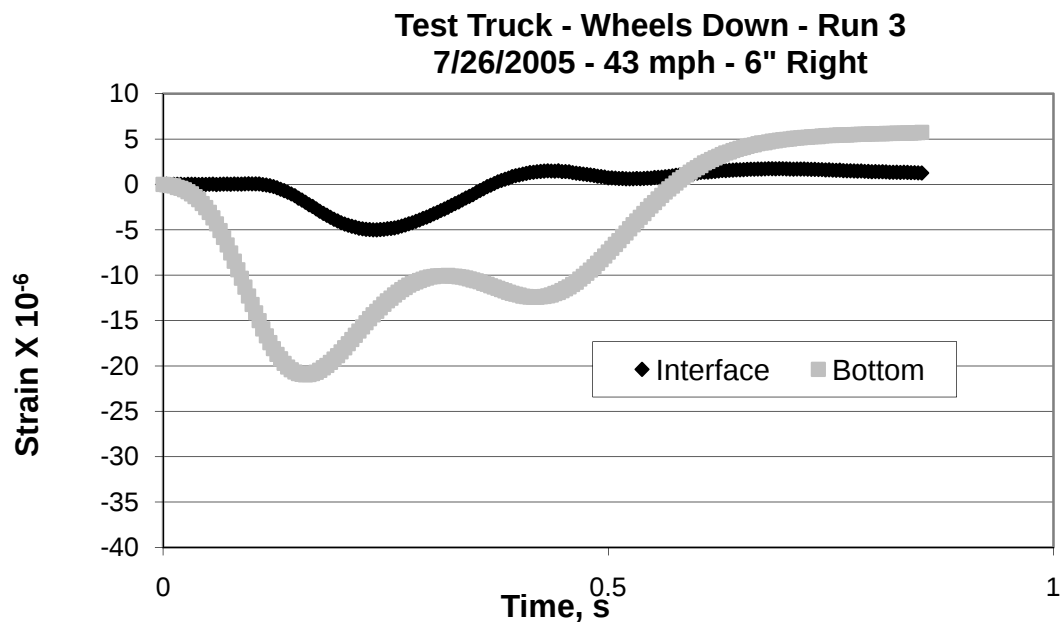
**Figure 13: Strain Measurement from Truck Run 3 – July 2005**

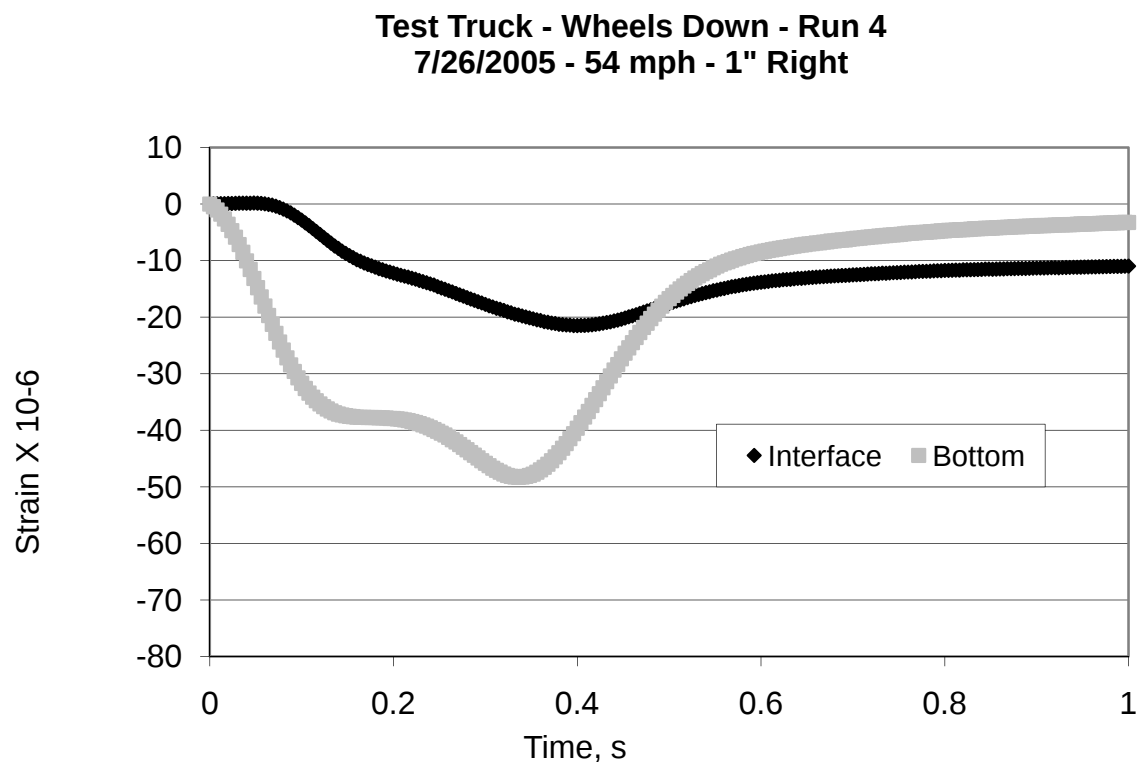
**Figure 14: Strain Measurement from Truck Run 4 – July 2005**

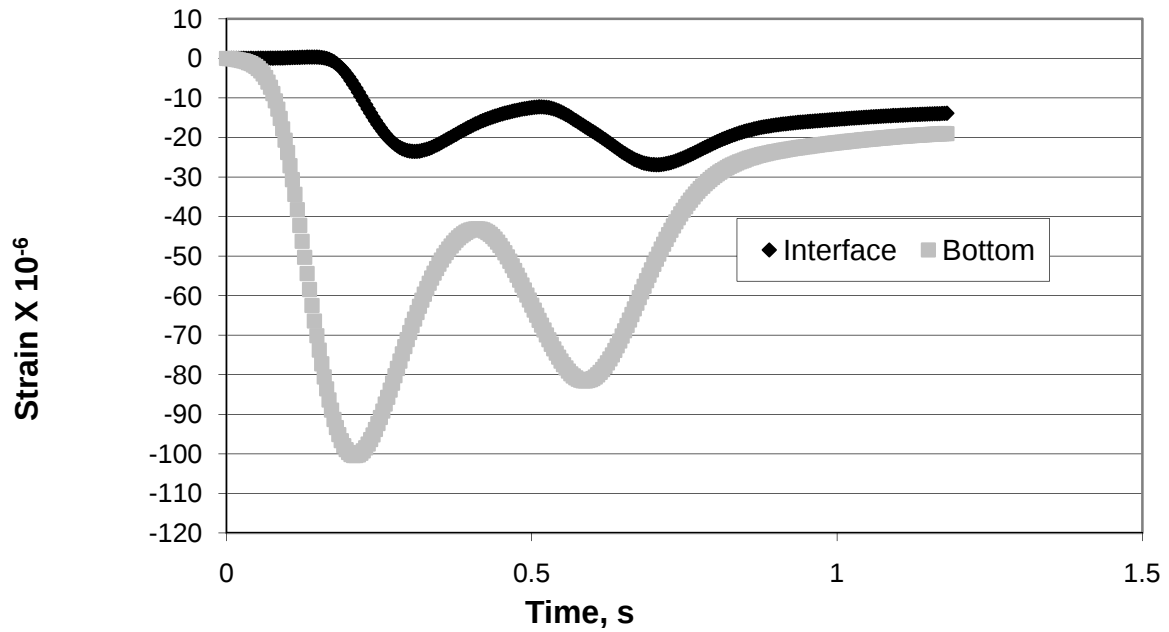
**Figure 15: Strain Measurement from Truck Run 5 – July 2005**

**Test Truck - Wheels Up - Run 2**  
**7/26/2005 - 39 mph - 5" Right**

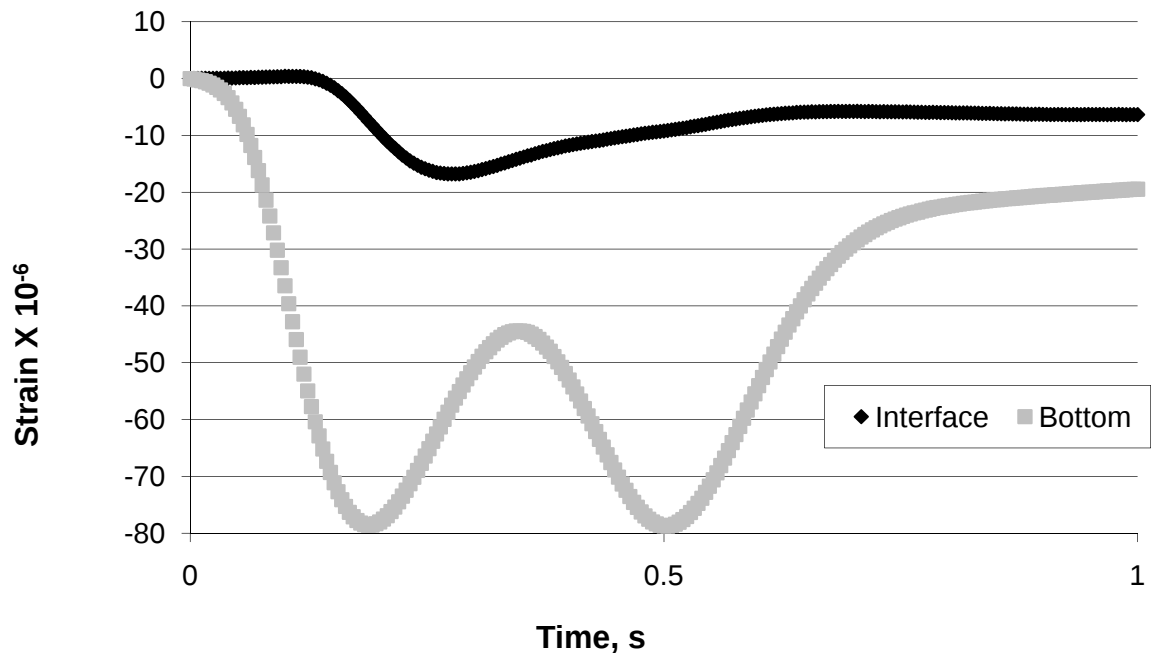
**Figure 16: Strain Measurement from Truck Run 6 – July 2005**

**Test Truck - Wheels Up - Run 3**  
**Kenosha 7/26/2005 - Speed Unknown - 13" Right**

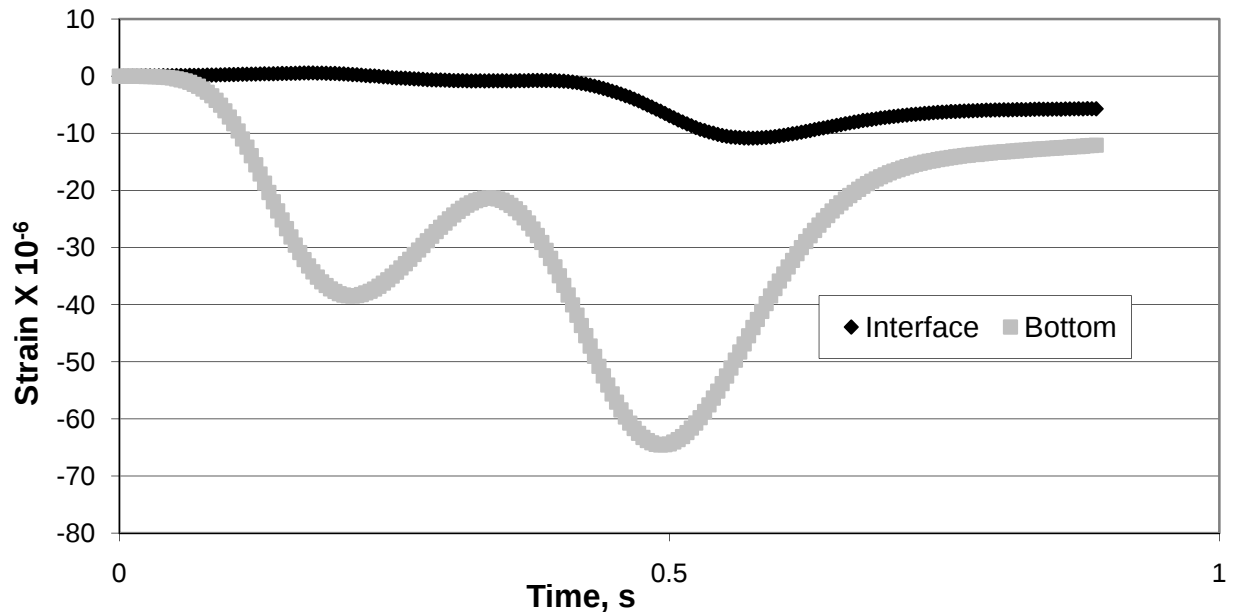
**Figure 17: Strain Measurement from Truck Run 7 – July 2005**

**Test Truck - Wheels Up - Run 4**  
**Kenosha 7/26/2005 - 52 mph - 8" Right**

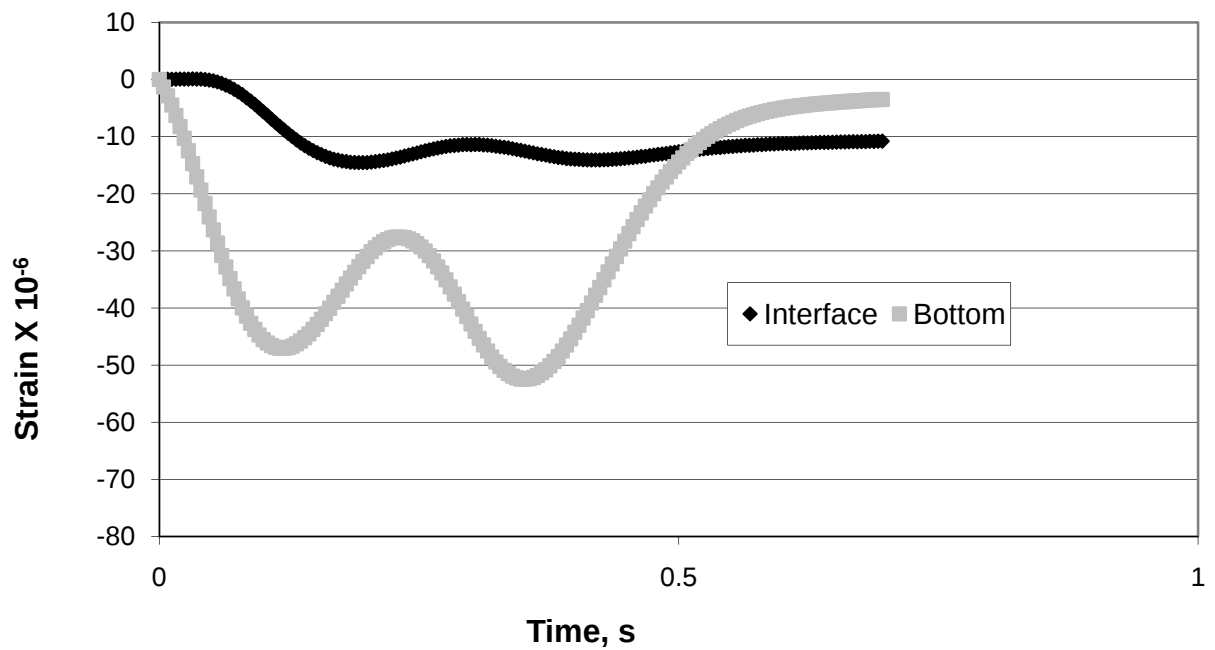
**Figure 18: Strain Measurement from Truck Run 8 – July 2005**

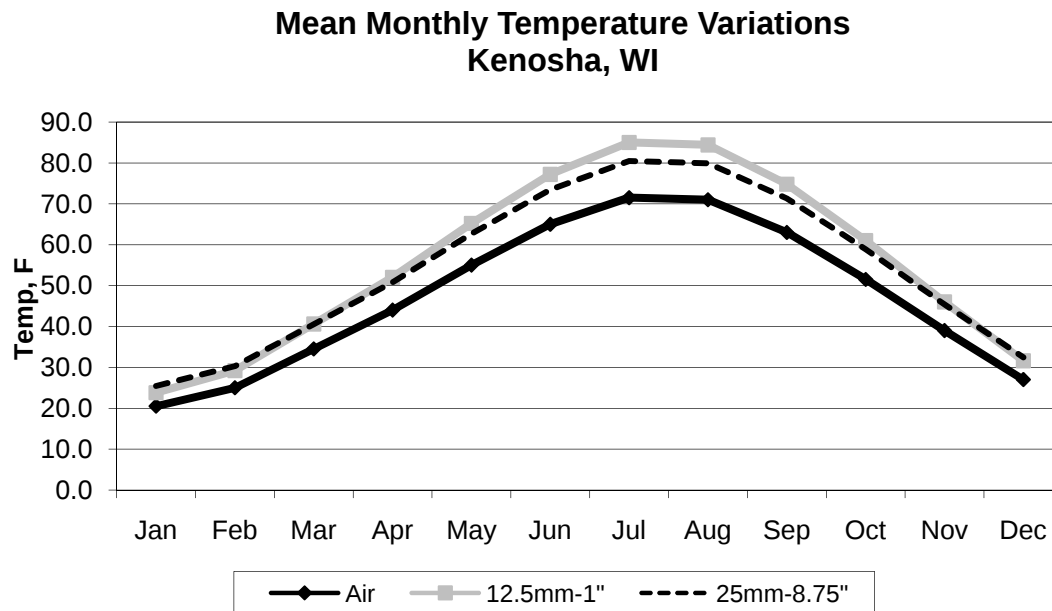
**Figure 19: Mean Monthly Temperature Variations for Kenosha, WI**

Figure 19 illustrates the variations in MMAT and MMPT established for Kenosha, WI.

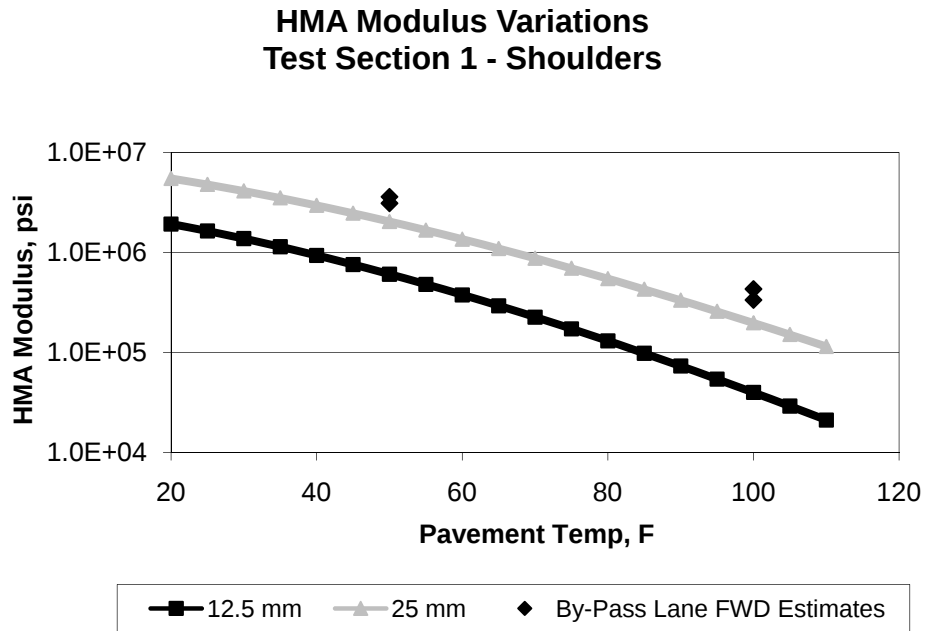
**Figure 20: Predicted HMA Moduli Variations for Test Section 1 Shoulders**

Equations for predicting the resilient HMA modulus versus NMA, pavement temperature, % voids and % AC were developed during WHP Project 0092-03-14 for the HMA shoulder layers used at the Kenosha facility. Figures 20 and 21 illustrate the trends in predicted HMA modulus versus pavement temperature based on the in-place % air voids and design % AC for the HMA shoulder in each test section. Also shown on Figure 20 are the FWD estimates of the by-pass lane combined  $E_{AC}$  layer values backcalculated from deflection data obtained during comparative strain measurements. As shown, the combined modulus estimated from the FWD data closely match the 25 mm NMA E-30X predicted modulus for Test Section 1. The bias of the 25 mm NMA

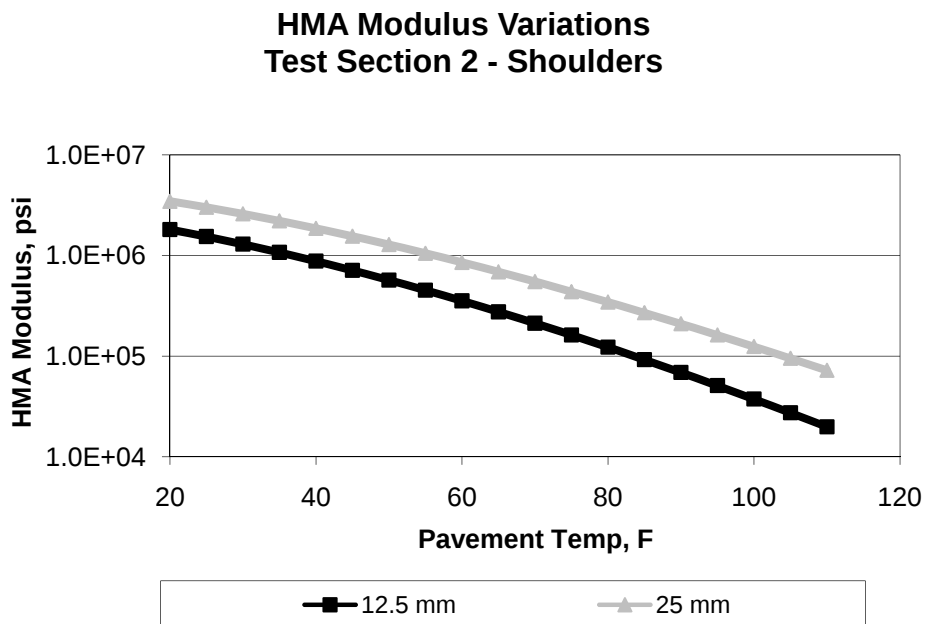
**Figure 21: Predicted HMA Moduli Variations for Test Section 2 Shoulders**

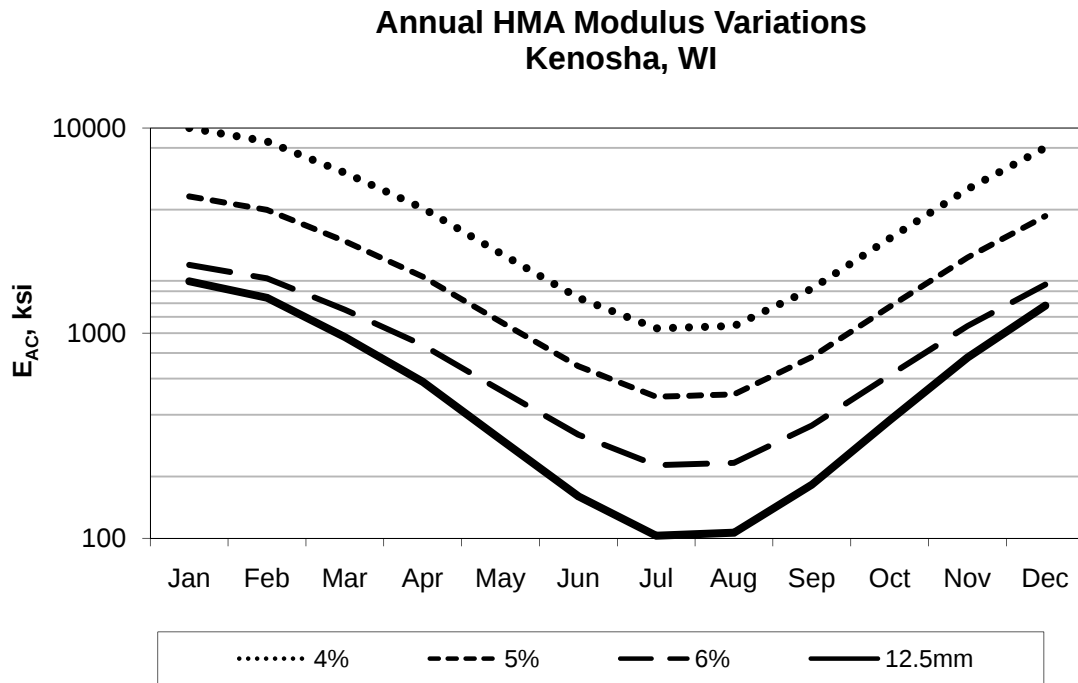
**Figure 22: Monthly HMA Moduli Trends for Layer Type**

The general trends of HMA modulus versus temperature were combined with the monthly pavement temperature variations typical for Kenosha, WI to develop a trend of average monthly HMA moduli values for the 12.5 mm surface layer at the design values of 6% air voids and for the 25 mm lower layers at air void contents ranging from 4% to 6%, as shown in Figure 22 and Table 6. It should be noted that the average monthly moduli values shown for September are significantly higher than values backcalculated during September 2003 FWD testing (Tables 1–3). This is due to the significant differences in the MMPT = 70°F and the FWD test temperature of 100°F. Conversely, the average monthly moduli values shown for October are less than those backcalculated from FWD testing in October 2003 (Table 4). This is again due to the difference in temperatures (MMPT = 59°F, FWD Test Temp = 50°F).
