### 2.4 SUPERSTRUCTURE

#### 2.4.1 Introduction

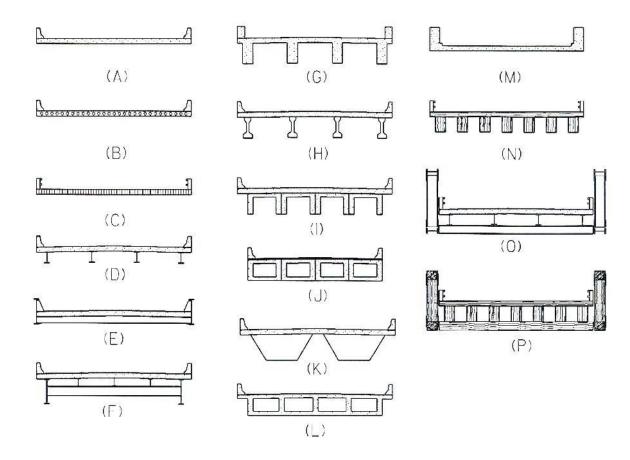
Figure 2.4.1-1: Common Superstructure Types – (A) Reinforced Concrete Flat Slab; (B) Reinforced Concrete Voided Slab; (C) Timber Slab; (D) Steel Multibeam; (E) Steel Through Girder; (F) Steel Girder/Floor Beam/Stringer; (G) Reinforced Concrete Tee Beam; (H) Prestressed Concrete I Beam; (I) Prestressed Concrete Channel; (J) Prestressed Concrete Box Beam; (K) Steel Box Girder; (L) Post-tensioned Concrete Box Girder; (M) Reinforced Concrete Through Girder; (N) Timber Multi-beam; (O) Steel Truss; (P) Timber Truss.

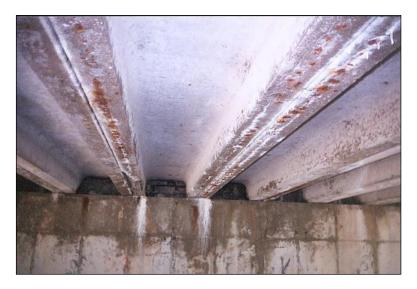
Figure 2.4.3-4: Deteriorated Prestressed Channel Beams.

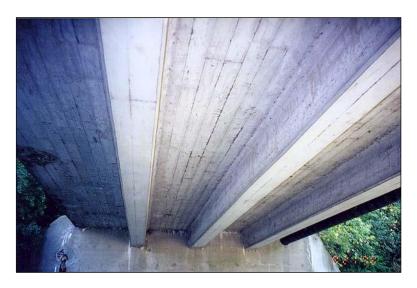
Figure 2.4.2.2-2: Reinforced Concrete Tee Beams – Condition State 1.

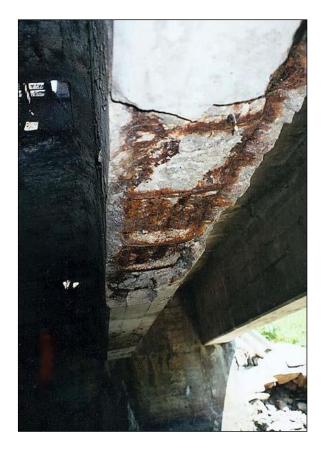
Figure 2.4.2.2-5: Reinforced Concrete Tee Beam – Condition State 4.

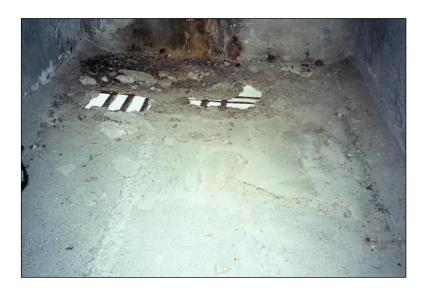
**Figure 2.4.2.2-7:** Reinforced Concrete Box Girder Bottom Flange Through Thickness Section Loss - Condition State 4.

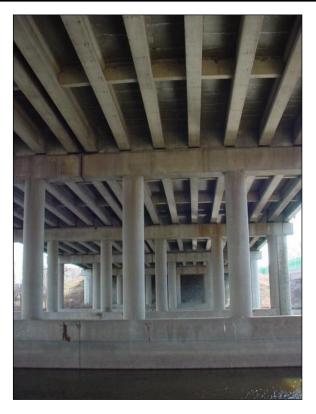
- 3. Prestressed I-beams and Bulb-Tees: Prestressed I-beams and bulb-tees are commonly precast members without voids. They make for efficient use of material by concentrating the concrete away from the beam's neutral axis where it is needed most for stiffness and strength. Concrete decks are often designed to act compositely with the I-beams. They are used for simple spans up to about 160 feet in length. They may also be made continuous over piers for live loads and secondary dead loads. This is done by placing conventional reinforcing steel longitudinally in the deck over the piers to resist negative bending. The main steel prestressing strands are placed parallel to traffic and located in the bottom flange of the beam. Conventional reinforcing steel ties are placed transversely along the beam for shear reinforcement. Secondary members of prestressed I-beam bridges include concrete diaphragms at the abutments and piers and either steel or concrete diaphragms within the spans.

Figure 2.4.3-1: Prestressed I-beams.

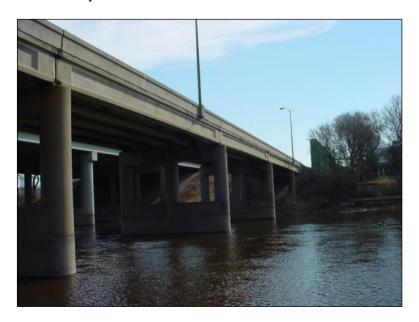
Figure 2.4.3.1-1: Prestressed Concrete I-Beam Bridge.

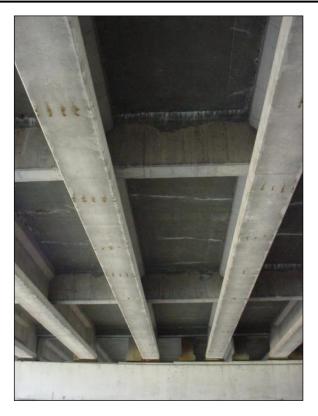
Figure 2.4.3.1-3: Prestressed I-Beams – Condition State 1.

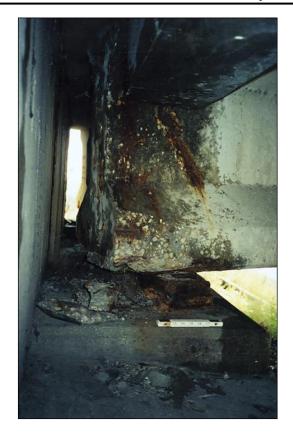
**Figure 2.4.3.1-5:** End of Prestressed I-Beam with Spalls and Exposed Strands and Rebar – Delamination/Spall/Patched Area Condition State 3.

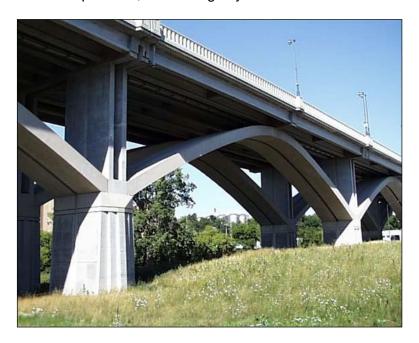
Prestressed arches are rare forms of the concrete arch. Arches are primary load-carrying elements that carry axial compressive stresses, as well as bending, tension, and compressive stresses. Normally, the axial loads are great enough on an arch that there are no net tensile stresses due to bending. When bending stresses are large enough to produce net tension, post-tensioning is used to pre-compress the arch cross-section. This keeps the entire cross-section in compression, eliminating any net tensile stress.

Figure 2.4.3.2-1: Open Spandrel Prestressed Arch Bridge with Struts.

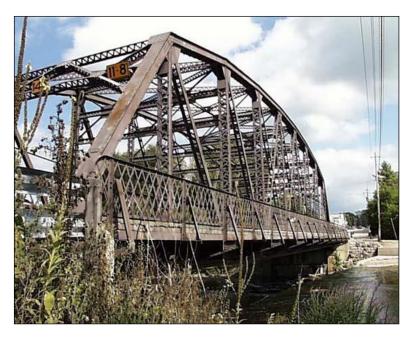
6. Trusses: Truss bridges are structures with two or more parallel trusses being the main load-carrying members. The deck may be placed on top of the trusses (deck truss) or between the trusses (through truss when there is overhead lateral bracing or a pony truss when there is no overhead lateral bracing). Through or pony trusses are most often constructed using two trusses, and therefore are considered NSTM structures. Deck trusses are constructed with two or more trusses. Only two truss deck trusses are NSTM structures. Truss chord, diagonal, and vertical members may be fabricated from eyebars, rolled shapes, or built-up members. Connections are made with rivets, bolts, welds, and pin connections. All truss bridges have floor systems similar to two-girder systems. To keep the two trusses in line longitudinally, secondary lateral bracing members diagonally connect the bottom chords. For deck and through trusses, the top chords are connected the same way. Sway bracing keeps the two trusses in line laterally. On deck and through trusses, sway bracing transversely frames between the truss verticals. On through trusses, sway bracing may limit vertical clearances. On pony trusses, sway bracing is usually placed as a transverse diagonal on the outside of the trusses. It connects the top chord to transverse "outrigger" floor beam extensions and functions to prevent buckling of the top chord.

Figure 2.4.4-6: Steel Truss Bridge.

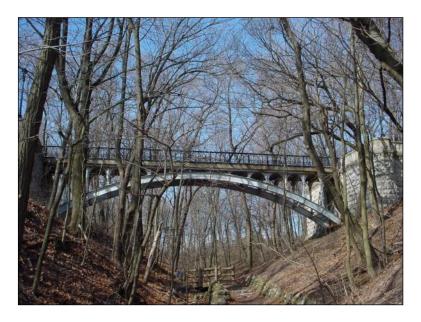
Figure 2.4.4-7: Steel Deck Arch Bridge.

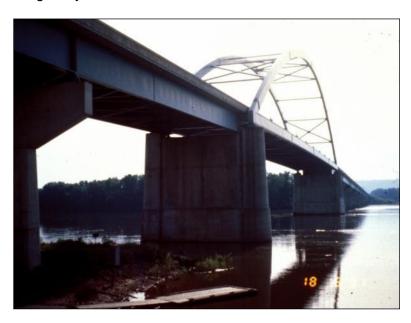
girder will directly lead to a failure of its associated arch. The tie girder may also behave as a bending member, in conjunction with the ribs, to deliver dead and live gravity loads to the pier. Primary and secondary members of tied arches are similar to those of through arches, although the arch ribs are typically solid box shaped elements. Floor beams frame directly into the webs of the tie girders, and cables or hangers (solid or hollow) directly support the tie girder. The hangers may be oriented vertically or diagonally.

Figure 2.4.4-8: Steel Tied Arch Bridge.

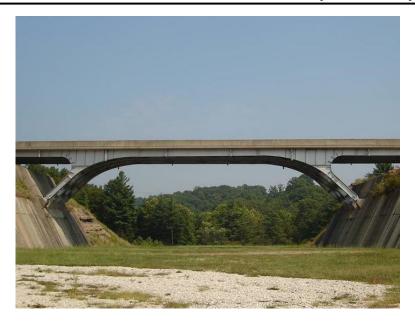
10. Rigid frames: Rigid frame bridges are structures in which the structure's inclined supporting "legs" are integrated with the girders to form a rigid frame. Rigid frames are usually constructed using welded plate girders and legs to form a "K" shape or, in some instances, an inverted triangular delta shape. Though the legs are used as bridge piers, the legs are actually part of the superstructure because of their rigid connection to the girders. This rigid intersection of the leg and girder is referred to as the knee and allows both the girders and legs to resist bending moments. Large moments and shear forces are resisted by the knee, resulting in a complex arrangement of stiffeners in this area. The legs are pinned at grade, and the girder ends supported by conventional abutments. Rigid frame bridges may use two or more frames to support the deck. The girders, legs, and bearings are all primary members on multi-rigid frame. Secondary members are the diaphragms, cross-frames, longitudinal stiffeners, transverse stiffeners, and radial stiffeners. Spans 50 to 200 feet are attainable using rigid frames.

Figure 2.4.4-9: Steel Rigid Frame Bridge.

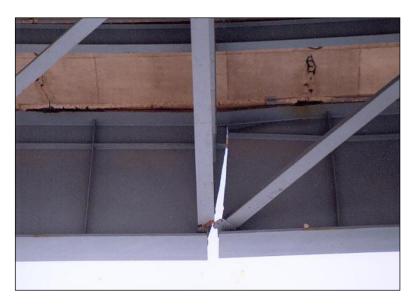
Figure 2.4.4.1-3: Girder Failure Due to Brittle Cracking – Condition State 4.

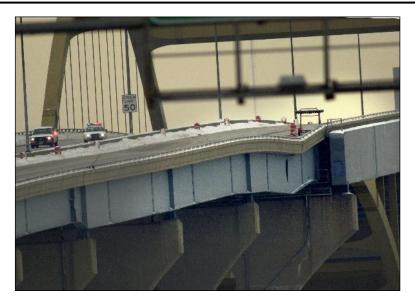
Figure 2.4.4.1-4: Girder Failure Due to Brittle Cracking – Condition State 4.

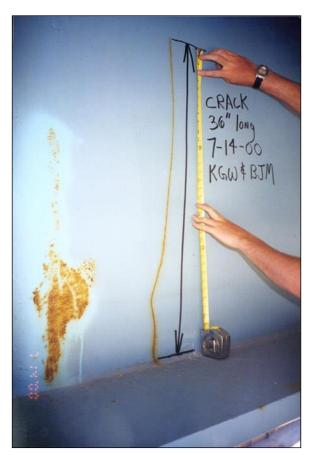
Figure 2.4.4.1-5: Brittle Crack 3 Feet Long in a Girder Web 10 Feet Deep, Opposite of Lower Lateral Shelf Plate -Condition State 4.

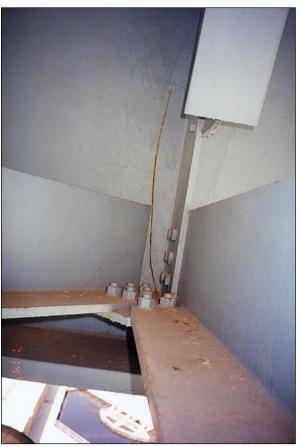
**Figure 2.4.4.1-6:** Same Crack as shown in Figure 4.75, Inside Face of Girder at Lower Lateral Shelf Plate - Condition State 4.

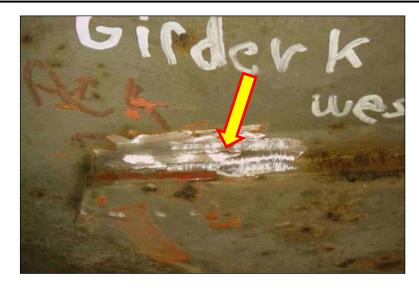
**Figure 2.4.4.1-7:** Fatigue Crack at a Welded Cover Plate End (Rust Line within the Ground Area).

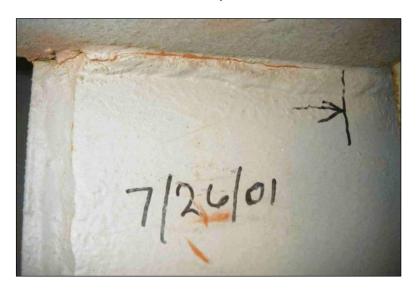
Figure 2.4.4.1-8: Rust Line at Weld Toe Indicating a Fatigue Crack.

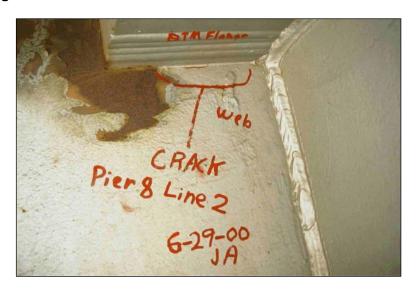
**Figure 2.4.4.1-10:** Fatigue Crack at the Girder Bottom Flange/Cross Girder Web Connection.

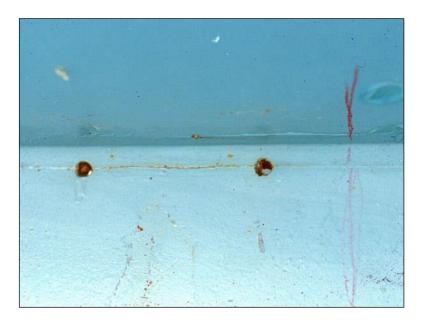
**Figure 2.4.4.1-12:** Fatigue Crack at Flange/Web Intersection Arrested with Drilled Holes - Condition State 2.

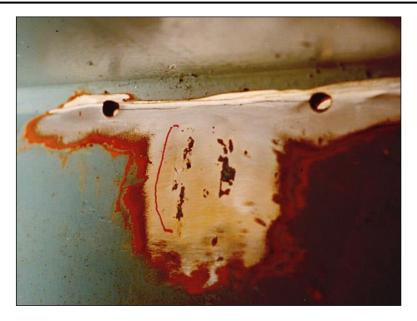
**Figure 2.4.4.1-13:** Fatigue Crack at Flange/Web Intersection After Cleaning – Condition State 2.

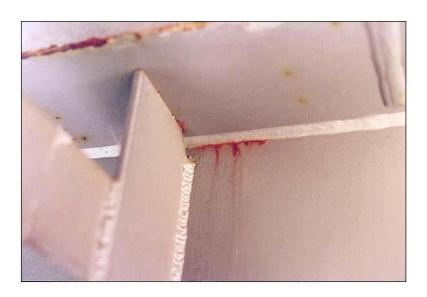
**Figure 2.4.4.1-14:** Fatigue Crack Indicated by "Fretting Corrosion" Rust Stains Along a Longitudinal Fillet Weld - Condition State 3.

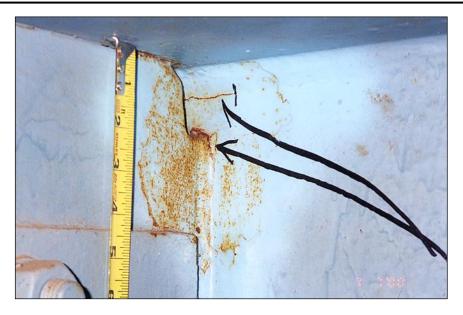
**Figure 2.4.4.1-15:** Double Fatigue Cracks in Girder Web, Top of Connection Plate – Condition State 3.

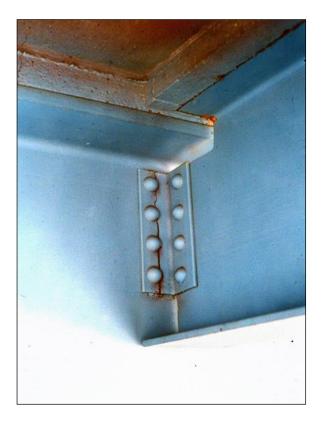
**Figure 2.4.4.1-16:** Fatigue Crack Through the Rivet Line of a Connection Angle - Condition State 3.

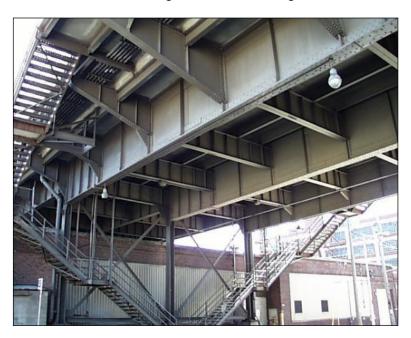
Figure 2.4.4.1-19: Fabricated Steel Girders and Floor Beams, and Rolled Stringers.

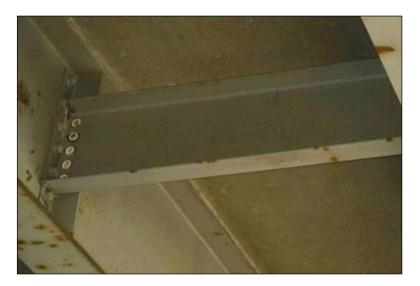
Figure 2.4.4.1-20: Sheared Off Diaphragm Bolts Due to Fatigue.

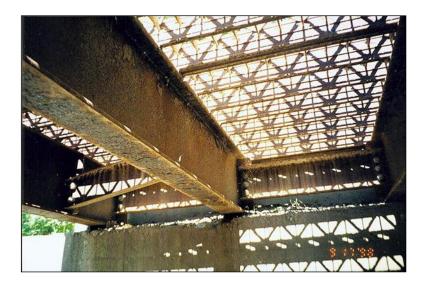
**Figure 2.4.4.1-21:** Weathering Steel Girders with Scaling on the Bottom Flanges – Condition State 3.

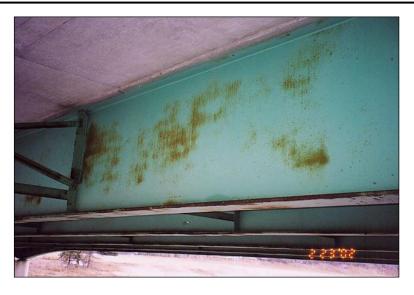
Figure 2.4.4.1-23: Girder – Corrosion Condition State 2.

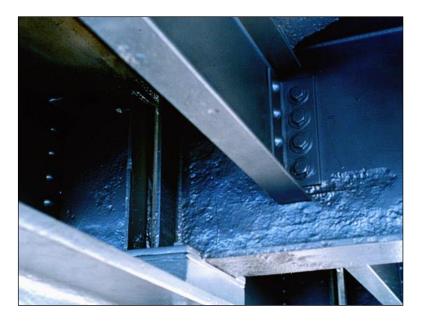
Figure 2.4.4.1-32: Section Loss on Girder Web Painted Over – Corrosion Condition State 3.

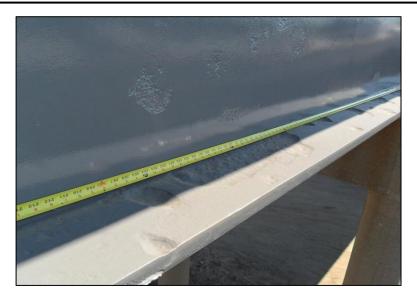
**Figure 2.4.4.1-33:** Severe Pitting Along Bottom Flange Painted Over – Corrosion Condition State 4.

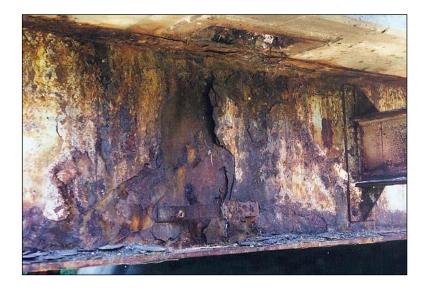
Figure 2.4.4.1-34: Laminate Section Loss of Web – Corrosion Condition State 4.

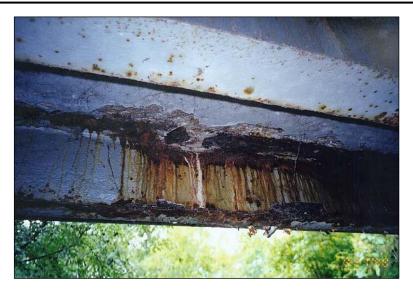
Figure 2.4.4.1-35: Steel Rolled Beams – Corrosion Condition State 4.

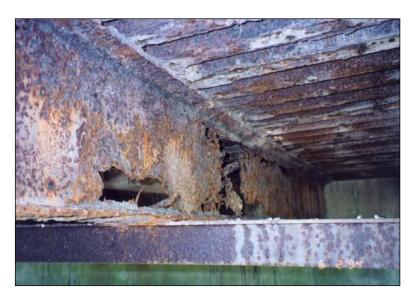
Figure 2.4.4.1-36: Steel Beam – Corrosion Condition State 4.

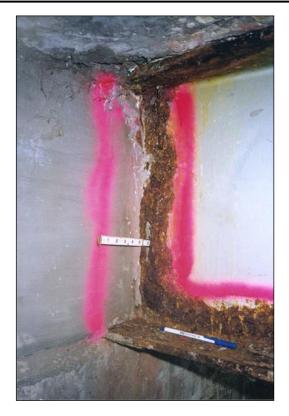
**Figure 2.4.4.1-37:** Through Thickness Section Loss of a Rolled Beam Web - Condition State 4.

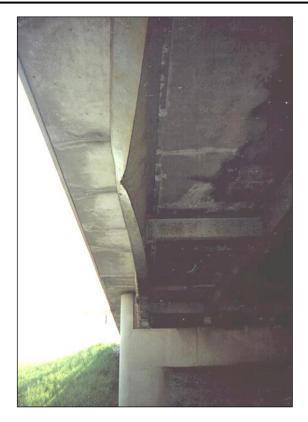
Figure 2.4.4.1-39: Impact Damage to Exterior Girder – Distortion Condition State 4.

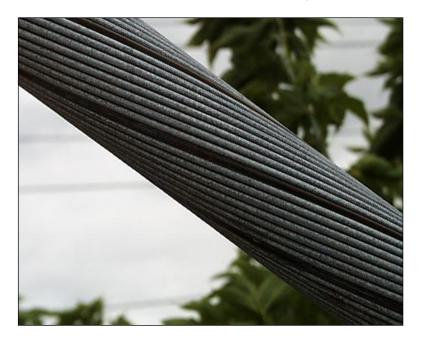
Figure 2.4.4.2-2: Galvanized Steel Cable – Condition State 1.

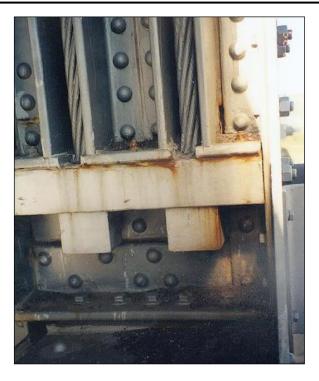
Figure 2.4.4.2-3: Cable Anchorage for a Tied Arch Bridge – Condition State 1.

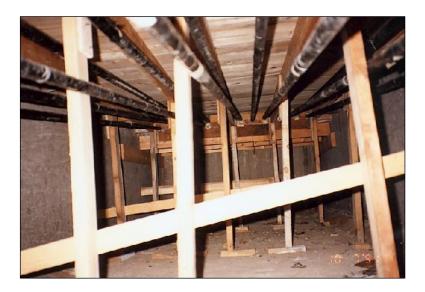
**Figure 2.4.4.3-1:** Exposed Post Tensioning Rods Inside of a Concrete Box Girder - Condition State 1.

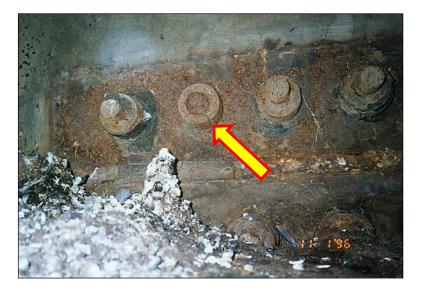
**Figure 2.4.4.3-4:** End of Post-Tensioning Rod with Cracked Nut – Connection Condition State 3.

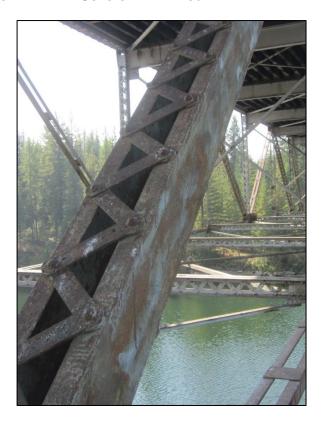
**Figure 2.4.4.4-3:** Diagonal Truss Member Exhibiting Rust with No Loss of Section – Corrosion Condition State 2.

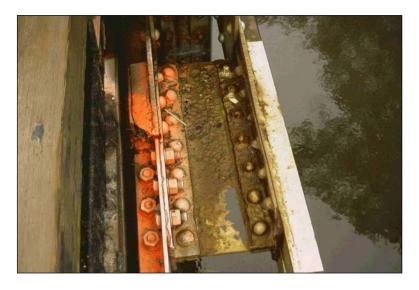
Figure 2.4.4.4-4: Batten Plate on Truss Bottom Chord – Connection Condition State 4.

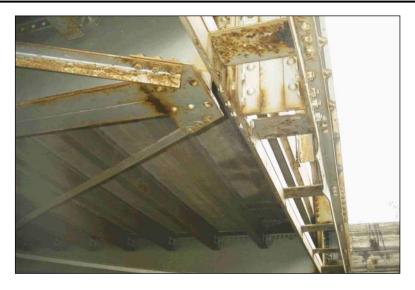
Figure 2.4.4.4-5: Truss Bottom Chord (Note Impact Damage) – Distortion Condition State 2.

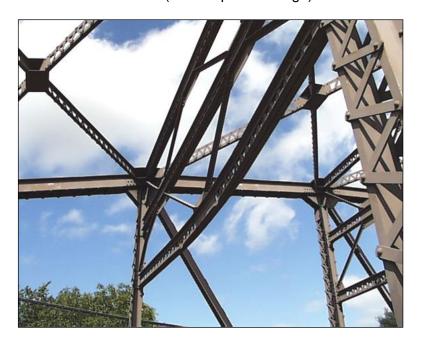
Figure 2.4.4.4-6: Impact Damage to a Truss Sway Strut – Distortion - Condition State 2.

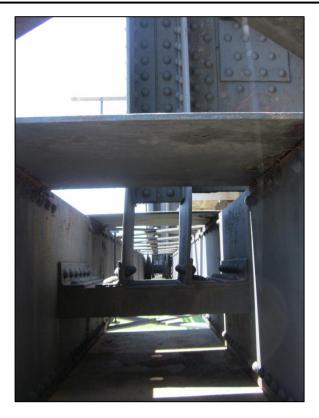
**Figure 2.4.4.5-1:** Vertical to Bottom Chord Gusset Plate Deformed Out-of-Plane – Distortion Condition State 2.

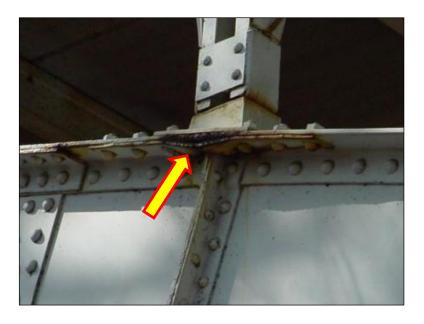
**Figure 2.4.4.6-2:** Pack Rust at Riveted Steel Arch Flange Plates – Connection Condition State 3.

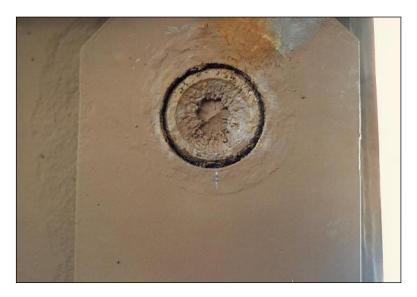
Figure 2.4.4.7-3: Pin Shear Failure.

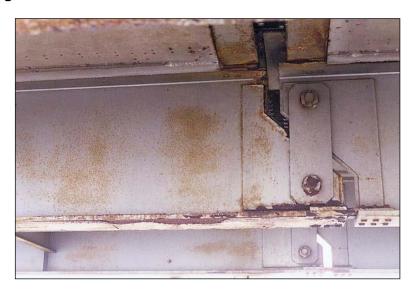
Figure 2.4.4.7-5: Girder, Pin, and Hanger – Corrosion Condition State 2.

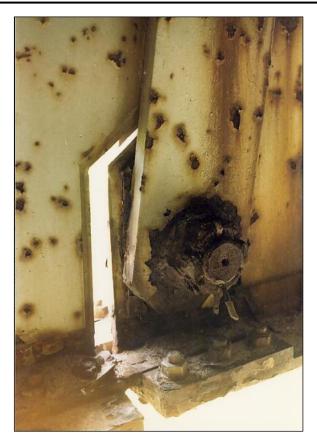
Figure 2.4.4.7-6: Pin and Hanger – Corrosion Condition State 4.

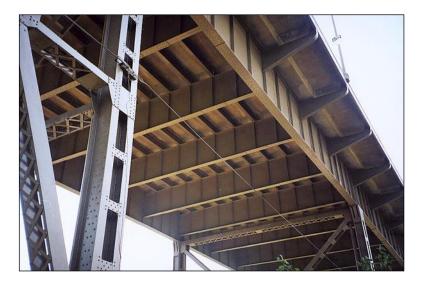
Members are classified as being either nonredundant steel tension member (NSTM) or non-NSTM. Per CFR 23 Subpart C 650.305, a nonredundant steel tension member is, "A primary steel member fully or partially in tension, and without load path redundancy, system redundancy or internal redundancy, whose failure may cause a portion of or the entire bridge to collapse." Superstructures that have one or two primary load-carrying members spanning between supports that are in tension or have a tension component are not load path redundant. This means that failure of one of these primary members will likely cause a collapse of the entire structure. Superstructures that have three or more primary load-carrying members spanning between supports are non-NSTM. These members are load path redundant, which means that if one of the primary members fails, the loads it carries can be redistributed to the remaining primary members, thereby preventing a total collapse.

Figure 2.4.4.8-1: NSTM Two-Girder Bridge.

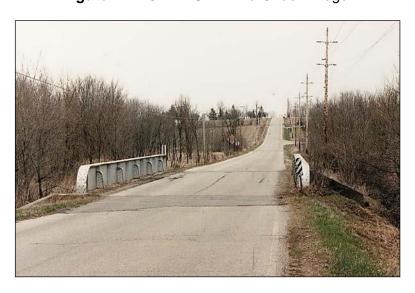
Figure 2.4.4.8-2: NSTM Through Girder Bridge.

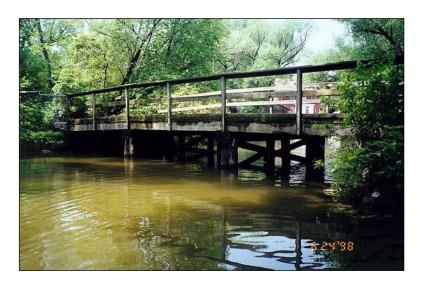
Figure 2.4.5-3: Solid Sawn Multi-beam Bridge.

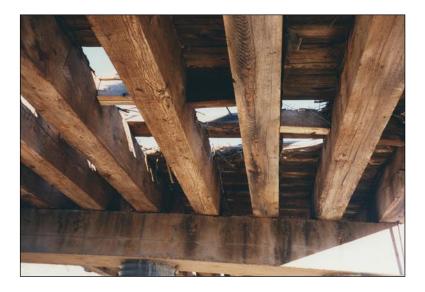
**Figure 2.4.5.1-2:** Timber Beams – Decay/Section Loss Condition State 1.

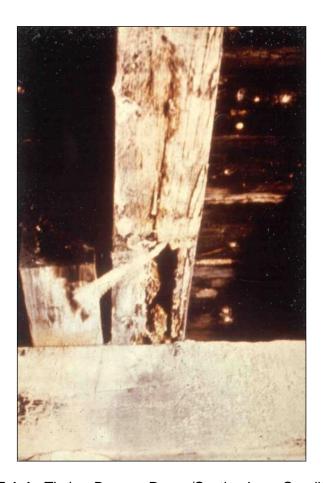
Figure 2.4.5.1-4: Timber Beam – Decay/Section Loss Condition State 4.

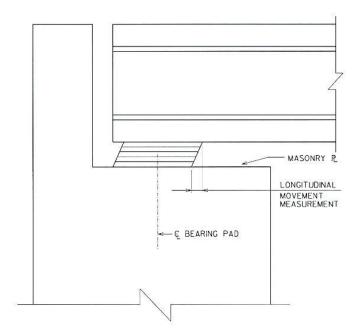
- Checking for cracking or spalling of the abutment and pier surfaces near the bearing pad.
- Checking for any elongation of the pad length at the masonry plate for plain pads. Elongation is the result of increased shear strain that can lead to shear failure. If a plain pad is designed/constructed too thick or if the bearing loads are too high, the pad may exhibit bulging or splits.

**Figure 2.4.8.1-1:** Elastomeric Bearing Movement Measurement.

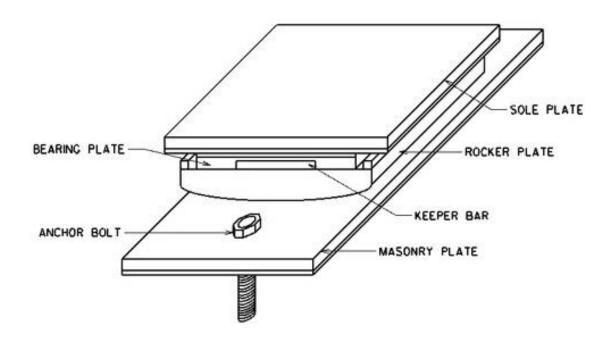
pintles keep it aligned. Keeper bars and ridges on the rocker plate restrain the bearing plate from walking out of position.

Figure 2.4.8.2-1: Sliding Plate Bearing.

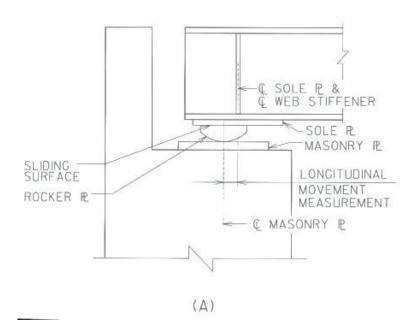
direction for the ambient temperature is also undesirable. Improper alignment may allow the roller to roll off of its bearing surface or roll out from under the girder on days of temperature extremes, allowing the superstructure to drop several inches.

Figure 2.4.8.2-3: Expansion Bearing Movement Measurements.

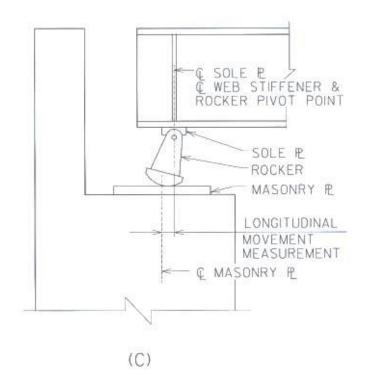
Figure 2.4.8.2-5: Expansion Bearing Movement Measurements.

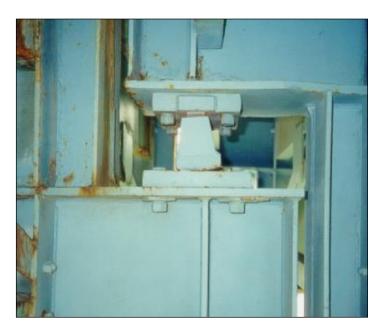
Figure 2.4.8.2-6: Rocker Bearing – Condition State 1.

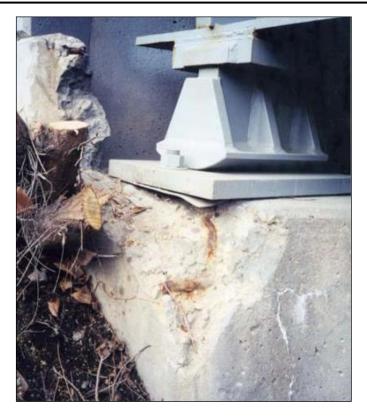
Figure 2.4.8.2-7: Rocker – Loss of Bearing Area Condition State 2

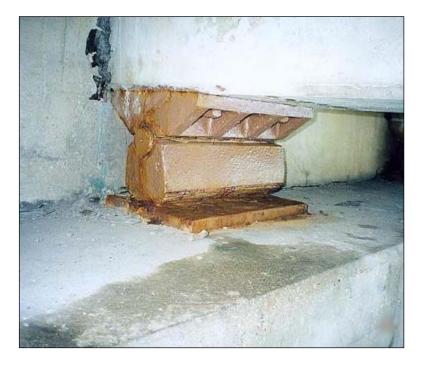
Figure 2.4.8.2-8: Rocker Bearing – Corrosion Condition State 2.

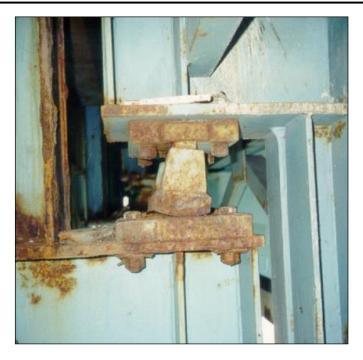
Figure 2.4.8.2-9: Rocker Bearing – Condition State 2.

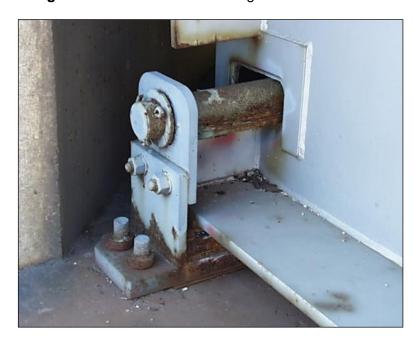
Figure 2.4.8.2-10: Hold-Down (Restraining) Bearing - Corrosion Condition State 2.

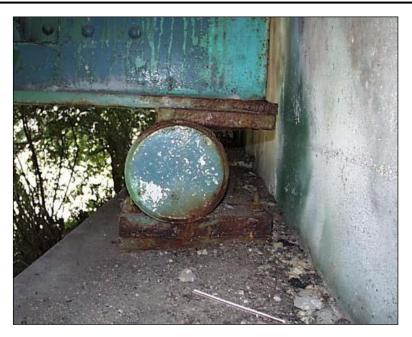
Figure 2.4.8.2-11: Critically Misaligned Roller Bearing – Alignment Condition State 3.

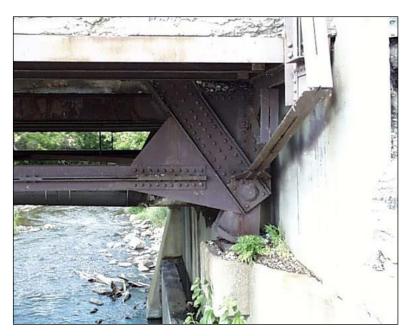
**Figure 2.4.8.2-12:** Rocker Bearing – Movement Condition State 3.

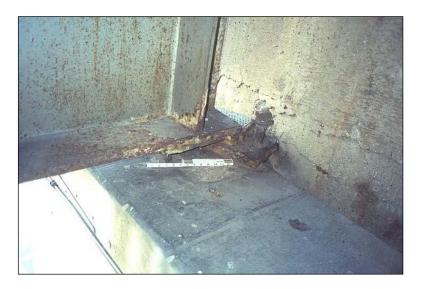
**Figure 2.4.8.2-14:** Masonry Plate Walkout Due to Failed Anchor Bolt – Connection Condition State 3.

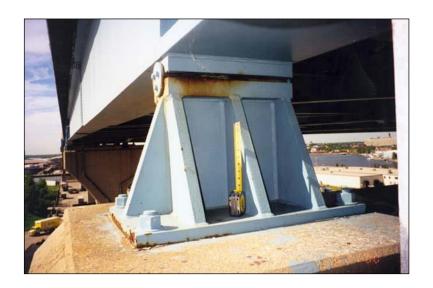
Figure 2.4.8.3-1: Fixed Shoe Bearing - Condition State 1.

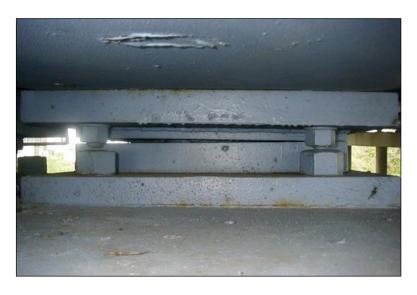
Figure 2.4.8.4-2: Tipped Pot Bearing – Movement Condition State 2.
