## PRELIMINARY ALTERNATIVES

### Spot Improvement Concepts: WIS 35 & Clinton St Intersection

## WIS 35 & Clinton St. Intersection

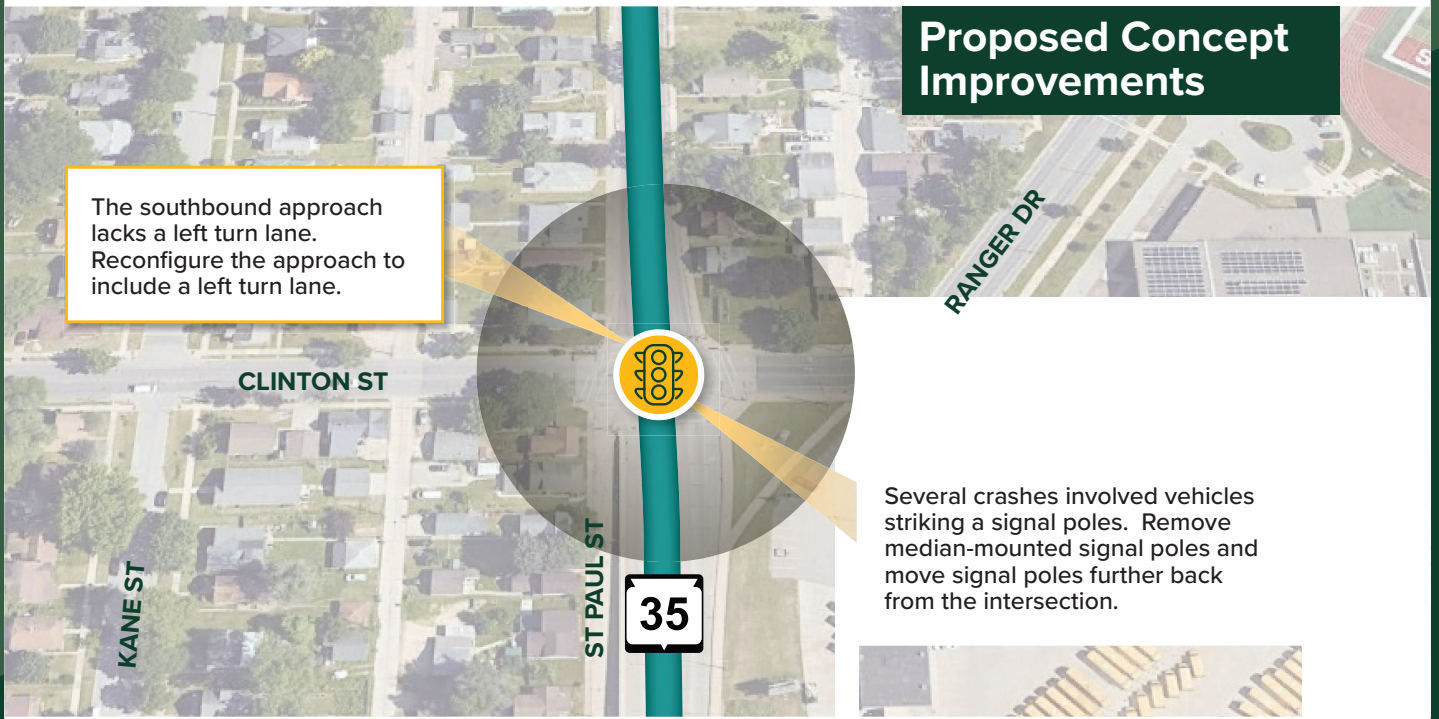
The WIS 35 & Clinton St intersection has one of the higher number of crashes within the WIS 35 corridor. This intersection has some geometric features that contribute to safety concerns for vehicular traffic, bicyclists, and pedestrians.

The sidewalk along the west side of WIS 35 ends short of the crosswalk. Pedestrians reaching the end of the sidewalk cannot activate the pedestrian signals. Opportunities to improve this situation will be explored.
