PRELIMINARY ALTERNATIVES

Spot Improvement Concepts: Bicycle/Pedestrian Crossing Safety

Bicycle / Pedestrian Crossing Safety

University of Wisconsin - La Crosse Campus Area

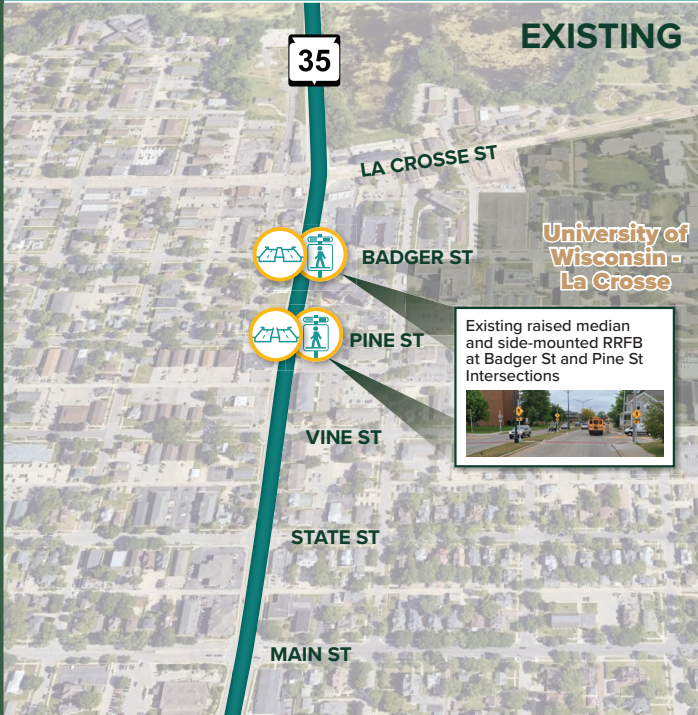
Existing

Bicycle/Pedestrian crossing safety is a concern near the UW-La Crosse campus. The unsignalized Badger St, Pine St, and Vine St intersections are among the intersections with highest number of crashes along the WIS 35 corridor, and the majority of crashes at these intersections involve a bicycle or pedestrian. Crossing enhancements that have already been implemented are in the map above.

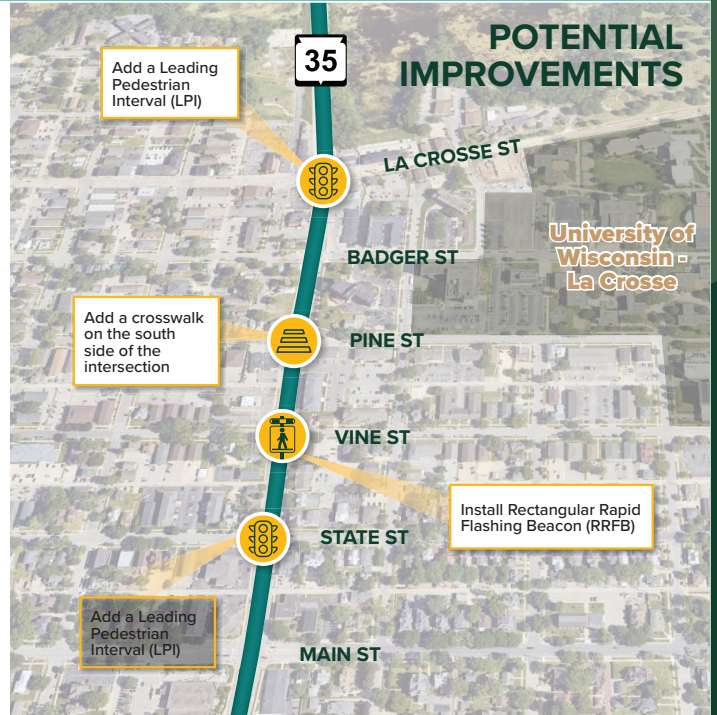
Potential Improvements

WisDOT has been brainstorming potential improvements that could improve crossing safety at these location and at nearby signalized intersections. Site-specific potential improvements are displayed in the map above. In addition, potential improvements to be considered at the unsignalized WIS 35 intersections with Vine St, Pine St, and Badger St include the following four items shown below:
