Concrete Joint Sawing Practices and Impacts on Durability

This brief summarizes Project 0092-16-01, “Joint Sawing Practices and Effects on Durability” Wisconsin Highway Research Program

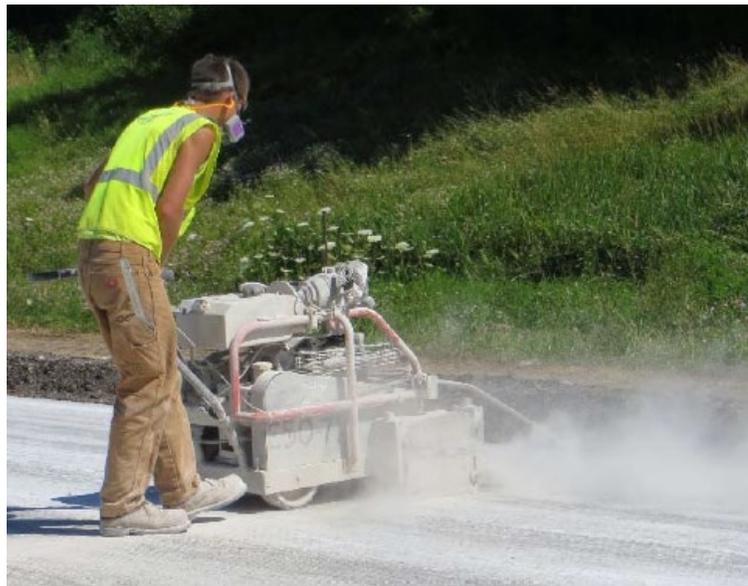
Performing an early-entry saw cut
