# When to Rubblize Before Overlay: Performance-Based Guidelines

*This brief summarizes Project 0092-05-07, "Guidance, Parameters, and Recommendations for Rubblized Pavements," produced through the Wisconsin Highway Research Program for the Wisconsin Department of Transportation Research Program, 4802 Sheboygan Ave., Madison, WI 53707.*

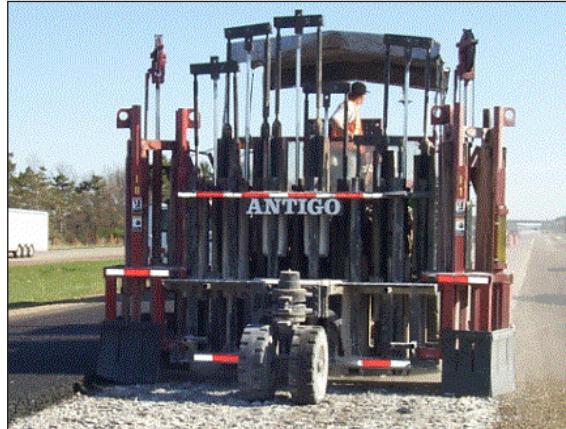
Machines such as guillotines, frequency breakers and this multiple drop hammer unit can pound portland cement concrete into rubble prior to overlay with hot-mix asphalt.
